# **Barn at 2 Lodge Lane, Cronton, Knowsley**

Level 2 Historic Building Record

661544

**JULY 2018**

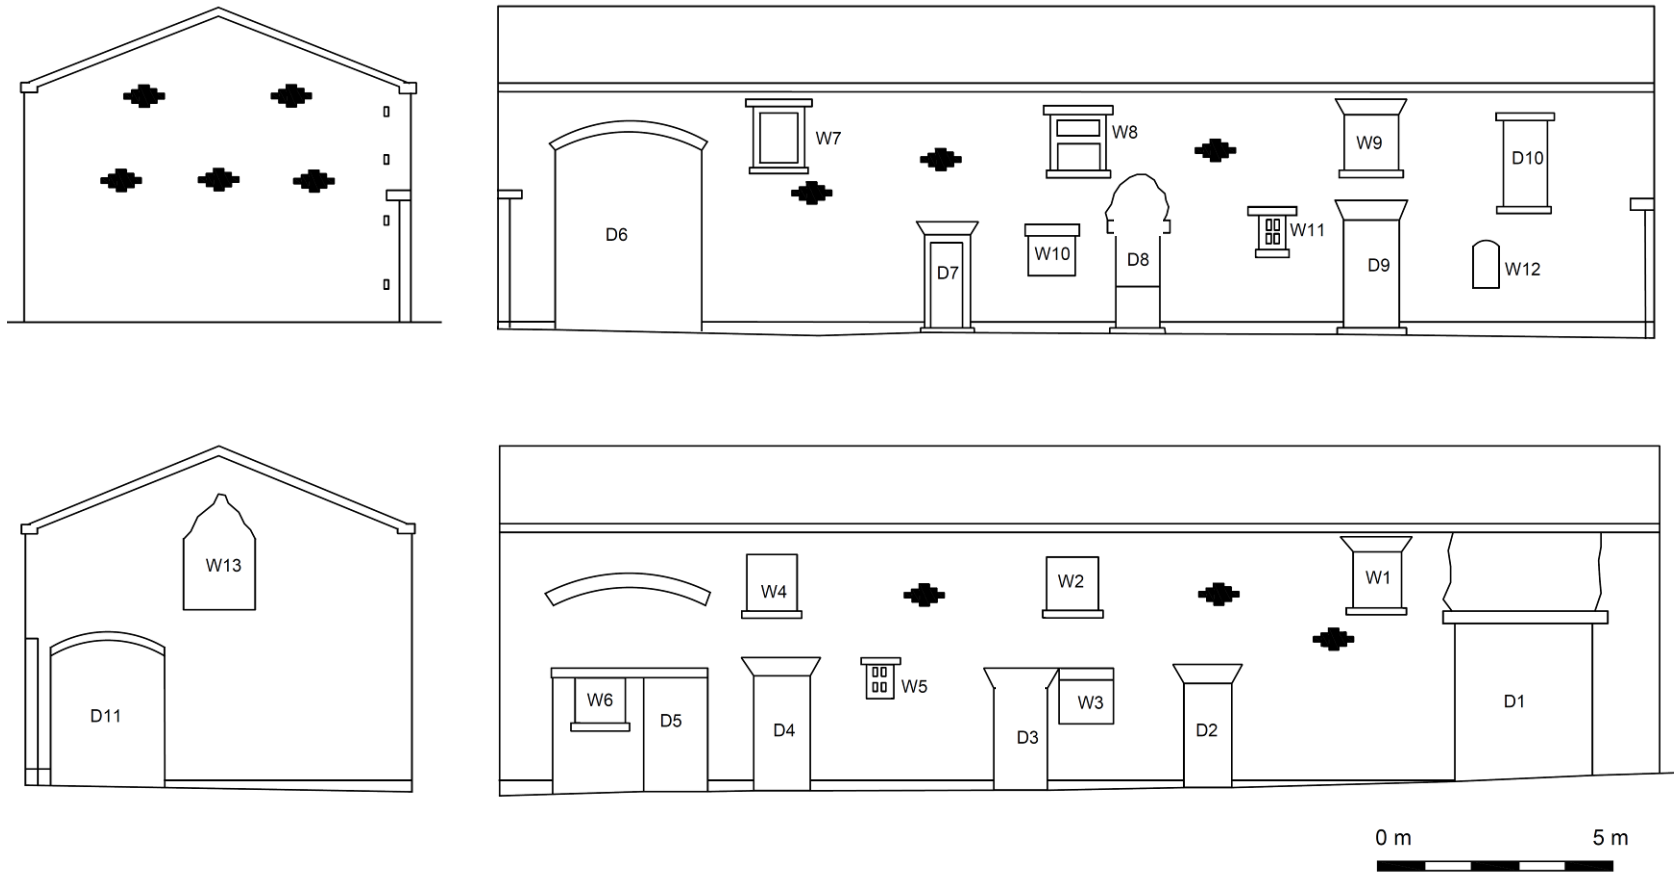
**Figure 11: Elevations with brick/sandstone detailing outlined. ID blocked doors and windows discussed in text**  
**TOP LEFT – North East Elevation**  
**TOP RIGHT – North West Elevation (yard side)**  
**BOTTOM LEFT – South West Elevation**  
**BOTTOM RIGHT – South East Elevation (road side)**

- 6.5 The barn is of a single phase of construction but has been extensively modified throughout its use. Openings have been blocked, or historically modified before being blocked; these are labelled on Figure 10 and discussed below.

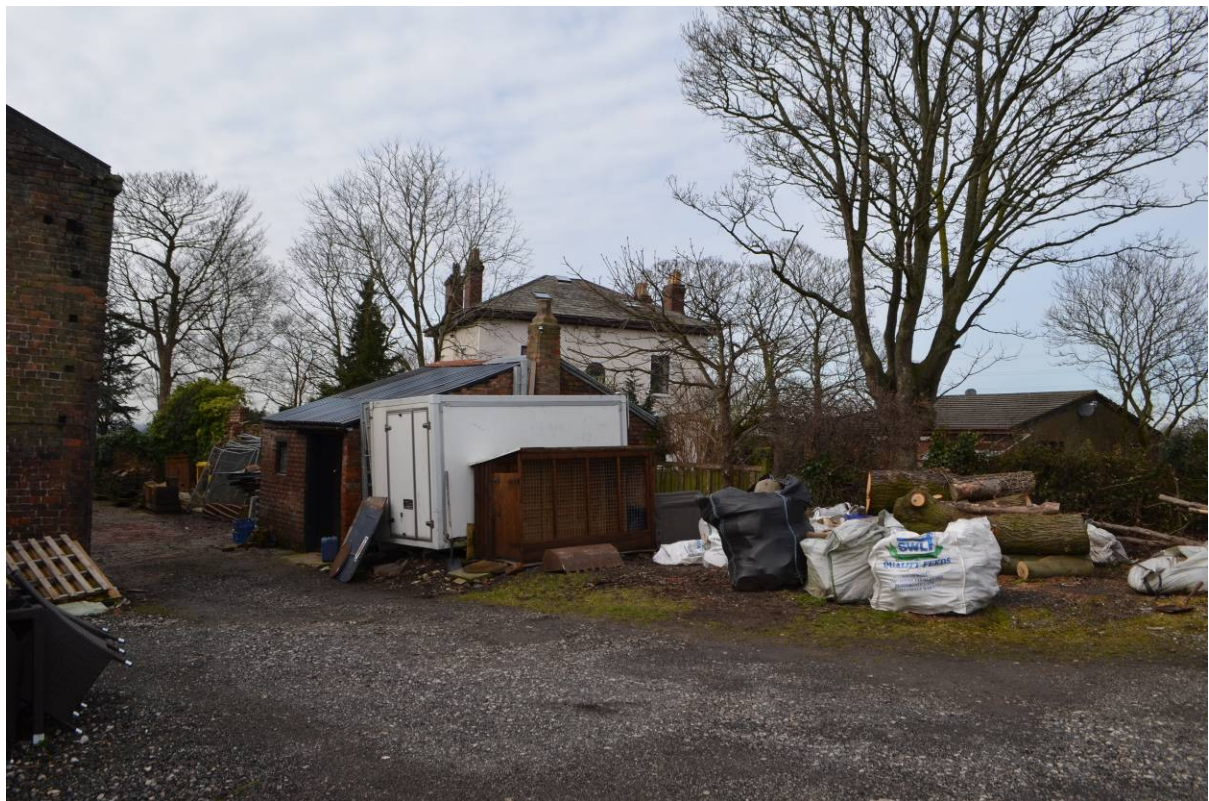
Report 661544: Barn at 2 Lodge Lane, Cronton: Level 2 Historic Building Record		Photographic Survey
Client: Mr P. Walton	Photo No. <b>003</b>	Date: 09.03.18	Direction Taken: NE

General context of barn, looking north east from the barn and showing evidence of demolished range of buildings as brickwork projecting from outbuilding.

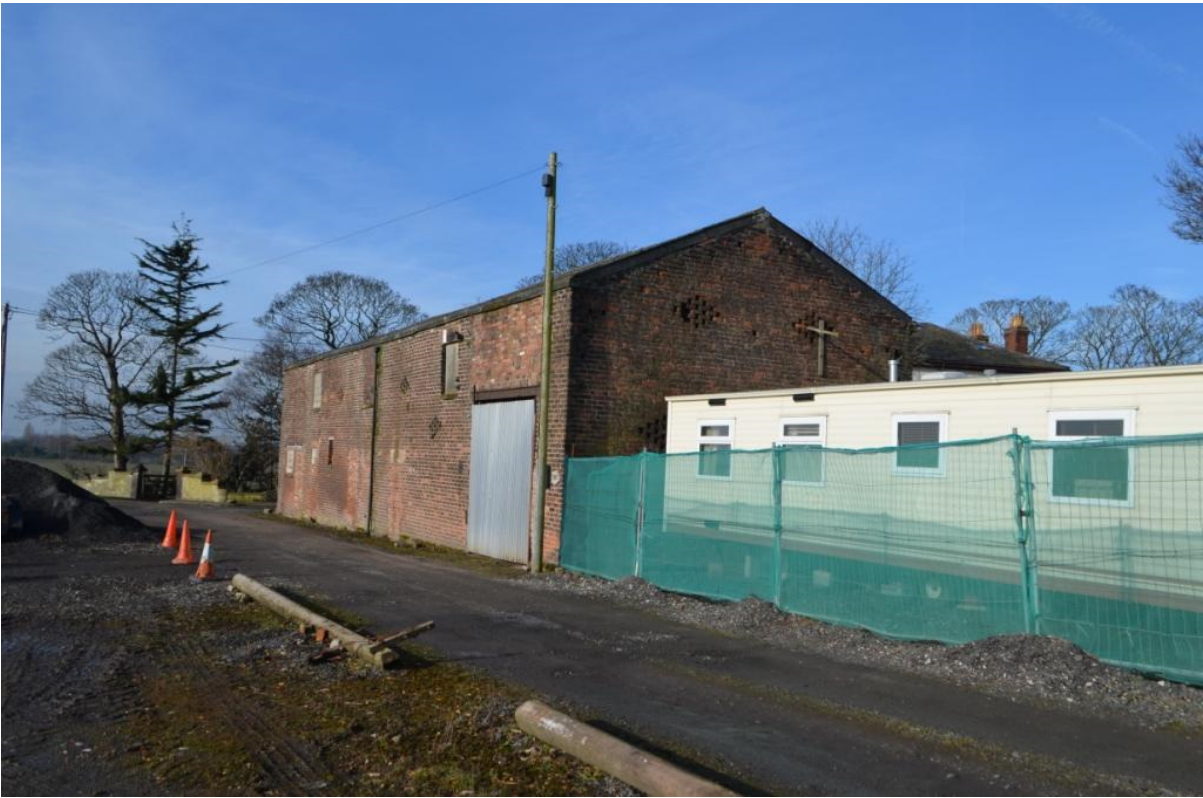
Report 661544: Barn at 2 Lodge Lane, Cronton: Level 2 Historic Building Record		Photographic Survey
<b>Client:</b> Mr P. Walton	<b>Photo No.</b> <b>005</b>	<b>Date:</b> 09.03.18	<b>Direction Taken:</b> SW

**Description:**  
 North east facing elevation, facing south west

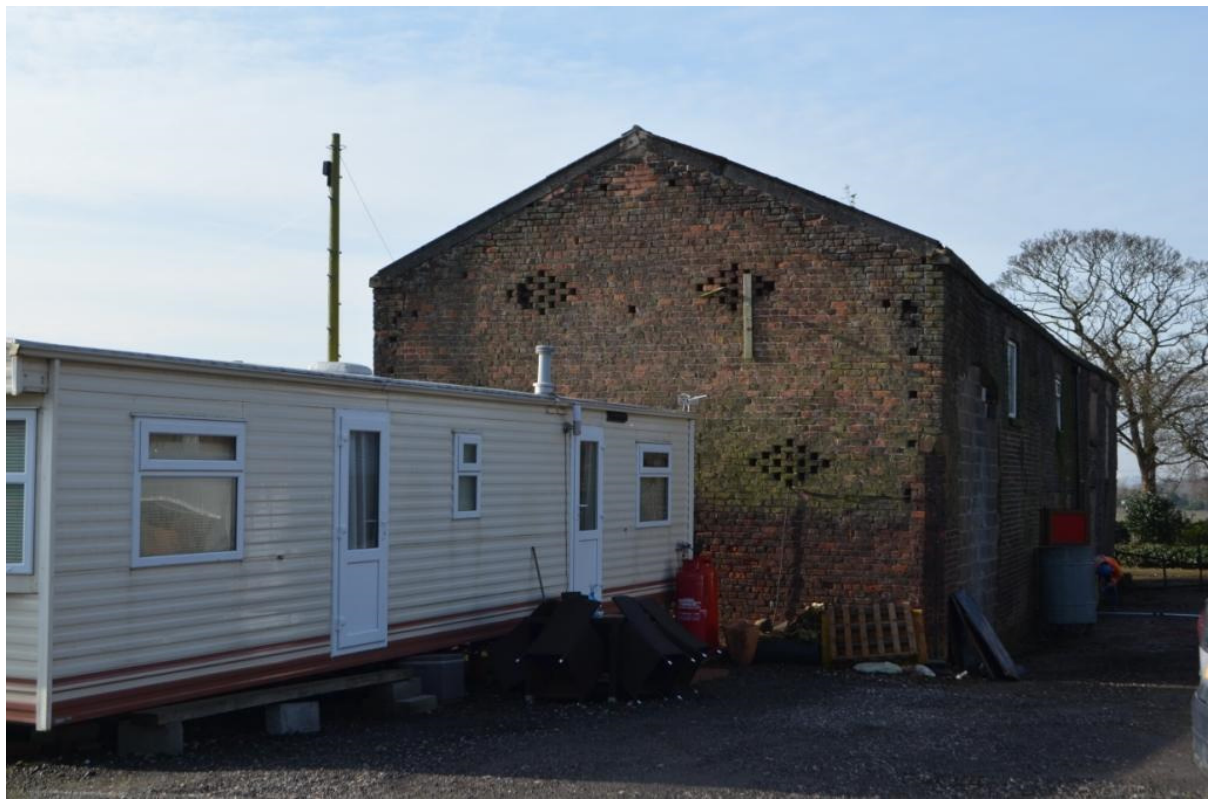
- 6.11 The brickwork rests upon a red sandstone ashlar plinth which is visible on the southern, western and eastern elevations. The plinth cannot be seen on the northern elevation; this may be because the ground level slopes down to the south and the foundations may have been cut more deeply, or else it is obscured by later build-up of ground surfaces in that area. The eastern and western elevations are capped by a course of dressed red sandstone.
- 6.12 The northern and southern corners are chamfered, with stops at first floor level created with north western and sandstone corbels (Photo 06).

Report 661544: Barn at 2 Lodge Lane, Cronton: Level 2 Historic Building Record		Photographic Survey
<b>Client:</b> Mr P. Walton	<b>Photo No.</b> 006	<b>Date:</b> 09.03.18	<b>Direction Taken:</b> S
<b>Description:</b> Detail of sandstone corbel acting as stop chamfer on north-west corner (corbel is c. 280 mm thick)

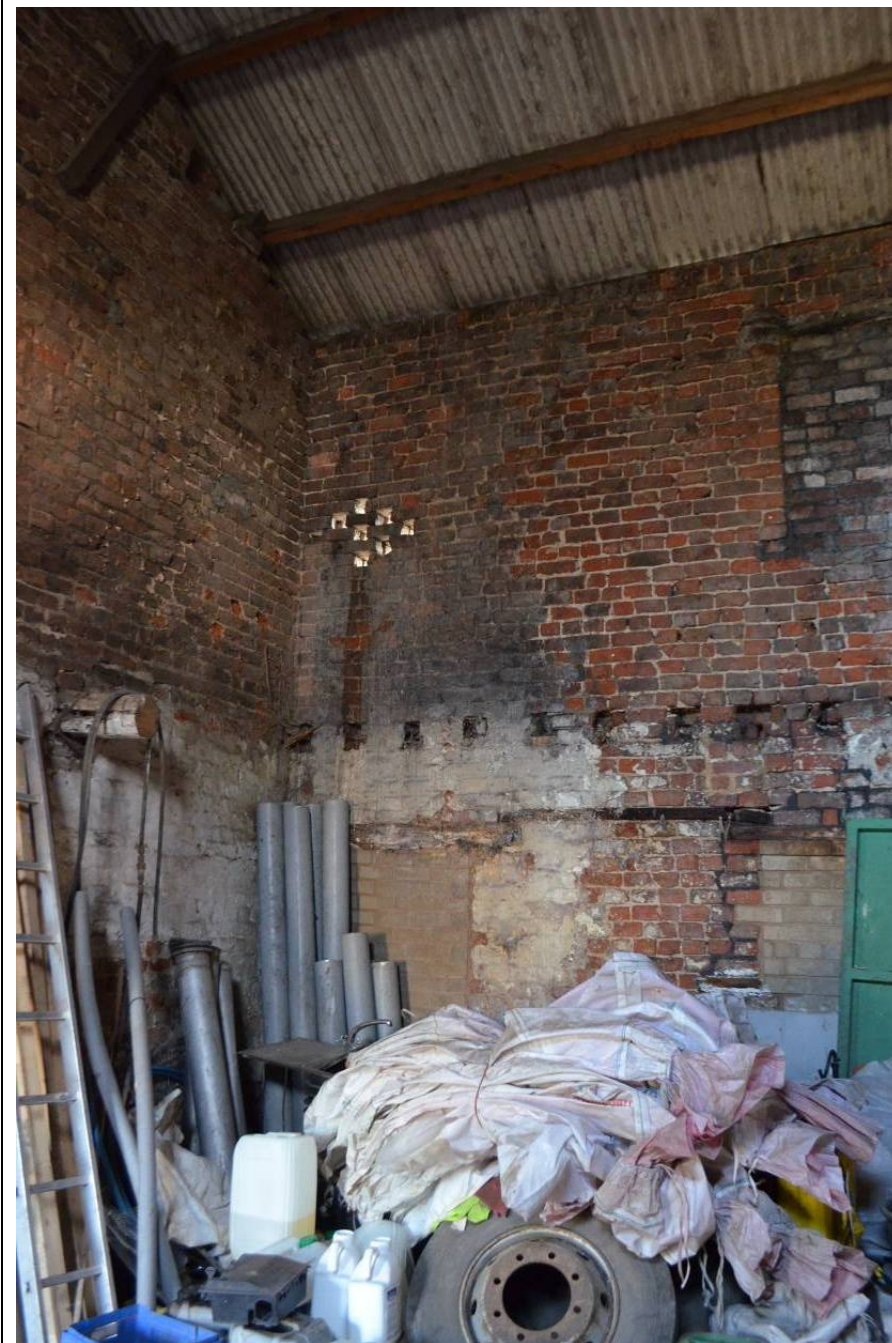
Report 661544: Barn at 2 Lodge Lane, Cronton: Level 2 Historic Building Record		Photographic Survey
Client: Mr P. Walton	Photo No. <b>012</b>	Date: 09.03.18	Direction Taken: SW

Internal detail of 2-strut king post roof truss, looking south west
