## PETERBOROUGH CATHEDRAL: THE TRANSEPT CEILINGS

**Record of Treatment and Additional Investigations  
following a fire in the Cathedral on 22 November 2001.**

**JULY - OCTOBER 2002**

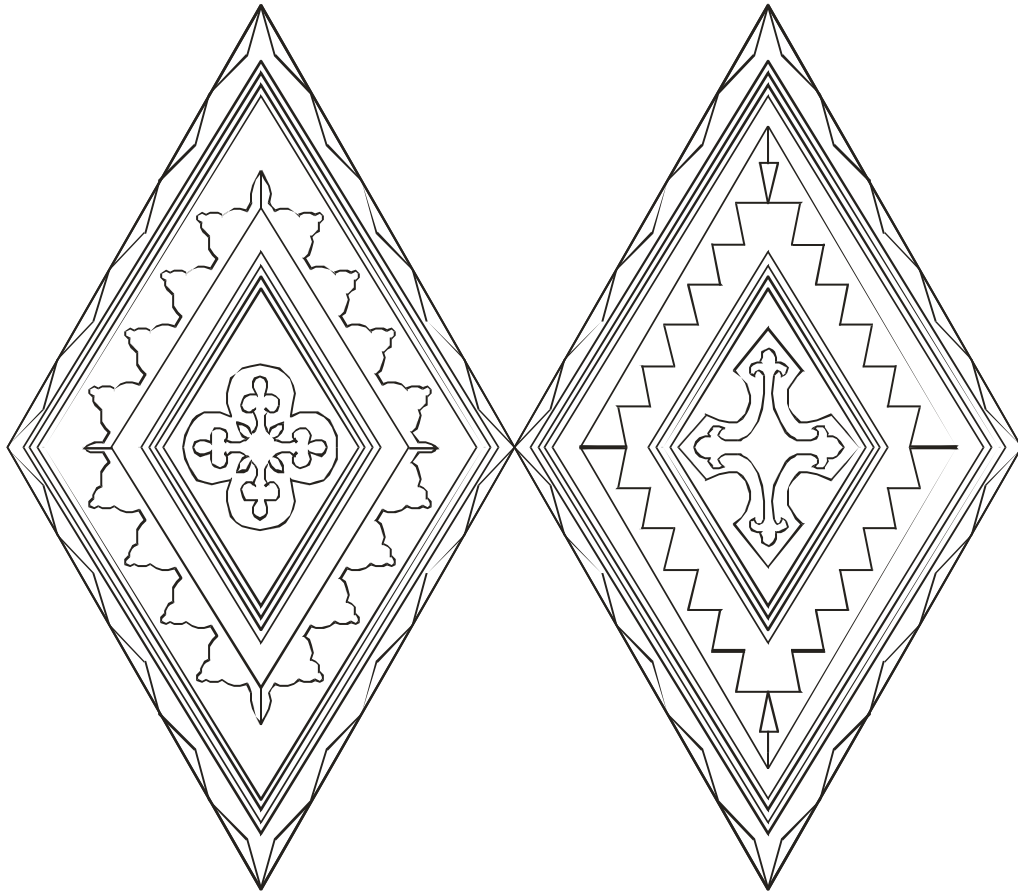
Ceiling boards to form interlocking rows of diamond-shaped compartments, with alternate rows ending with half compartments. The inner boards of each compartment were decorated with a cross. Embellished, linear versions of both the Cross Fleurie and the Cross Treflée are visible in shallow relief. Also each compartment had an inner and outer band of four parallel lines painted in grooves. One board on the North Transept Ceiling appears to have in shallow relief traces of a border design: what for the Nave Ceiling we have described as a bun pattern. This would suggest the early scheme included a series of linear border patterns as well as the parallel lines within each diamond compartment (see Fig. 3).

**Figure 3.** *Speculative reconstruction of two C13<sup>th</sup> linear painted lozenges on the Transept Ceilings. There is firm evidence only for the crosses and inner and outer band of four parallel lines. No original paint has been found to indicate the original colour scheme.*

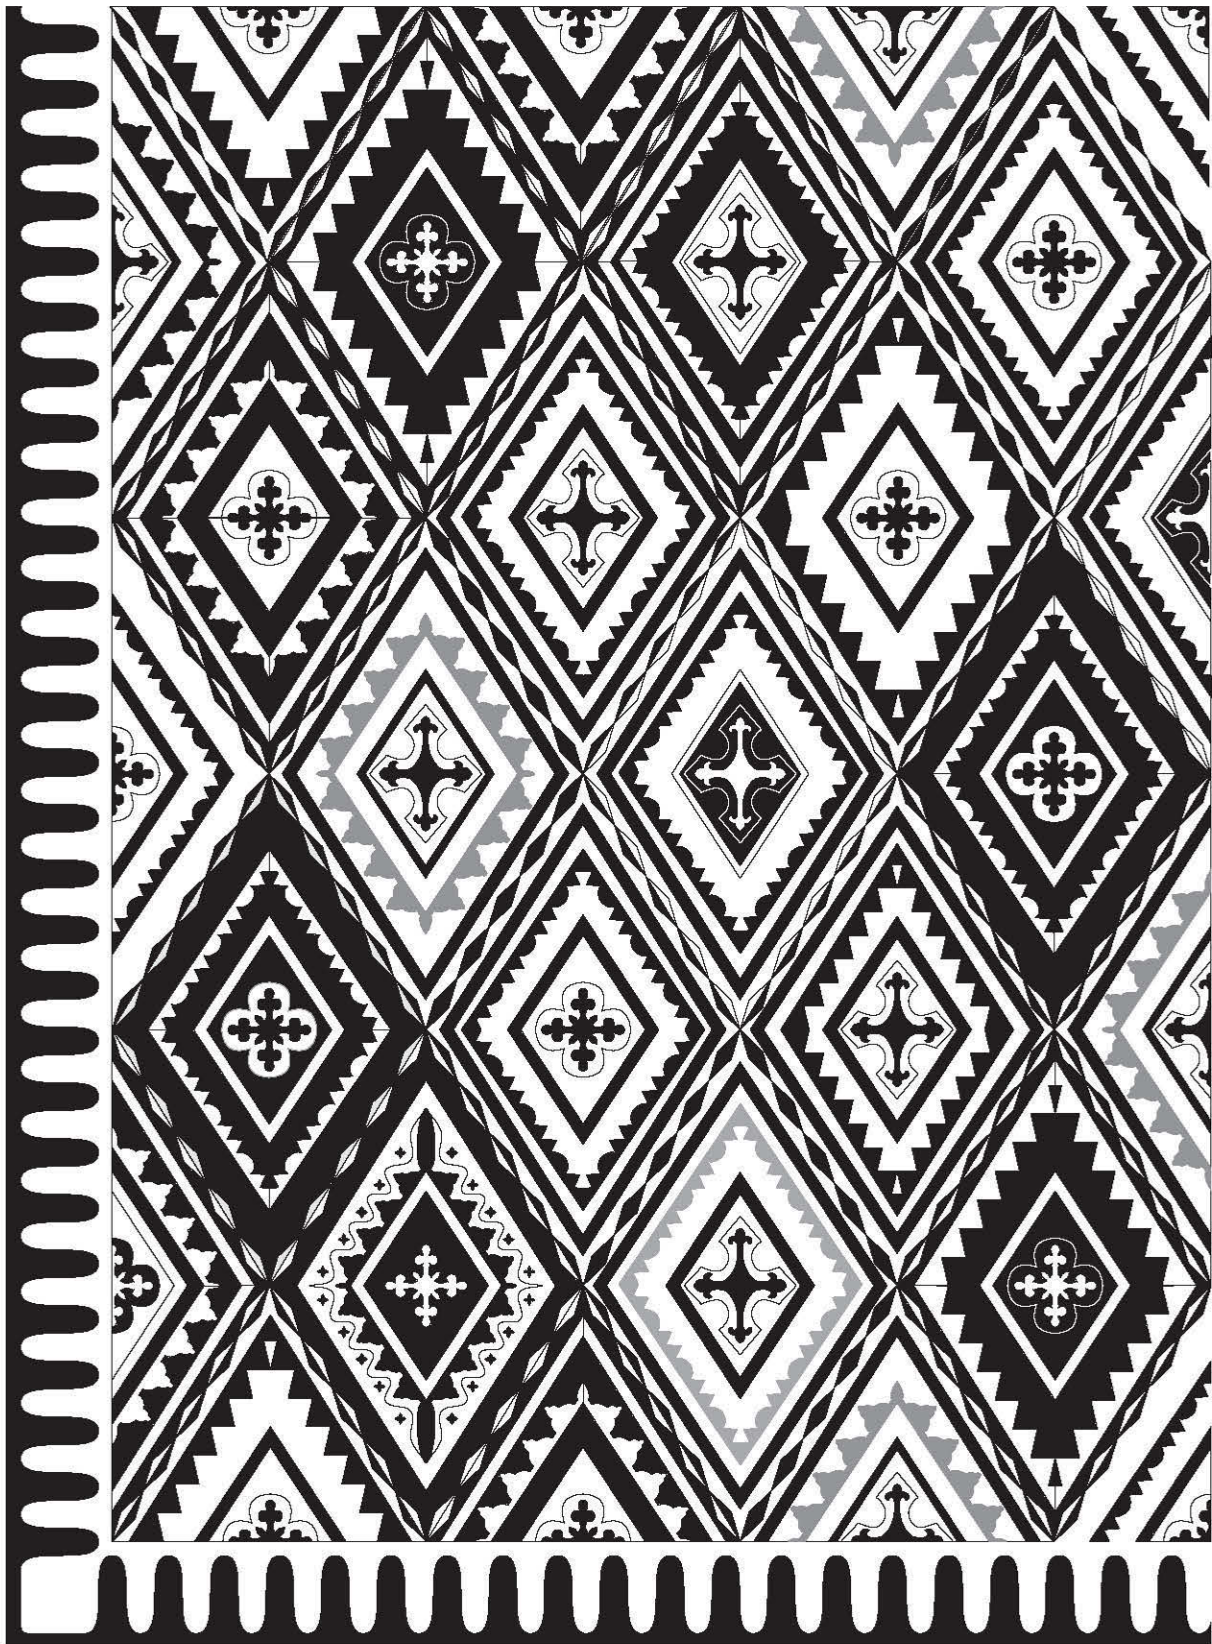
The Cross Fleurie or Cross Treflée design at the centre of each lozenge was inpainted. The grooving in the boards was ignored and the four-parallel-line inner and outer borders replaced by a number of different border patterns. The evidence of paint shadows, the paint found on overlapped edges of boards removed for dendrochronological dating, and the pre-1880s photograph (reproduced as **Fig. 4**) all indicate the border patterns were variations based on dogtooth and bun patterns and that the light/dark sequencing varied within different lozenges. This is illustrated in **Fig. 5** below.

**Figure 5.** Reconstruction showing some of the probable 1740s lozenge designs. Traces only white, off-white, black and brown/black paint were found on the Transept Ceilings. Evidence from the Nave ceiling suggests red, at least, would also have been used in the 1740s scheme.

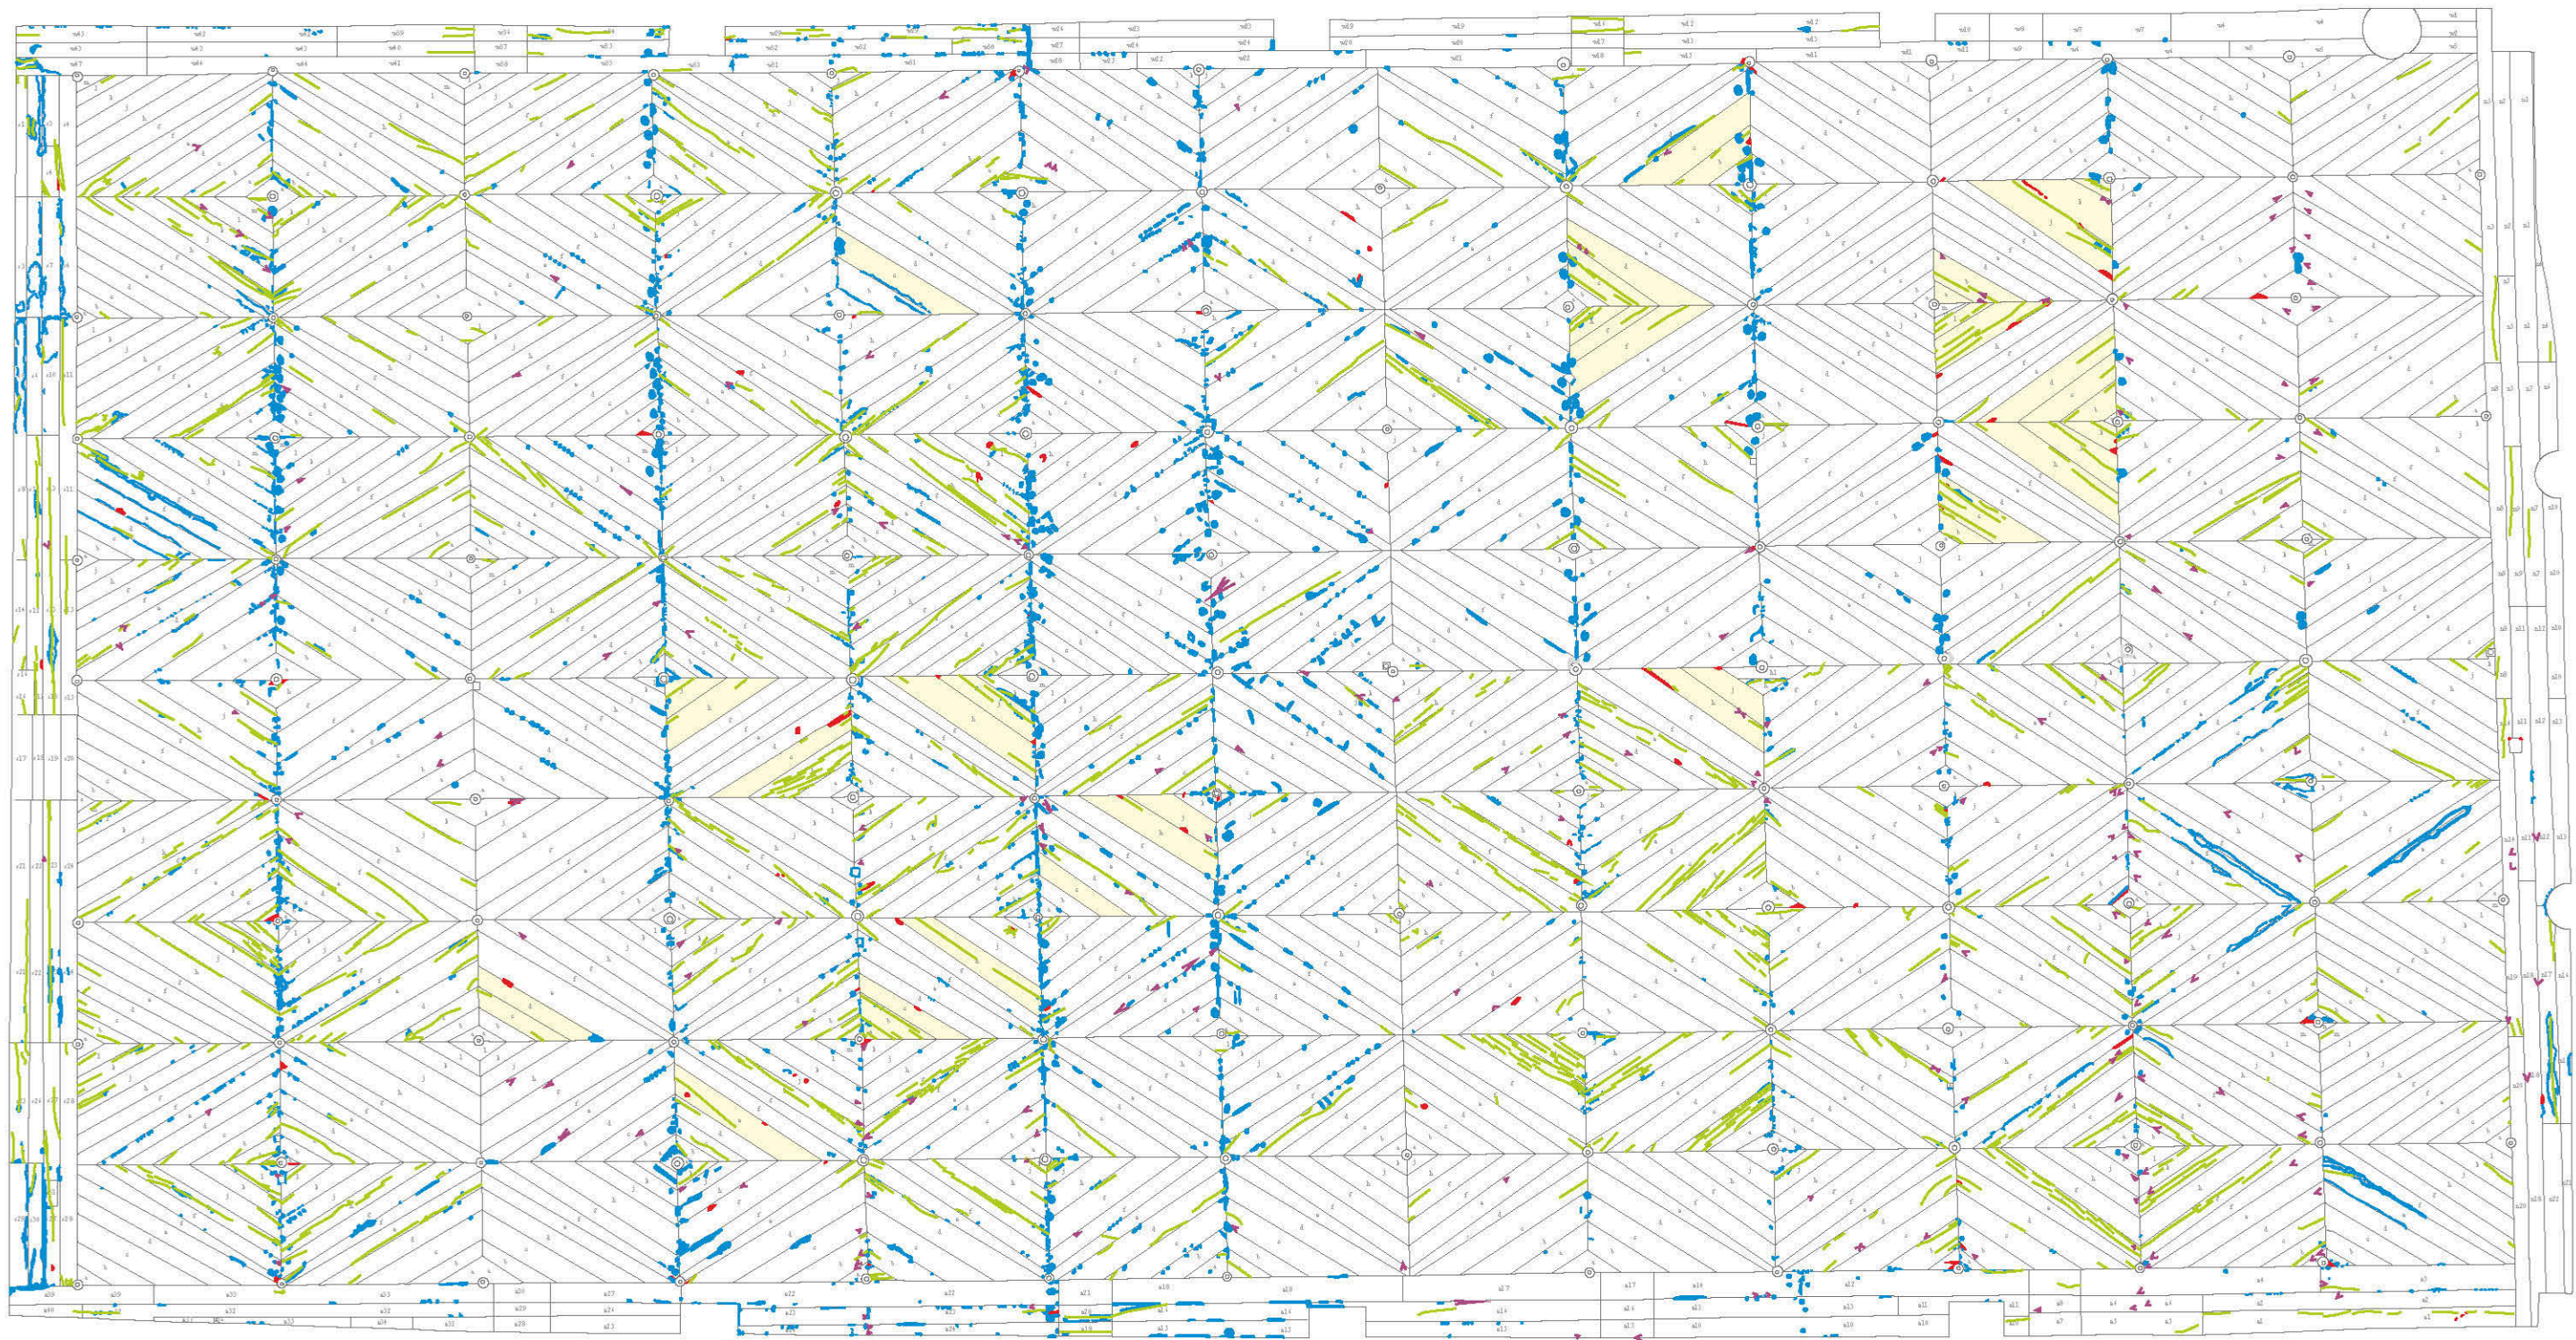
GRAPHIC: 5 (NT)

CONDITION OF CEILING BOARDS

- Surface glue
- Intended wood loss
- Wood loss
- Surface splintering
- Splits in boards
- Original boards
- 1660s replacement boards

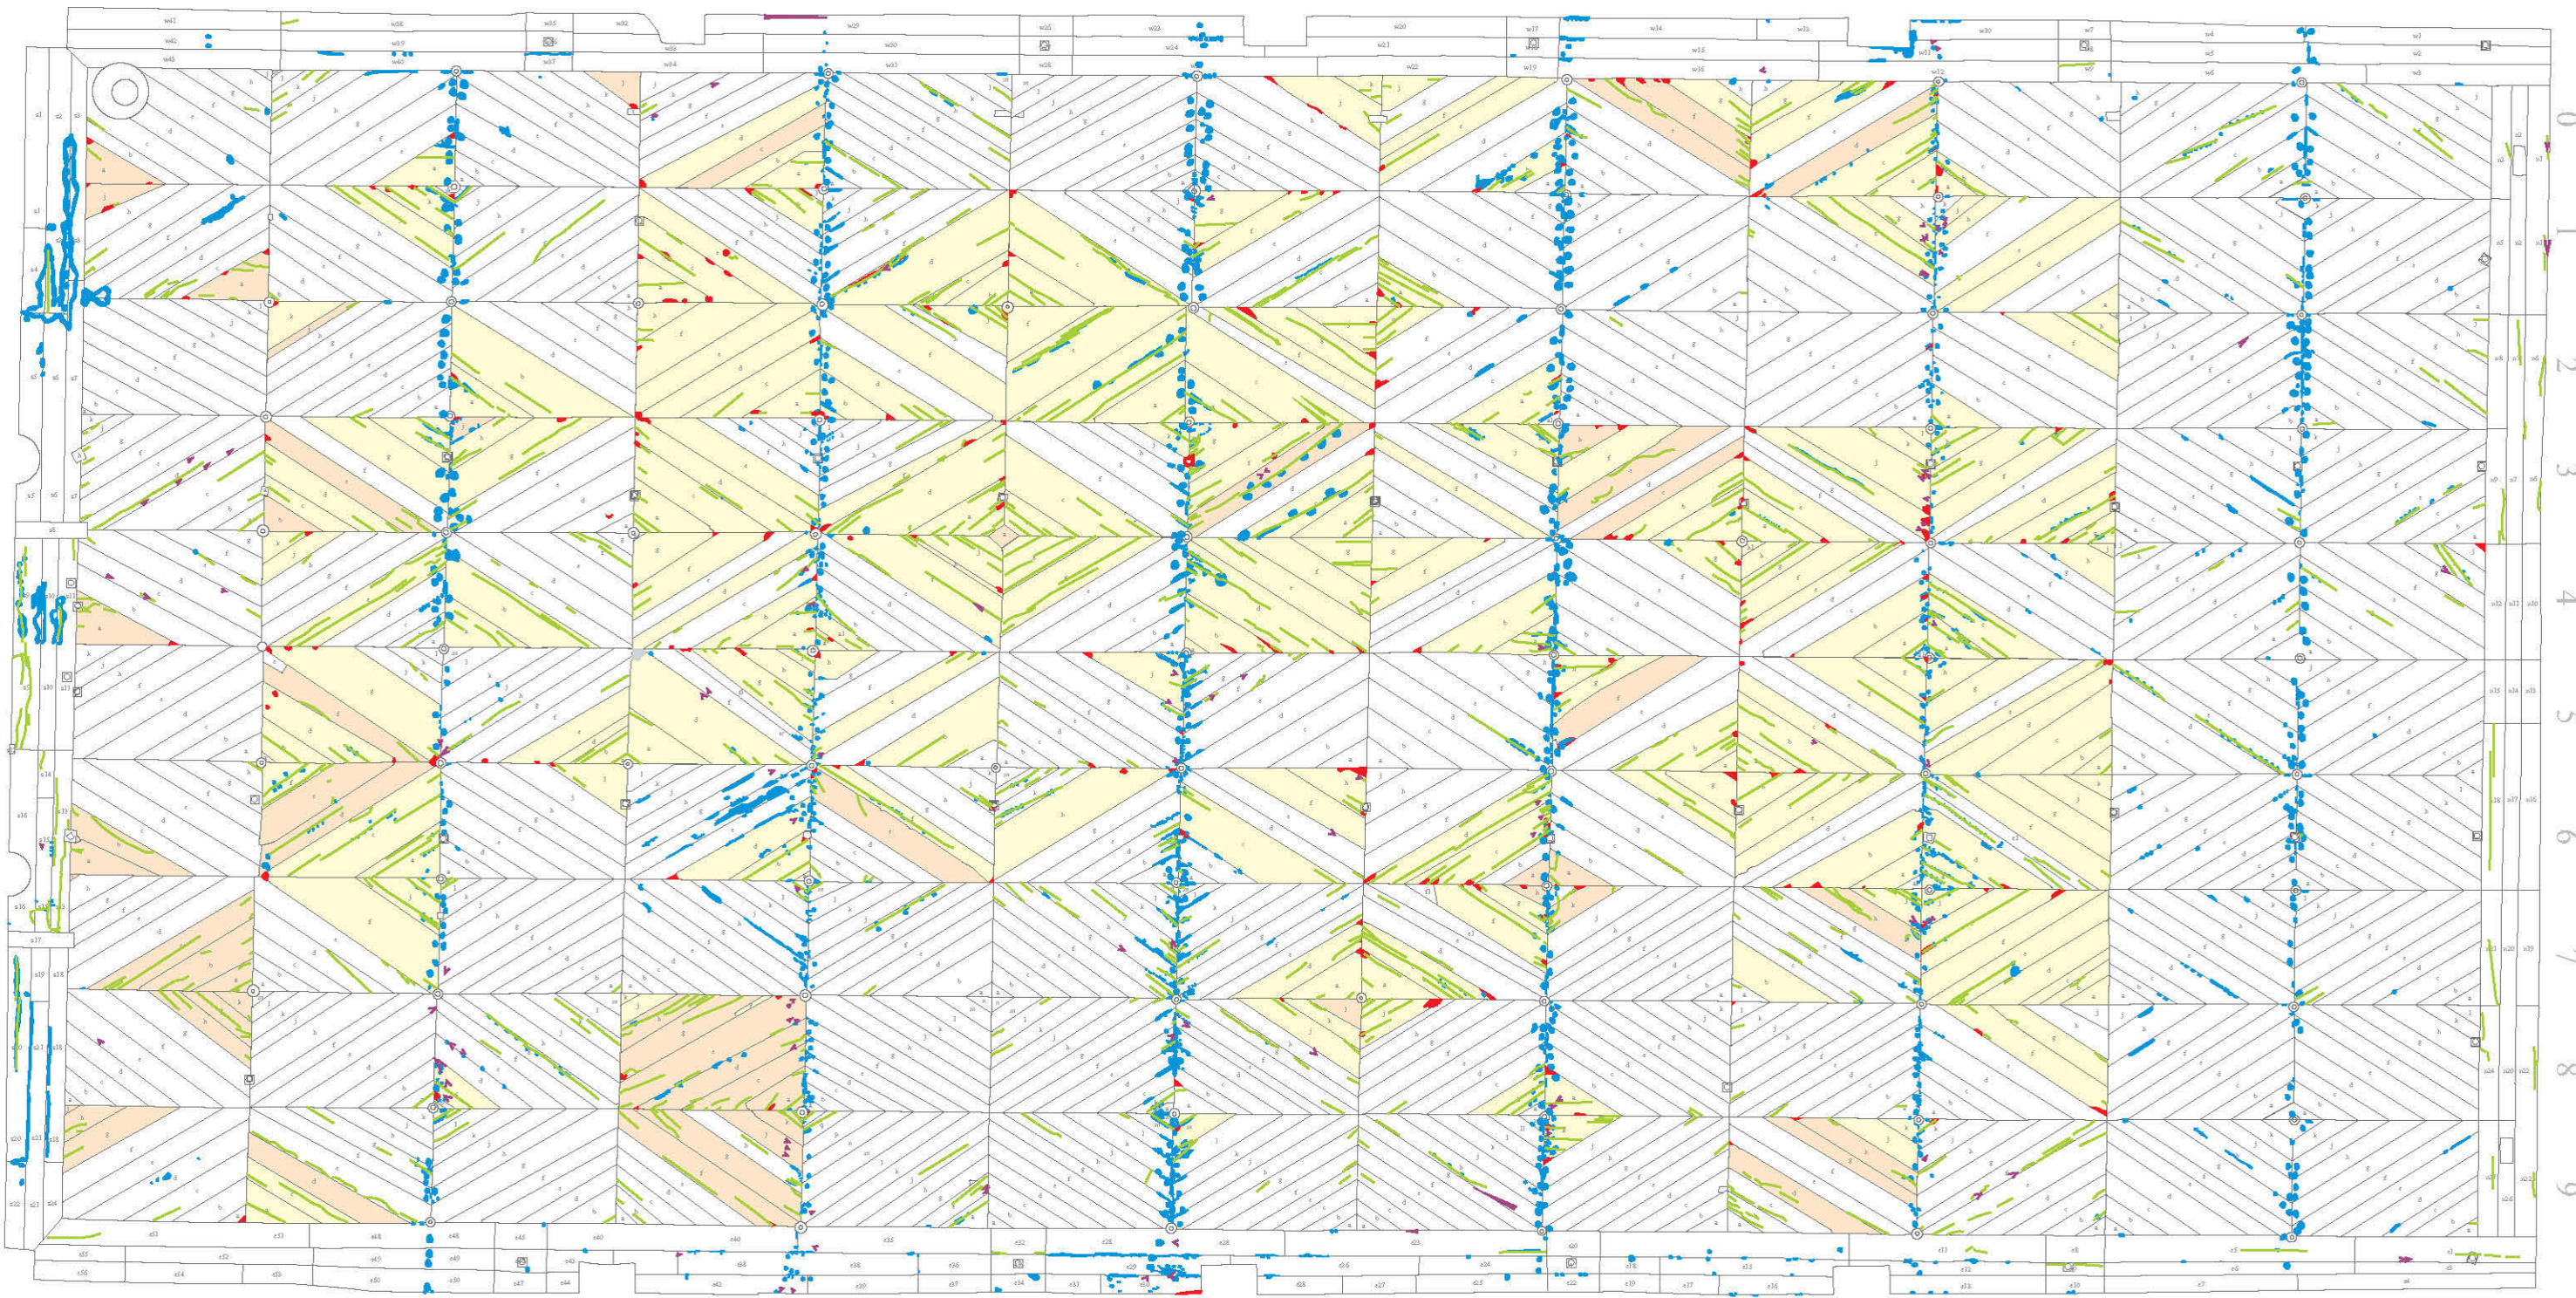
GRAPHIC: 5 (ST)

CONDITION OF CEILING BOARDS

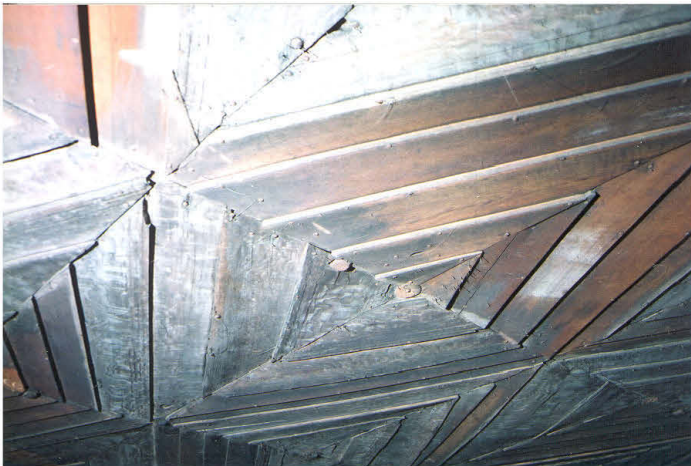
- *From our inspection from clerestory level we had the impression that many of the smooth-faced oak ceiling boards were seventeenth-century boards partially re-faced or sanded down in the 1890s, when it is known that the painted decoration on the ceiling was removed. Closer inspection has revealed the smooth-faced boards are in fact 1890s boards. The confusion arose because there is a darkened coating and/or white ground partially smeared over many of the 1890s boards adjacent to early boards (see **Plates 1, 3, 4 and 5**). The reason for the coating is unclear.*

Plate 1. A typical lozenge showing the smooth-faced 1890s oak boards that are partially smeared with a darkened coating and/or some form of white ground where they are adjacent to early boards.

- *Limited test were carried out to determine whether it will be possible or desirable to remove the darkened coating and/or white ground partially smeared over many of the 1890s boards adjacent to early boards. The coating is not affected by water or white spirit but may be removed by swabbing with Industrial methylated spirits and/or acetone: this results in a slight lightening in the colour of the underlying wood surface (see **Plate 4**). It would not be technically difficult to remove the coating from the 1890s boards but it would more than double the time involved and therefore the cost of the surface cleaning process. Samples of the coating have been sent for analysis. When the findings are available the project team must decide whether or not we should conduct more extensive tests for its removal.*

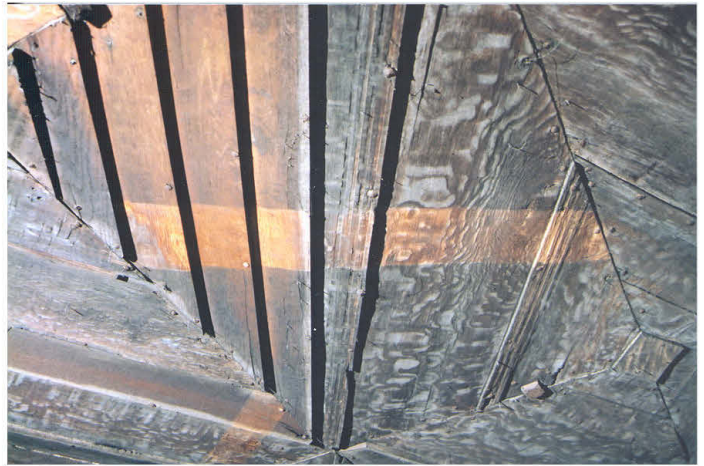
Plate 2. A surface cleaning test using wishab sponges to remove the thick accretions of soot and surface dirt across original and 1890s ceiling boards.

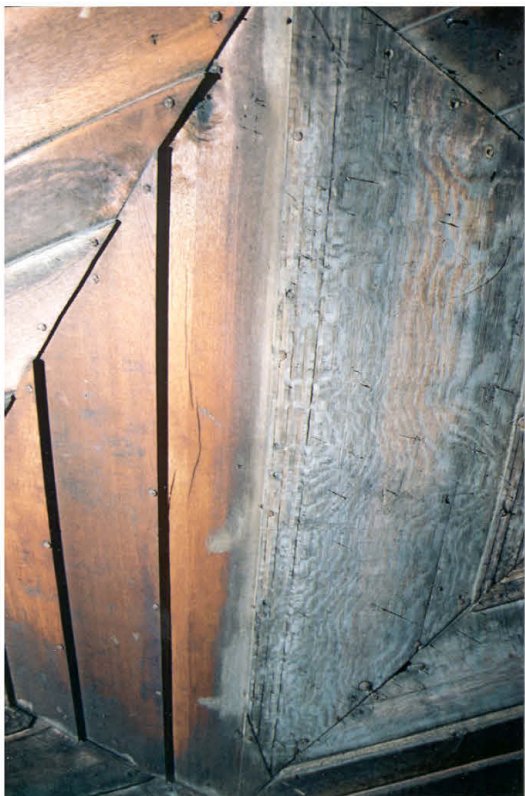
Plate 3. (left) An 1890s board that has been partially smeared with the unidentified coating/ground where it is adjacent to an original board.

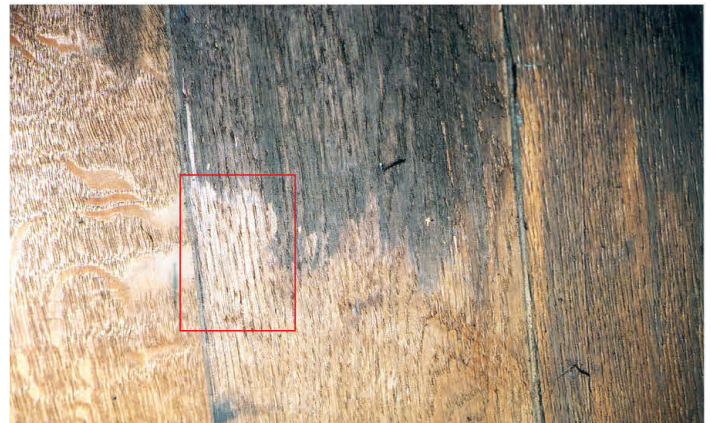
Plate 4. Detail of an area of the darkened coating, following soot and dirt removal, from which samples were obtained for analysis (Sample 1). The red square shows the location of a small test to remove the coating with IMS. The underlying wood surface is marginally lighter than the uncoated surface.

The cross-section shows oak with a blackened upper surface. Some of this blackening is due to surface dirt, but the discoloration penetrates through several layers of wood cells. There is no iron in the layer and no iron oxides particles visible in dispersion, and the colour must be due to an organic stain or dye. The only elements picked up by the SEM analysis were tiny amounts of sulphur, calcium and potassium.

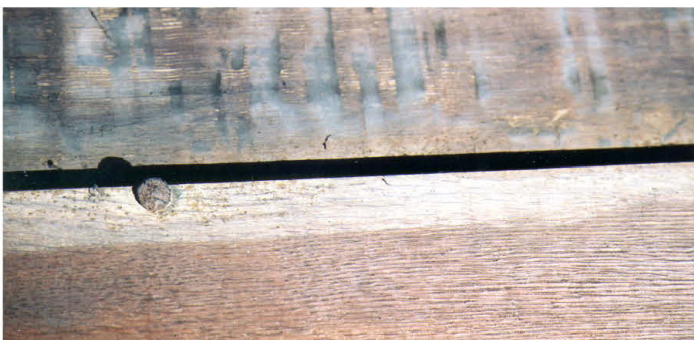
Plate 5. Detail of an area of the on the edge of an 1890s board. Samples were obtained for analysis from this area (Sample 2).

In this fragment, the wood has a similar dark-stained upper surface to that seen in sample 1, but here it is overlaid by a film of semi-opaque, whiteish material. Analysis found this to contain lead, calcium and iron and consists of lead white, calcium carbonate and iron oxide. The layer has a white fluorescence which may indicate resin, but the calcium carbonate content would also produce this effect.

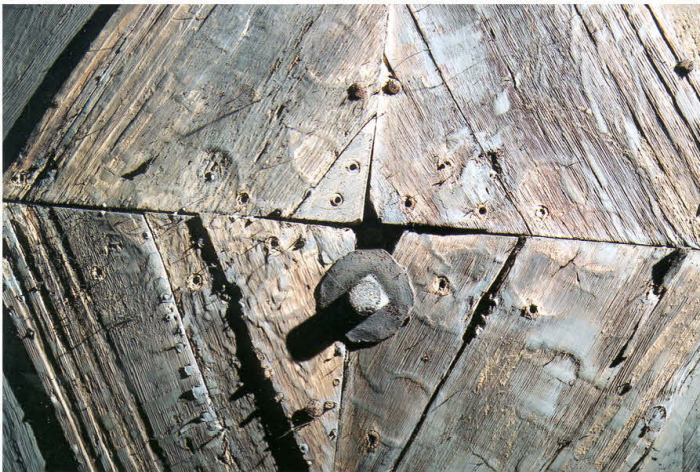
- *The early boards appear to be of two different ages typified by less surface weathering and quite different grain characteristics. However the majority are early oak boards – easily distinguishable from the 1890s boards by their weathered appearance. Close examination has confirmed our observations in the tender regarding the parallel grooves and the original paint scheme visible in shallow relief on the timber surface (see **Plates 8 and 9**).*

Plates 8 & 9. Raking light details showing some of the original painted decoration now showing as relief within the weathered timber surface.

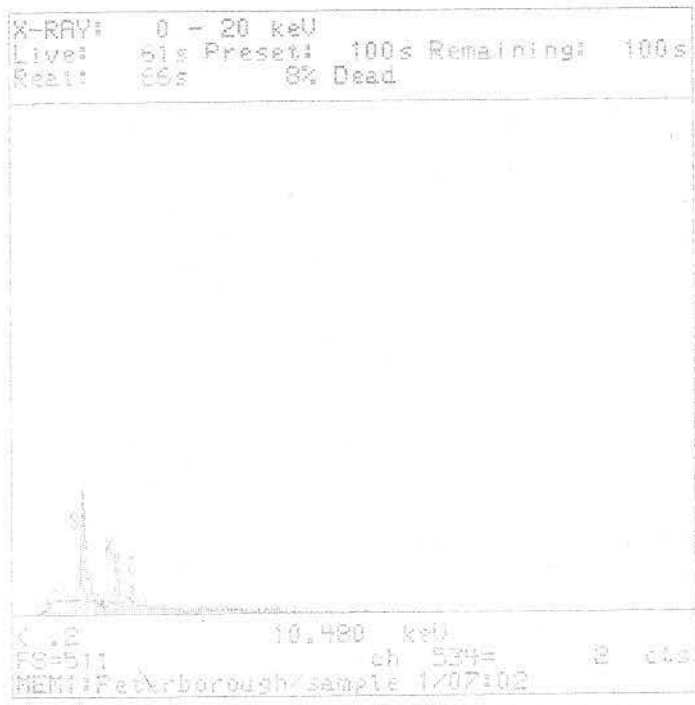
SEM Analysis of surface of **Sample 1**

Calcium [Ca], sulphur [S] and potassium [K]

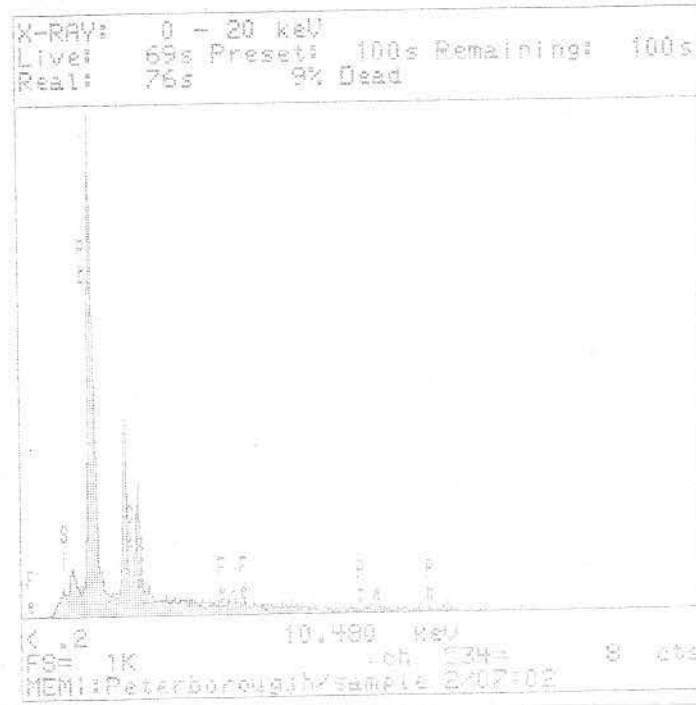
SEM Analysis of surface of **Sample 2**

Leas [Pb], calcium [Ca] and iron [Fe]

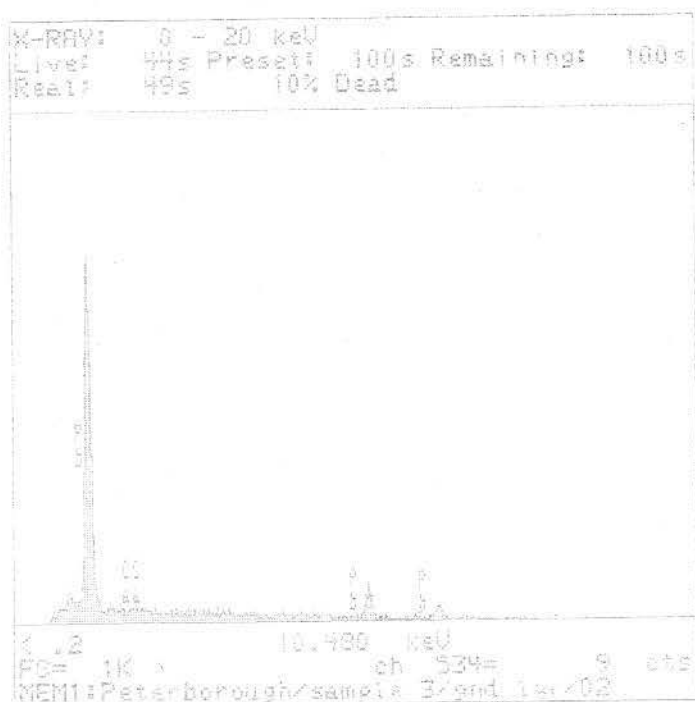
SEM Analysis of surface of **Sample 3**

Lead [Pb] and calcium [Ca] are the principal elements detected.

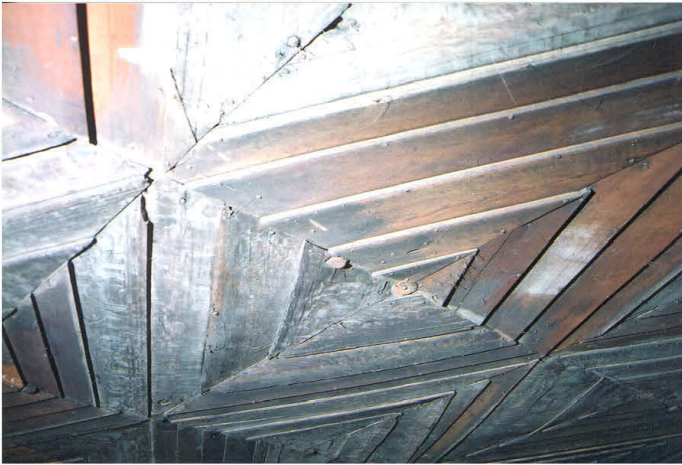
A typical lozenge showing the machined 1890s oak boards, some partially smeared with residue resulting from the stripping of painted decoration from the early thirteenth century original boards and the seventeenth century 'intermediate' boards.

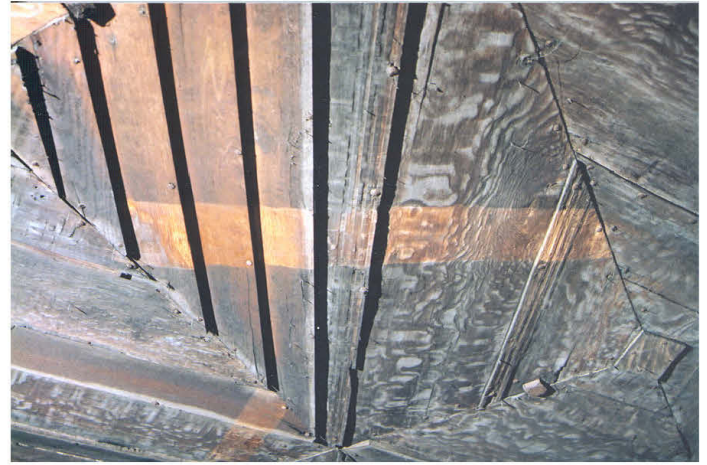
A surface cleaning test using wishab sponges to remove the thick accretions of soot and surface dirt across original and 1890s ceiling boards.

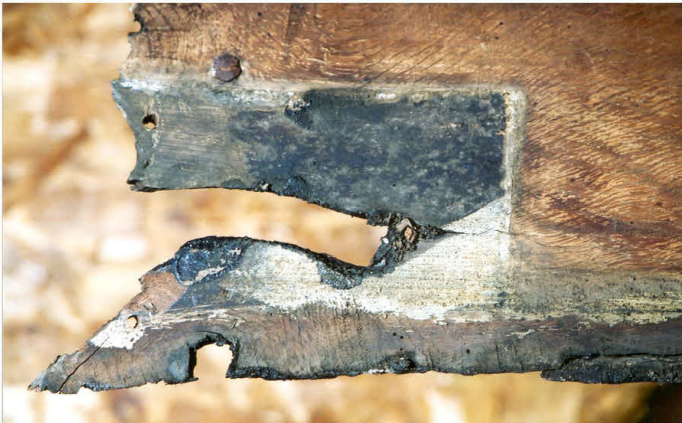
1. Board M5 f (detached intermediate board): Paint surviving under overlap proving that, in the 1890s, the paint was stripped from the surviving original and intermediate boards after the ceiling boards had been nailed back into position. Black from the tip of a black chevron (?). The residual painted decoration consists of a thin strip of white ground with a series of tips of black chevrons on an intermediate board. The decoration only became visible when the adjacent original board (g) was removed for dendrochronology. The black paint is very gritty and therefore similar to the 1740s paint found on the nave ceiling. However, archive documents suggest the ceilings were redecorated in the 1830s.

2. Board M5 f (detached intermediate board): White ground to the black chevron (see sample 1). This paint is also gritty in this area.

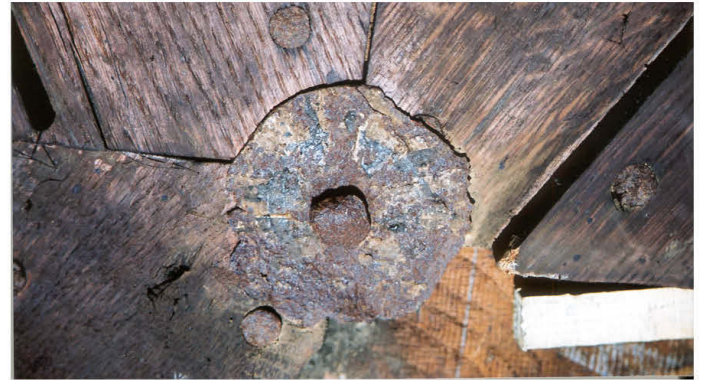
3. Black paint on ceiling bolt & washer at junction of M4/5 & N4/5. The washer has remains of a white ground with black drawing.

4. White ground from washer (as sample 3).

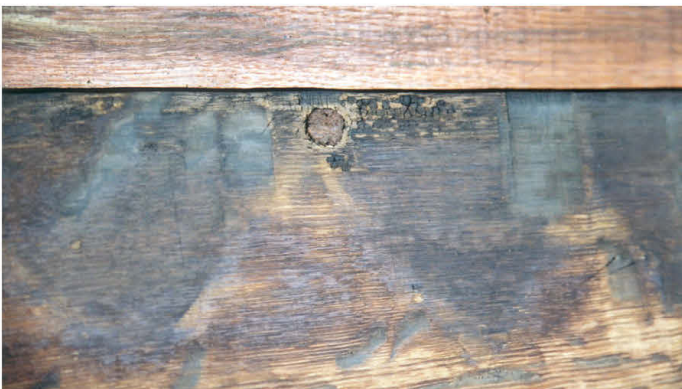
5. Board G8 j: Black paint of faint chevron (original board). The paint has been largely removed from the board surfaces in the 1890's and only faint traces remain of a chevron design on some original boards. This is often only a shadowy image. The residual paint on this board is quite thick and is flaking and crazing.

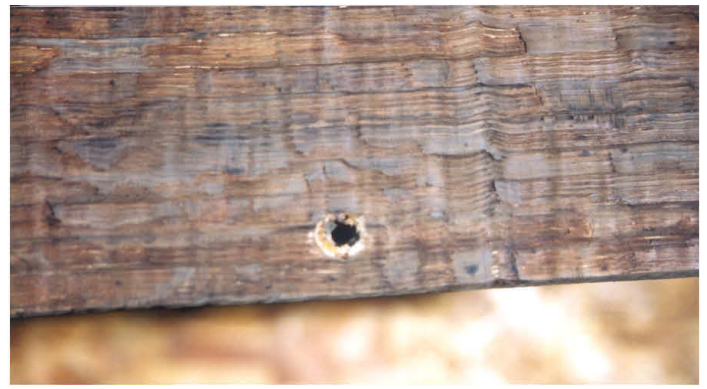
6. Board M5 g (detached original board): White paint from under lost nail head in an original groove. This sample is to identify both the visible white paint and any possible earlier paint layer that may remain in the groove.

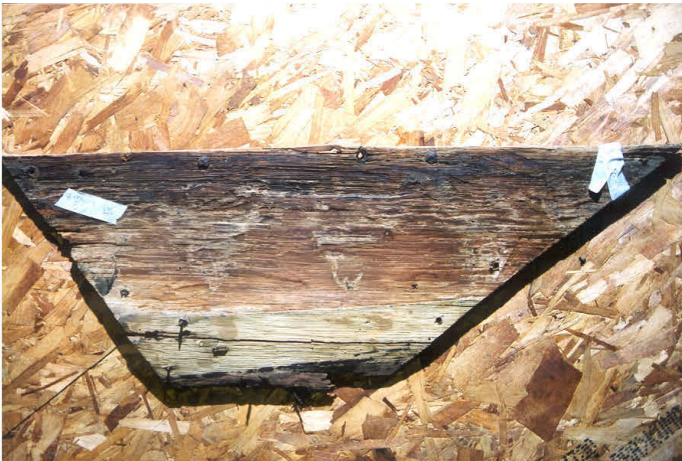
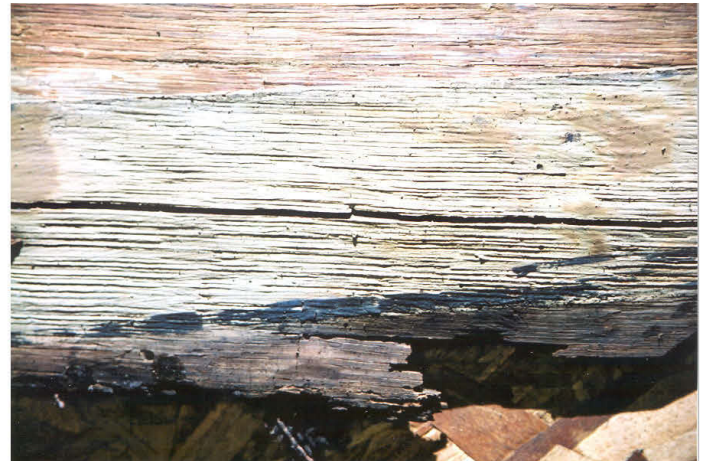
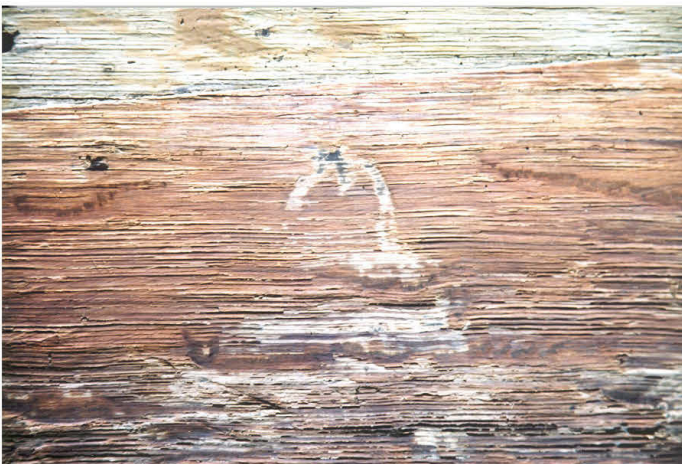
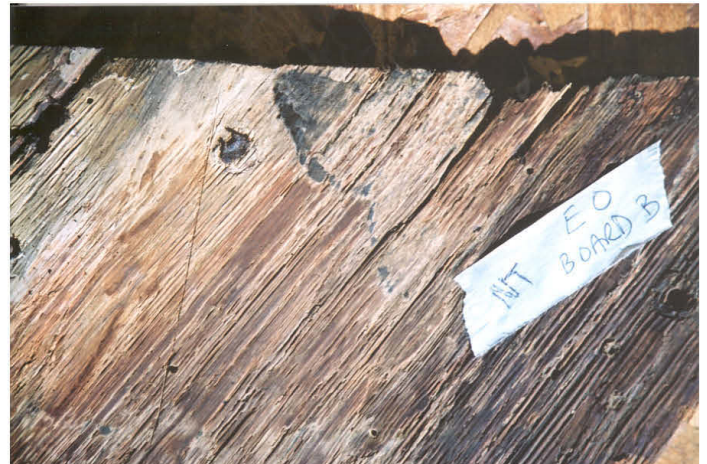
- 7 Board E0 b (detached original board): White paint surviving under overlap.
8. Board E0 b (detached original board): Black paint surviving under overlap.
9. Board E0 b (detached original board): Brown/black paint surviving on raised bun pattern design.

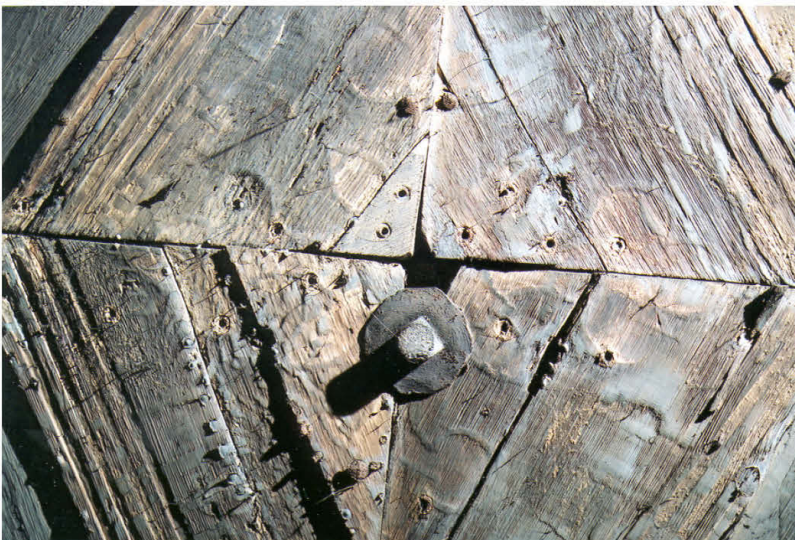
Raking light details showing some of the original painted decoration now showing as relief within the weathered timber surface.
