K 1226: Small gold rectangular plate or fitting with cloisonné garnets and blue enamel glass inlay
Conservation Report

Conservation started: 21.9.10

Finished: 23.9.10

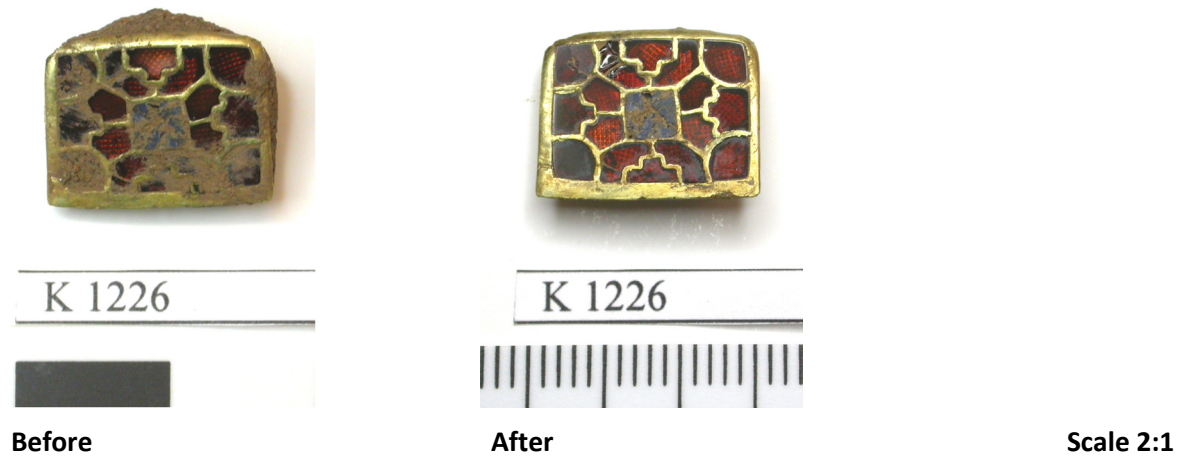
The small rectangular plate or fitting is in a deteriorated condition, in particular the central square cell with the blue enamelled glass inlay. All four sides and the back surface are completely covered with granular, compact soil from the burial context, which contains small round inclusions up to 0.5 – 1.0 mm, such as quartz. These types of inclusions are abrasive, particularly to the gold surfaces since quartz has a hardness of 7 on the Mohs hardness scale, while gold has a hardness of ca. 2.5 – 3.0 and glass has a hardness of 5.0-6.0. Garnets have a Mohs hardness of ca. 6.5 – 7.5, and should therefore be less susceptible to scratching from the hard, granular soil than the gold or glass.

The blue enamelled glass inlay is the most deteriorated part of the plate and has cracked and fractured into numerous fragments that appear to be held in place by the soil deposits on the surface, particularly in the central part of the cell. This deterioration appears to be old and due to the burial context, as the soil is overlying the fragmented surface of the enamelled glass, and the edges of the cracks are covered in soil.

The 16 foil-backed cloisonné garnets on the front surface appear to be secure, and are relatively complete. There are 3 cracked or split garnets, 1 with a hairline crack, 3 raised up slightly from the cell walls and 3 sunk slightly below the cell walls.

The ca. 0.5 mm gold cell walls appear to be intact and stable. There is only one area with a small ca. 1.0 mm gap in the gold dividing wall, and this is filled with soil. The edges of the gold plate are slightly bent downwards and there is a small area of loss at one corner adjacent to one of the cracked garnet cells.
