Prudhoe Hospital

Prudhoe, Northumberland

Historic Building Recording : August 2016

Gentoo Homes Ltd

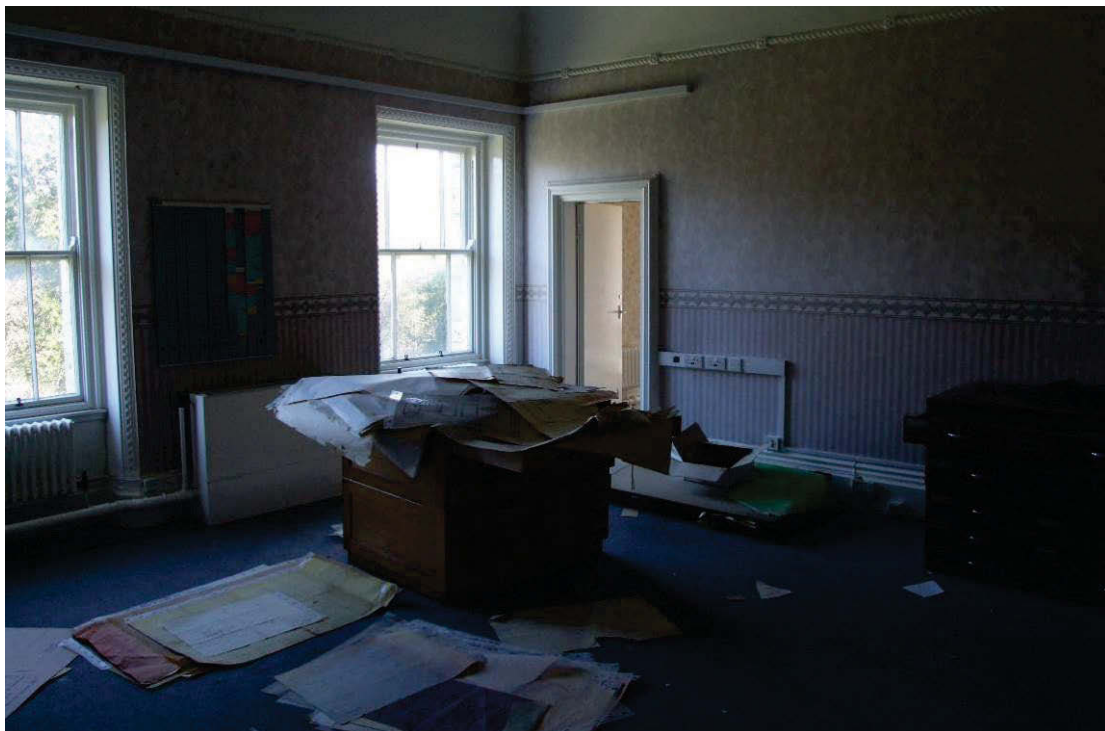
There are a large number of drawings currently in unsupervised storage in two rooms in the hall. The drawings are organised with a numbering system of the building identification number, and stored in two plan-chests. These are an important resource for understanding the history of the site, and are vulnerable to theft, damage or loss due to carelessness.

Figure 29 One of the two rooms with drawings. This room is on the first floor of the c.1870 block. The other room is on the ground storey, in the former service wing of the hall.

The drawings should be checked and catalogued. Not all of these drawings will be significant and there are many repetitions. However, as part of the photographic and measured survey discussed below, a record should be made of these drawings.

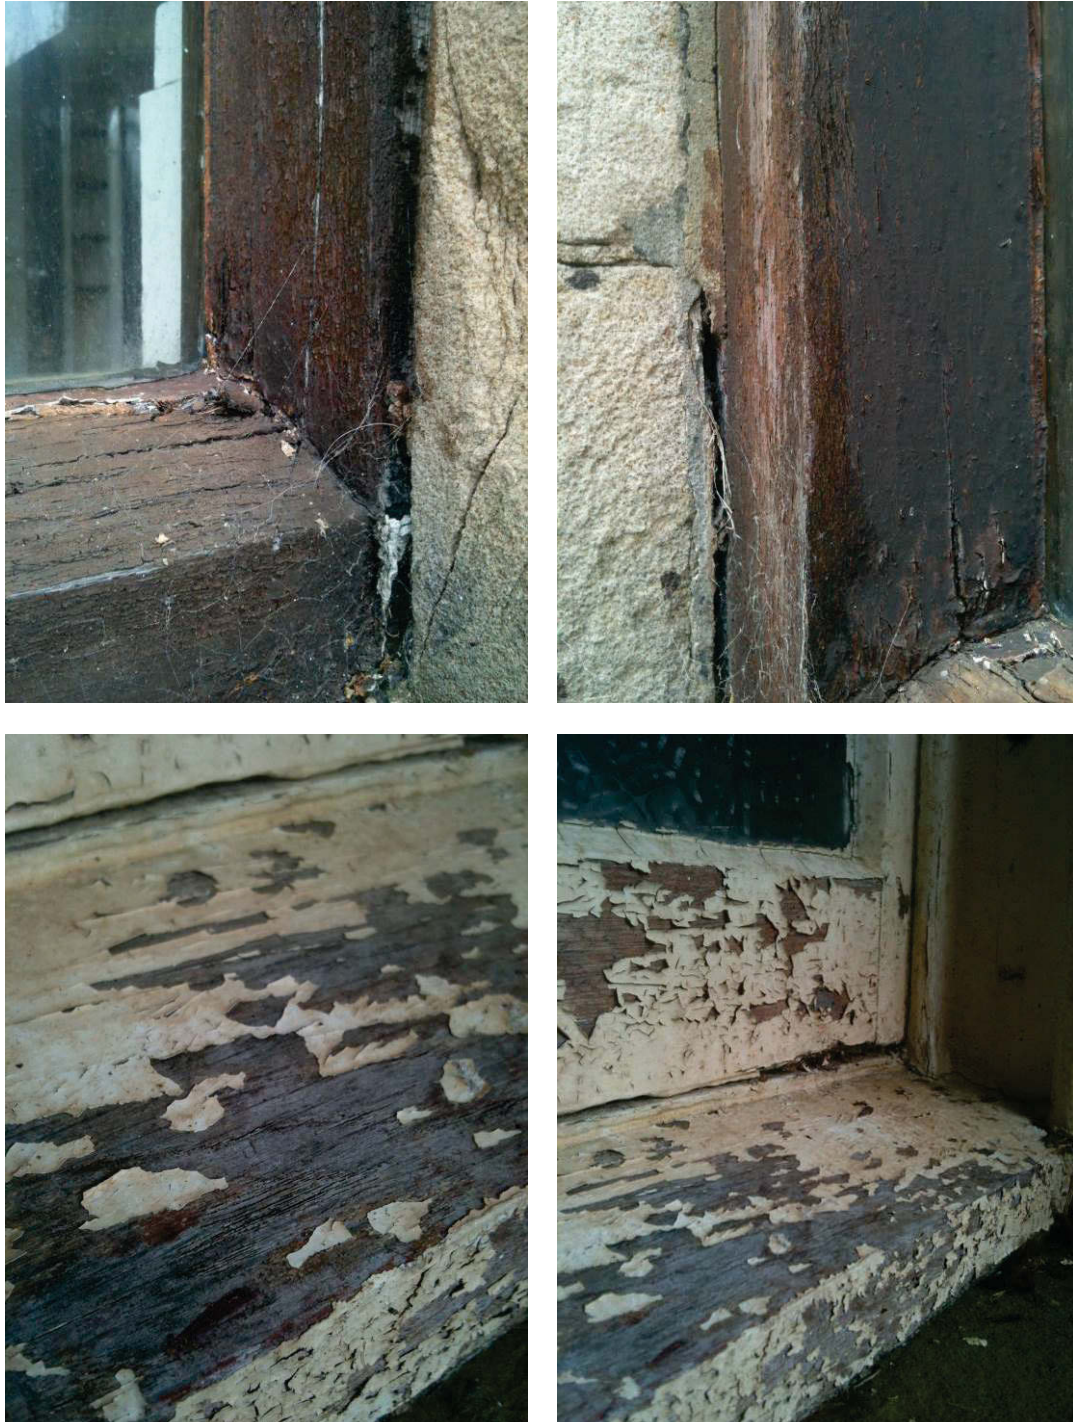
It seems probable that the original colour of the external window frames was a red brown colour. This should be reinstated if proved by analysis.

Figure 43 Ground storey windows showing possible red-brown original colour.

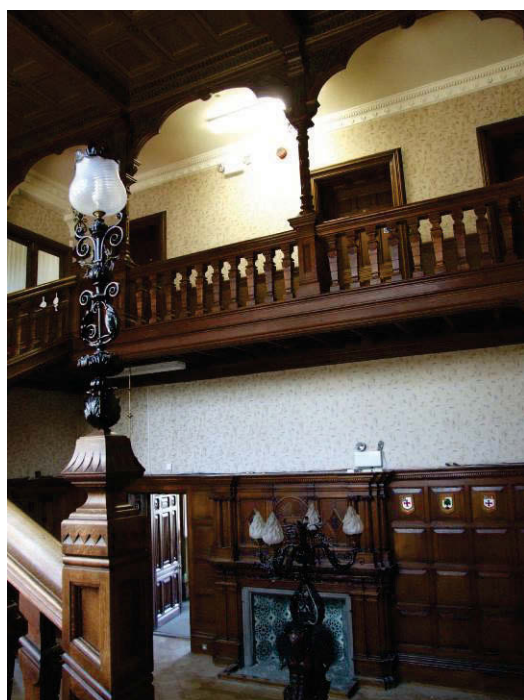
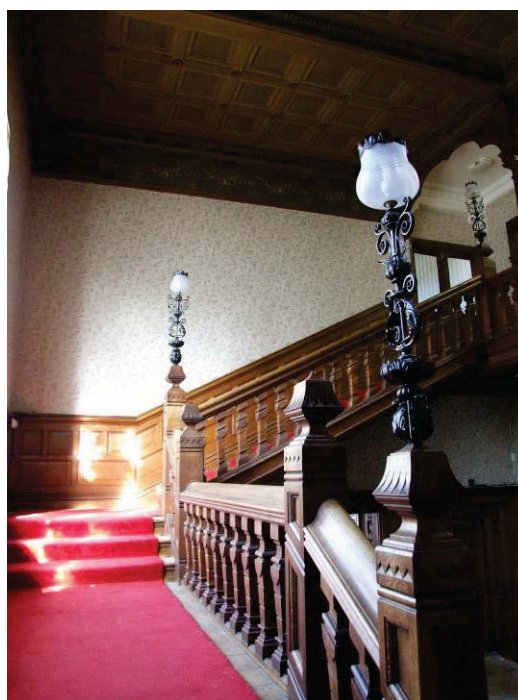
Figure 45 The stair hall.

On the newel posts are elaborate wrought iron lamps including a four-bulb lamp on the newel at the foot of the stairs. This newel has a lion holding a shield with the lamp passing above it. The lamp looks like an afterthought because the lamp position and the wiring does not particularly suit the lion. However, this lamp should be retained. The other lamps have the character of having been gas lamps originally, converted for electricity in 1889. The lamps have never been ceiling fixings because the monogram in the main part of the lamp just above the base where the letters E, L and J are the right way up.

The remainder of the walls have modern wallpaper on them which spoil the character of the room. Some research might show the original wallpaper but it is likely that an embossed, patterned and strongly coloured paper was on these walls originally.

The joinery is in good condition and can be overhauled by wax polishing in the minor points of scratches and damage. Accretions such as lights, cables and applied timbers should be removed. The frieze paper should be cleaned and repainted as necessary. The modern wallpaper should be replaced with a more appropriate paper. The lamps should be returned to full working order as electric lamps.

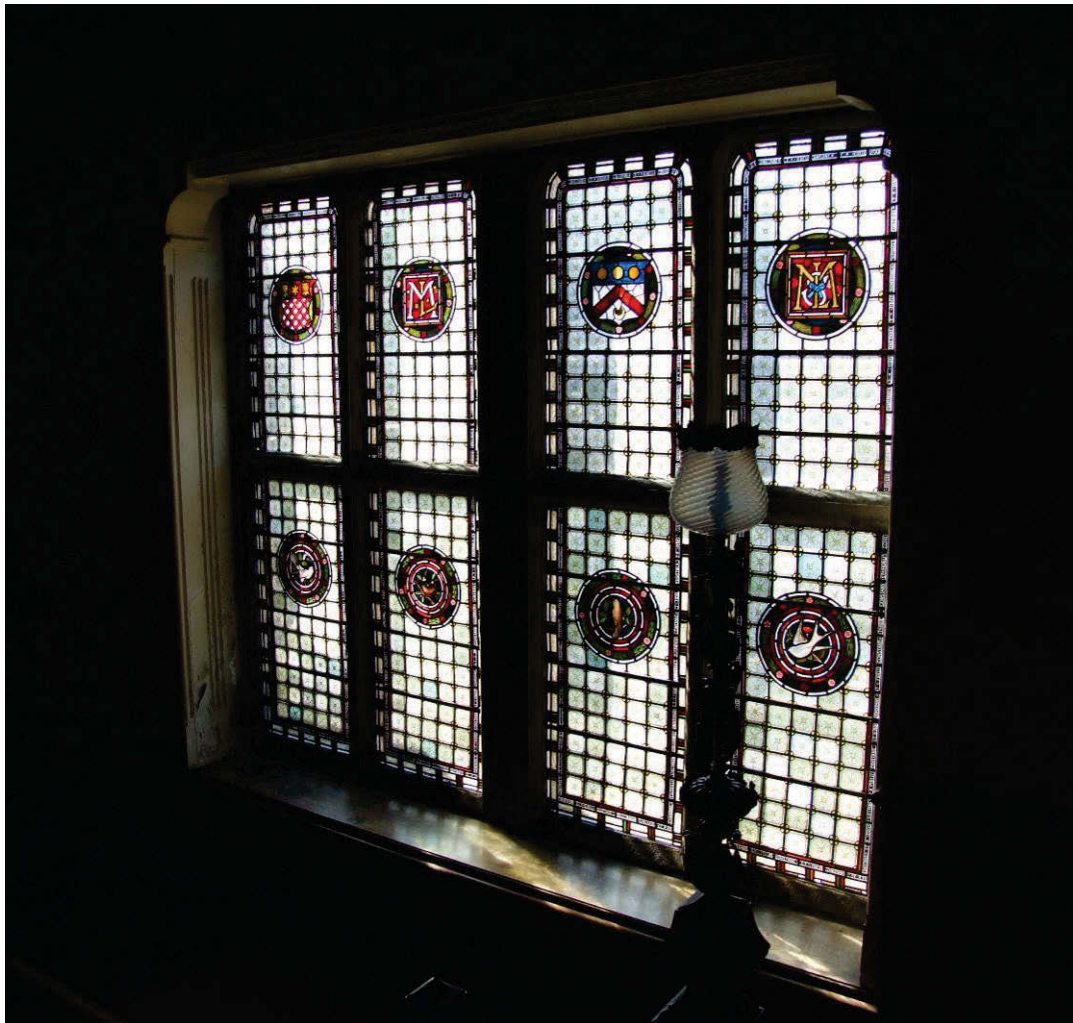
Figure 46 The stair hall stained-glass window by Daniel Cottier. Set in roundels, there are Liddell heraldic devices and initials in the upper parts, and English songbirds below.

The stained glass is in fairly good condition. About a quarter is distorted to such an extent that might need to be taken out and rereaded. The glass is signed in the lowest right panel from the inside: 'Daniel Cottier Glasgow. Prize awards London and Paris'.

The stained glass is the most important element in Prudhoe Hall. There are a finite number of surviving examples of Cottier glass in domestic settings in England, and how Cottier came to work in this setting is interesting, because of the Roman Catholic client and architect. The glass requires assessment and conservation by an historic stained-glass specialist. It should be repaired.

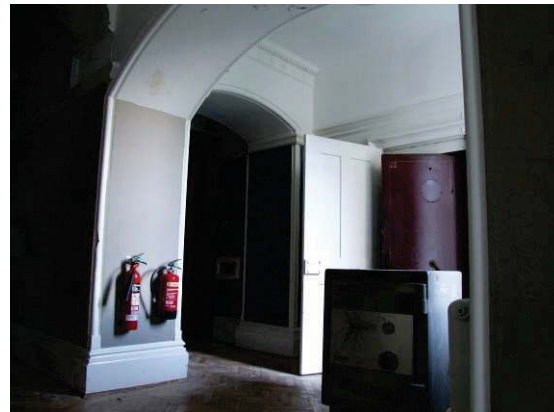
Figure 59 Former servants' preparation area for the dining room, at the east end of the 1870s chapel corridor. The safe door is on the right.

At the eastern end of the corridor is an arch which was the servants' preparation area for the dining room and is associated with the safe. There is quite a lot of water damage in this arch and some dry rot fruiting bodies. The timber of the picture rail which runs at roughly the level of the springing of the arches in the arcade is badly decayed by dry rot. This seems to be a localised incident but needs to be tackled. This is urgent work.

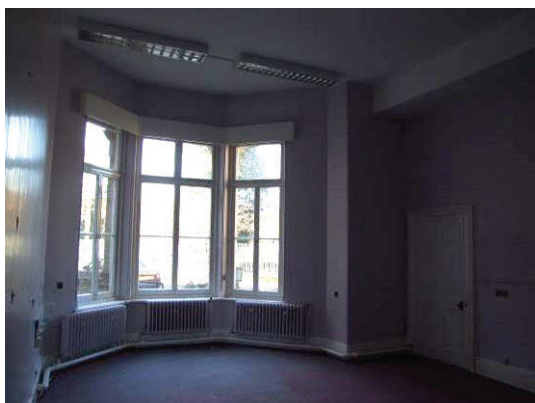
In the room with the bay window, there is a large beam supporting a structural wall above. This suggests that this is where the end wall of the original 1870s block was removed at ground storey level. The stability of this beam should be checked at either end in case it is timber. A metal beam in this position, which is more likely, is likely to be sound but a timber beam could be subject to rot decay.

Figure 62 Room with bay window and load-bearing beam above right. This may be where the c.1870 hall end wall was, and this room may have been an external courtyard.

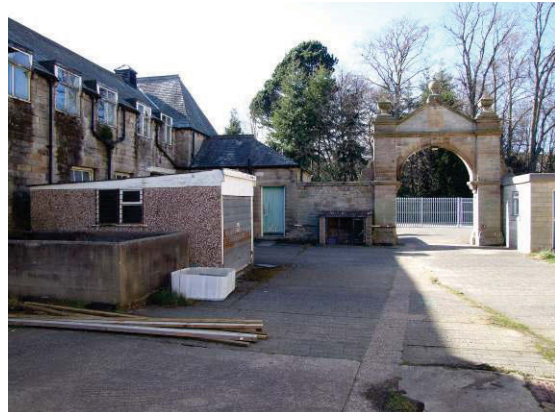
Figure 74 The service court looking north towards the entrance arch.

Some of the walls are in poor condition. There is a chimney to the north of the main pend which requires 100% pointing and this chimney might be leaning slightly. An allowance should be made for taking down and rebuilding. About 75% of the masonry on the rest of the building needs pointing. Some areas are saturated particularly below the five windows which have been inserted into the wall face to the north of the pend. The clock should be repaired. The finial and the head of the north side of this pend should also be reinstated. This might be missing a weathercock. It would be an appropriate position for a weathercock associated with the clock. Some windows have been blocked with cement and should be opened up. The 1970s garage and concrete trough next to the north wall should be removed.

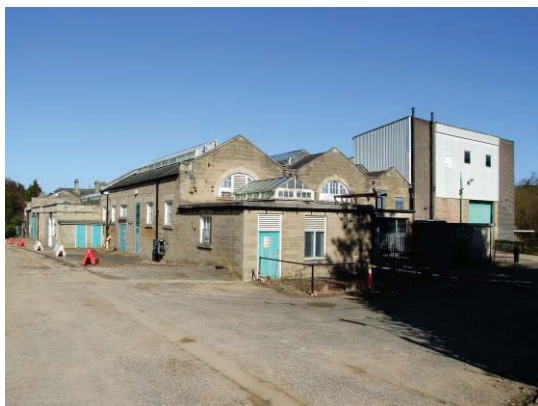
Figure 79 The 1920s laundry building with the 1970s boiler house to the right.

The distinction between the original sandstone part of the service block and the extension for the hospital which formed the laundry and boilerhouse is evident in a change of walling material from sandstone to cast stone. Only the eastern bay of the entire north front is part of the original service block. This masonry block is also badly stained and needs to be repointed with the dormers and escape door removed. The escape stair should also be removed. It is badly rusted.

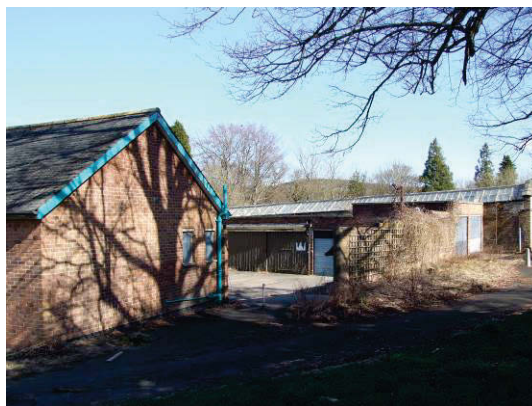
Figure 80 The mid-20th century sheds between the laundry and the walled garden.

To the west of the boilerhouse are various mid to late 20th-century sheds (Figure 80). None of these buildings have any significance and some, like the boilerhouse, have negative significance and should be removed. It can be assumed that all of these buildings can be removed and the space made available for development.

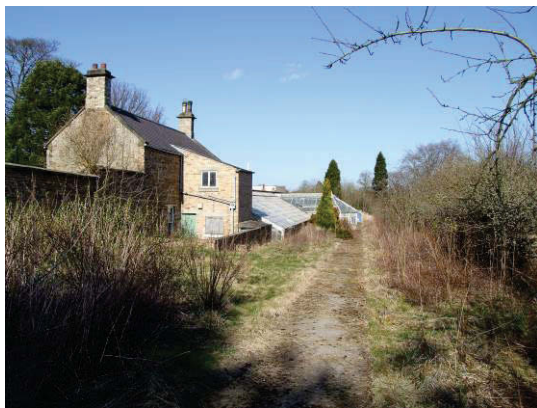
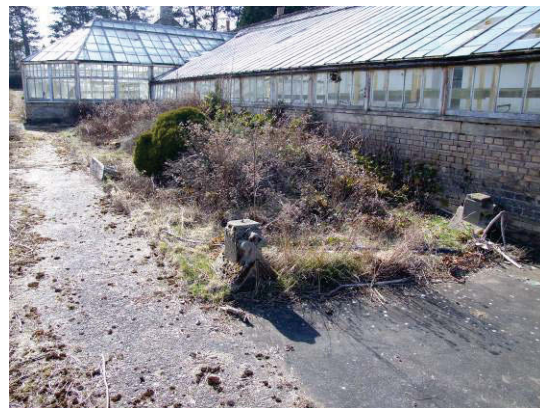
The wall of the walled garden is not particularly significant in itself. It is built of brick and appears to be late 19th-century or early 20th century. However the glasshouses, altered by Richardson of Darlington are significant. These glasshouses have been built in three phases with an extension to form a conservatory. The condition of these glasshouses is poor and very considerable work is needed to repair the timber structure and the glazing.

Figure 83 Walled garden from the west. Gardener's house on the left, with glasshouses.

Figure 84 Walled garden glasshouses, with masonry fragments in the foreground. More are embedded in the rockery in this photograph.

Certain structures around the walled garden are of low significance, and could be demolished or altered. However the main glasshouse should be retained and restored. In any proposed subdivision of the garden the character of it being one space should remain intact.

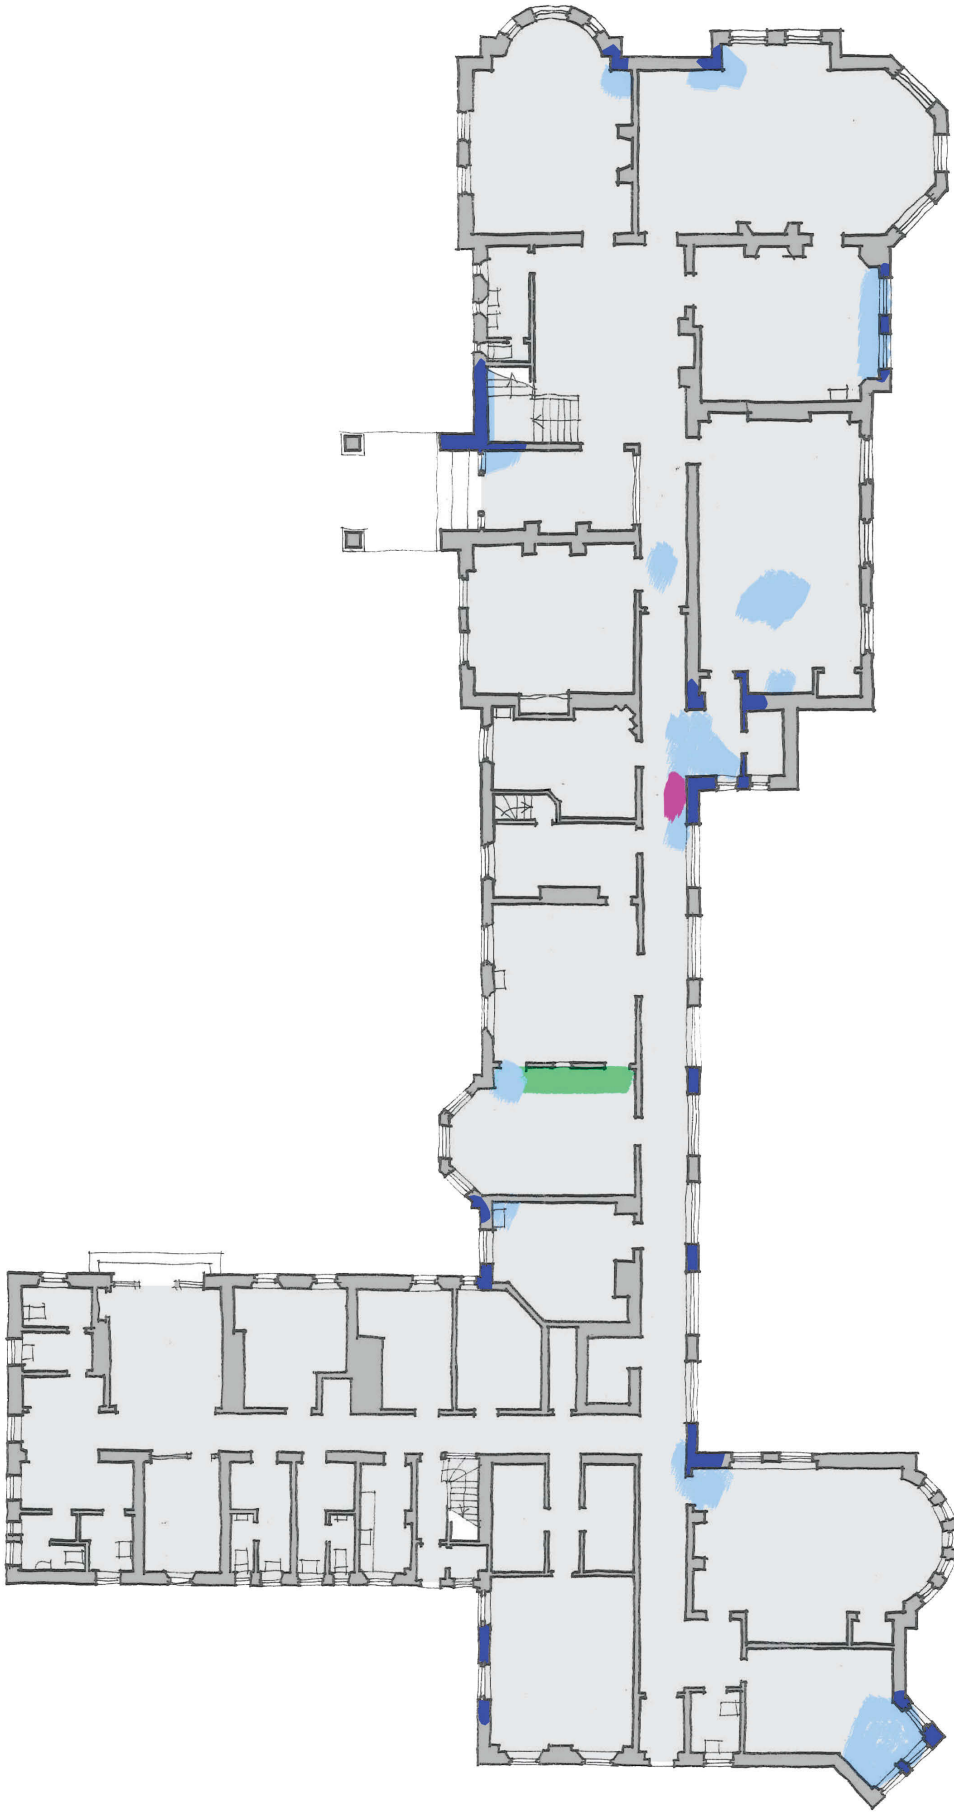
Ground storey - condition

- Evidence of decay due to water in wall
- Signs of damp on interior finishes
- Beam ends should be checked
- Dry rot fruiting body

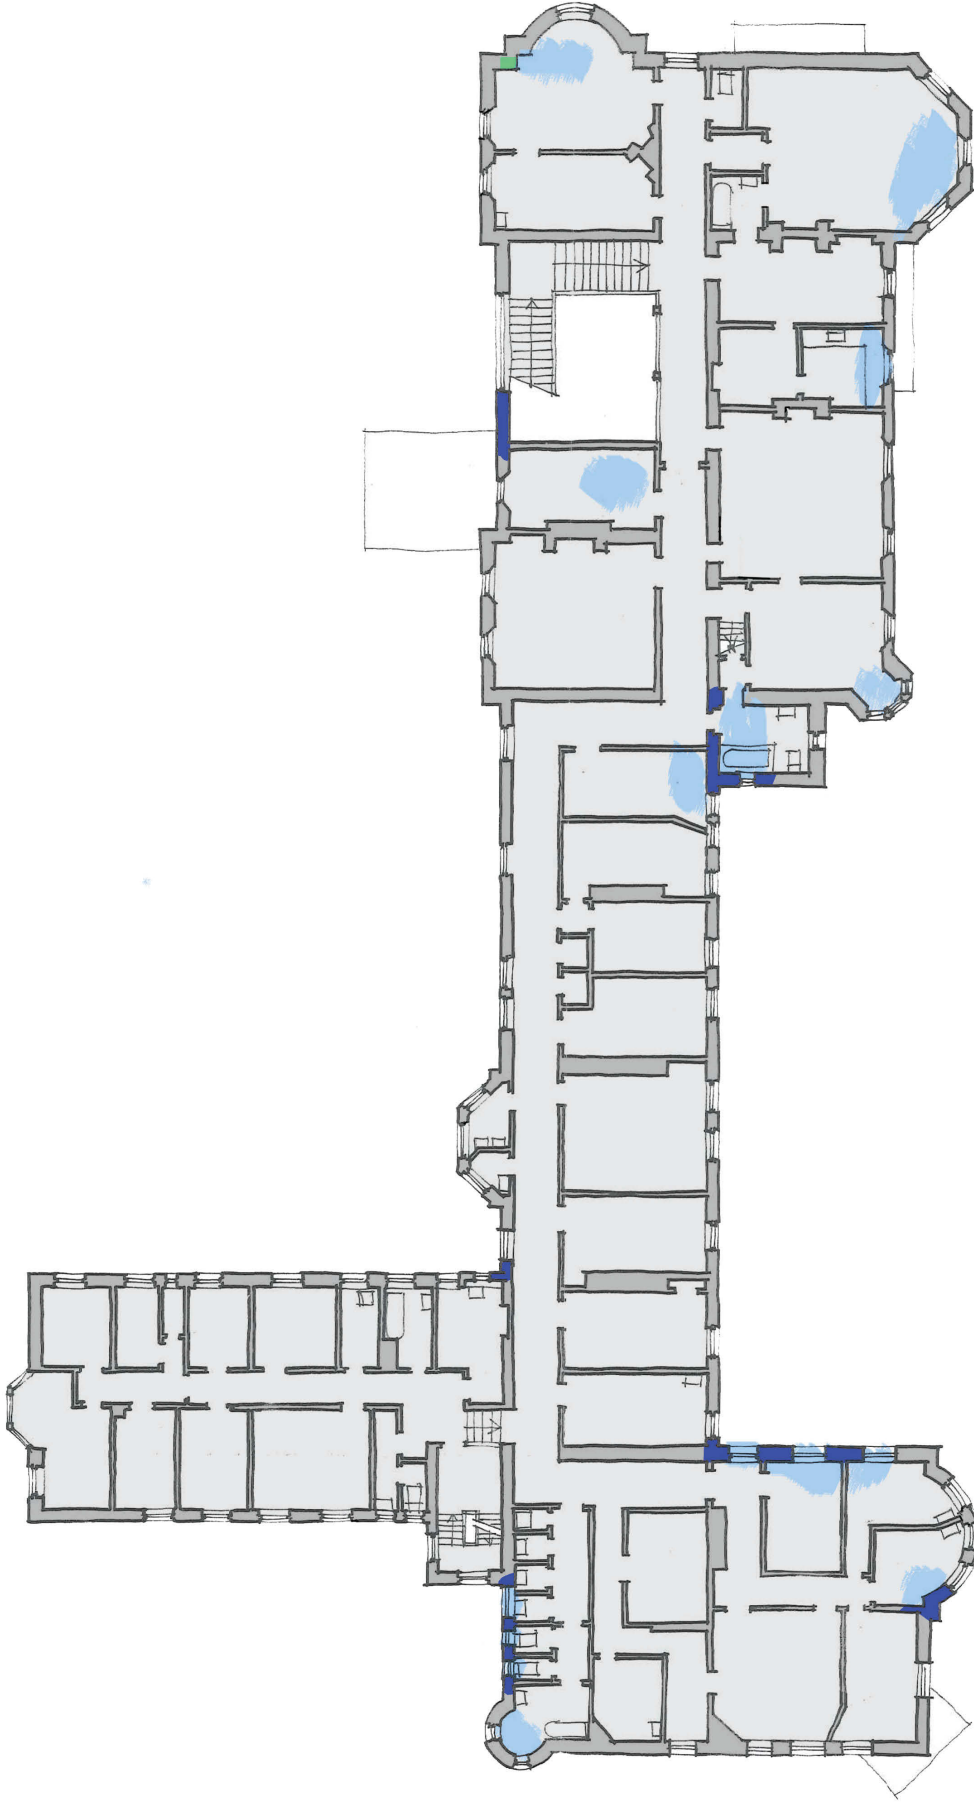
First floor - condition

Beam ends should be checked

Dry rot fruiting body
