**NO.10 LINCOLN ROAD,
WELTON, WEST LINDSEY,
LINCOLNSHIRE.**

**HISTORIC BUILDING
SURVEY**

Site Code: WERD 11
NGR: TF 0109 7957
Planning Ref: 126997
LCCM Acc No: LCNCC 2011.91

June 2011

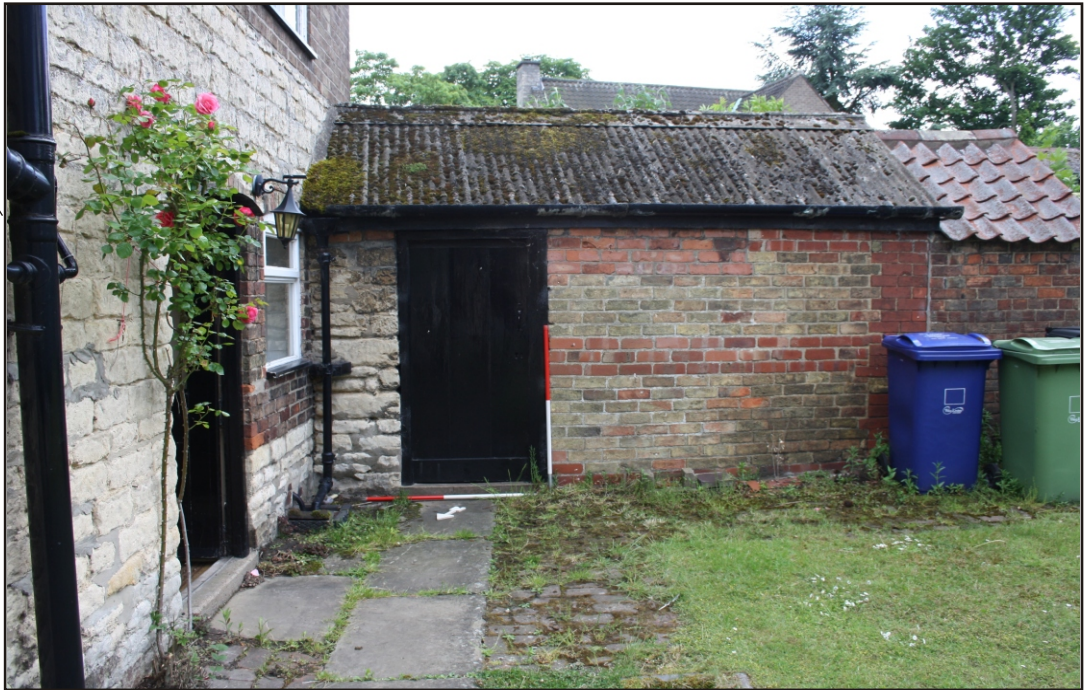
FIG. 9

The overlooking 'blocked' upper window to the outshut, blocked with brick identical to the 1960's extension. *see above right*

The outbuildings leading from the south/west corner of the outshut, with the remains of a possible former stone structure to the immediate left of the door. *see right*

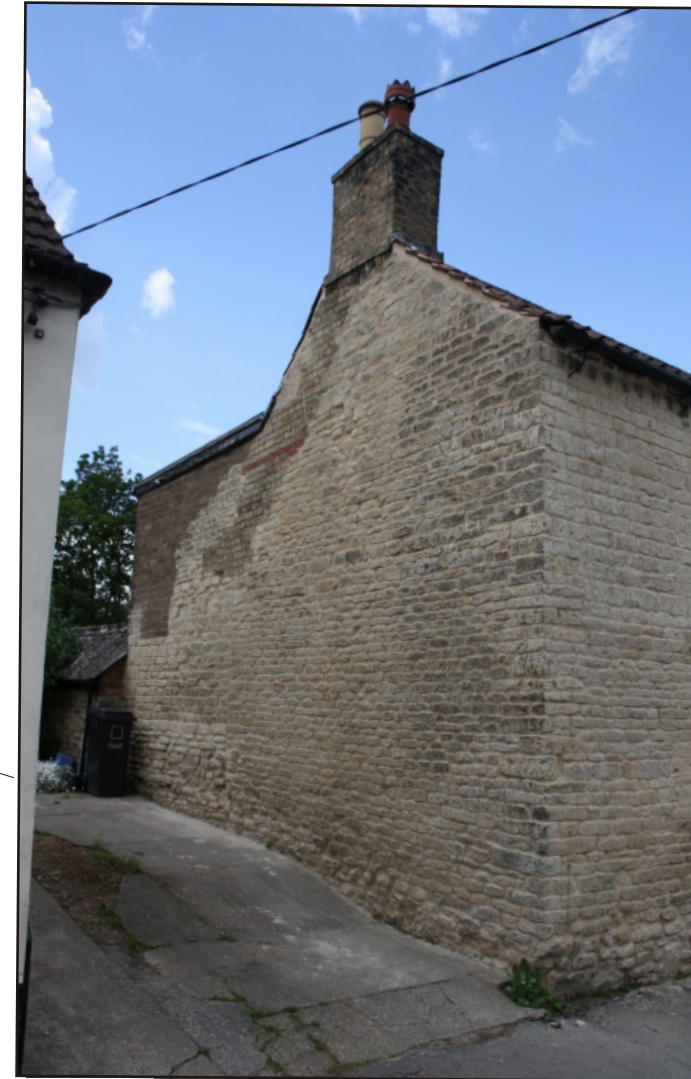
South Elevation

The south facing stone wall of the outbuilding can just be made out projecting slightly south of No.10 and could possibly be an earlier outbuilding or structure, *see right*

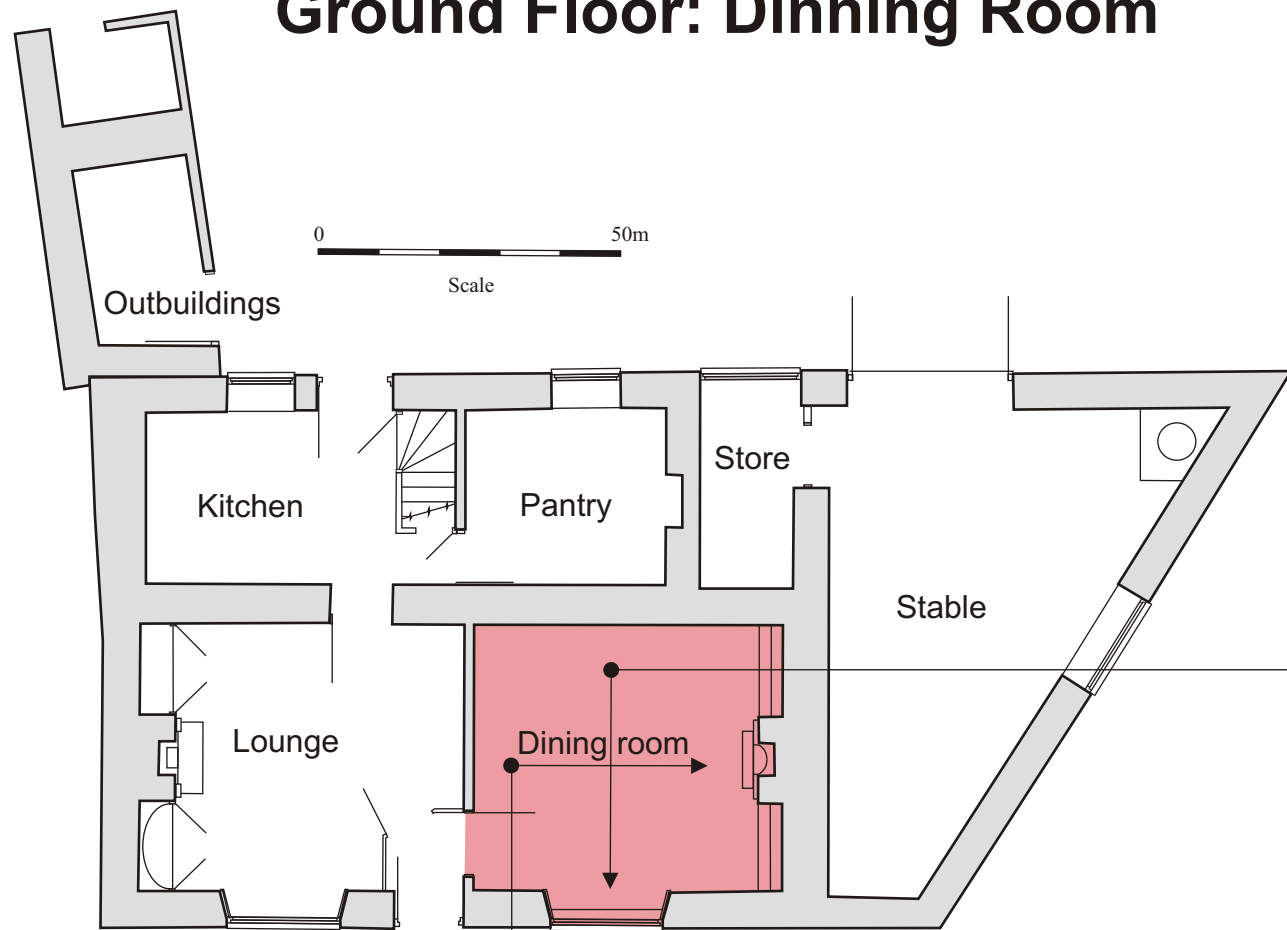
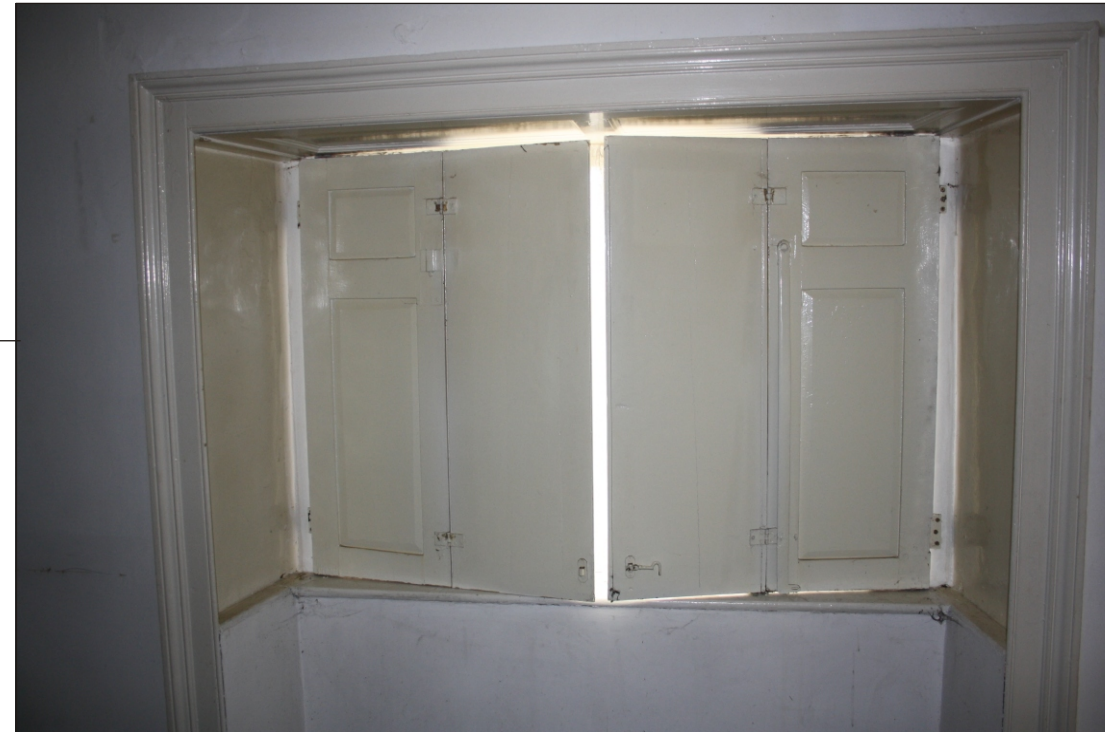
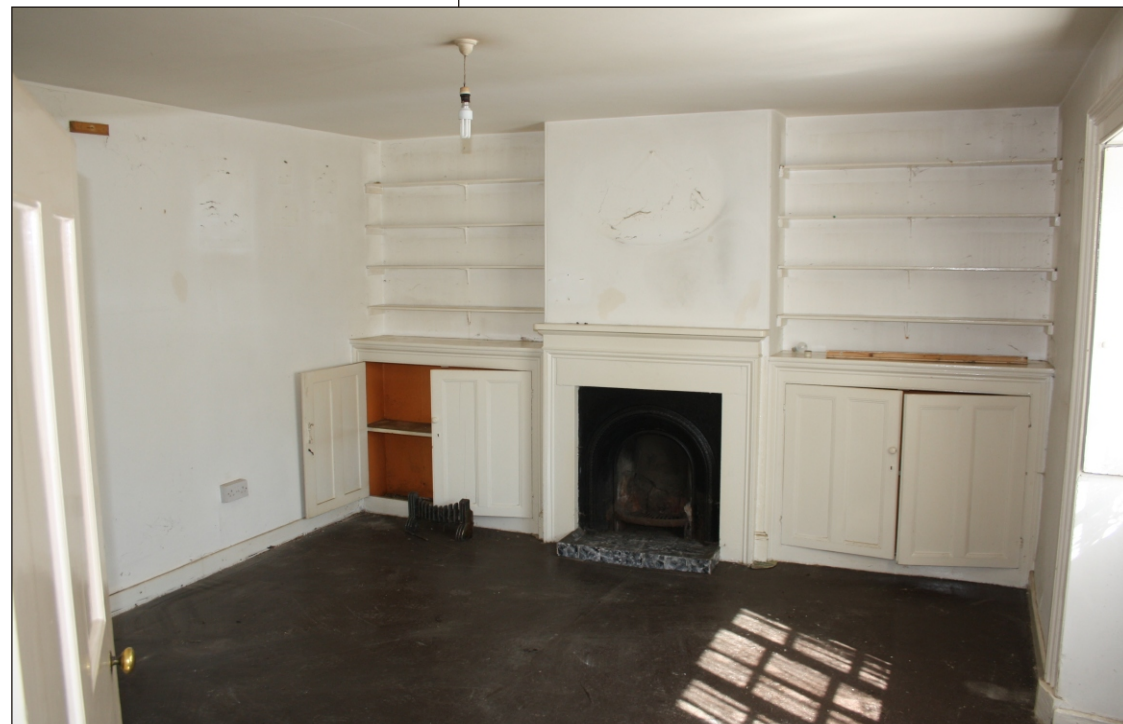
FIG. 11

The dinning room is accessed via the lobby entrance to the front of the house, it is square in plan with a low plastered ceiling, while the floor is covered in Linoleum and fitted with plain skirting. There is a single hearth situated within the north gable wall and fitted with a mid/late 19th Century cast iron insert. The entrance door is of the four panelled variety and is fitted with a skeleton spring latch, there are wooden shutters fitted to the windows. **see left and above**

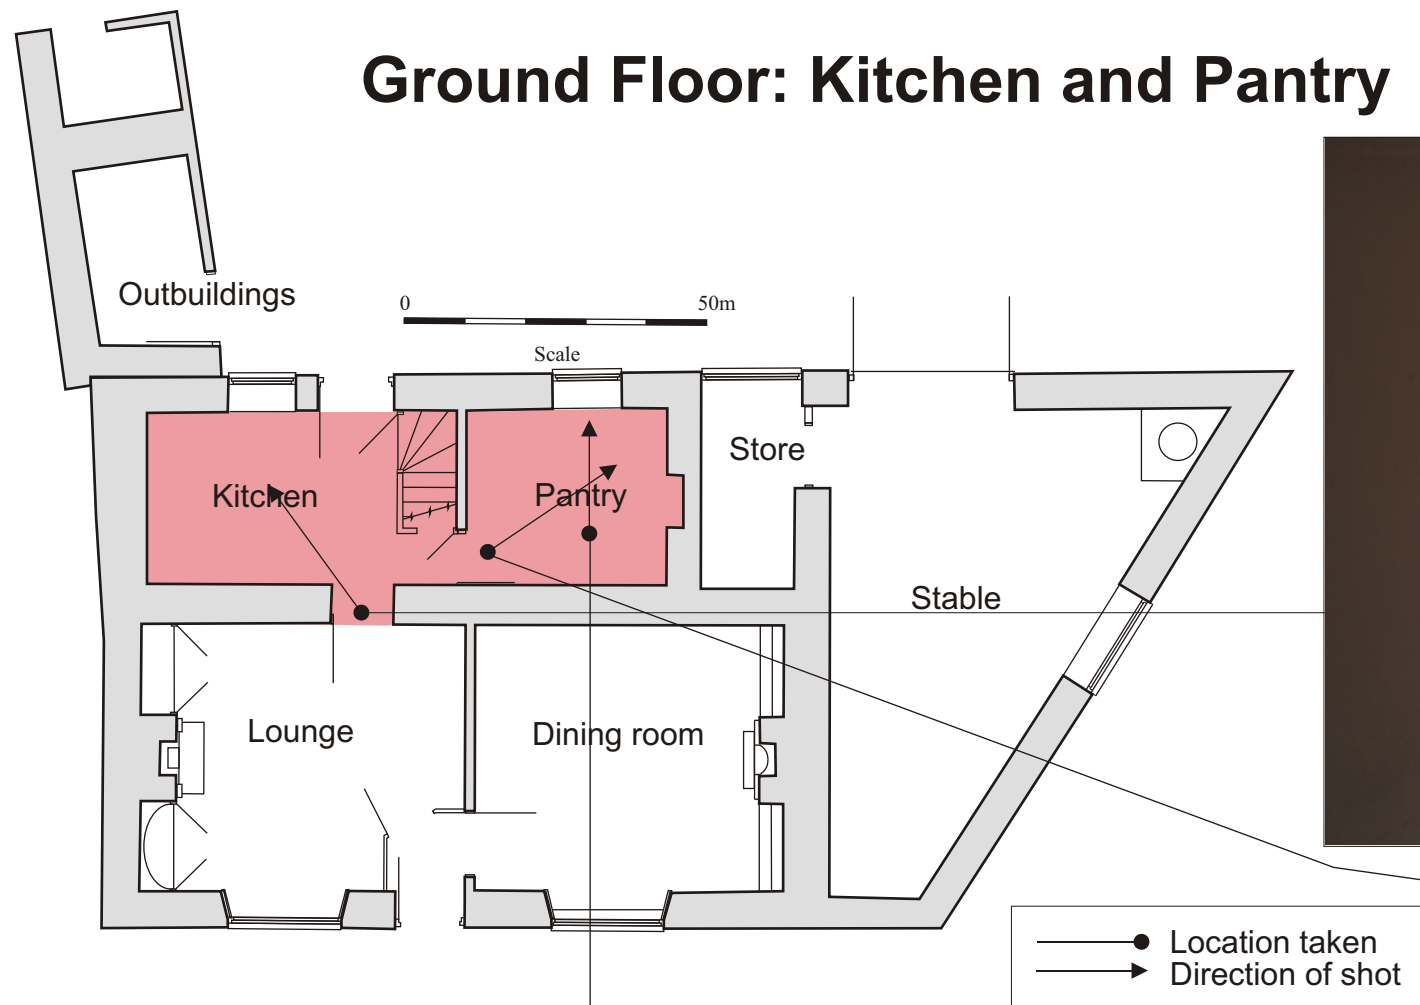
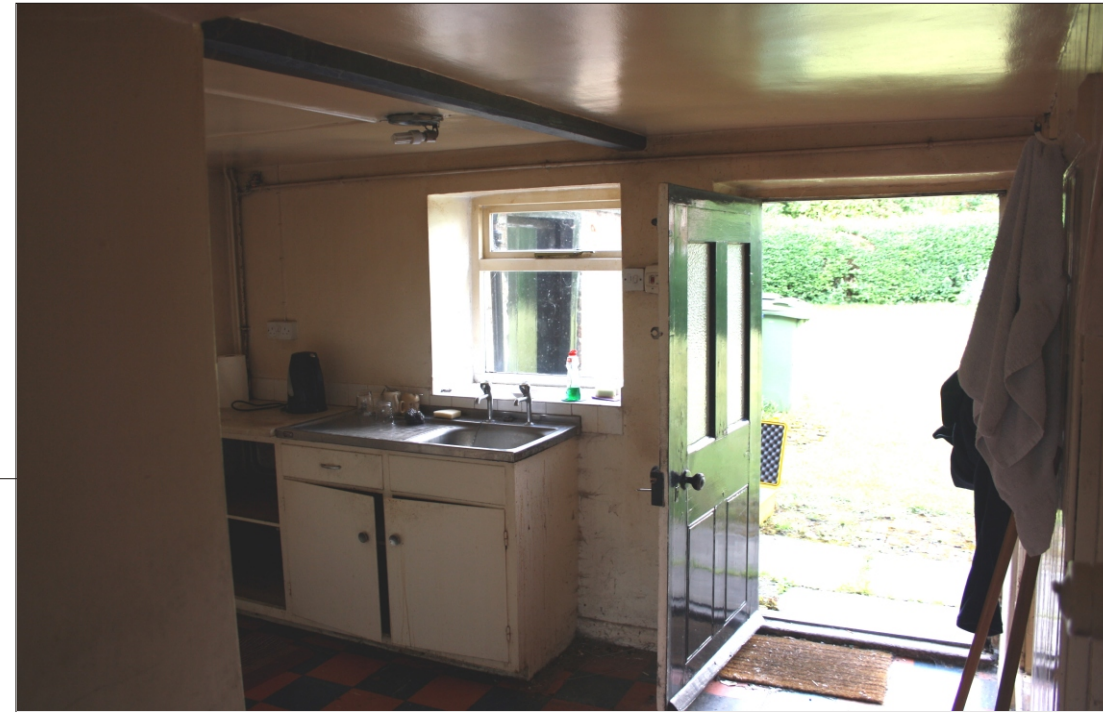
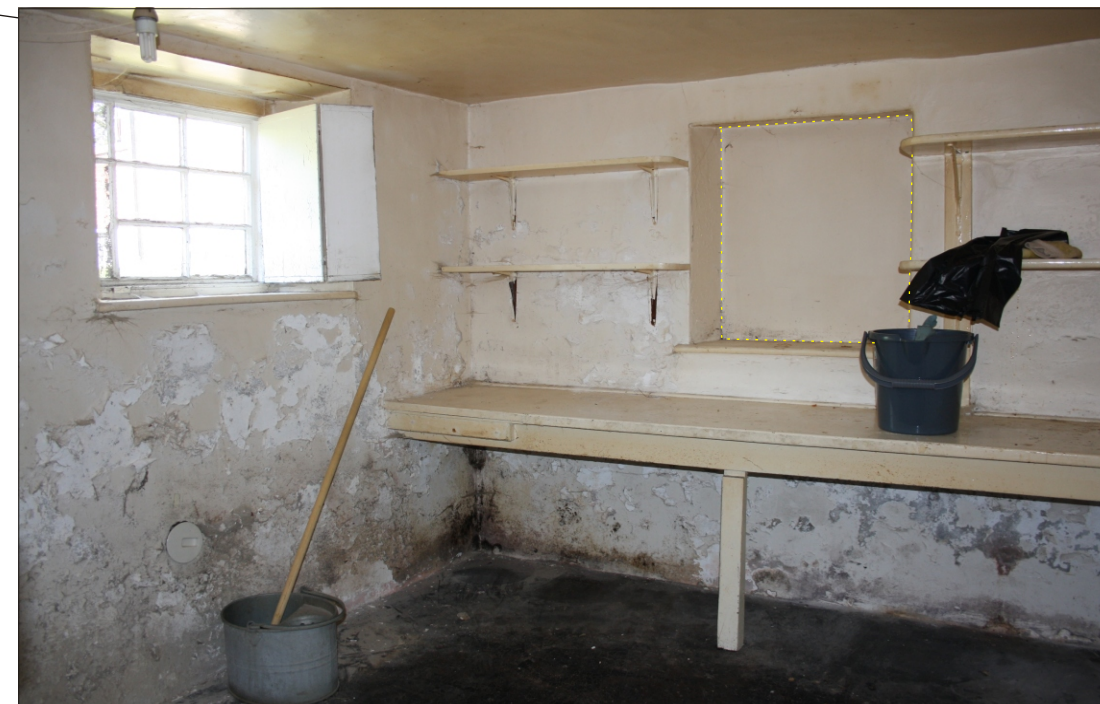
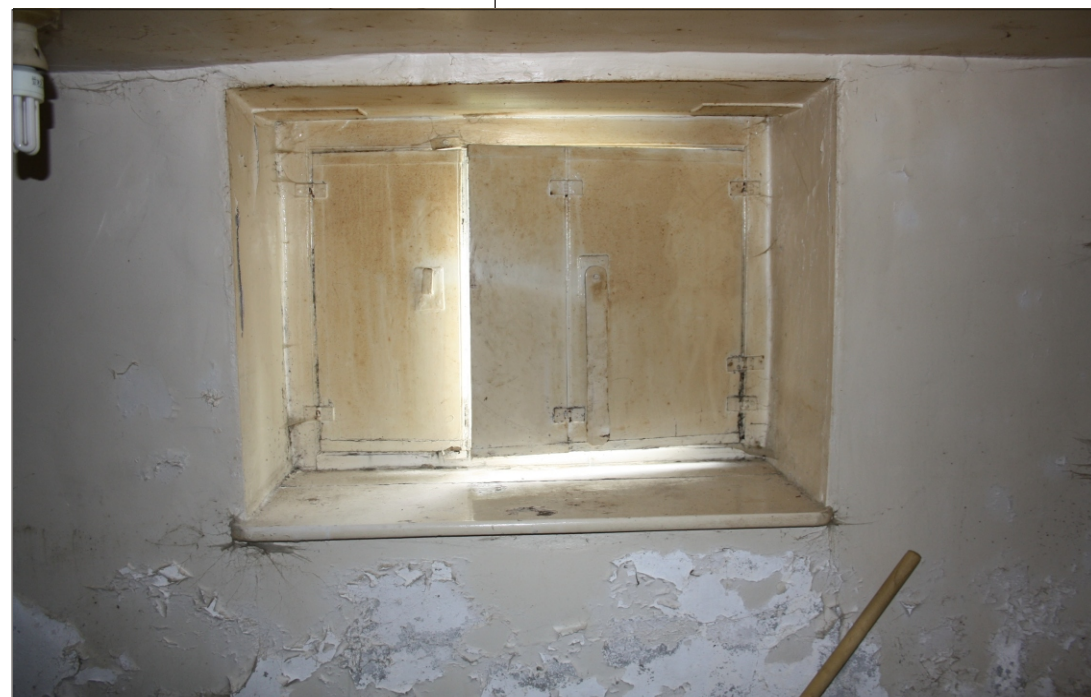
Ground Floor: Kitchen and Pantry

The kitchen and pantry are situated to the rear of the building within the outshut extension. **see top left.**

The kitchen is rectangular in plan and accessed by both the lounge to the east and a door opening onto the garden area to the west. The ceiling height reflects that of the two previous rooms and there is an east/west axial beam fitted, although not original as its was inserted during the improvements undertaken to this property during the 1960's. The floor is covered with Linoleum tiles, while the skirting is plain. **see top**

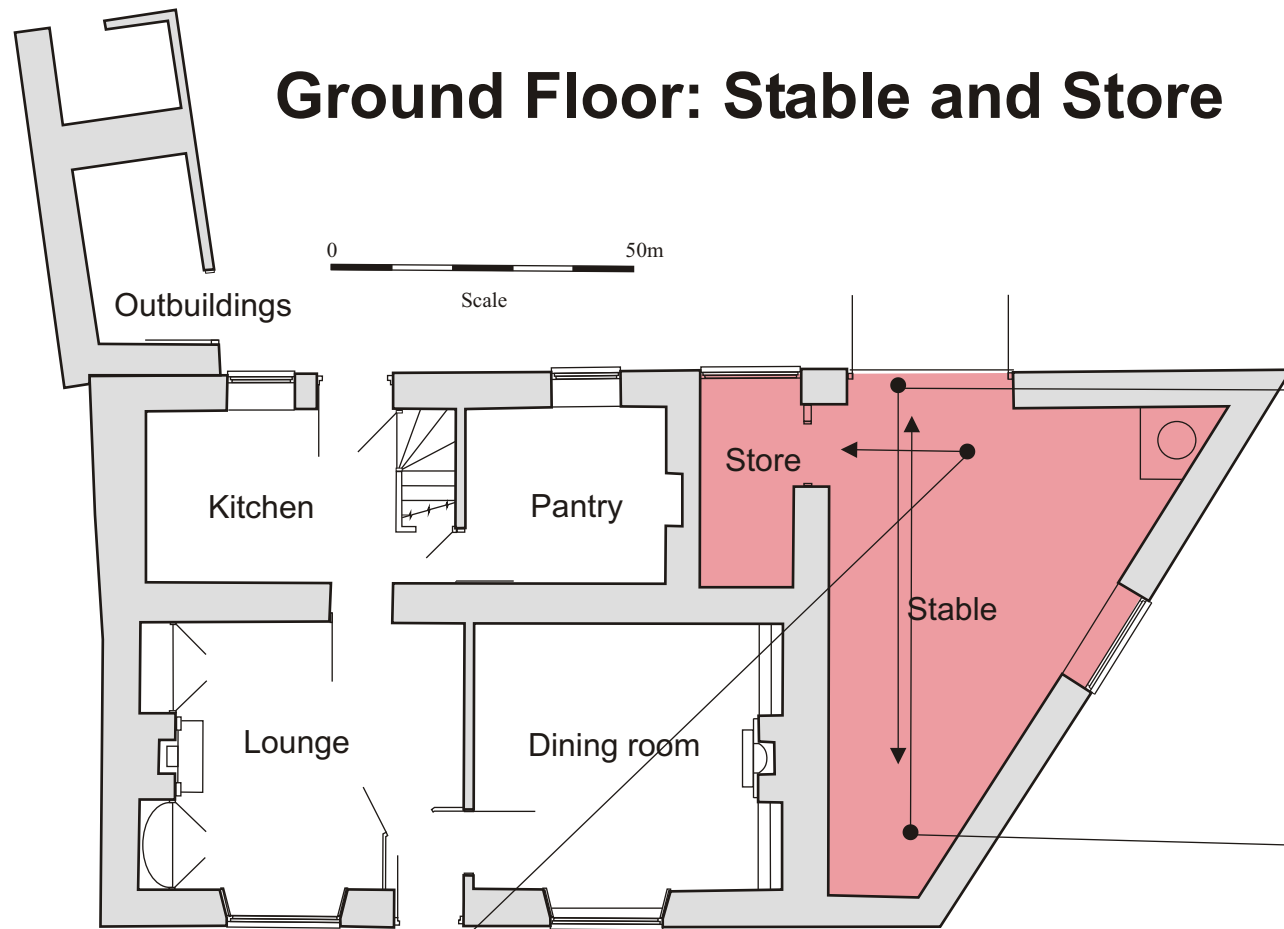
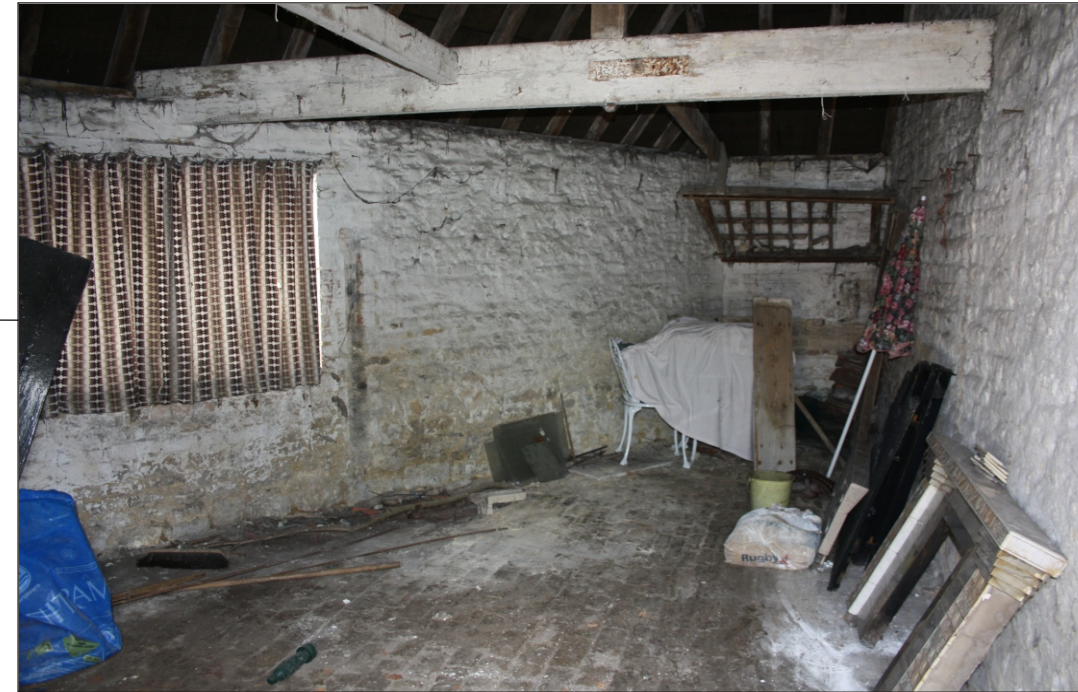
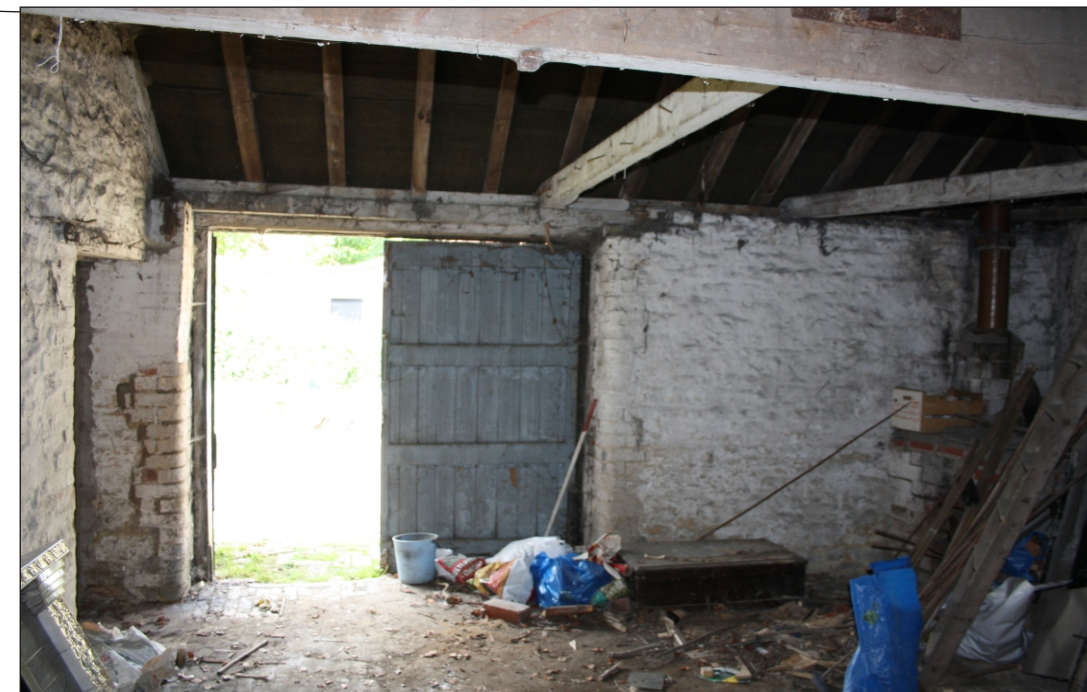
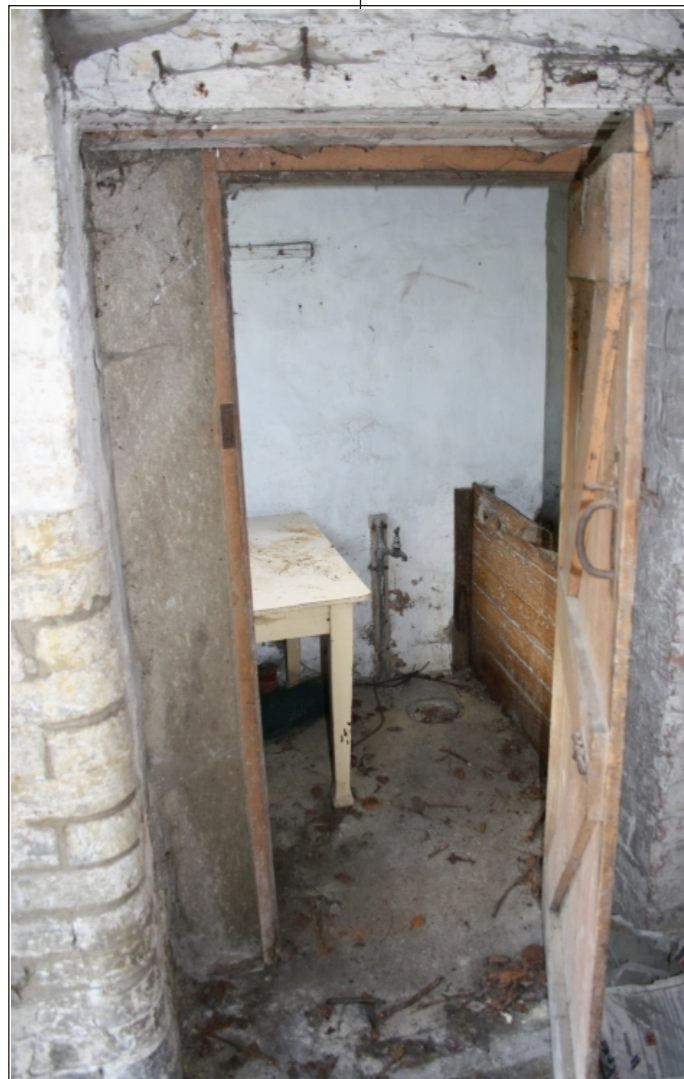
FIG. 14

The stable is roughly triangular in plan and accessed from the garden to the west. **see top**

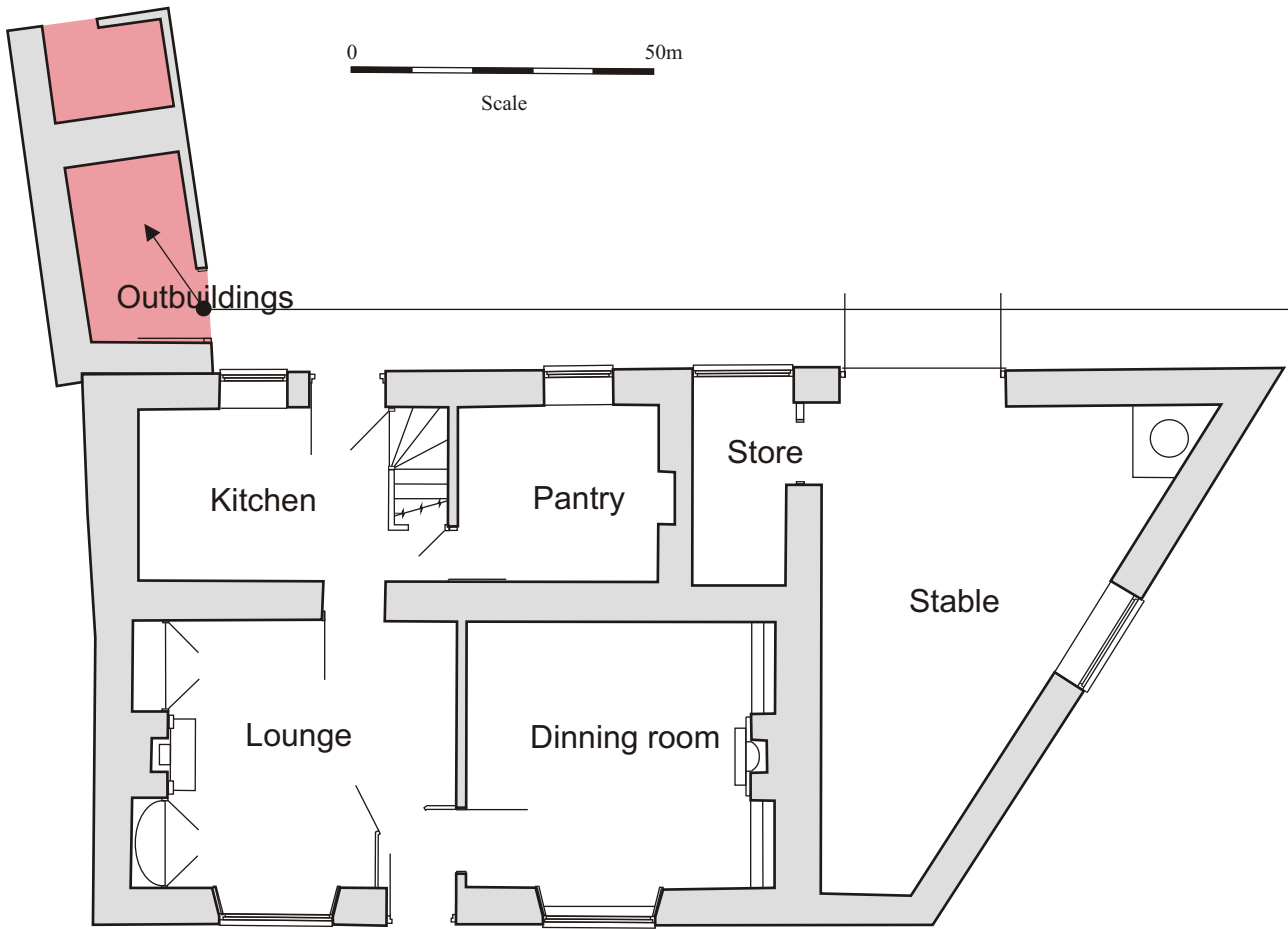
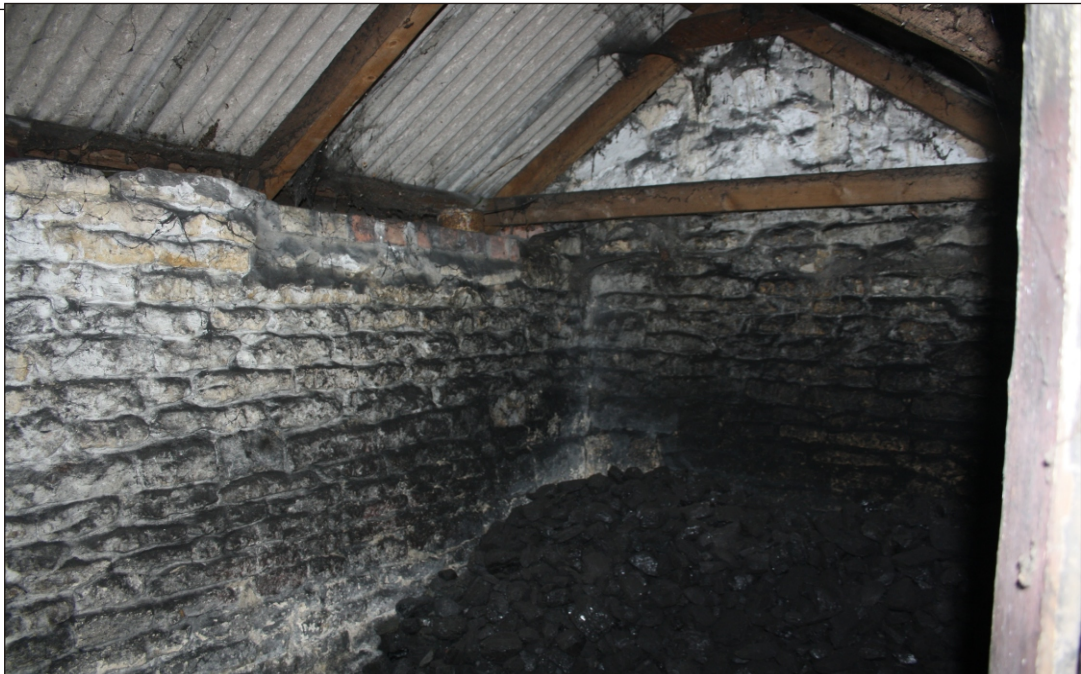
FIG. 15

The outbuildings to the rear of the property form an oblong range of two room projecting awkwardly off of the south/west corner of the outshut. **see top left**

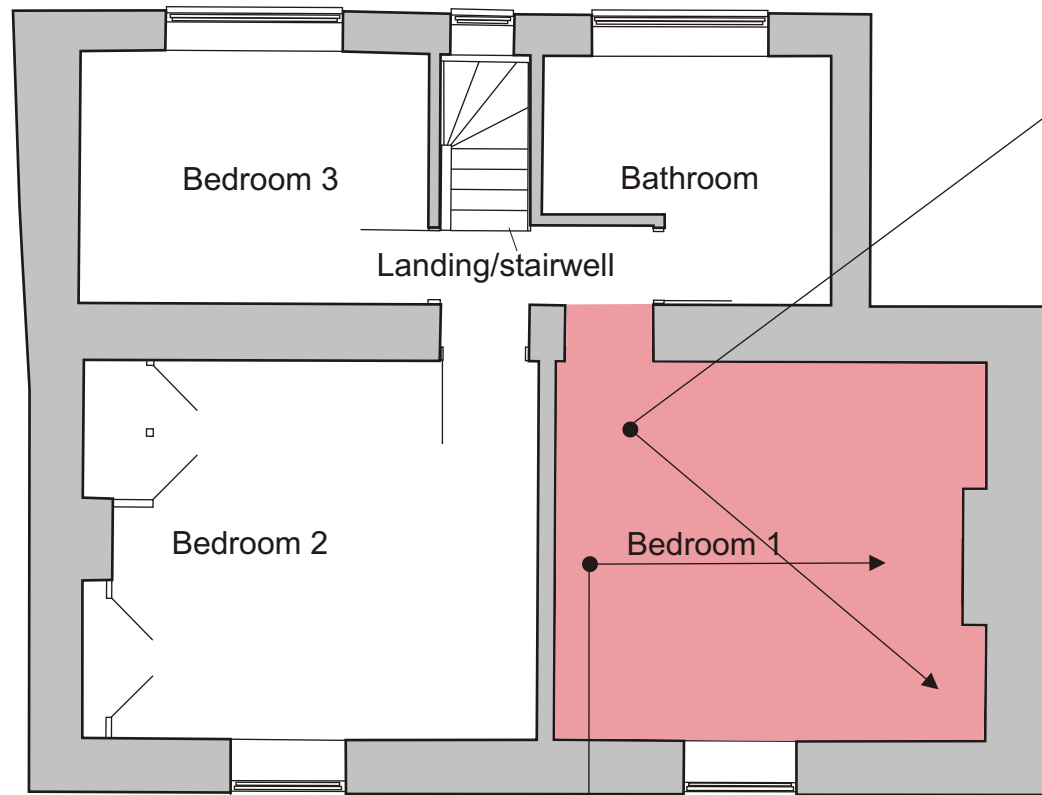
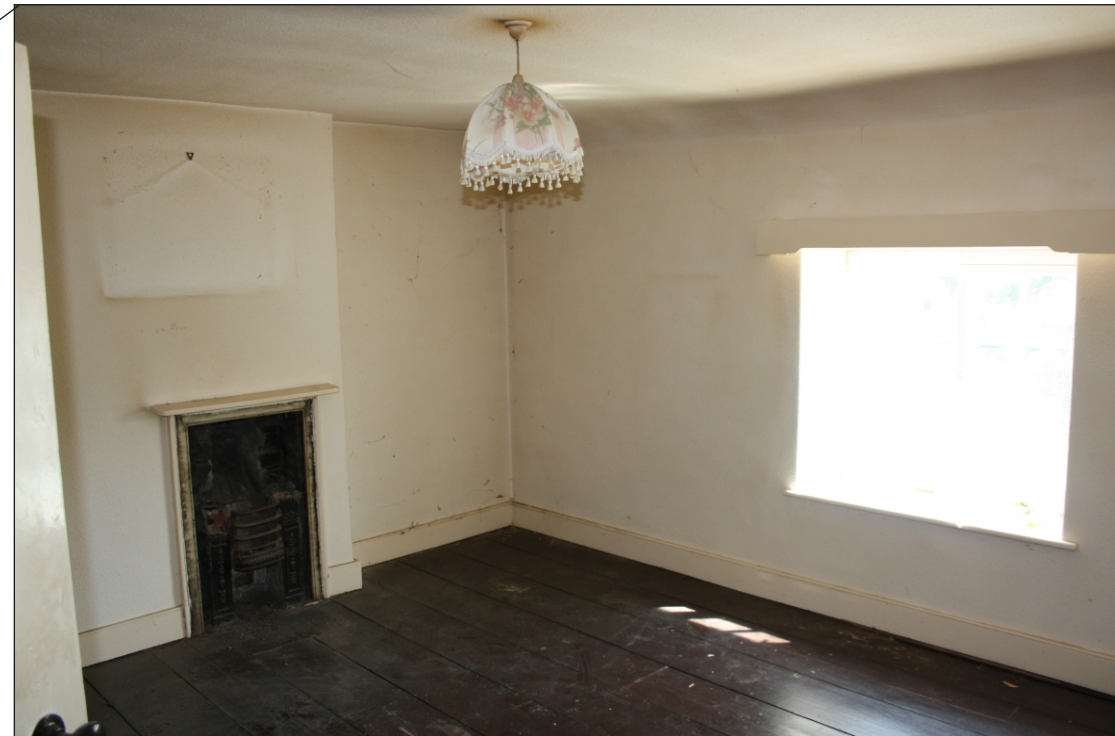
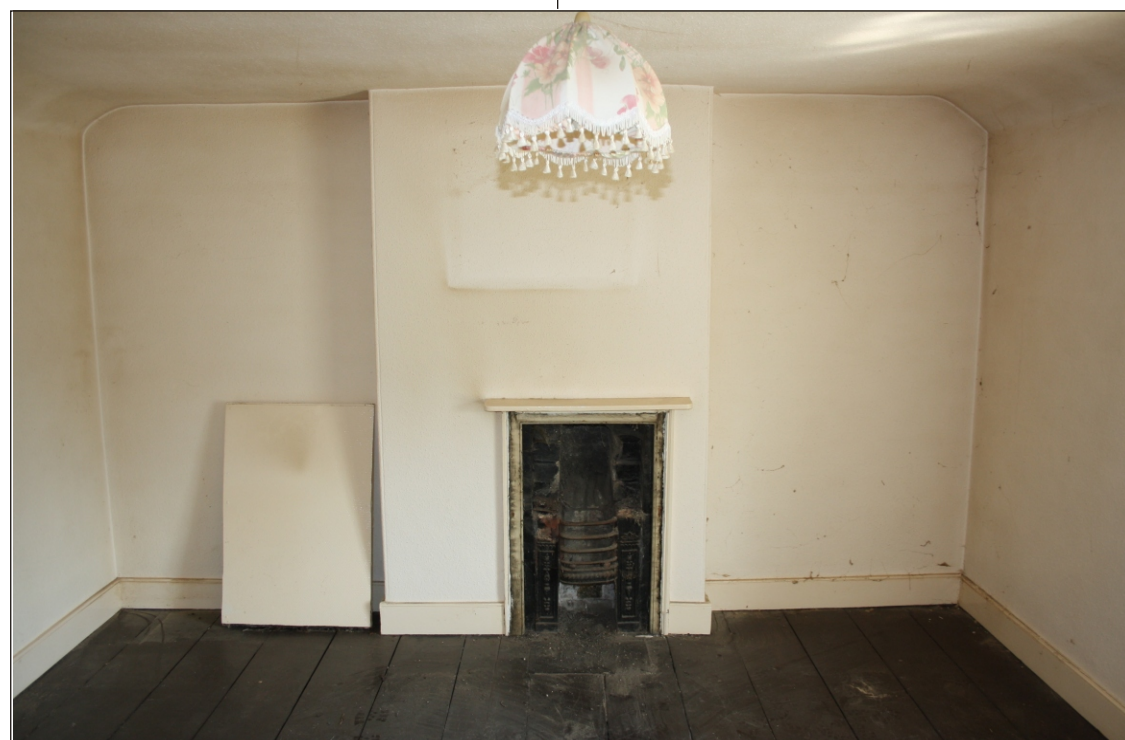
Ground Floor: Bedroom One

Bedroom One is square in plan, located directly above the dining room and accessed from a small landing within the upper storey of the outshut. **see top left**

The ceiling is relatively low, while there is a hearth located off centre within the chimney breast on the north wall and retains an early 19th Century cast iron hob grate. The floor boards are of pine and approx 25" in width and appear to be contemporary this room. **see left**

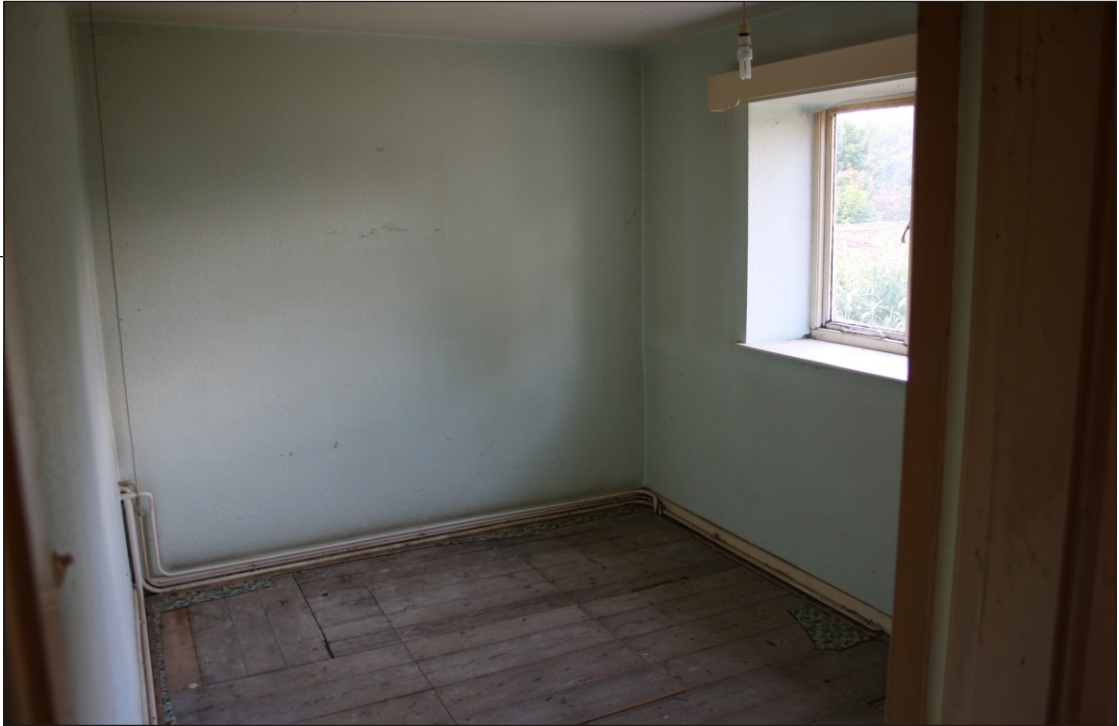
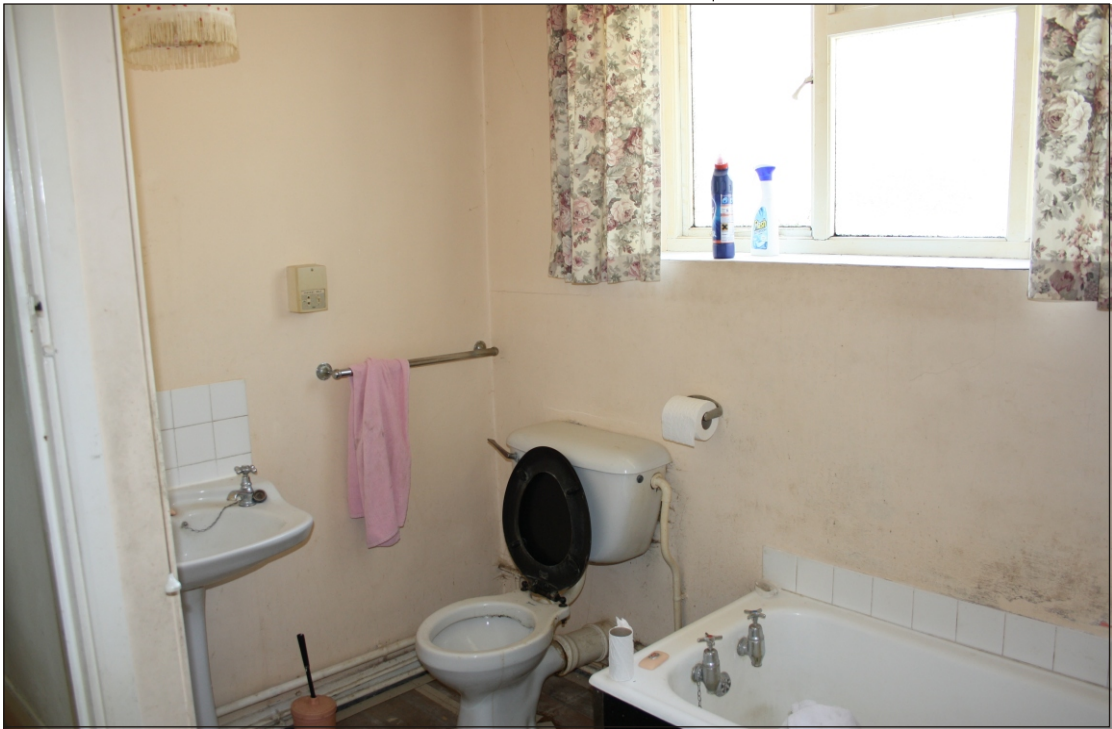
Bedroom Three is located within the south/west corner of the property and is part of a 1960's upper storey extension to the outshut. **see top left**

The room is rectangular in plan with a single entranceway accessed from a small landing to the north, the floor is of narrow pine boards, while the door is of hollow construction. **see above**

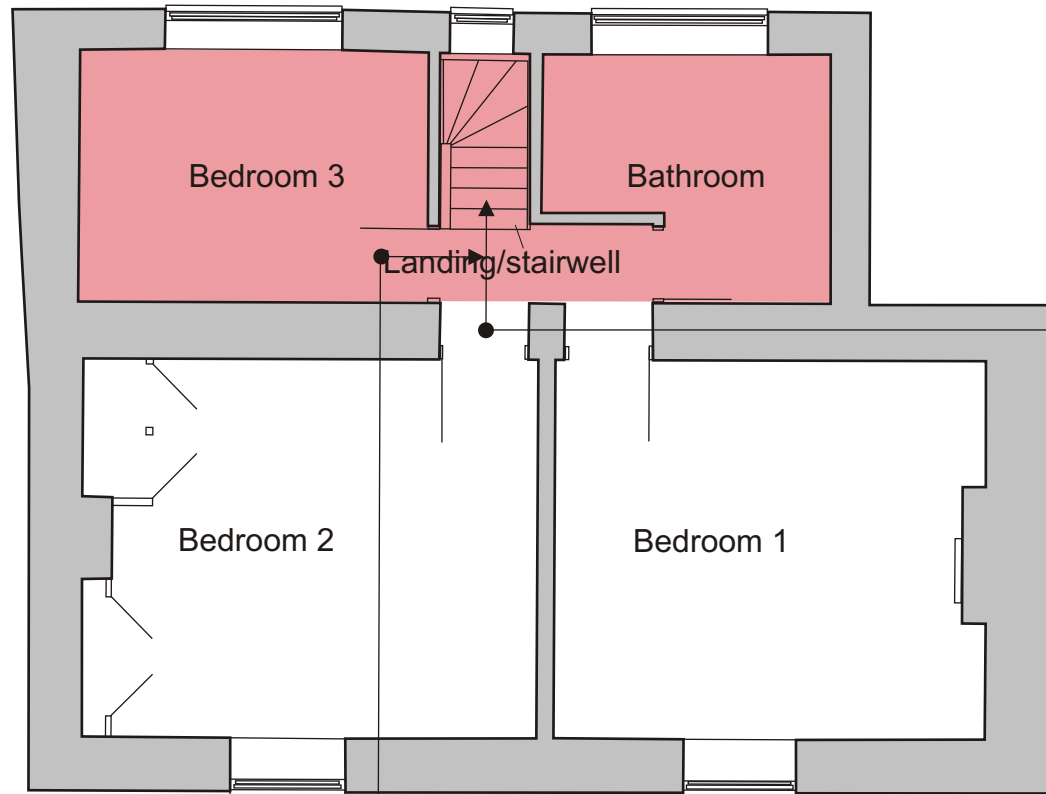
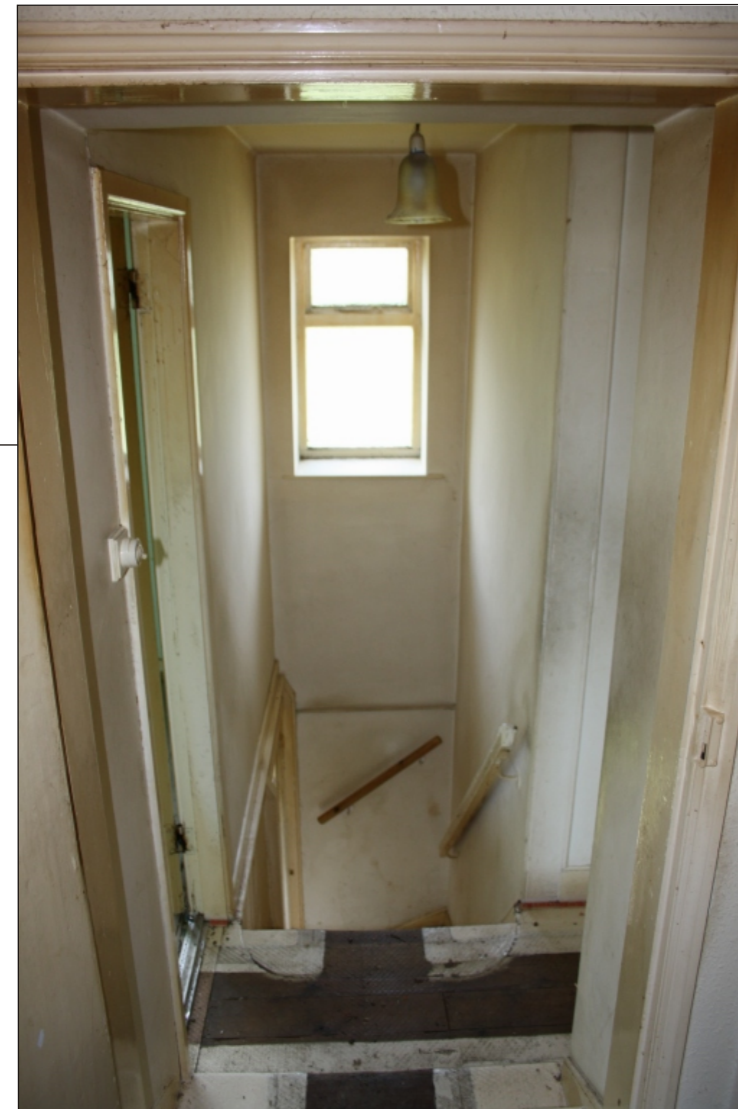
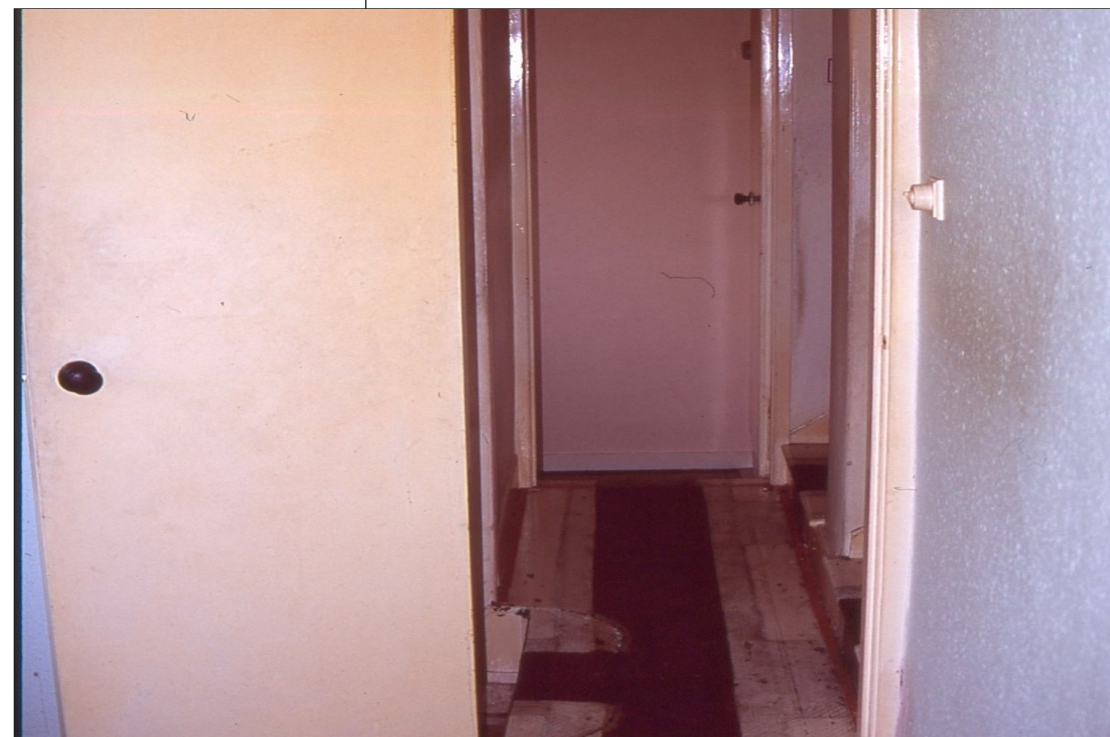
A small narrow landing stepped down from the two front bedrooms connects the third bedroom and bathroom and is accessed via the ground storey by a narrow Kitewinder staircase. **see above**
