14 Hilgrove Street, St Helier, Jersey

Archaeological Appraisal

**Archaeological appraisal of the suitability of 14 Hilgrove Street to be
considered for designation as an
Archaeological Site**

August 2010

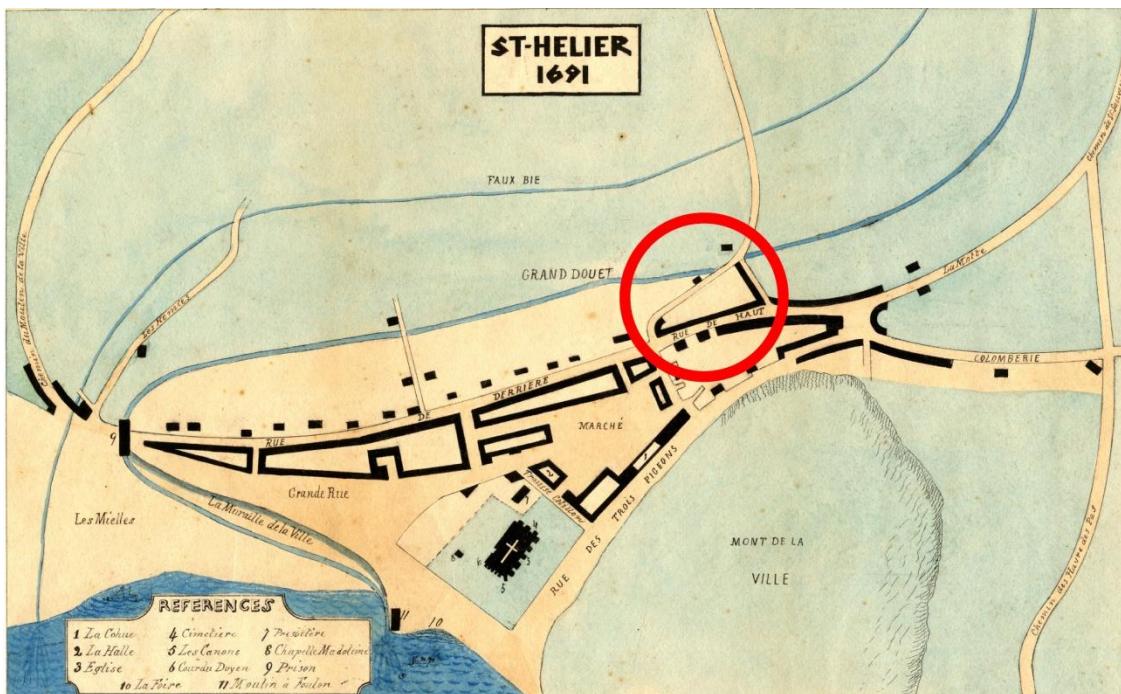
St Helier 1691

- 2.4** In addition, a 1691 plan of St Helier illustrates the establishment of Hilgrove Lane by the late 17th century (Fig. 2). Two buildings are located to the north of Hilgrove Lane. One is identified as La Ferme (the farm), as shown in the 18th century Hedley plan. The other is shown fronting onto the road, although it appears to be located too far east to occupy the study area. However, the potential for development within the study area dating to the 17th century, once again, should not be discounted.

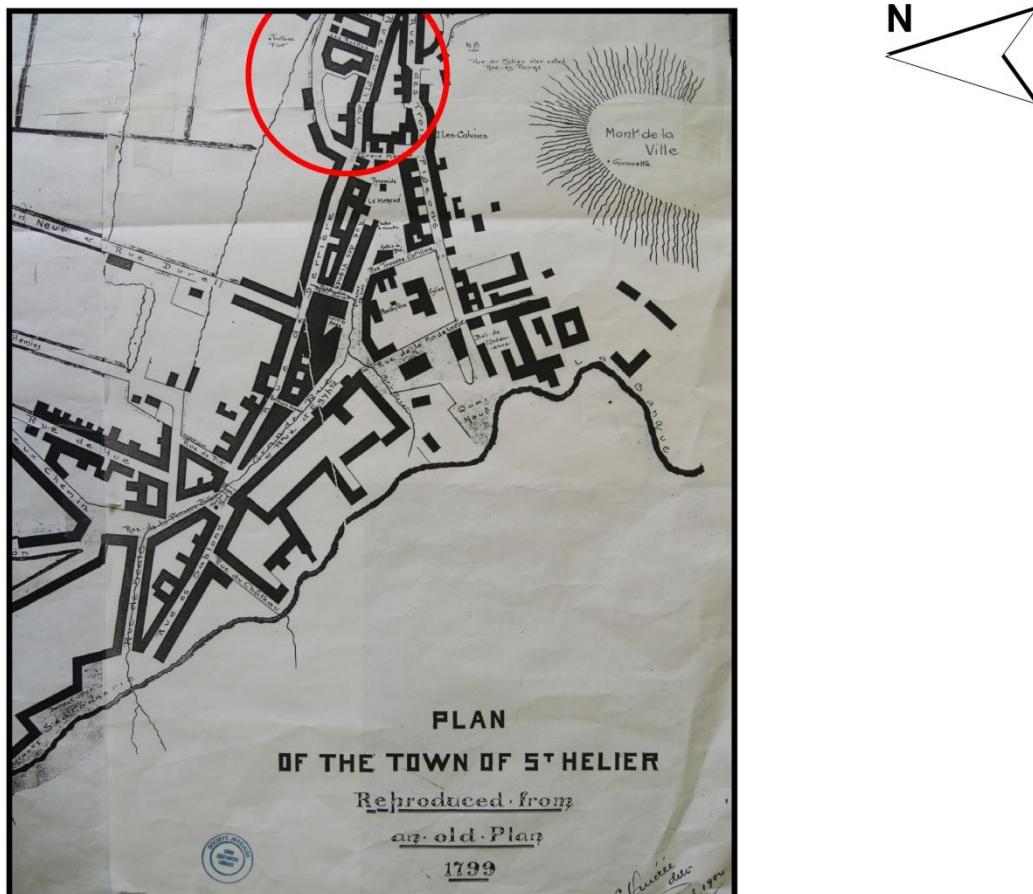
Plan of the Town of St Helier 1799

- 2.2** The earliest map referenced in the above report, is the 1799 Hedley plan of St Helier (Fig 4). Hilgrove Lane (later Hilgrove Street) is clearly shown in this map, with development to the north and south of the road, focussed to the east at this time. However, contrary to the Carey report, it is noted here that the development is recorded near to (to the west of) the area of the plot now occupied by 14 Hilgrove Street. Due to the unreliable nature of maps from this period, the potential for development on the site cannot be ruled out from the available data. To the rear of the buildings runs Grand Douet watercourse, flowing WNW to the harbour.

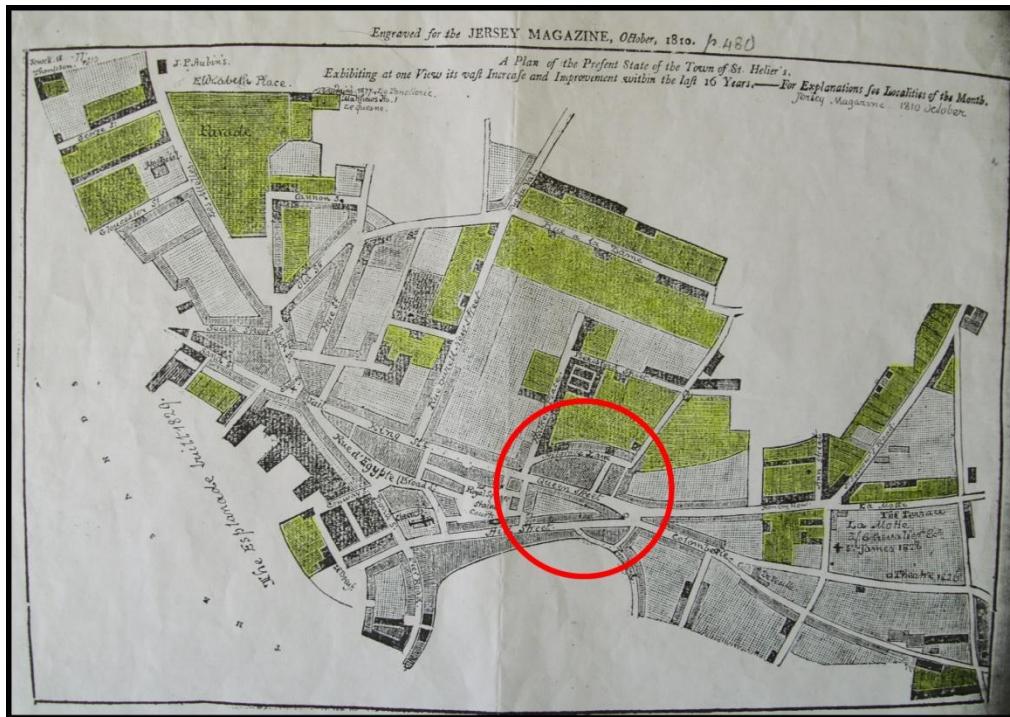
Jersey magazine Plan of St Helier 1810

- 2.5** The 1810 map clearly shows the development of the study area and the establishment of Halkett Place to the west of Hilgrove Lane (Fig. 6). By the completion of the 1834 ‘Le Gros’ map, the area north and south of Hilgrove Lane is fully developed with substantial building activity seen fronting the road, with garden plots to the rear.

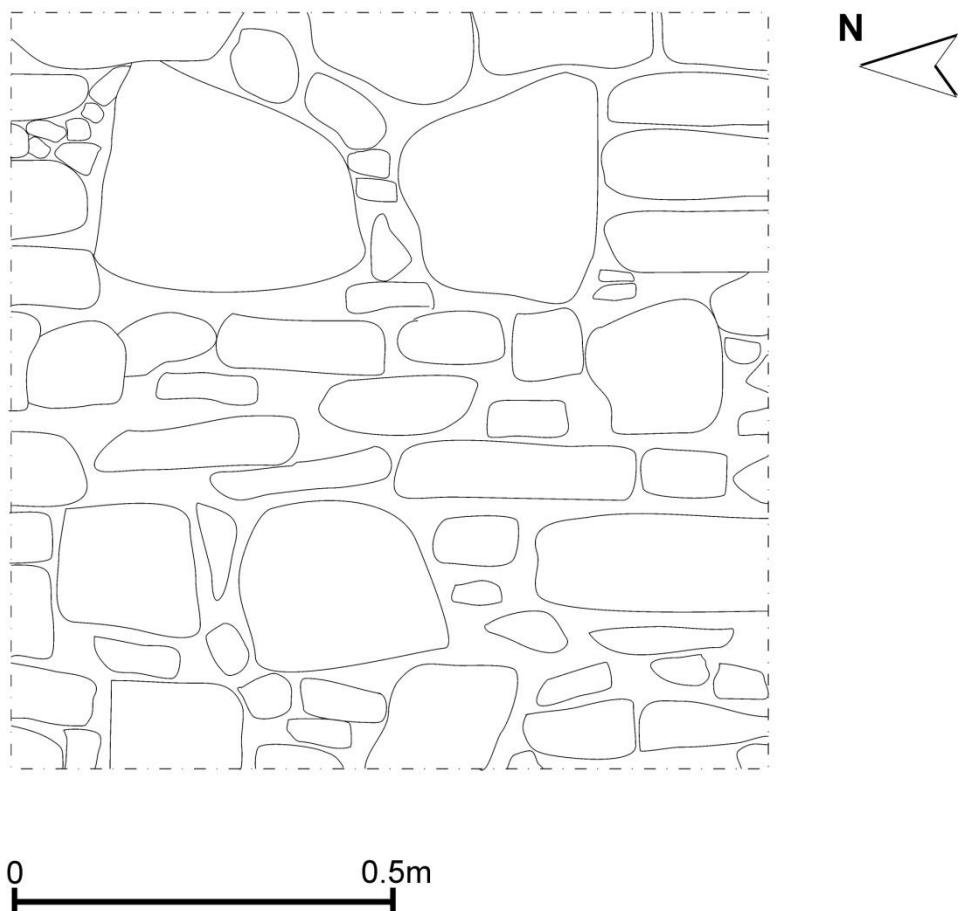
9.3 Detail of Uncoursed Granite West Facing Cellar Elevation

- 5.2.5** The contemporary cellar construction exhibits a piecemeal design, with a mix of random uncoursed granite walling, comprising roughly hewn granite blocks and 19th century brickwork elevations, incorporating roughly hewn granite (Photo 4). The bricks show evidence of extensive damage from the rising damp. To combat the problem, the lower c. 900mm of the cellar walling is sealed with thick cement, which appears to be covering lower courses of roughly hewn granite building material.
