**Roebuck Barracks
Acaster Malbis
North Yorkshire**

Archaeological Building Recording Level II

LS Archaeology

January 2015

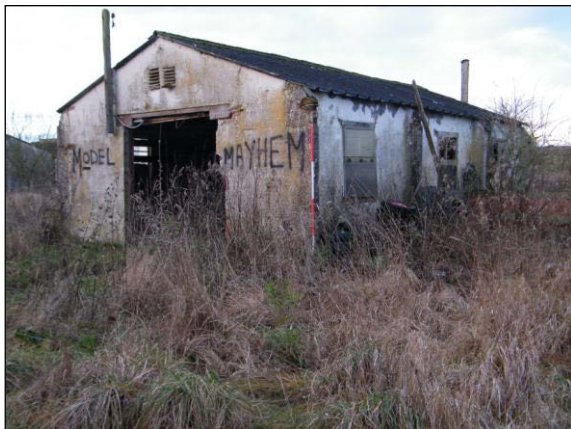
Plate 2: Building 1 looking west

Building 1; consists of a rectangular shape in plan brick and cement walls, concrete floor, cast iron window frame, with an iron frame roof and asbestos tiles. A small wood door located at the south west corner of the west wall. A large vertical sliding door was fitted at the east.

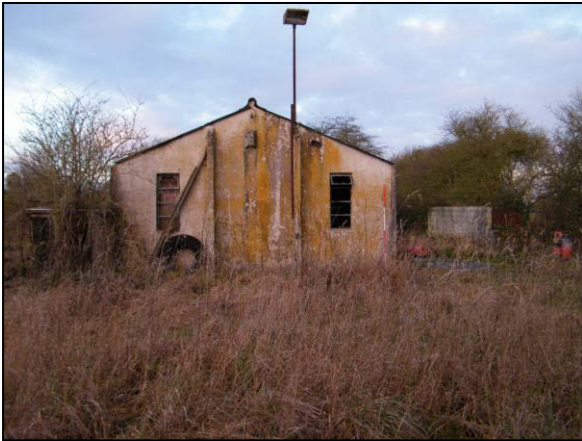
Plate 4: Building 2 looking west

Building 2; is a small two rooms dwelling, with concrete floor iron frame roof and asbestos tiles. All interior walls have fake wood cladding.

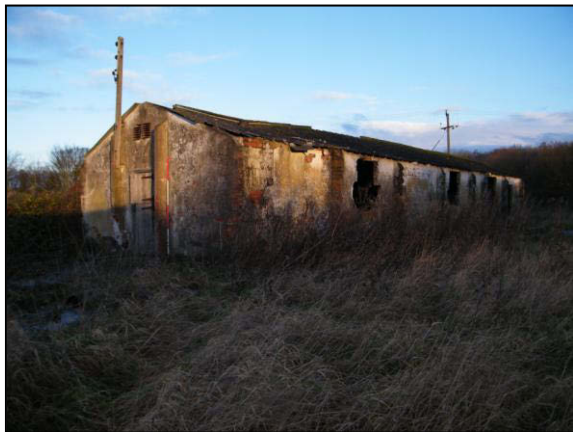
Plate 10: Building 4 looking south east

Rectangular shape in plan building with walls made of bricks and mortar, an iron frame roof with asbestos tiles. All windows have been removed, and new opening for modern large door are visible along the east wall. The interior is filled with debris from the collapsing walls and roof. This building has been deemed unsafe to enter.

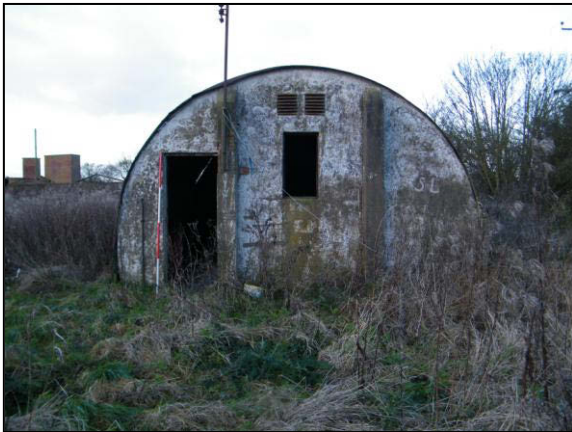
Plate 14: Building 5 looking west

Nissen hut, with brick walls at each north and south end, and corrugated iron roof. The hut appears to be in a better state of preservation than hut 3. Inside two side walls made with concrete bricks have been added when the hut was converted for piggery use.

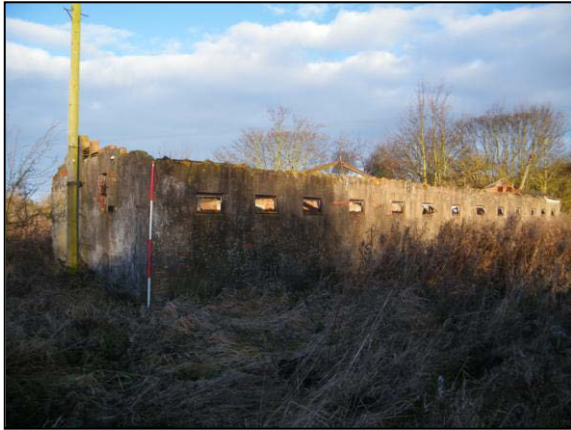
Plate 18: Building 7 looking north west

Rectangular building with walls made of brick and mortar, and orientated on a north northeast to south southwest direction. Of the roof structure only the iron tie beams survived. It also has a concrete floor and two entrances located at each end with the south entrance blocked with modern concrete bricks.

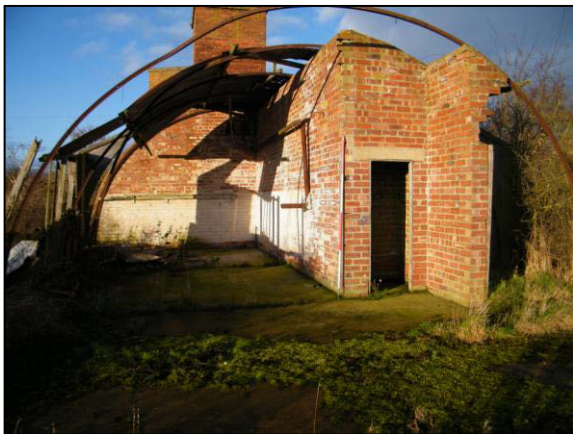
Plate 20: Building 8 looking west

Nissen hut, which has internal partition brick and mortar walls, and a brick and mortar build tower at the west end. The east end of this dwelling has not survived and so is most of the corrugated iron roof and structure.

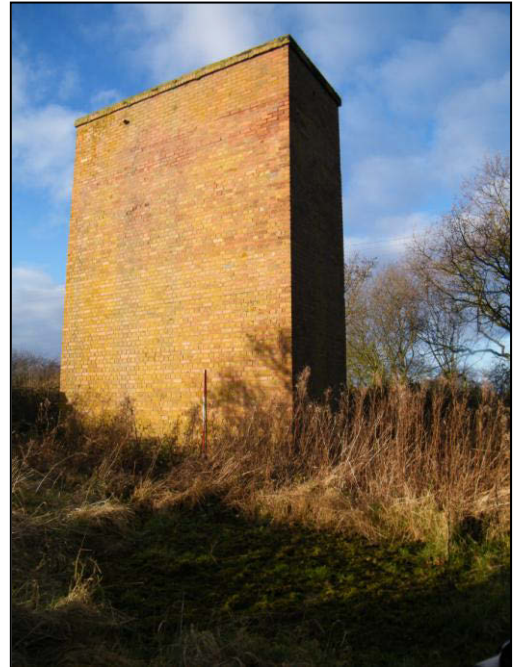
Plate 23: Building 9 looking south west

Building 9 is a rectangular brick and mortar built tower, with access to the south. A substantial amount of derides has been deposited around this building creating a mound which made access to the tower difficult and unsafe.

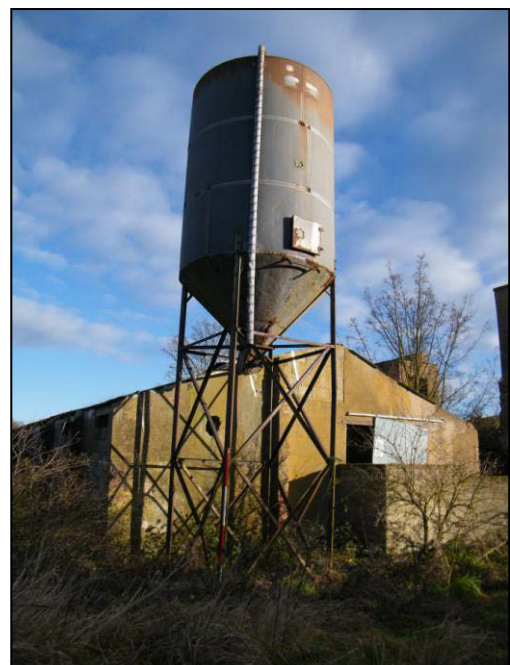
Plate 25: Building 10 looking northeast

Building 10 is of a rectangular shape in plan, built with bricks and mortar, and orientated on a north northeast to south southwest alignment. The roof

cover consists of asbestos corrugated tiles. At the south end it has a metal silos. Inside this building alterations made for the piggery are visible although a good part of the ceiling has collapsed making the access to this building unsafe. A tall brick and mortar square tower rise at the center of this building, the access to this part of the building is restricted due to falling ceiling.

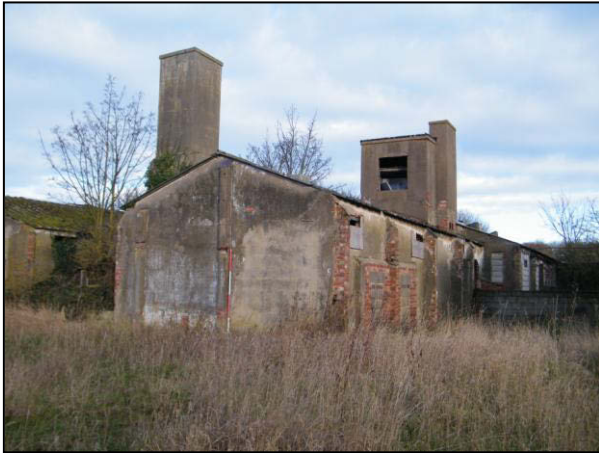
Plate 26: Building 11 looking north west

Building 11, similar to Building 10, is of a rectangular shape in plan, built with bricks and mortar, and orientated on a north northeast to south southwest alignment and set between buildings 10 and 12. The roof

cover consists of asbestos corrugated tiles. Inside this building alterations made for the piggery are visible although a good part of the ceiling has collapsed making the access to this building unsafe. A tall brick and mortar square tower (shorter than the tower of building 10) rise at the center of this building, the access to this part of the building is restricted due to falling ceiling.

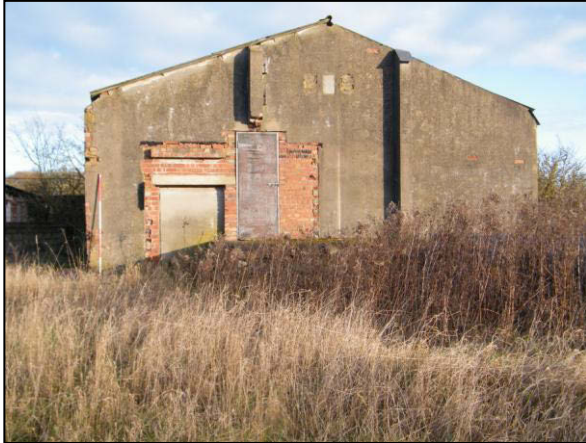
Plate 30: Building 12 looking north east

This building is of a rectangular shape in plan, built with bricks and mortar, and orientated on a north northeast to south southwest alignment, located at the east of Building 11. The roof cover consists of asbestos corrugated tiles. At the north east end it has a metal silos. Inside this building alterations made for the piggery are visible although a good part of the ceiling has collapsed making the access to this building unsafe.

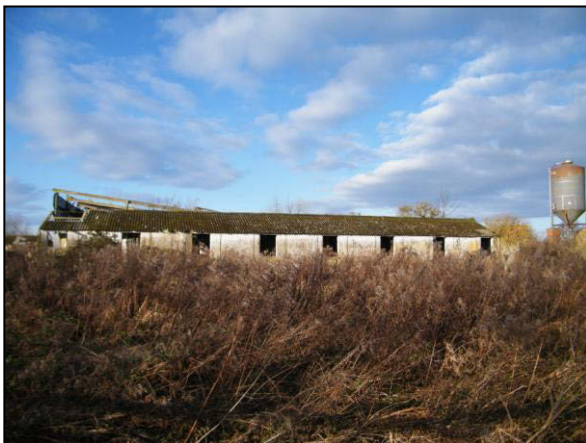
Plate 33: Building 13 looking west

Building 13 orientated on a north to south direction, and of a rectangular shape in plan it has a concrete floor, and walls made of bricks and mortar. The roof like all the other rectangular structures consisted of the principal and common rafter, hammer beam, hammer brace and pendant post made of cement, while the ridge pole consists of a long iron bar bolted at each end. The roof cover consists of asbestos-cement undulated tiles. No window frames survived.

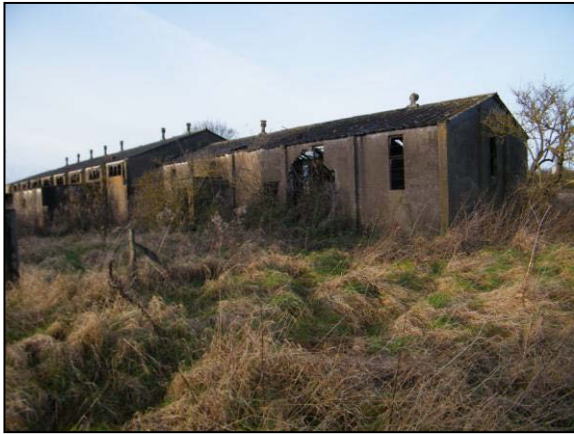
Plate 48: Building 19 looking north west

This building located at the centre of the site consists of two rectangular shapes in plan, structures, with the one at the east narrower and shorter in high. The structure is of brick and mortar with a concrete floor and is orientated on an east to west alignment. The roof structure is of metal and has asbestos tiles. At the top of the north and south walls, rectangular windows frames are still in place. A large door has been cut through to the west end wall, most likely to provide access

for large machinery. Along the south wall at the western end, two square cubicles built with bricks and mortar and flat roof have been added to the main building, most likely to be associated with the farming activity. All in all the building is in a relatively good condition of preservation, although the eastern end of this building appears in a very poor state of preservation, with the roof nearly all collapsed.

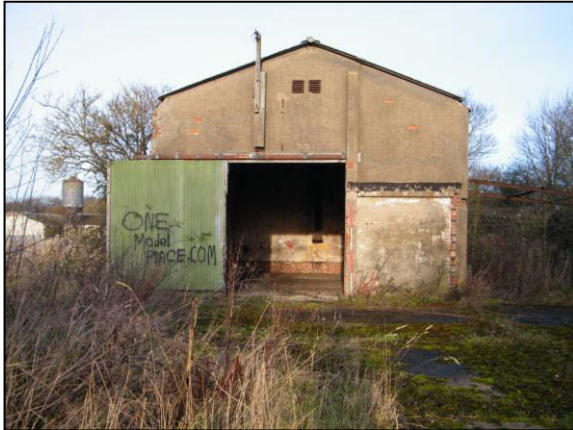
Plate 51: Building 20 looking north

Building 20 has a square shape in plan, with walls constructed with bricks and mortar, the roof frame is made of metal and is covered with asbestos tiles, the floor is concrete and the building has a single window along the west wall. A large metal sliding door has been inserted in the south wall. There is large metal chimney still hanging from the roof adjacent to the north wall.

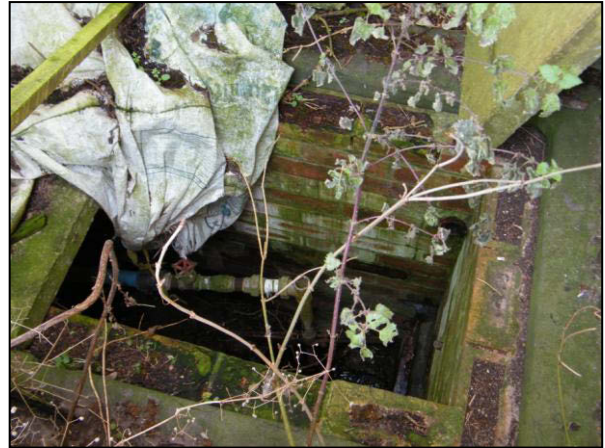
Plate 56: Building 22 pumping engine

Buildings 21 and 22 are two small brick and mortar shed with a flat roof gently sloping eastwards. It is likely that one of these building could have functioned as pumping station, for the air base. Evidence of metal pipes and engine are still visible in one the hall located inside building 22.

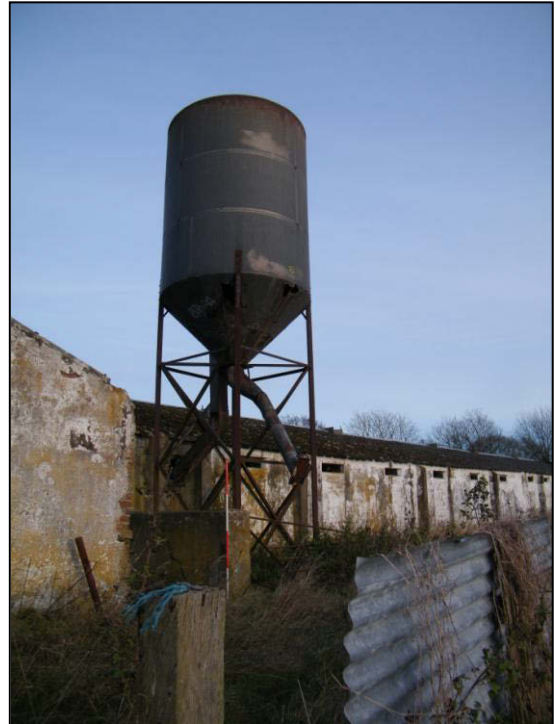
Plate 61: Building 24 looking north east

This building is of a rectangular shape in plan, built with bricks and mortar, and orientated on a north northwest to south southeast direction, located at the north east end of site. The roof cover consists of asbestos corrugated tiles. At the north westt end it has a metal silos. Inside this building alterations made for the piggery are visible although a good part of the ceiling has collapsed making the access to this building unsafe.

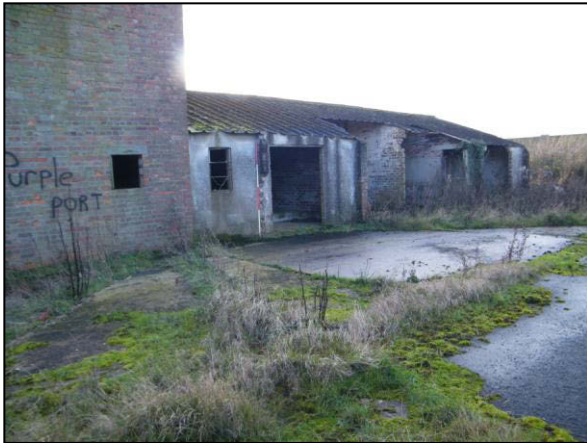
Plate 71: Building 29 looking south west

Building 29 is a small rectangular brick and mortar building orientated on an east to west direction, and located south of building 19. It has a metal roof frame and asbestos tiles, a concrete floor and few remaining windows however the state of preservation of this structure is very poor, deemed unsafe to enter. Part of this building also consists of a large rectangular tower erected at its eastern end. Inside the tower block metal pipes attached to the west wall, going through the ceiling are visible.

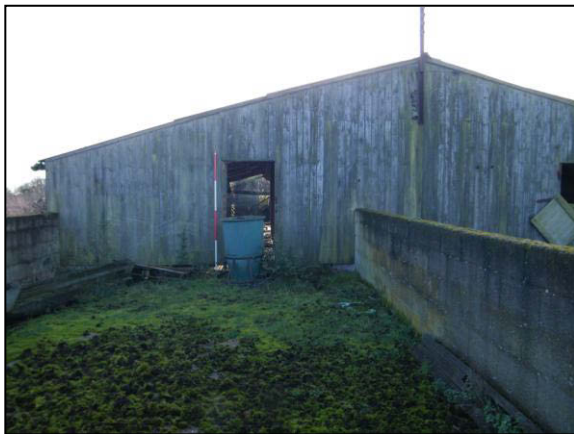
Plate 77: Building 31 looking south

Building 31 is a modern steel frame shed and wood panels outside. Partitions for poultry farm use still in place. Orientated on north to south direction this building of a rectangular shape in plan is adjacent to building 32 (east side). It appears in a very poor state of preservation and deemed unsafe to enter.

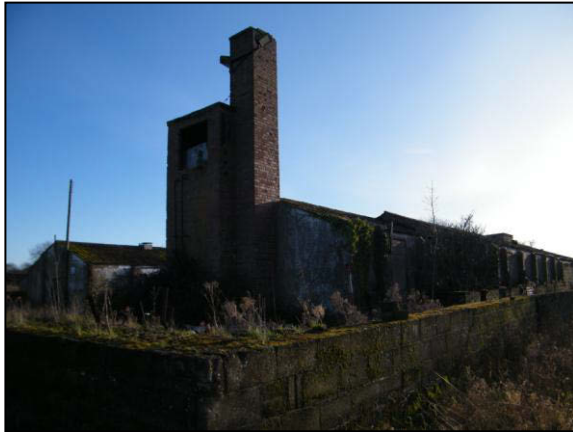
Plate 79: Building 32a looking south east

Buildings 32 a, b and c are a set of three building linked to each other. Orientated on a north to south direction have a brick and mort structure with a metal roof frame and asbestos tiles. All these buildings have been converted for piggery, with partitions built with concrete brick, and metal gates. Due to its poor state of preservation access to building 32c was blocked by falling debris.

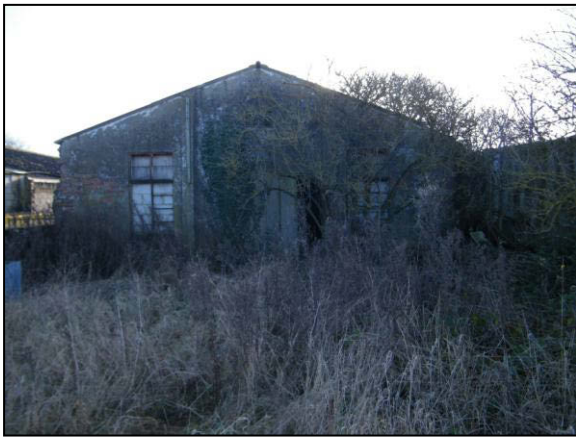
Plate 85: Building 33 looking south

This building located to the near east of the building complex 32, has a brick and mortar structure with a metal frame roof covered with asbestos tiles. The interior has been converted for piggery use, with concrete bricks partitions. Building 33 is in a very poor state of preservation deemed unsafe to enter.

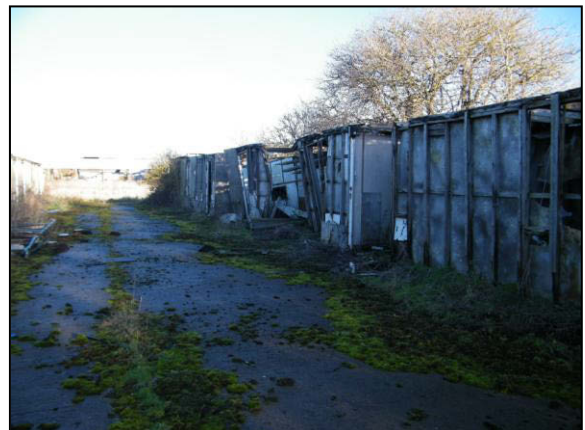
Plate 87: Building 34 looking north

Building 34 is a series of modern wooden shed built along the west side of building 33. These set of wooden structures appears in a very poor state of preservation, also similar to Building 35.

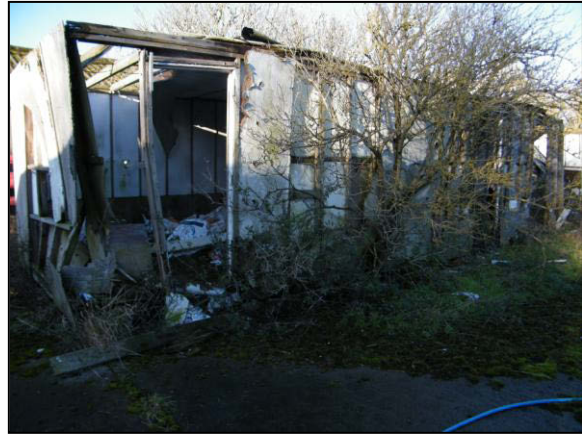
Plate 88: Building 35 looking north

Building 35 is a series of modern wooden shed built along the east side of building 36. These set of wooden structures appears in a very poor state of preservation, also similar to Building 34.

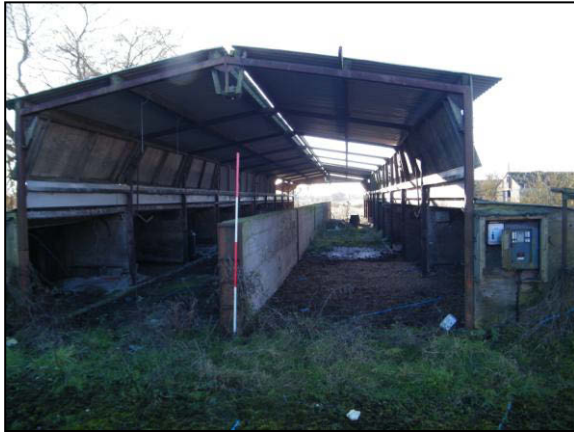
Plate 92: Building 37 looking south

Building 37 is a modern steel frame shed and corrugated metal panels outside. Partitions for poultry farm use still in place. Orientated on north to south direction this building of a rectangular shape in plan is located to the south of buildings 33 and 36. It appears in a poor state of preservation.

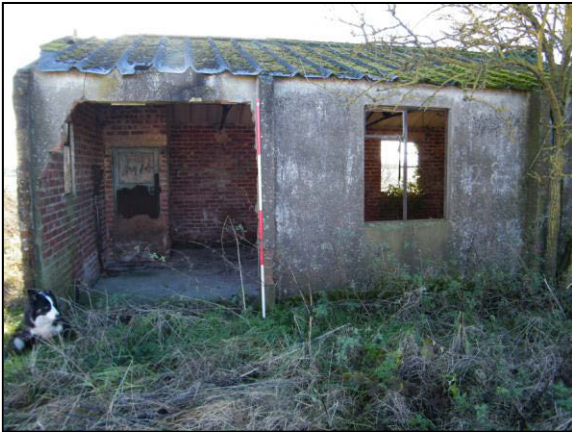
Plate 107: Building 40 looking south

Building 40 is a small square shape in plan building located towards the south west corner of the site, to the immediate west of building 38. The structure is of brick and mortar, it has a concrete floor and the roof has a metal frame covered with asbestos tiles. A large door has been created into the north elevation, with three metal window frames still in place. This is the only dwelling, which still have in place some of the mid 19 century electrical plug and switch. A small cubical built at the south east corner.

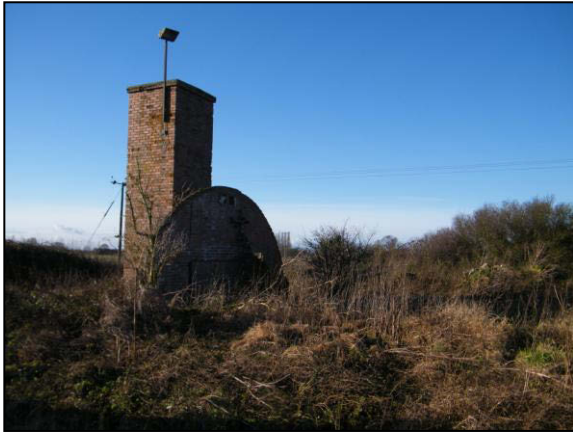
Plate 109: Building 41 looking south west

Building 41 are the remains of what once was a Nissen hut. Only the south wall and tower are still standing, both of bricks and mortar. This building is located at the far south west corner of the site.

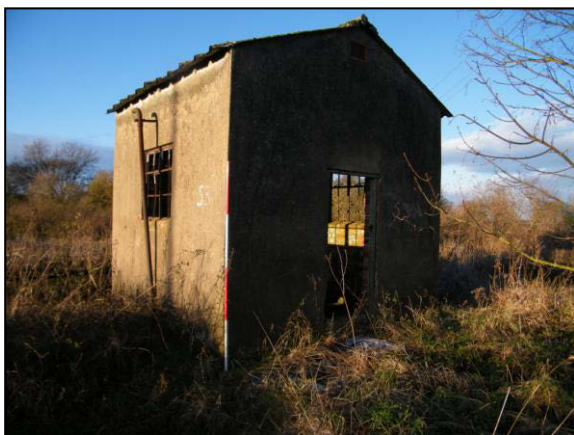
Plate 111: Building 46 looking west

This building is a small square in plan structure built with brick and mortar and it has asbestos roof tile. a small door opens on the north east side of the building, and two window with metal frame are inserted into the southeast and northwest walls. Inside a deep circular hall hosts a pumping engine. The remains of a metal pipe are still attached to the exterior of the southeast wall.
