**A Heritage Asset Survey at Chartlands,
The Farmhouse, 1 Cherry Tree Lane,
Great Houghton, Northamptonshire**

4 August 2014

A Heritage Asset Survey at Chartlands, The Farmhouse, 1 Cherry Tree Lane, Great Houghton, Northamptonshire

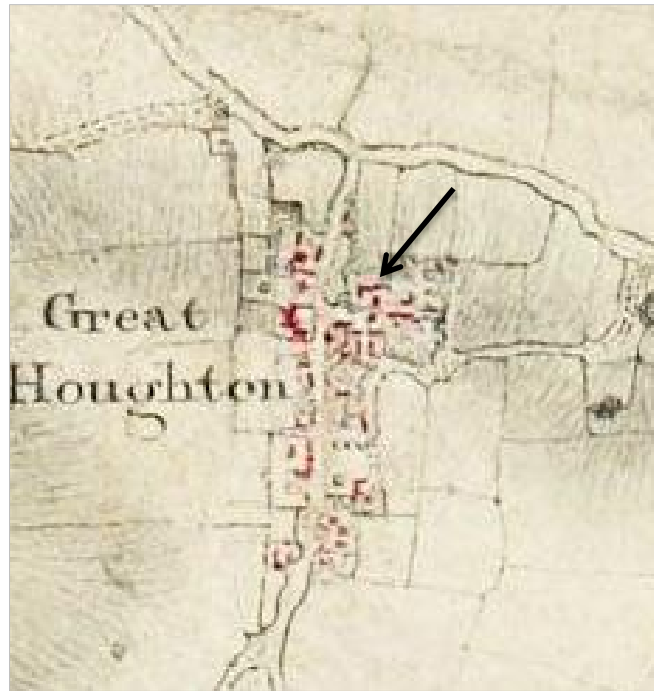
Fig 2: Ordnance survey Surveyors' Drawing 1813, for which see further www.bl.ac.uk (Northampton 11 sheet); not to scale. The small original scale cannot fail to hide the long farmhouse range (arrowed). Other than that, detail is hard to discern. At this date, there also appears to be a building directly in front of it.

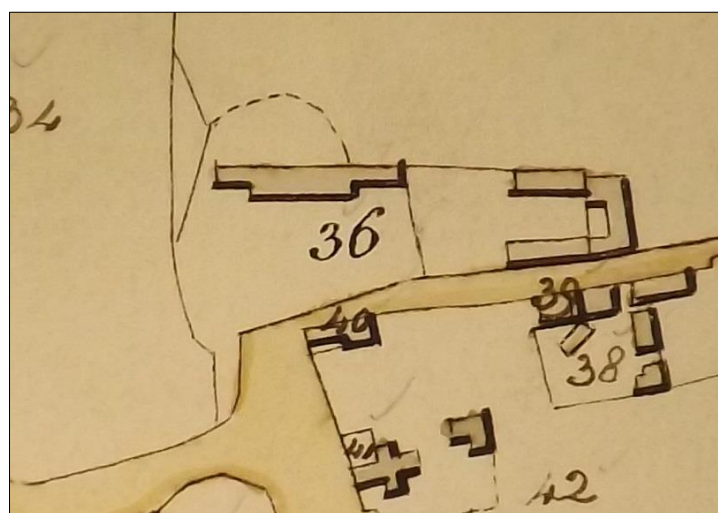
By the time that the Tithe Map for the village was produced in 1839, the detached frontage structure had gone, but the detail of the farmhouse is such that one can see clearly that the main building was indeed long and thin, comprising the main house as the central block with narrower, flanking wings (Fig 3). These are interpretable on the basis of what survives today as the main house, with the service range added to the west. A balancing range on the east seems to have been lost thereafter.

Fig 3: 1839 Tithe Map (NRO: T153). This is a distinctive, balanced and symmetrical building, lacking the later rear extension, but has an eastwards range as a counterpart of the surviving service range.

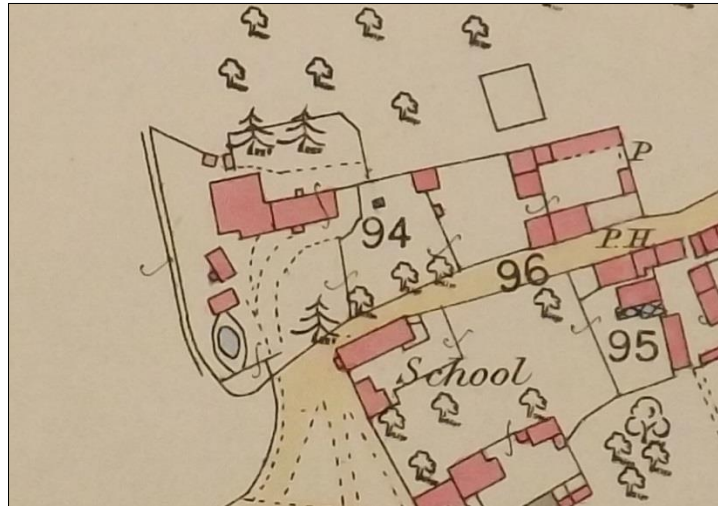
In 1886 the 1st edition of the Ordnance Survey national coverage was published. The 25-inch map shows the house almost as it is known today (Fig 4). To the western service range has been added a rear, northern extension, while to the south-west have been built two detached buildings, the location of one of which is mirrored by the modern garage. The sweep of the current drive has been established and the spring and pond near the road frontage is shown for the first time. The farmhouse had lost its former eastern arm before this date.

Fig 4: 1886 1st Edition Ordnance Survey. Since 1839, the farmhouse has lost its eastern range but has gained the rear extensions which survive today. Note the two buildings to the south west, now replaced by the single garage building.

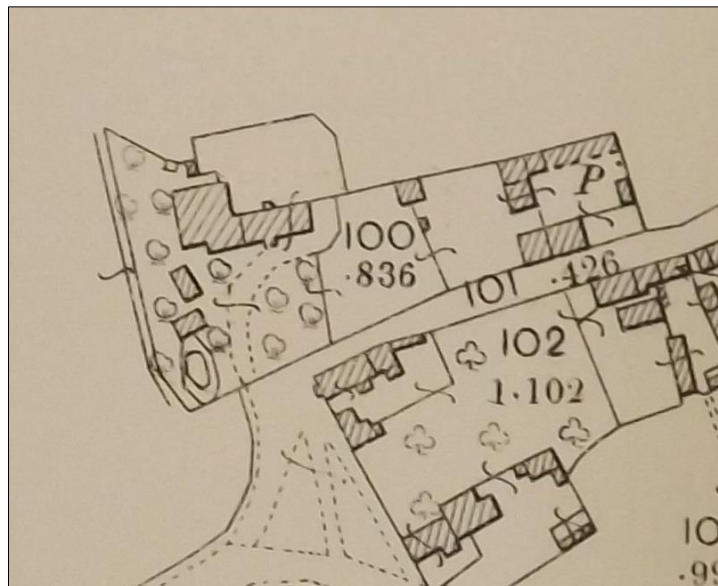
The 2nd edition Ordnance Survey map shows the property virtually unchanged from 1886 (Fig 5).

Fig 5: 1900 2nd Edition Ordnance Survey. Little has changed since 1886

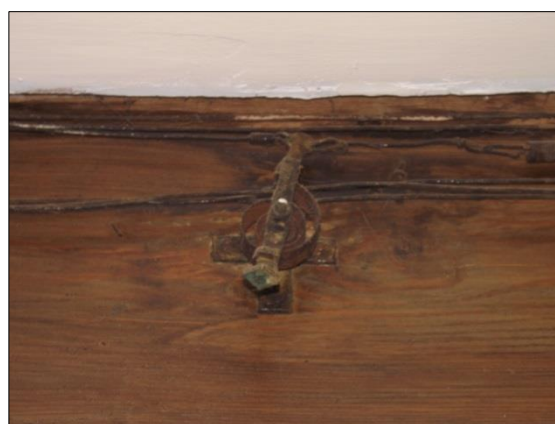
Fig 10: A bell-stump on the bell-board
