### A Level 2 building record of former stables at the Old Bakehouse

### Maidwell, Northamptonshire

### Summary

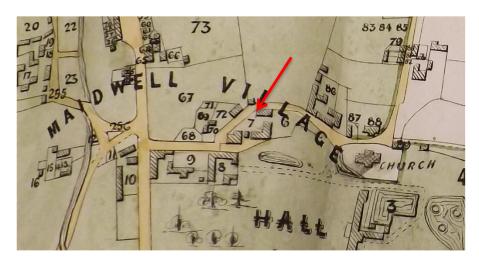
Fig 2: An estate map of 1884; the eastern half of the stable range only is depicted, suggesting the eastern building was slightly earlier than the current, surviving one (NRO YZ6835)

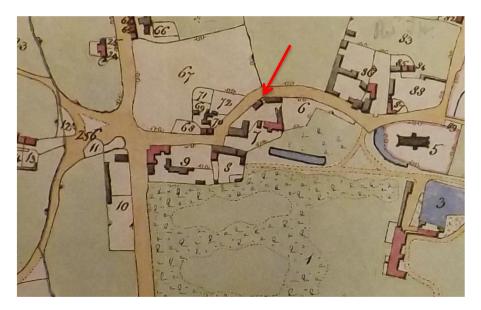
Fig 3: Late 19<sup>th</sup>-century Parish Map; there are two halves to the building including that surviving (NRO Map 1715)

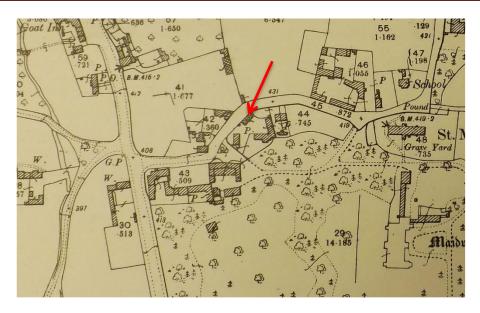
Fig 4: Second edition Ordnance Survey map 1900; building shown correctly 'as is' for the first time, with the eastern half lost. This is the layout which survives.

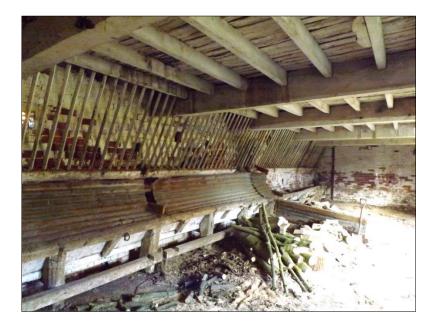
Fig 11: for comparison: timber manger and hayrack at a stable in Warwickshire
