A Heritage Asset Survey of Holly Bank

31 High Street, Bugbrooke.

A Heritage Asset Survey of Holly Bank, 31 High Street, Bugbrooke

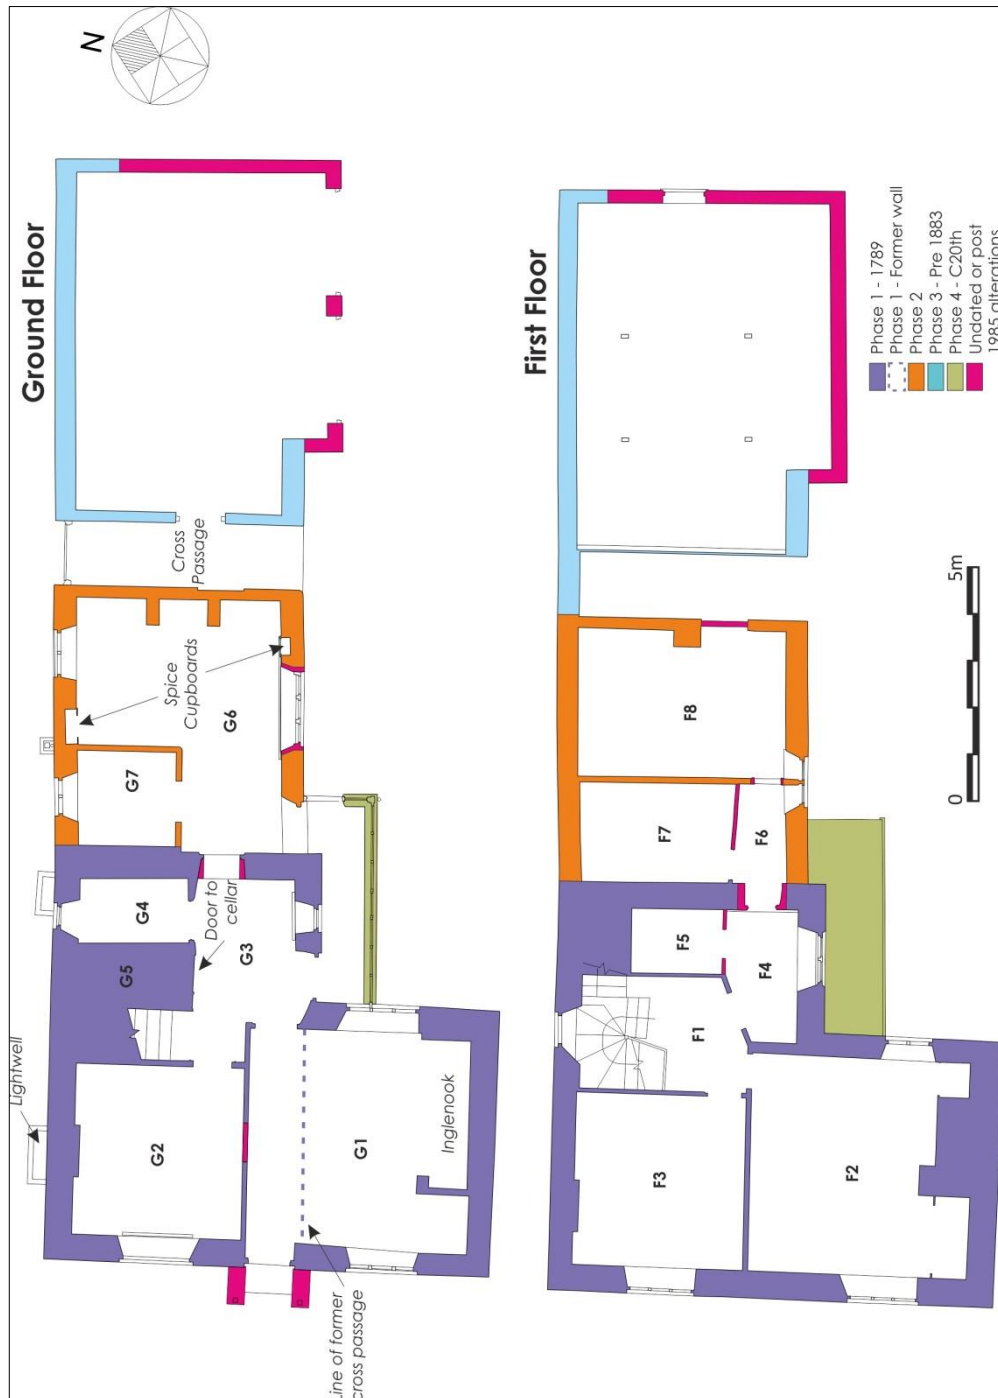
Fig 9: The house, Ground and First floors, phased; cellar (under G2) and attic plans not included

A two-storey rectangular block was added against the rear (east) wall of the original house (Figs 9 and 11). On both the south and north walls where it joins the existing structure it can be seen that the stonework of the new addition was simply butted against and not cut into the structure of Phase One. The stonework of Phase Two is also of Northampton Sand with Ironstone, a similar colour but slightly less well dressed in ashlar blocks with a wider mortar joint. The entire east wall of this addition is built of red brick and is nineteenth-century in date (Figs 5 and 6).

G1. Currently used as a sitting room, it has a limestone slab floor which extends into the inglenook situated against the south wall (Figs 9 and 13). The scar of a former cross passage which extended from the front door to an interior door in the east wall can be seen faintly in the limestone surface. The existing front door appears to be a replacement and is painted on the interior surface. The windows are simply as previously described from the exterior, the splayed reveals of the window openings retain simple panelled shutters. The inglenook is spanned by a bressumer in what is probably elm, which is crudely finished and still retains a wayney edge in places. Carpenter's scribe marks and other incongruous working of the timber suggest that the bressumer may have been reclaimed from an older building. The interior of the inglenook appears to have been much altered

F1. The landing is a simple, unadorned space with plain plastered walls apart from on the east side which is panelled in the same way as the stair panelling beneath (Fig 9). It appears to be twentieth-century in date, but may have replaced earlier panelling. Three doors lead into two bedrooms at the front of the house, and into a small lobby area (F4 and F5, see below) which presently provides access into the upper part of Phase Two, but which was almost certainly formerly a third small bedroom. The only historic feature is the window in the south wall, previously described.

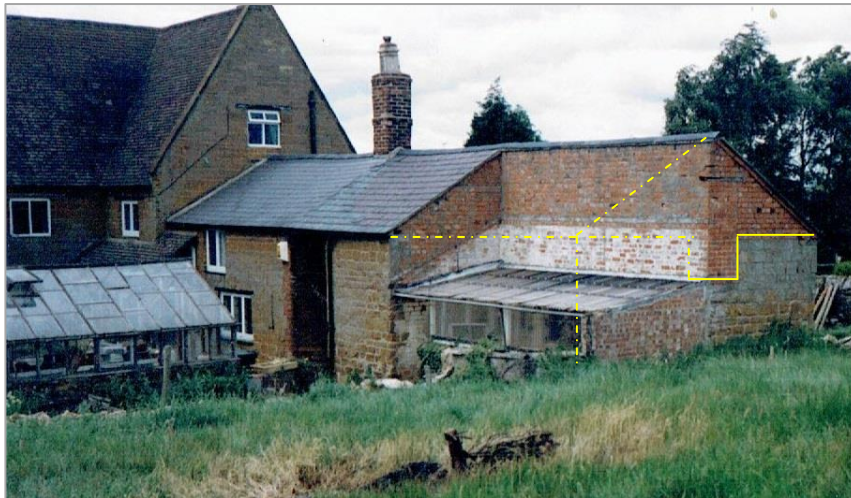
- Phase Three seems to have been added to provide further storage. It was present by 1883. It was later partly rebuilt (below) and incorporated a glasshouse which itself went through two phases of layout, as can be seen by the lime-wash marks (Many thanks to Mr Parry for providing access to this helpful photograph, which shows the numerous alterations previously carried out on this one phase of building).
