**Follow-up recording at Bailey's Cottage,
4 School Lane, Eydon, Northamptonshire, 2015**

Iain Soden BA MCI*f*A

Bailey's Cottage, Eydon: Follow-up recording

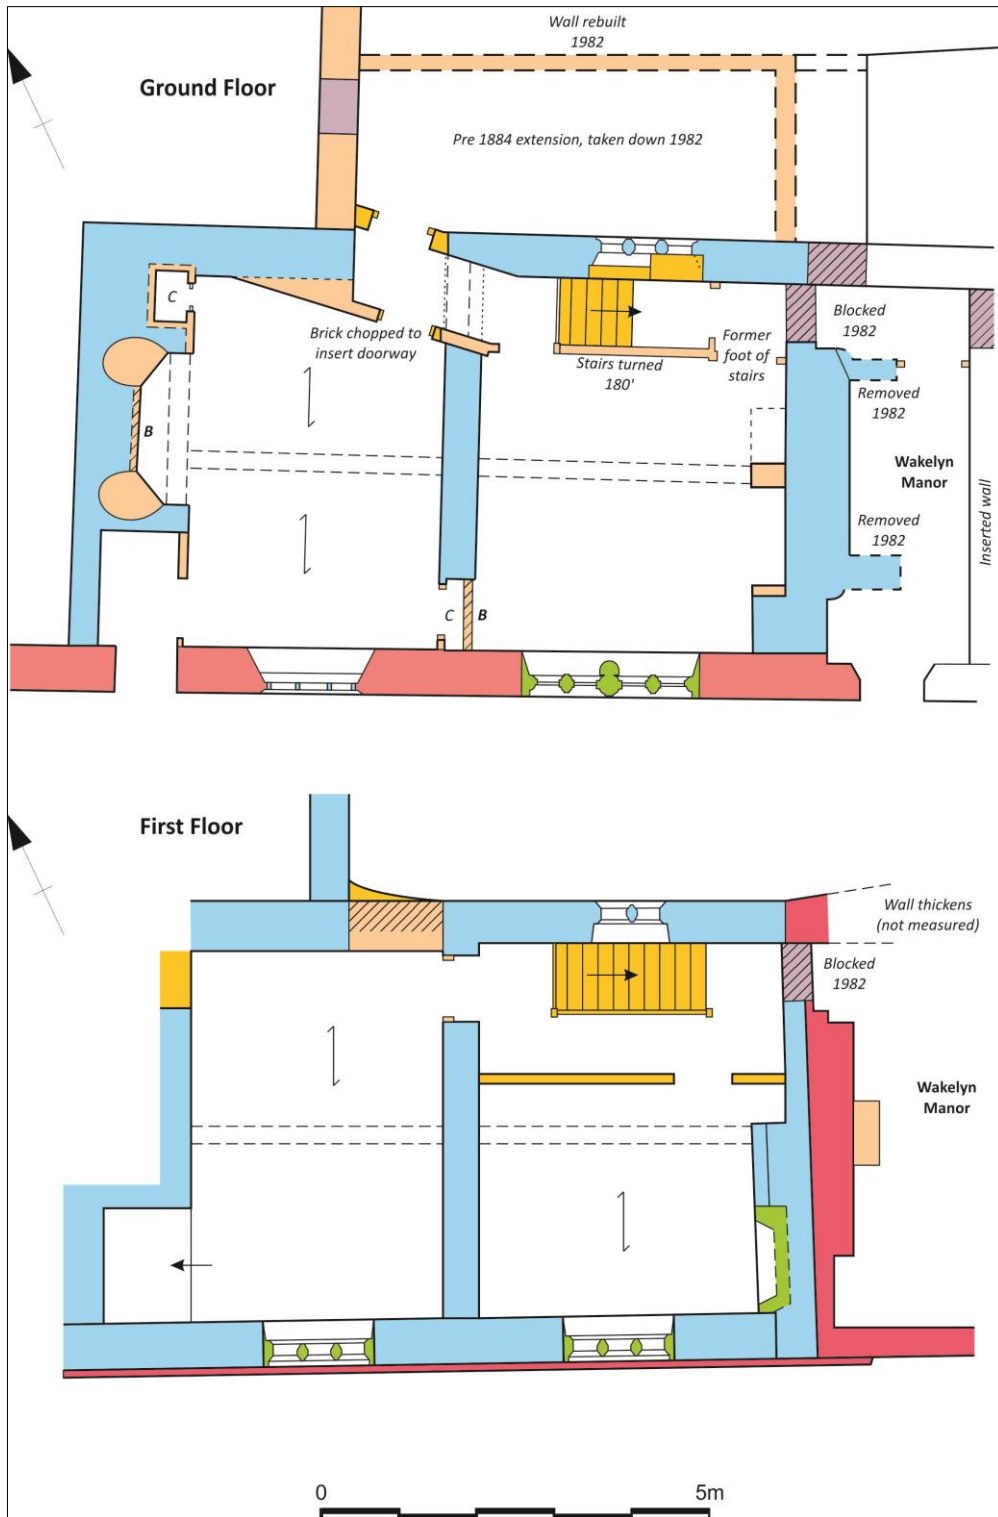
Fig 14: Phased floor-plans of the property, from the initial recording of 2013.

The figure below updates the understanding of the property with the previously-presented phased plan of the building following the original recording of 2013.
