Building Recording at 42-54 Broad Street, Earls Barton, Northamptonshire

Joe Prentice and Charlotte Walker

Summary

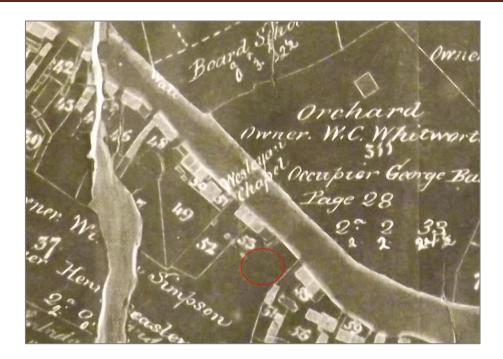
The plot on which the workshop lies was empty in 1838, although some stone buildings to the southeast were already present (Fig 2). The owner of the land appears to have been William Simpson. By 1885 a number of buildings had been constructed on the plot, including a small building on the frontage and a larger one to the rear (Fig 3).

Fig 2: 1838 Inclosure map of Earls Barton

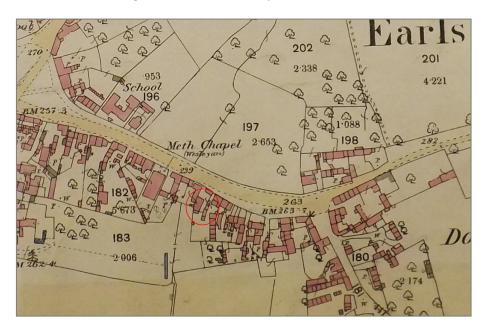
Fig 3: First Edition Ordnance Survey map, 1885

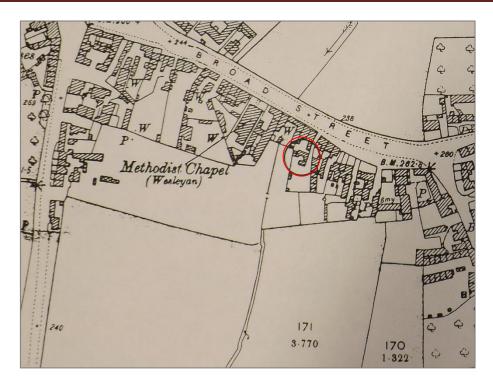
By 1899, both these buildings had been replaced by two houses on the frontage, Bridgeway House and Langton House, and the workshop to the rear. There was a further small building adjoining the southern elevation of the workshop (Fig 4). No evidence of this is currently observable on the surviving building due to the presence of render. This small building had been demolished by 1969.

Fig 4: Second Edition Ordnance Survey, 1899

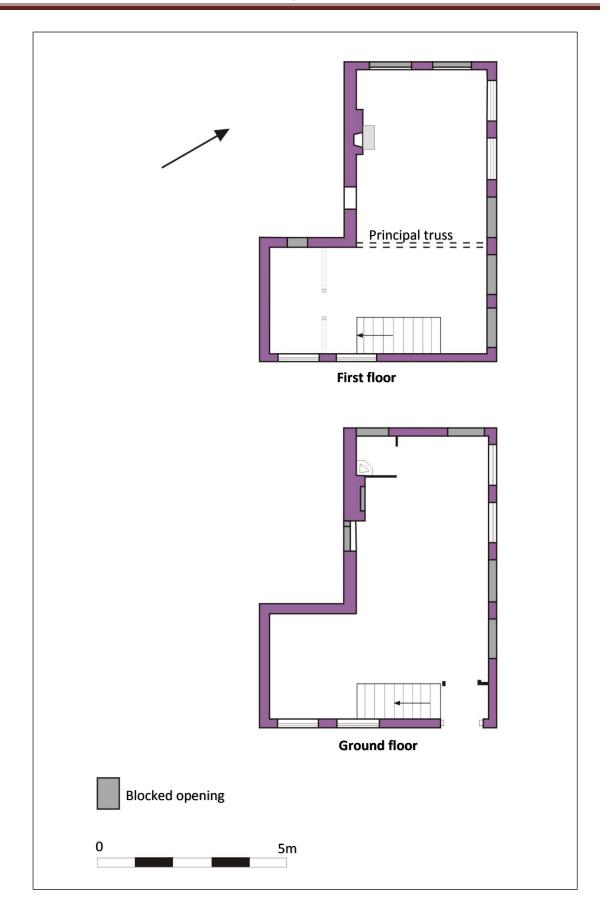
Fig 6: Ground and first floor plans of building
