A building recording survey of former stables at The Plough, Everdon, Northamptonshire

A building recording survey of former stables at The Plough, Everdon, Northamptonshire.

The Plough, Everdon

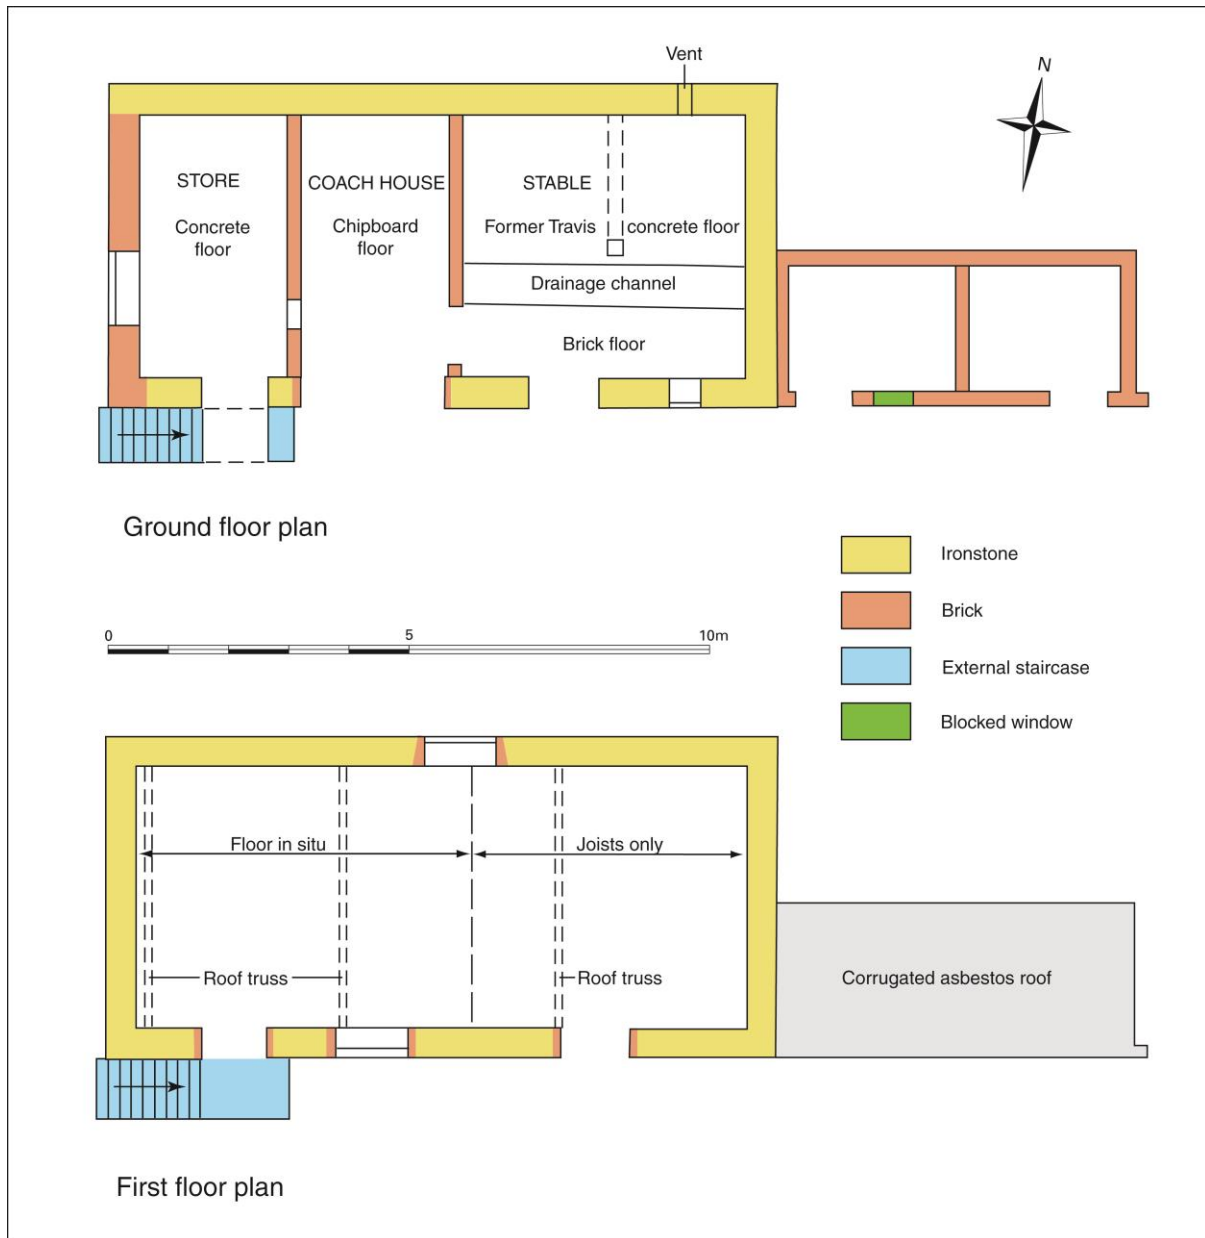
Fig 2. The ground and first floor plans of the buildings (Andy Isham after Lucinda Hudson Design).

The former stable block is a rectangular building aligned with its long axis almost exactly east-west (Fig 2). It comprises three rooms on the ground floor and a single space on the first floor accessed by an external flight of brick steps added later against the west end of the south elevation. A two part brick-built single storey addition abuts the east gable end.

The ground floor comprises three rooms (Fig 2). They are described here from west to east and the names given are those of the author of this report.

Situated at the western end of the main block this comprises a simple rectangular space accessed by the pedestrian doorway in the south elevation (Figs 2 and 3). The door is a simple vertical plank door, ledged but not braced internally. There was formerly a small glazed panel in the upper part of the door, now infilled with timber sheet (Fig 6). There is a simple iron drop latch internally and iron strap hinges. The internal surface retains what may be late nineteenth-century paintwork but the exterior has been repainted.

This room comprises the central of the three ground floor rooms (Figs 2 and 3). It is entered through a double-width opening which extends the full width of the room beneath a shallow brick arch (Fig 7). The present doors and doorframe are modern and there is no scar on the brickwork of the jambs or arch to indicate the presence of an earlier doorframe. It is therefore possible that this coach house was formerly without doors.

The stable occupies the eastern half of the ground floor (Figs 2 and 3). It is entered through a single pedestrian doorway in the south elevation. The present door and frame are modern replacements. To the east of the doorway is a small, single-pane fixed light window which also appears to be a replacement. The interior retains a section of red brick flooring along the south side of the room only. The bricks have been laid on their sides and show signs of wear in the doorway. To the immediate north of this, located east-west across the room, are the remains of a drainage channel for waste material and liquid; it is currently filled with gravel to level the floor surface. The eastern end of the channel was not visible where it joined the east gable wall due to the amount of stored

items. It is not clear if there was originally a gully or channel through the wall at that point though this seems most likely as there is no sign of sign an exit in the internal dividing wall, nor would none be expected. On the north side of the room a slightly raised portion is laid to concrete; this was the location of two former stalls (Figs 2 and 8).

The first floor of this block comprises a single space now accessible via a flight of brick external stairs located at the west end of the south elevation (Figs 2, 3 and 9).

The stairs are built of red brick bonded in lime mortar. They have bullnose bricks at the southern corners where the jambs of the addition form a porch to the west storeroom. The lintel above that porch is formed of a single slab of stone, perhaps York stone. Each tread is surfaced with embossed moulded blue engineering brick paviments to provide additional grip. The whole staircase is butted against, but not bonded with - the south elevation; its lowest step projects slightly beyond the west gable wall (Figs 2 and 9). A simple wrought-iron railing provides a handrail.

At the top of the stairs a single pedestrian door gives access to the first floor. Previously a second doorway situated towards the eastern end also provided access at this level (Figs 2 and 3). There is no staircase there and so it must be assumed that access there was provided by a ladder, perhaps on a seasonal basis when hay and straw were stored above the stable. Both doors are simple plank doors, ledged but not braced. The first floor was not accessed due the flooring being apparently unsafe. It was therefore viewed from the doorway only.
