**A building recording survey at Highfields Farm,
Newnham, Northamptonshire**

A building recording survey at Highfields Farm, Newnham, Northamptonshire

Summary

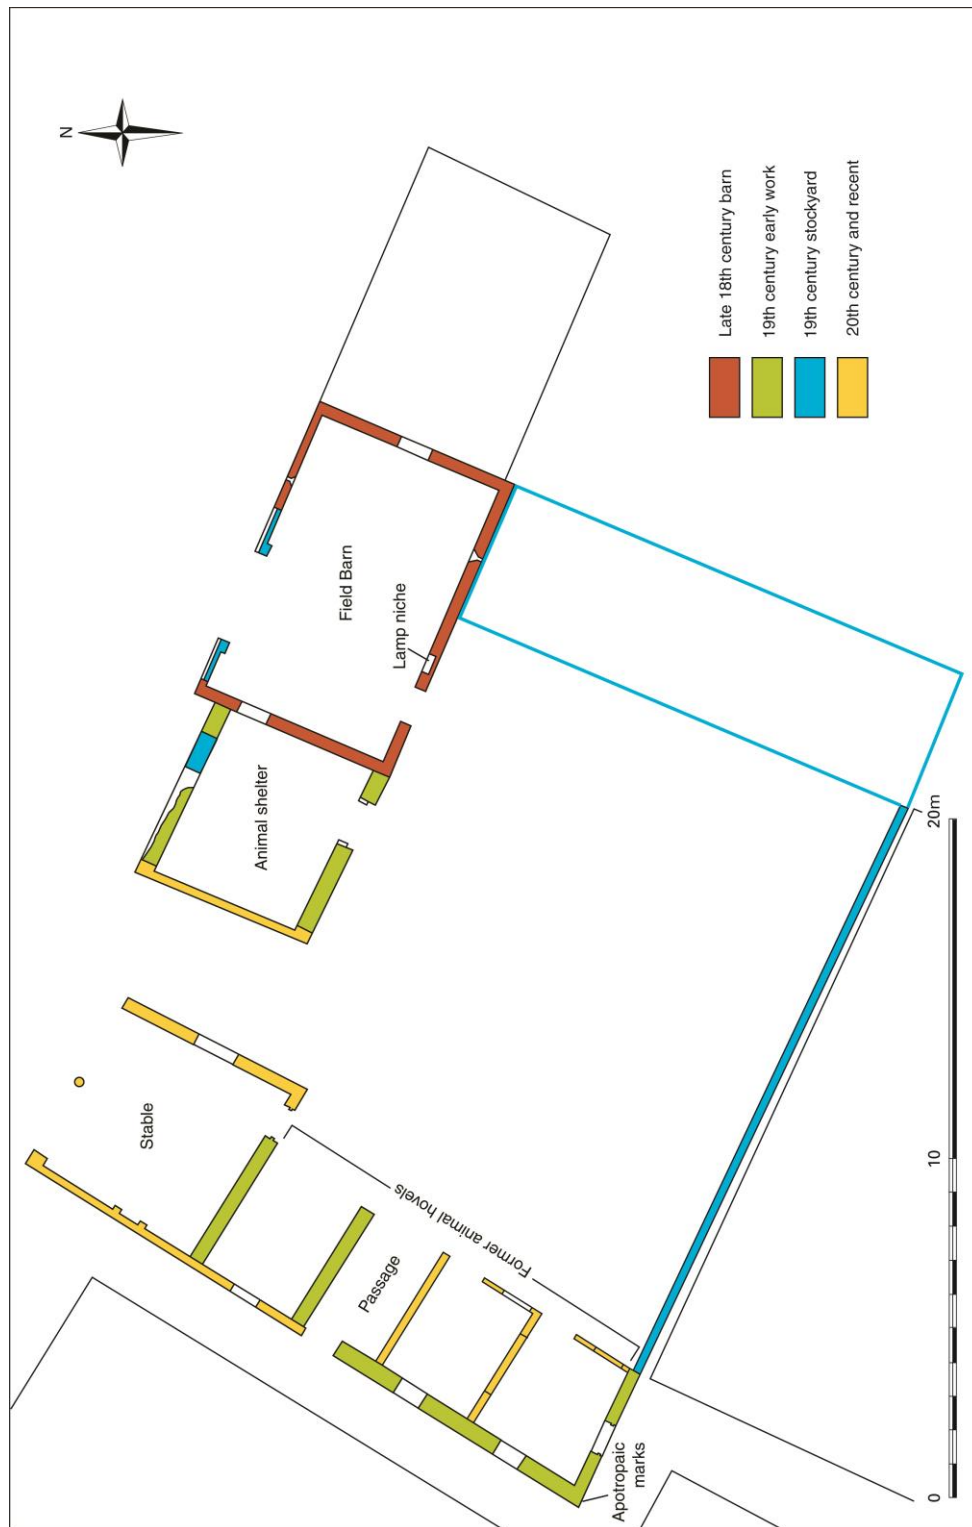
Fig 3: Plan of the farm buildings phased (Andy Isham after Roger Coy Partnership).

This is the largest single structure of the group and is situated at the north-east corner of the complex (Fig 3).

The north wall has partially collapsed along its outer face and only the inner skin remains. This reveals that the wall was originally built in ironstone rubble. There is an oak lintel within the inner section of stone walling which indicates the location of a former doorway (see Fig 3). The west end of the wall has been rebuilt in both stone and brick in at least two phases.
