Iain Soden Heritage Services Ltd

Archaeological survey and recording before and during conservation of basement rooms at Kelmarsh Hall, with observation and recording on outbuildings

Joe Prentice and Iain Soden

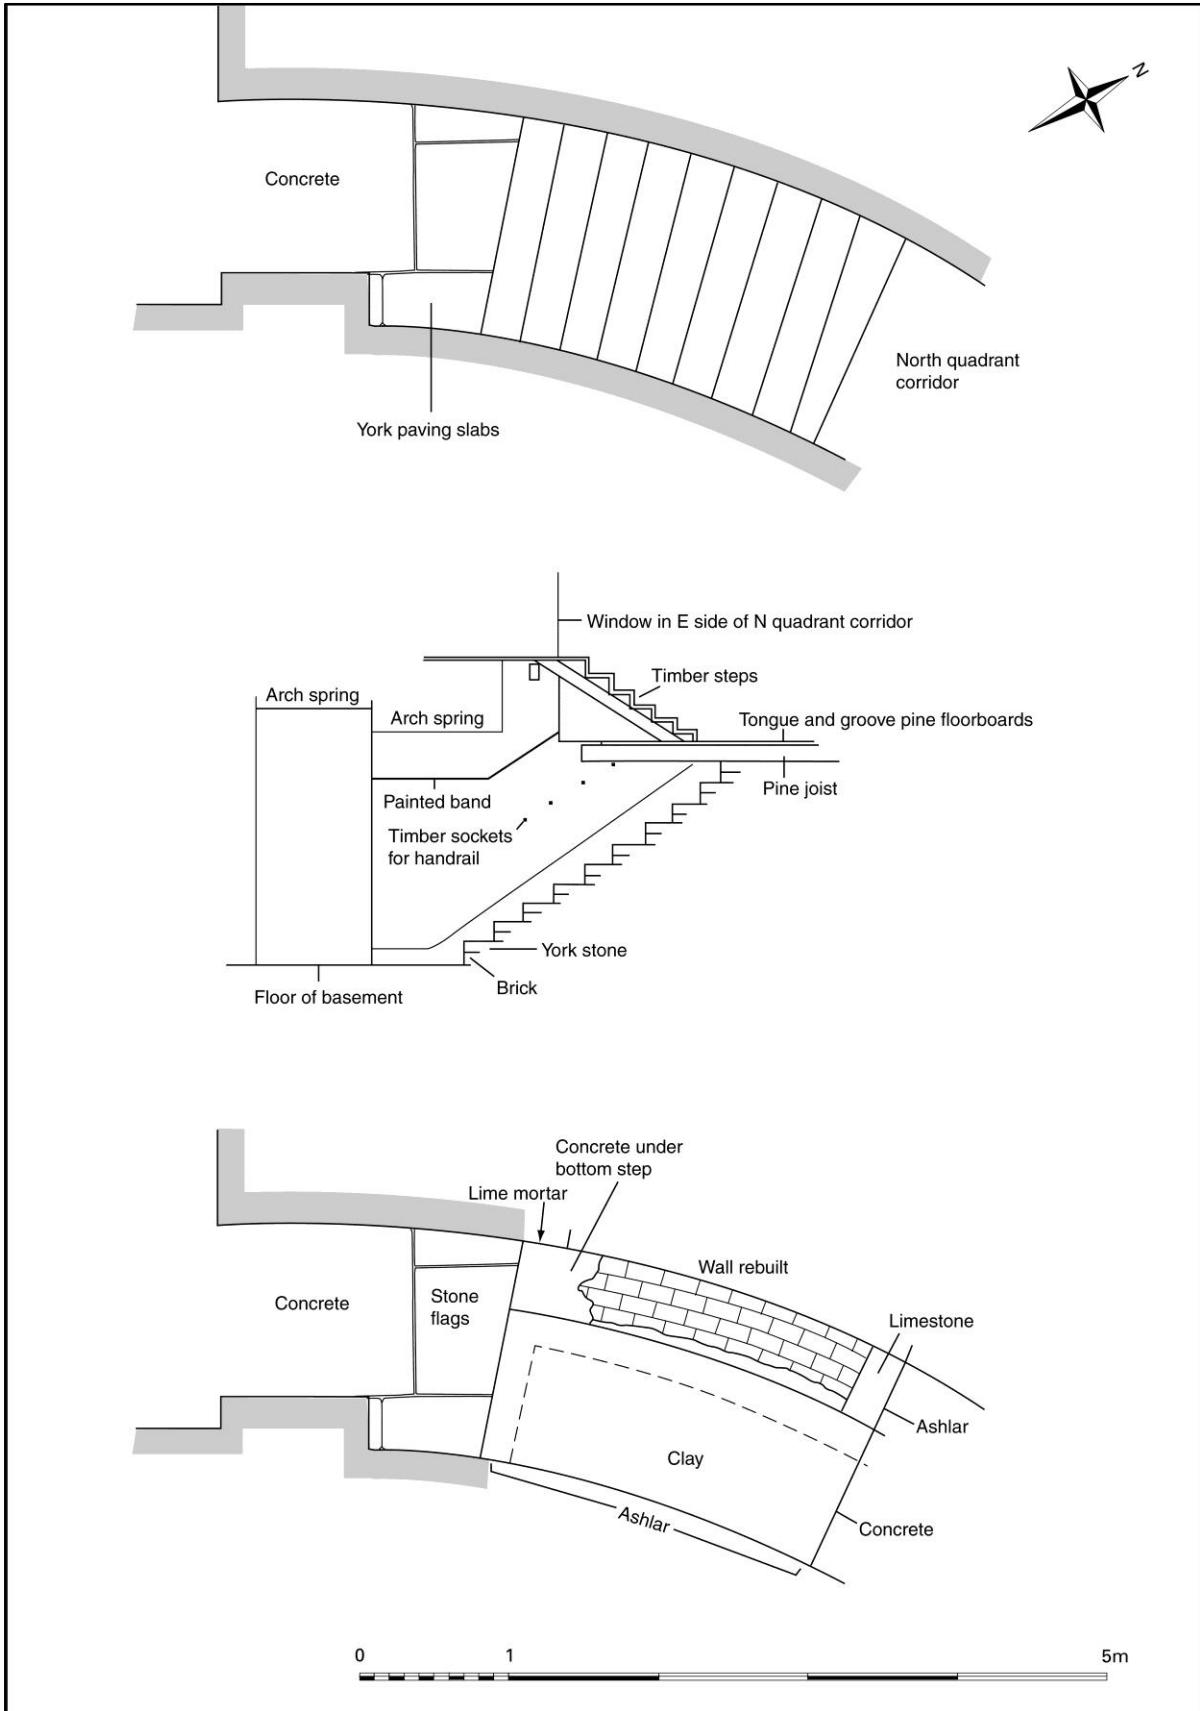
Fig 5: The North Quadrant Stair as entered from Room B3– Top: plan before removal; Middle: section; Bottom: plan after removal for new lift (Andy Isham).

The flight of stone and brick steps which led up from the basement to the quadrant corridor comprised ten treads including that level with the corridor floor. Each tread was made from York stone and some were slightly wedge-shaped in plan to accommodate the curve of the quadrant into which it had been inserted. The floor at the base of the flight was also of York stone flags almost as far as the doorway through the north wall of the basement (Fig 5); west of that point it was of modern concrete.

The earlier sequence of structures had been partially removed by the insertion of the existing flight of steps which appear to have been inserted during the nineteenth century. Beneath them an almost central curving spine wall remained in a truncated condition which shows that formerly the space had been at least partly accessible and on the north-west side of that spine wall a brick floor remained *in situ* (Figs 5, 6 and 7).

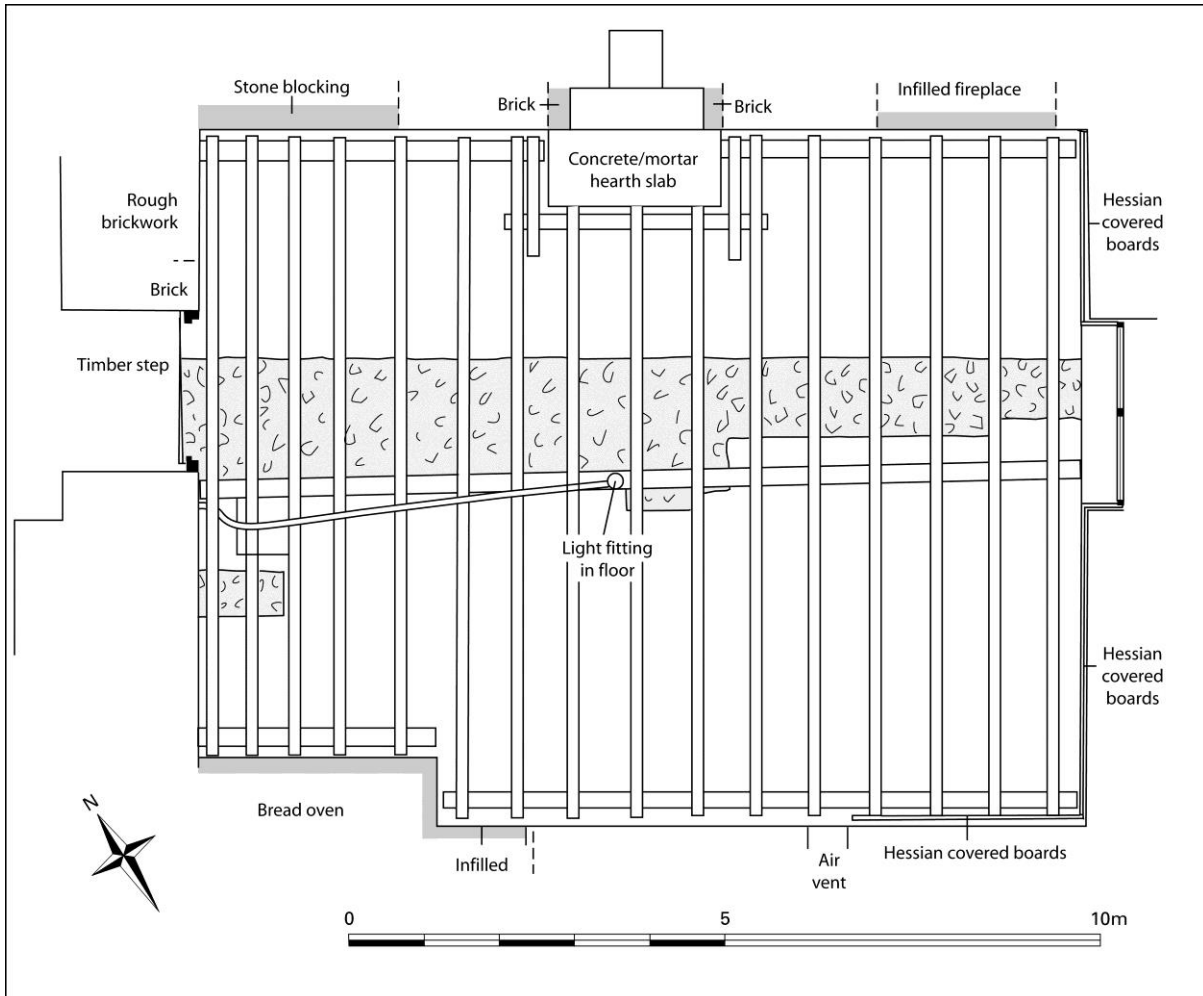
Fig 10: Plan of Room B7 showing sub-floorboard features (Andy Isham).

The removal of the pine floor boards revealed that the whole room had been fitted with this raised timber floor in one phase of works (Fig 10).

Three rows of single brick 'sleeper-walls' extended across the room from east-west with subsidiary sections of the same located around the concrete hearth slab on the north side of the room and a short section in the south-west corner where the bread oven of the adjoining room projected into the space (Fig 10). Laid on top of each of these low walls were sheets of blue slate, to act as a damp-proof barrier and laid over these were single tongue and groove floor boards of the same size and type as those used to form the finished floor surface (115mm wide x 20mm thick, 6 inches x ¾ inch). Unequally spaced across those principal joists were the secondary joists which were laid north-south and onto which the tongue and groove floor boards were nailed. Thus the joists and floorboards were supported above the level of the original floor surface which largely remained intact and comprised red brick laid flat.

Across the room, extending from almost the full width of the doorway into the room to directly below the window an area of the brick floor had been removed (Fig 10). It appears that this narrow channel was used to conceal a sub-floor lead water pipe, only the western end of which was observed where it turned southwards and was exposed in a deliberately constructed inspection chamber (Fig 12). The channel though the brick floor had been backfilled with clay and brick rubble along with mortar fragments.

The only other features related to the timber floor was a ceramic two-pin electrical plug set in a brass collar fitted with a hinged cap (See Fig 10). The cabling which supplied power to the socket was fed through a hollow iron conduit and which was laid beneath the floor, set in shallow notches cut into the joists. It was set into the east face of the west wall of the room and its final route was not visible beyond that point.

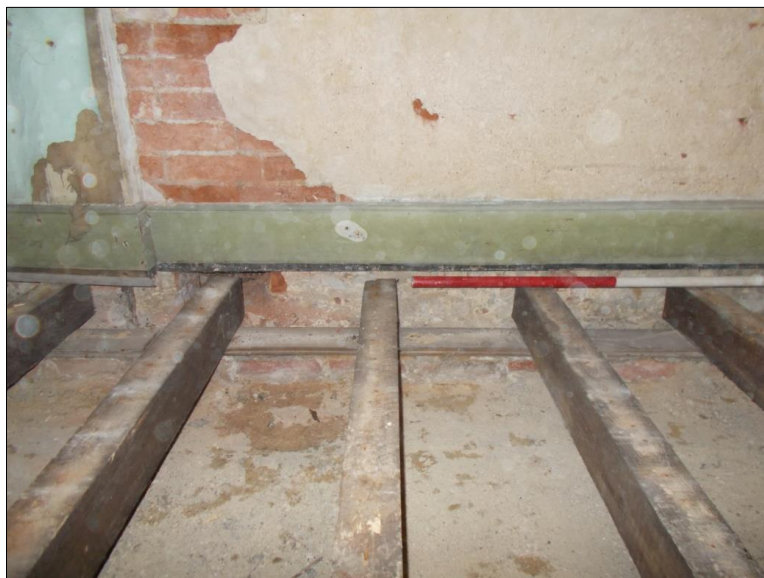
Fig 11: The supporting single brick sleeper-wall capped with a single floorboard supporting the joists, looking south; scale 1m.

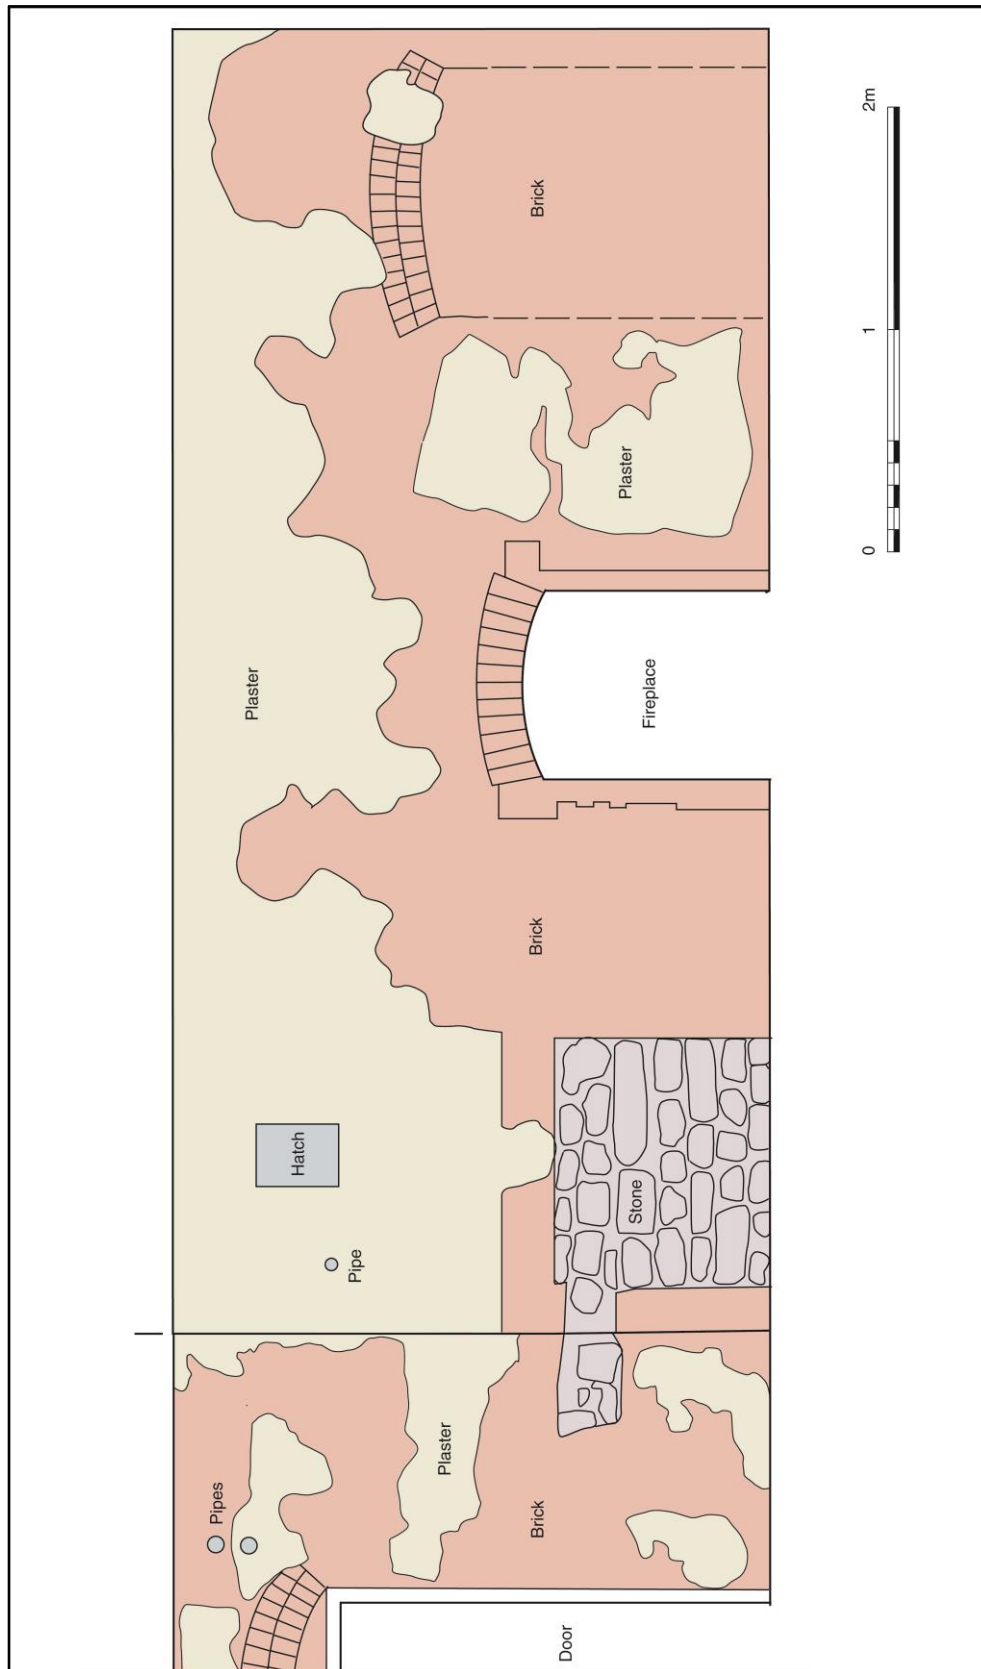
Revealed beneath the degraded wall plaster to the east and west of that central fireplace were the outlines of two further fireplace openings (see Figs 13).

Fig 13: The short west and long north walls of Room B7 showing (opened out) three former fireplaces and, in the west wall the conjoined blocking of a (?) former oven door (Andy Isham).

The western of the two blocked openings was infilled with coursed limestone rubble with occasional ashlar pieces bonded in lime mortar. The eastern example was infilled entirely with red brick. Each infilled arch had vertical jambs which rose to a height of 1.6m above the brick original floor level. It is not certain when the two arches were infilled and the different infilling materials might indicate different times, although their infill may simply reflect the material available at the time. Three fireplaces are indicated on the Gibb's plan (see Fig 9) which on that plan shows the room to be a single space with the now separate B8 to the south.

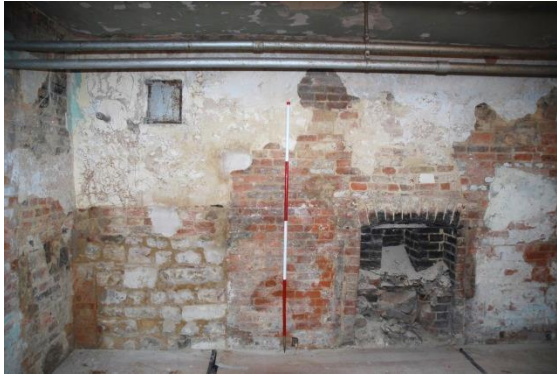
Fig 14: Middle (open) and left-hand (blocked) fireplace in B7; scale 2m

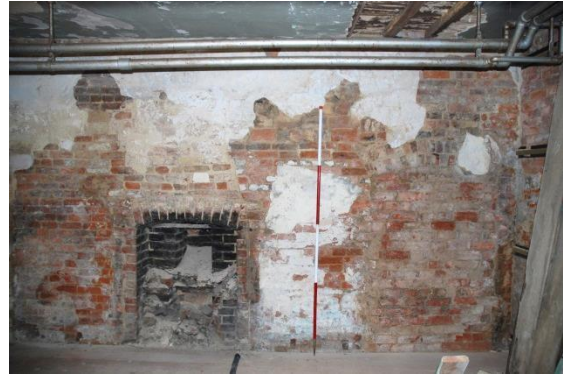
Fig 15: Middle (open) and right-hand (blocked) fireplace in B7; scale 2m

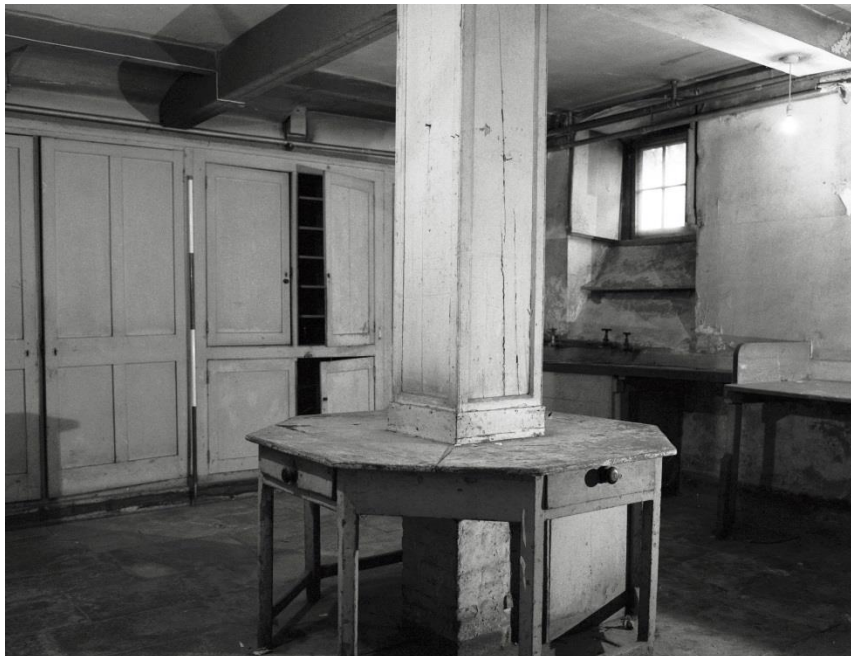
In addition the panelled timber cladding of the supporting post in the centre of the room was removed in order to fit it better. This exposed the brick column inside. The column had clearly supported a coat of lime-wash as might be expected to keep a brick wall clean and free from bacteria. This relates seemingly to a use of the room which predates the current one.

Fig 19: The Butler's Pantry. Beneath timber cladding, the brick central column is lime-washed throughout. Scale 2m

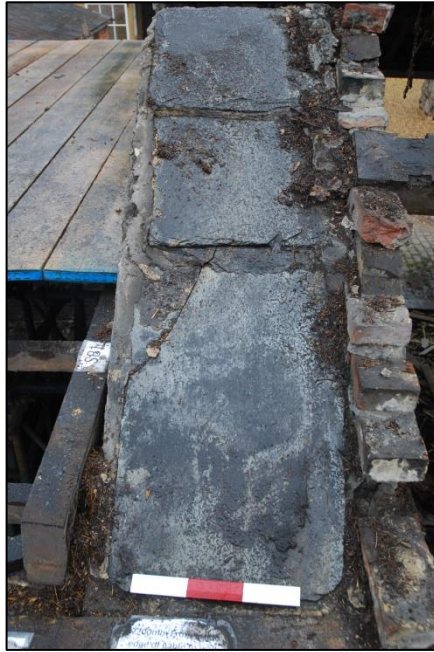
High in the south gable wall was a corbelled brick box which was capped with mortared Welsh slates. This formed a channel which slanted upwards under the gable to join the chimney stack which served the fireplaces below. This is believed to be a primitive steam-hood or collector for the clouds of steam (and fumes) which early smoothing irons would have produced.

Fig 25: Slate-covered channel on interior gable for collecting and channelling smoke and steam away.
Scale 30cm

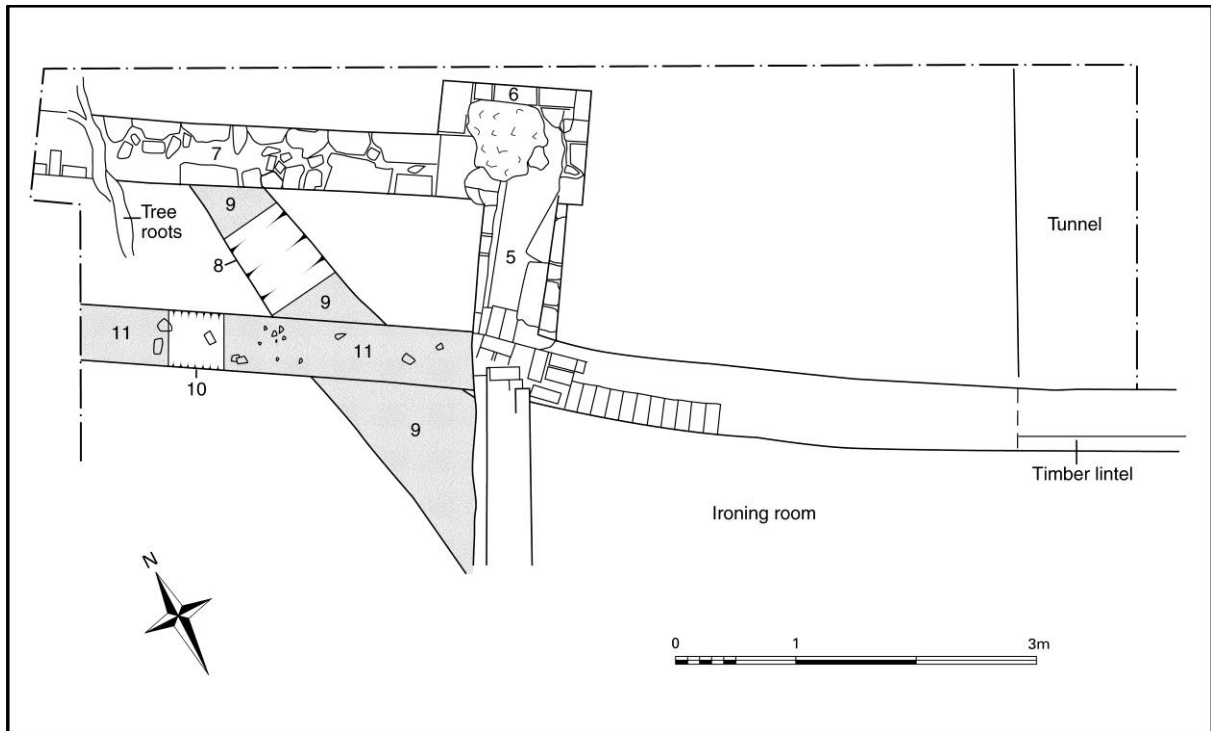
Apparently truncated by the creation of the north and south walls of the ironing room were the remains of two further stone walls, also aligned north-south [5] and east-west [7] but pre-dating the construction of the ironing room. Wall [5] was 0.7m in width whilst wall [7] was 0.5m in width.

Fig 27: Plan of the stone walls and features truncated by the creation of the ironing room.
(Andy Isham)

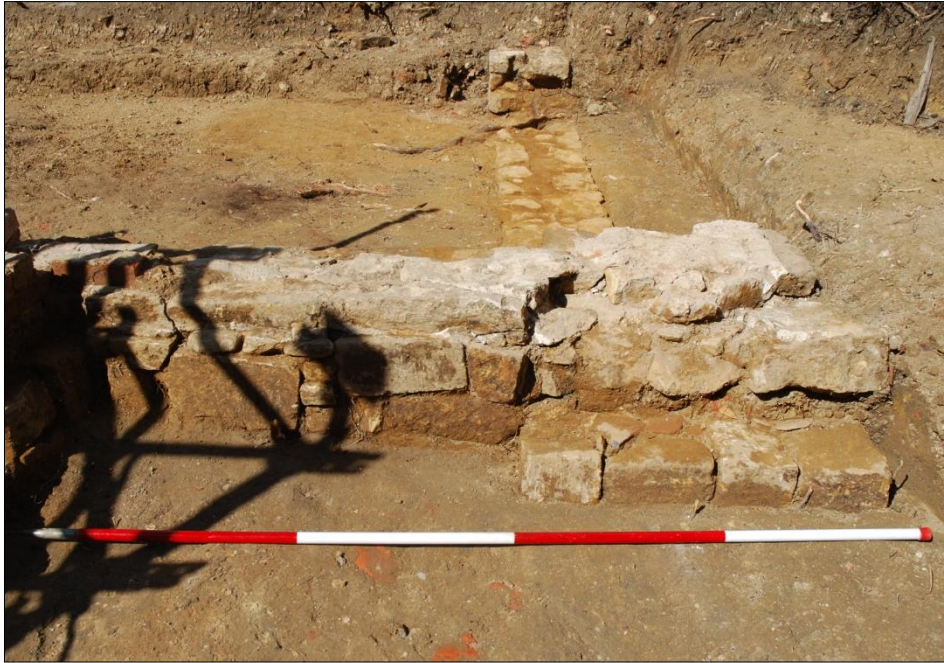
The walls were constructed of both dressed and un-dressed pieces of ironstone and limestone. Where dressed pieces were used they were mostly, but not exclusively, used to form the outer faces of the wall. The majority of the footing was un-mortared but bonded with clay, presumably extracted from the surrounding natural geology. However, at the north-east corner the wall was thickened to form what appear to be clasping buttresses on the outer faces of the two walls [6]. At this point the stonework was bonded in a creamy white lime mortar.

Fig 28: The wall footings looking west: 2m scale.

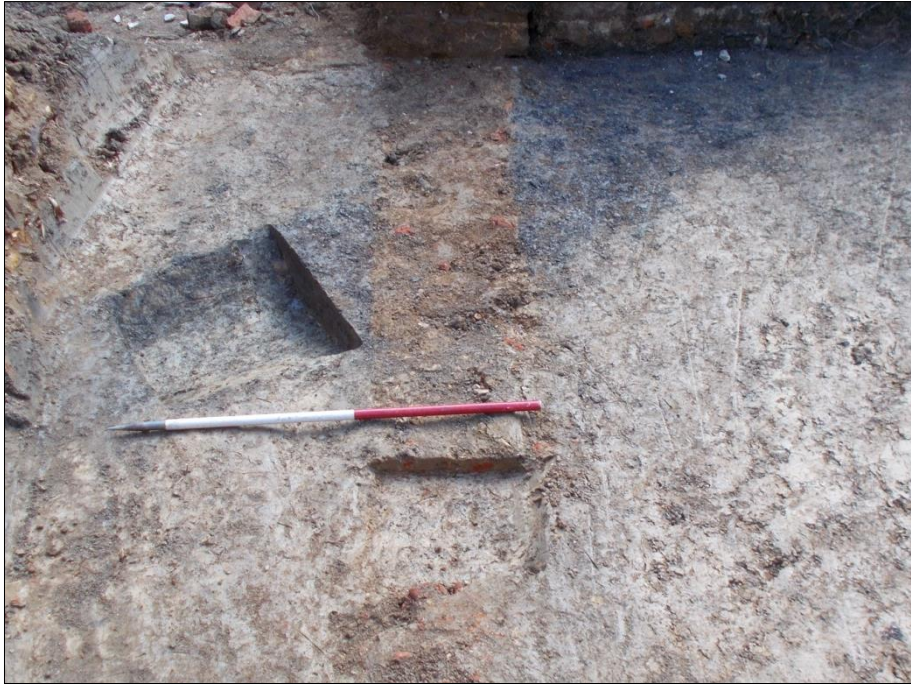
Fig 29: The east-west robber trench [10] and underlying angled Romano-British ditch [9]. 1m scale, looking east.

This trench was neatly cut into the natural blue clay and extended westwards from the corner of the ironing room although appears to have been unconnected with it; the association seems to have been coincidental. It probably related to an earlier wall on a similar alignment. The westward limit of the robber trench extended beyond the limit of the excavations and so is unknown. The trench was c0.5m in width and survived only to a depth of 40-50mm. It retained a flat base and was filled by dirty natural clay with occasional fragments of red brick and mortar with small slivers of green bottle glass.

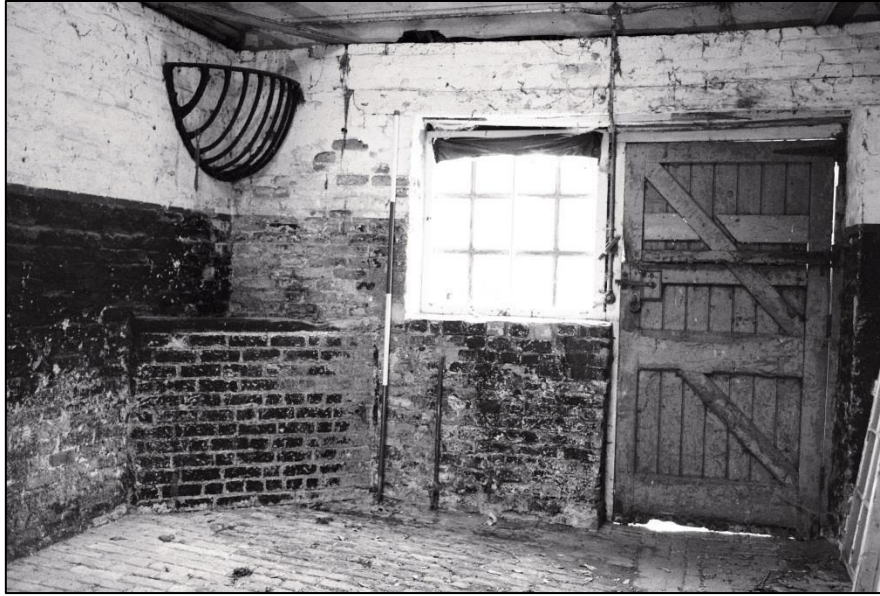
Fig 35: The front of the stable, with two part door, added brick corner trough and iron hay-basket;
scale 2m

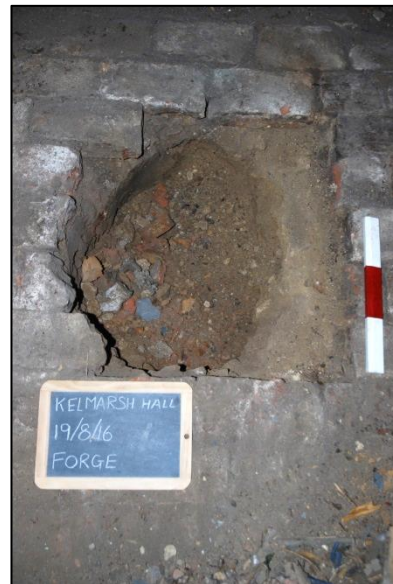
Firstly it must be noted that a forge was not the original, intended use of the room, since the base for the anvil, a huge waney-edged tree trunk log of (probably) elm, was set into a 300mm-deep pit dug through the existing blue-brick floor. Excessively rotted, it was not retained.

Fig 37: the pit for the anvil base; scale 30cm

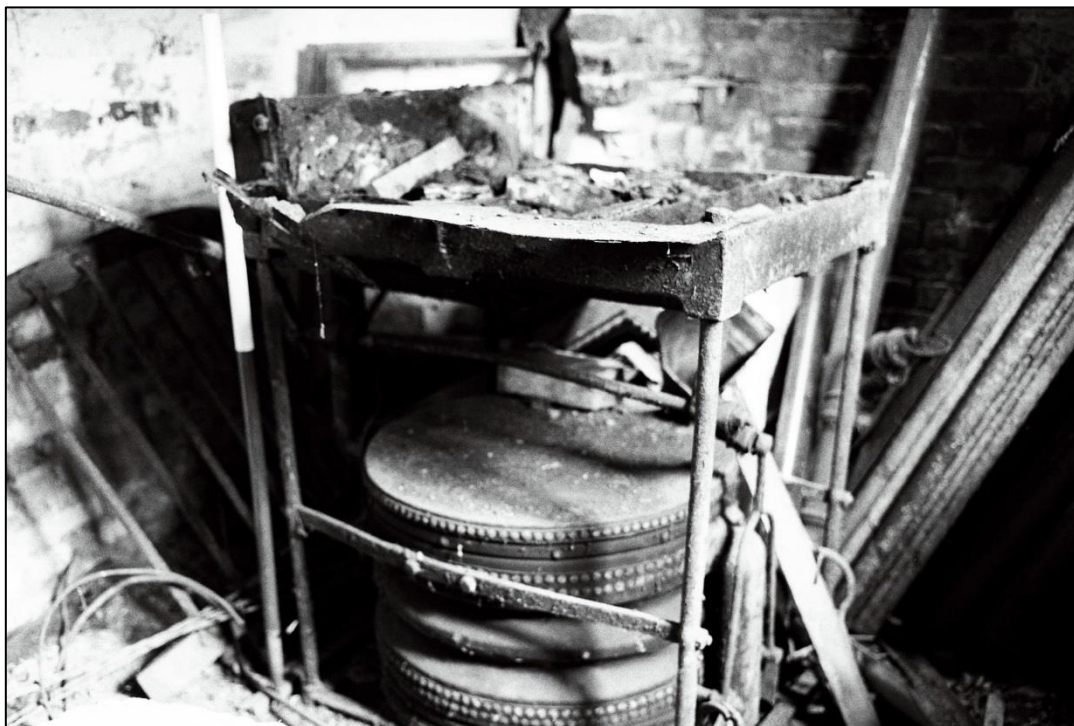
Fig 40: The heart of the forge – an excessively heavy mobile bellows and hearth combined; scale 1m

Close to the centre of this small room was a very heavy iron and steel structure which combined hearth and bellows. It still contained a deal of spent fuel in the hearth itself, liberally strewn with

discarded tongs, pliers and other tool-attachments. Seemingly the abandonment of the forge had not been particularly planned, nor was there ever any attempt to put the room to an alternative use thereafter. Only the anvil had been taken out, leaving deep locator-holes for spikes which held it fast onto its sunken tree-trunk base, still rotting in its pit.

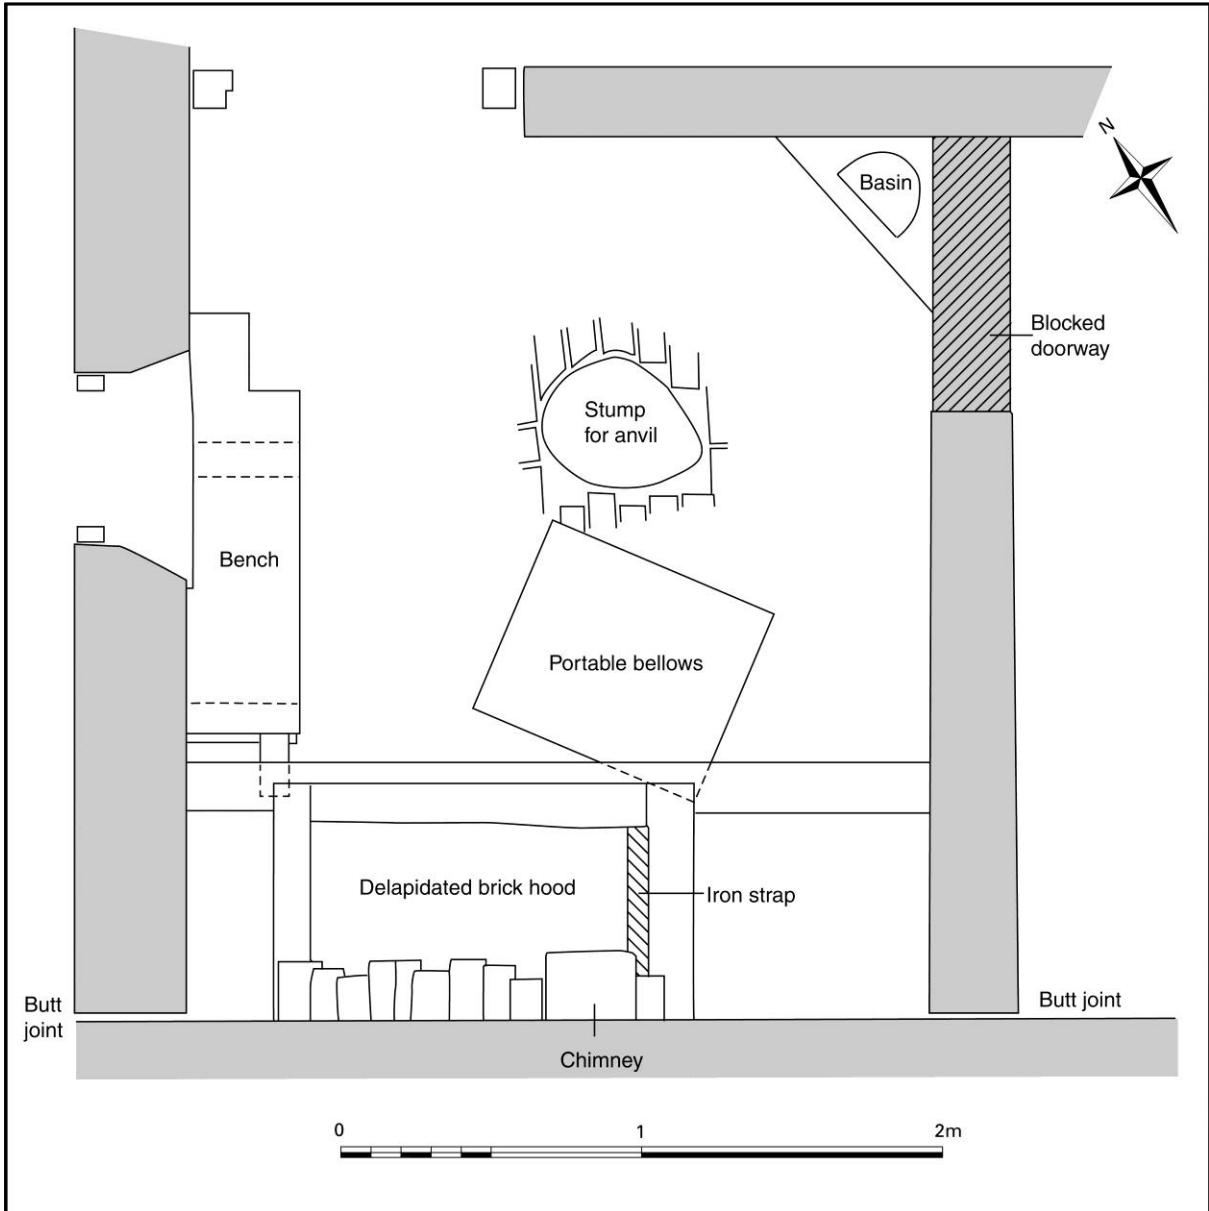
Fig 41: plan of the forge layout. Note the surrounding brickwork butt-joints (Andy Isham).

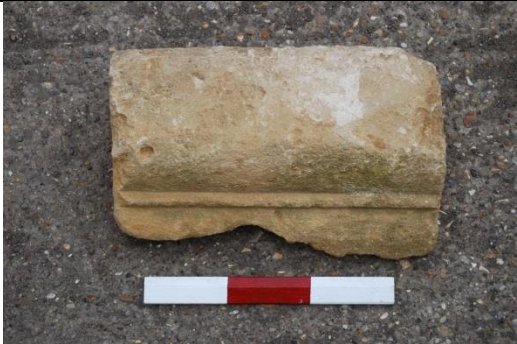
1a	Cornice fragment in fine-grained limestone. Size 380mm x 234mm x 120mm. Context 5; Scale 30cm

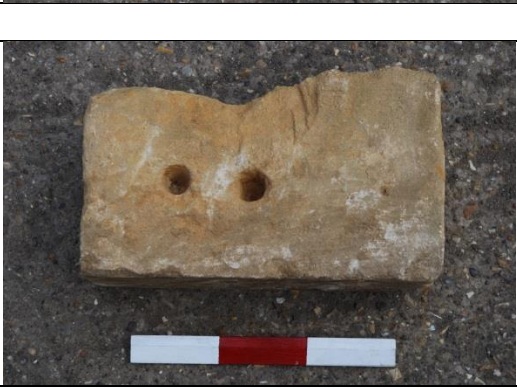
1b	Underside view of same, showing (?) fixing holes.

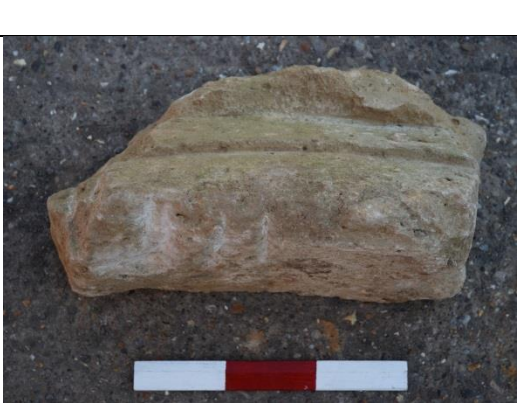
2	Fragment from an arch, curved door-head or coping from shaped gable in fine-grained limestone. Size 480mm x 200mm x 245mm. Context 5; Scale 30cm

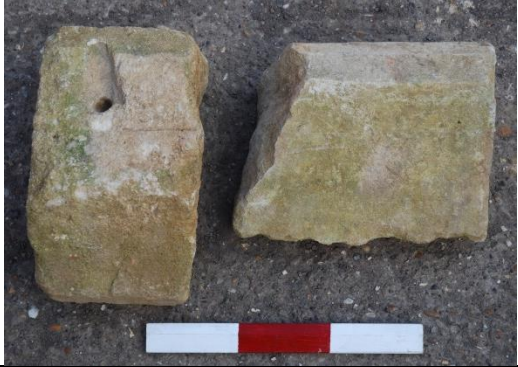
3	Two fragments of a window sill or coping in fine-grained limestone. Sizes: (left) 285mm x 170mm x 135mm; (right) 275mm x 200mm x 140mm. Context 5; Scale 30cm.

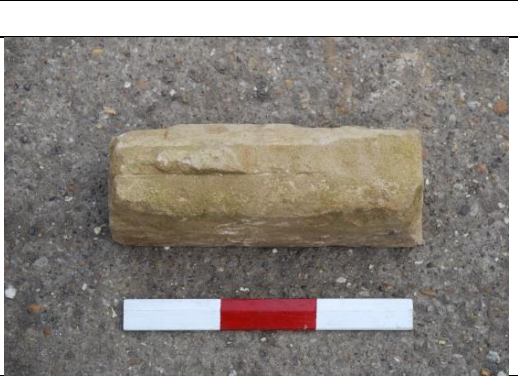
4	Fragment of ovolo mullion or transom in fine grained limestone, cut down. Size: 325mm x 140mm x 95mm. From East wall footing of North Quadrant; scale 30cm.

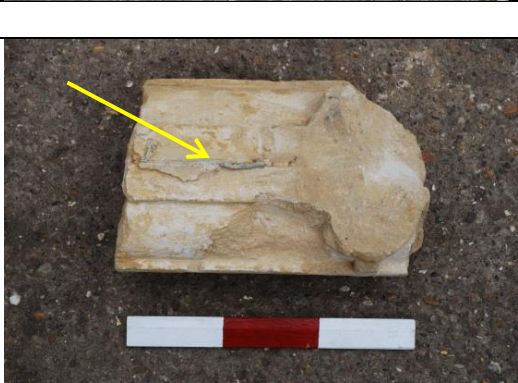
5a	Junction piece from ovolo mullion and transom, with lead came (arrowed) in glazing groove on ovolo (underside) of transom. The piece has a plain upper surface (to run off rain), ovolo beneath on the transom. The mullion has ovolo on both sides. Limewash traces on the interior. 315mm x 200mm x 125mm; Context 5; Scale 30cm.

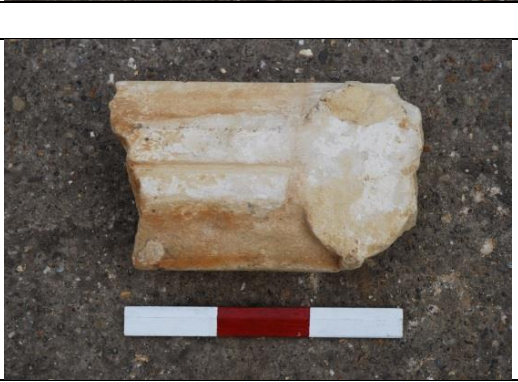
5b	Upper (chamfered side) view of the same. Scale 30cm.

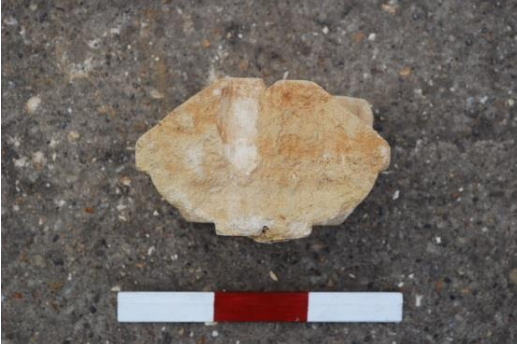
5c	Profile view of the transom of the same, with chamfered upper and ovolo underside. Context 5; Scale 30cm.

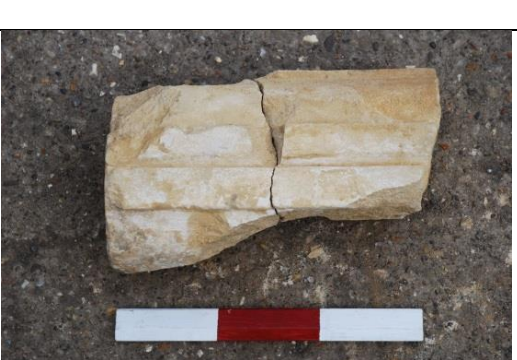
6	Two joining fragments of ovolo mullion in fine grained limestone. (310mm) x 190mm x (125mm). Context 5; Scale 30cm.
