**Buildings Recording at  
Park View Farm, Grange Cottage & Yew Tree Cottage,  
Astwith, Derbyshire; three properties belonging to  
The National Trust.**

Joe Prentice and Iain Soden

### Summary

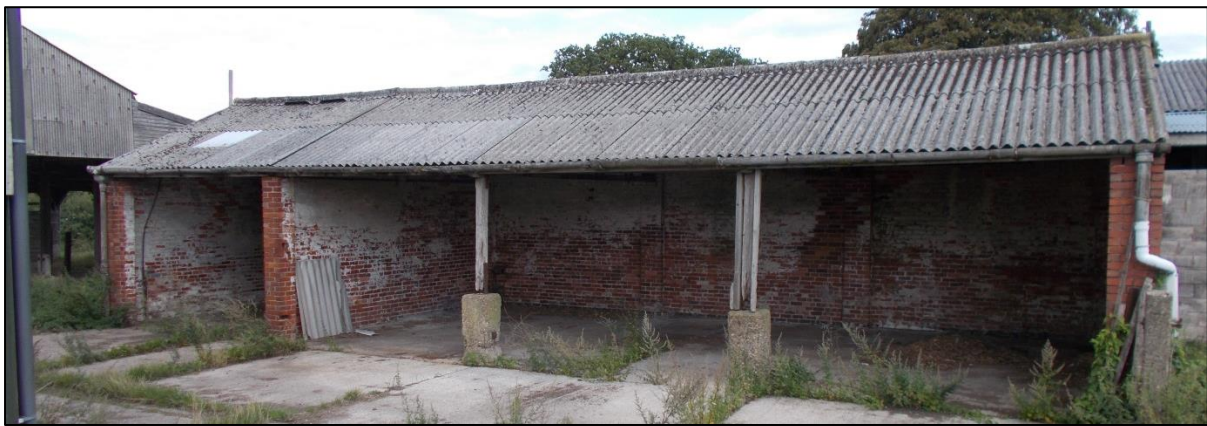
- A narrow, open-fronted brick shed facing south-west (Figs 5, 6 and 7). Map regression shows this was built during the period 1955-61 and is probably original to the farm. It is simply constructed with brick laid in the frugal *Flemish Stretcher Bond* with a timber framed roof covered in Trafford Tile (asbestos). Its front wall plate is set upon timber uprights resting on concrete stanchion bases. A single concrete-framed window with built-in sill-mounted ventilator faces north-east. The building is probably a former animal shelter, which would have been suitable for sheep. There are no internal details surviving. Onto the back of this building is a low block-walled enclosure around a steel frame with asbestos roof (Fig 8). This was recorded by Lott (1997) as a cow shed, having been built in 1981. There is nothing to suggest otherwise.

Fig 6: The open-fronted shed 1955-61, looking north-east

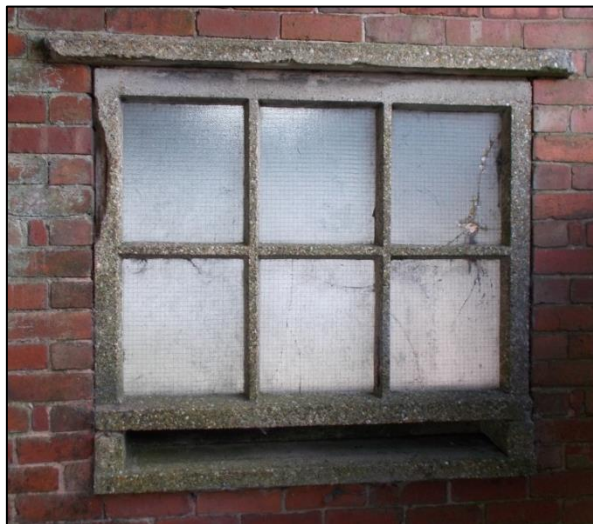
Fig 7: Pre-cast ferro-concrete window unit with ventilator-sill in the 1955-61 animal shelter

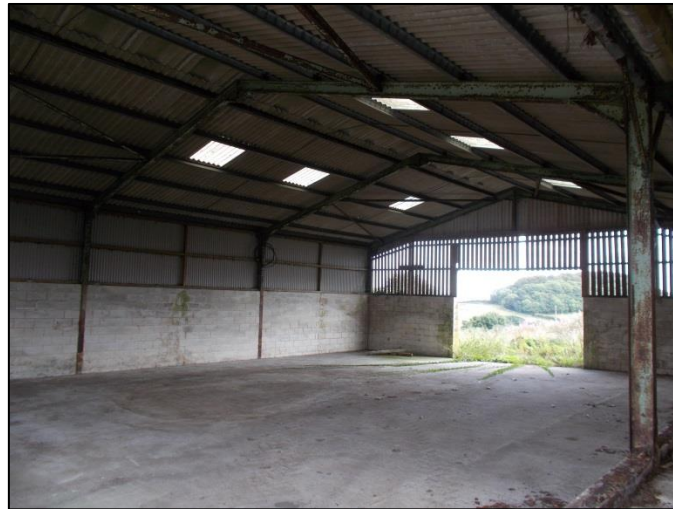
Fig 8: Steel-framed shed of 1981 built onto the back of the 1955-61 brick animal shelter.

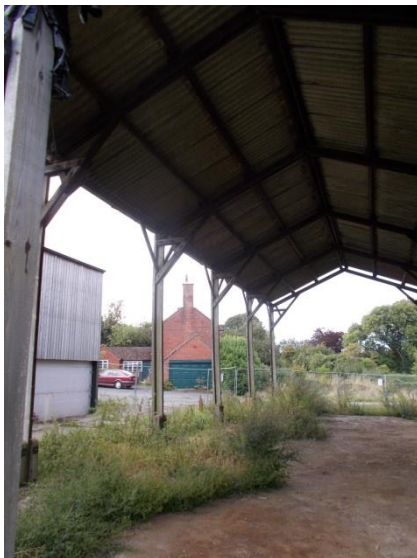
- A high timber shed, Dutch-Barn style, with Trafford tile roof; extended and doubled in size to the north-east (Fig 5, 9 and 10). Map-regression show that the initial build took place in 1955-61, probably original to the farm, and that the lean-to extension took place in the period 1962-70. Lott (1997) indicates that its use at that date was as a hay-barn, which might be expected of a high open-sided Dutch- barn style structure.

It is distinguished by its use of double-uprights of parallel softwood posts, individually too thin for stability but stronger paired. These were probably a cheaper alternative to steels. These are bolted to concrete godfathers set in concrete stanchions to defray rot at their base.

Fig 9: The hay barn looking north-west towards farmhouse

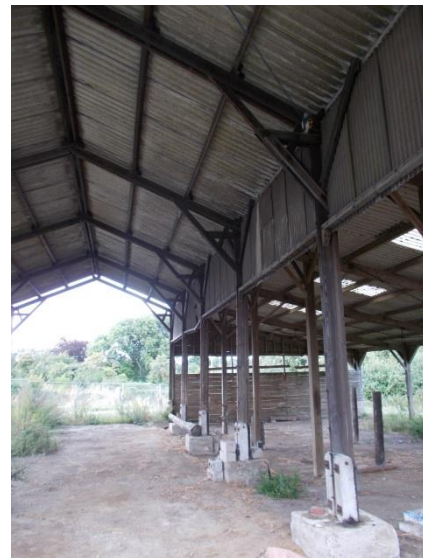
Fig 10: The view through to its 1962-70 extension (right)

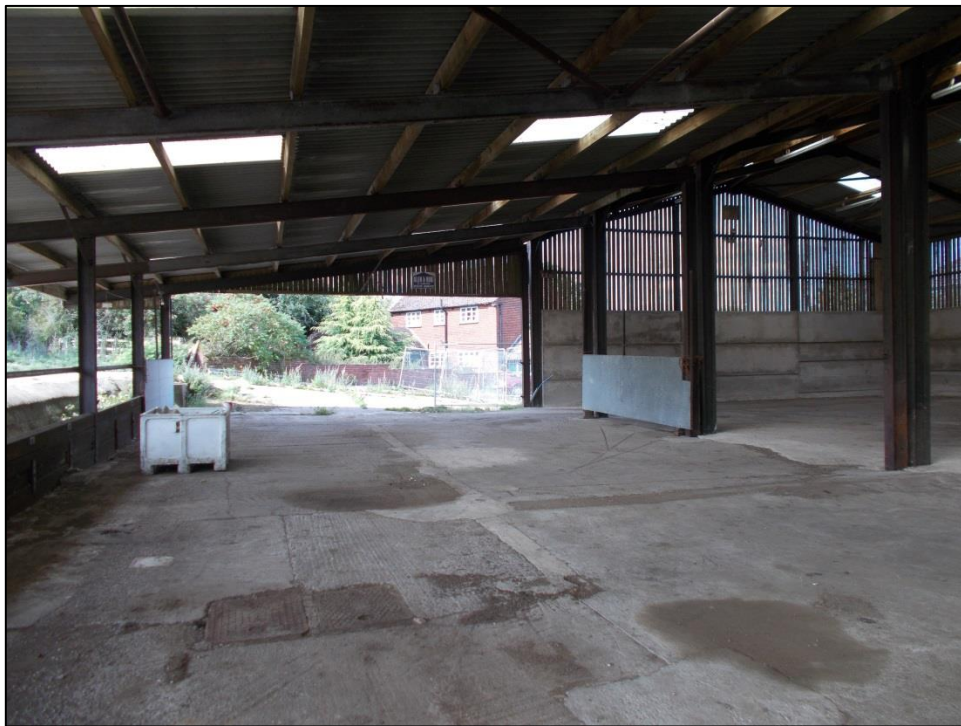
A steel-framed lean-to extension was built on the west side in 1995, helpfully dated by a contractor's plaque in the northern gable (Figs 5 and 11 and 12).

Fig 11: The 1995 steel-framed lean-to which extended the original 1950s cow shed; the 2007 replacement lies on the right – note they have separate, back-to-back steel uprights.

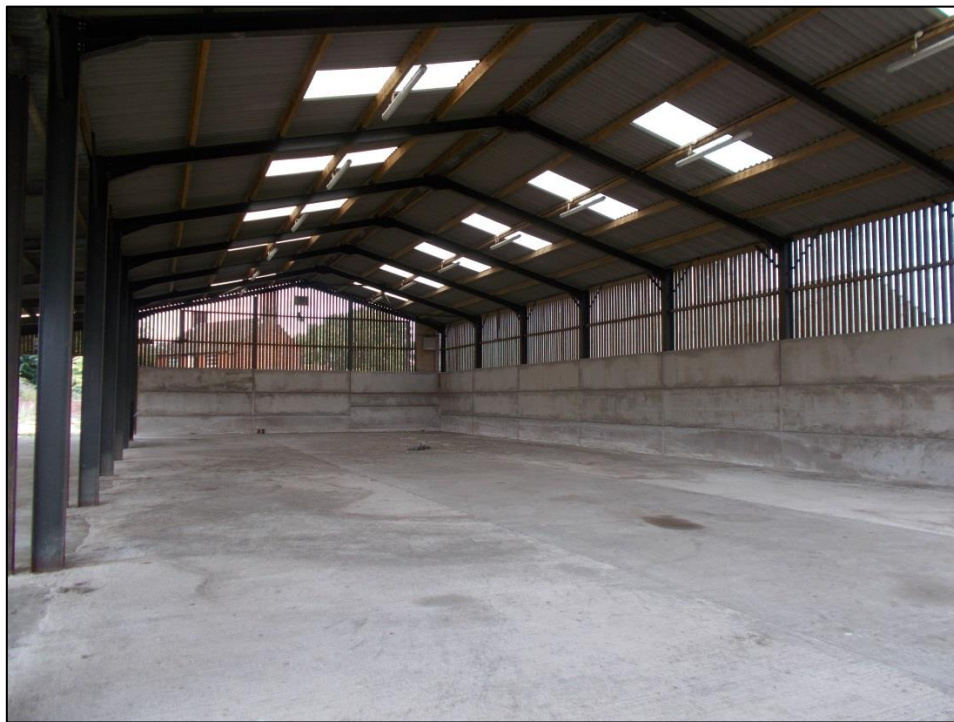
The 1951 cow shed was subsequently demolished and replaced by a modern steel-framed and sectional concrete shed in 2007, and which stands today (Figs 5, 11, 12 and 13). A satellite image (Google Earth timeline) shows the site with the stanchion pits of the foundations just dug and ready for the new shed to be erected (Fig 12).

Fig 13: The 2007 Cow Shed. The farmhouse lies glimpsed beyond.

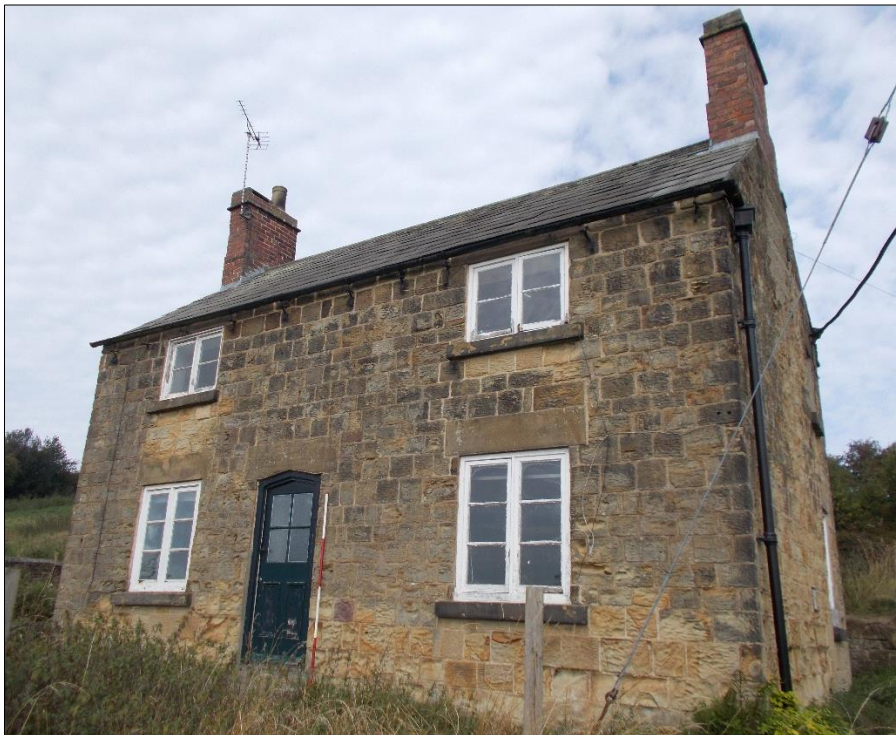
The principal elevation of the cottage comprises a symmetrical two-bay, two-storey configuration with a central doorway (Figs 18).

Fig 18: Grange Cottage, the south elevation, looking north-west. 2m scale.

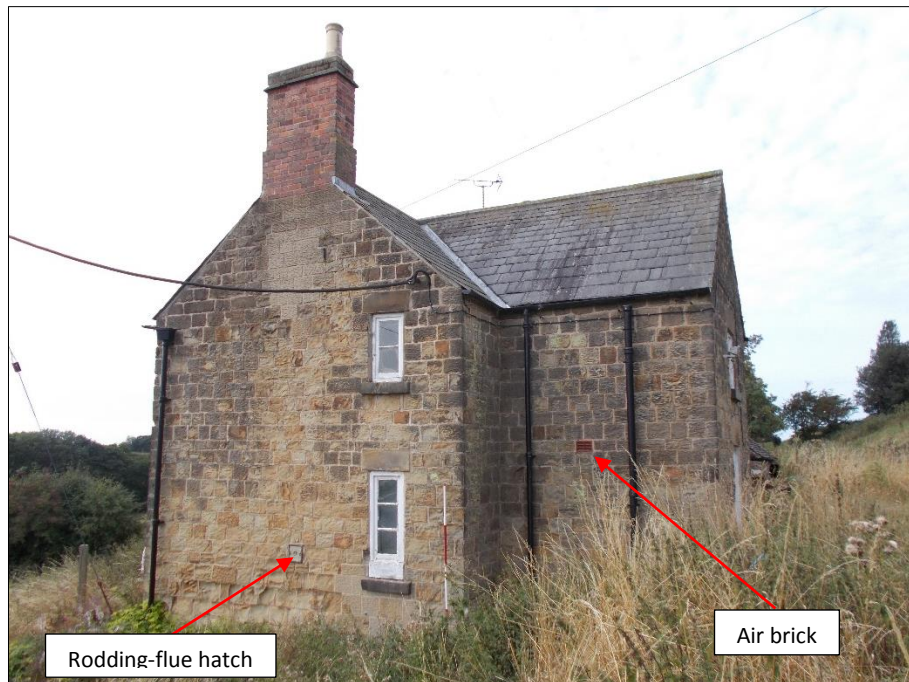
Fig 19: Grange Cottage, the east gable wall and east side of the north bay, looking south-west. 2m scale.

Built from the same stone laid in the same way as the south elevation, the east gable wall has two narrow casement windows set towards the northern end of the gable wall. That on the ground floor has three panes, the first-floor example has two. The ground-floor window has a boarded-over lower section which appears to have been added when the interior sink was inserted (see below, interior). Otherwise the gable wall is almost entirely plain, the only variation being the variable weathering of the stonework, noticeable on original eroded blocks and new replacements and a square flue-rodming hatch. This feature perhaps suggests the former presence internally of a fixed cooking range which would have needed the flue removing when the chimney required sweeping. The external rodming-flue hatch would have allowed the flue to have been swept without the need for any removal of an interior stove-pipe.

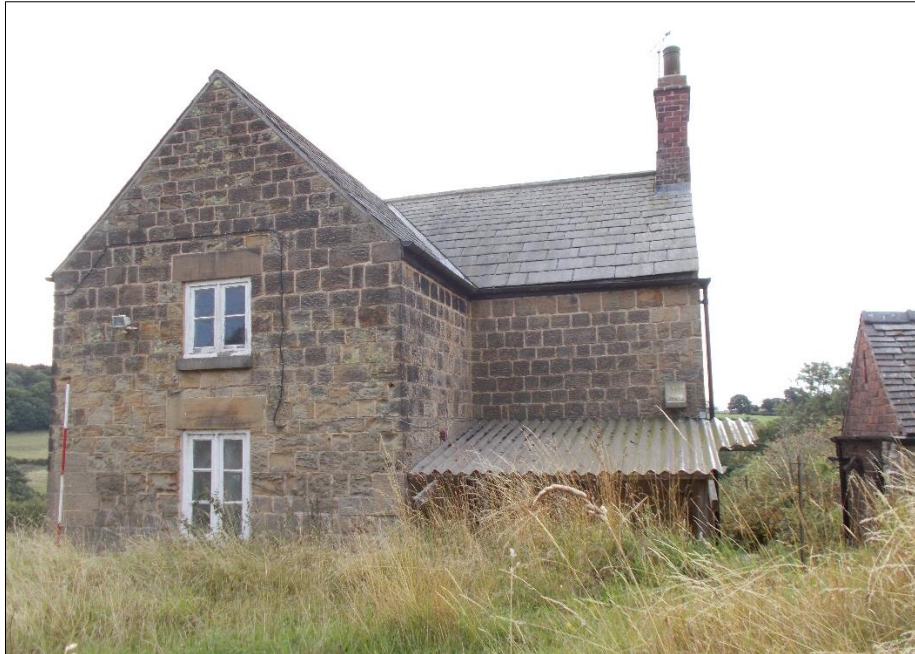
Fig 20: Grange Cottage, the north elevations, looking south. 2m scale.

Built from the same stone as the previous elevations, this side of the building contains no windows in the short north face of the east bay, two in the central gabled section and one in the west portion (Fig 20).

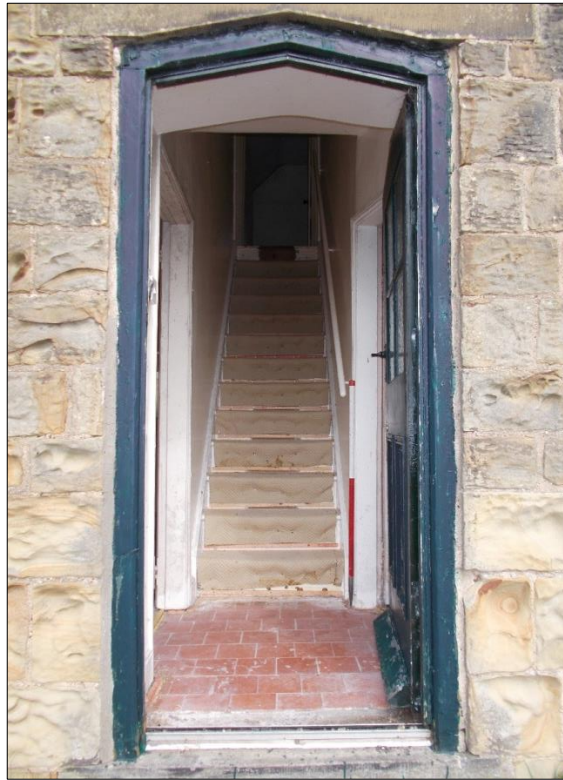
Fig 24: The entrance lobby and staircase, looking north; 1m scale.

Almost devoid of any decoration, the lobby simply provides a connecting space for the internal circulation within the building and is purely utilitarian. The doorway has a plain ashlar sill and the lobby floor is laid to red clay quarry tiles. The eastern reveal of the doorway is splayed, the western is straight, apparently to allow the front door to fully open. The door architraves to the rooms on either side (G1 and G2) are of simple machine-moulded wood, painted.

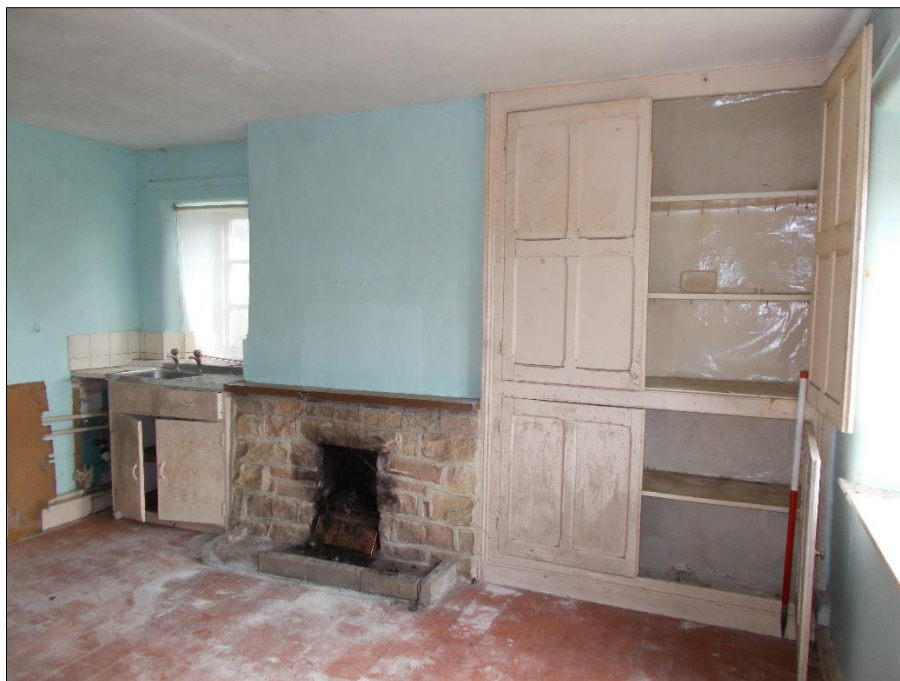
Fig 25: Room G1, looking north-east; 1m scale.

The floor is laid to the same red quarry tiles used in the entrance lobby and there is a chimney breast on the east wall, currently fitted with a modern stone fireplace and hearth slab with a timber mantelpiece; it appears to be of 1970's or 80's date. It is most likely that this fireplace replaced the original cooking stove, most probably within a wider opening.

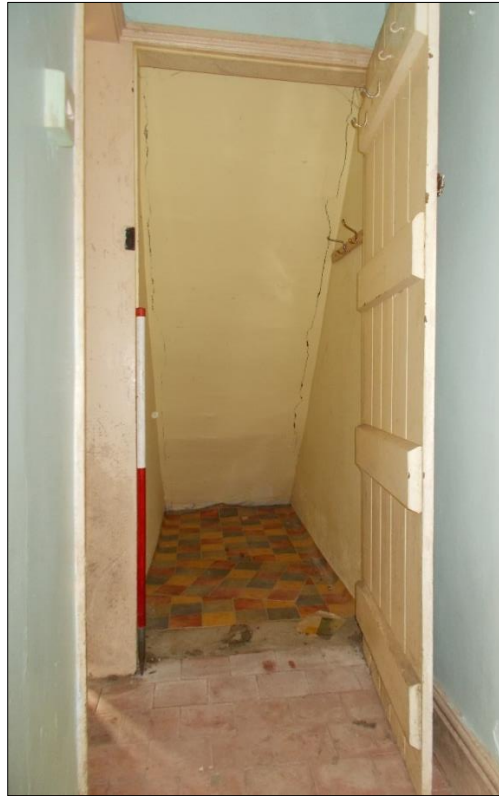
Fig 26: Room G3, the rear lobby and under stairs cupboard, looking south; 1m scale.

The floor of the lobby is laid to red quarry tiles, the under-stairs cupboard the same. There is no decoration to either space apart from the skirting board and simple architrave around the door-cases. The door to the cupboard is of vertical planks, ledged but not braced with a drop latch on the exterior. Internally there are modern coat hooks on the west wall, fitted on a wooden batten.

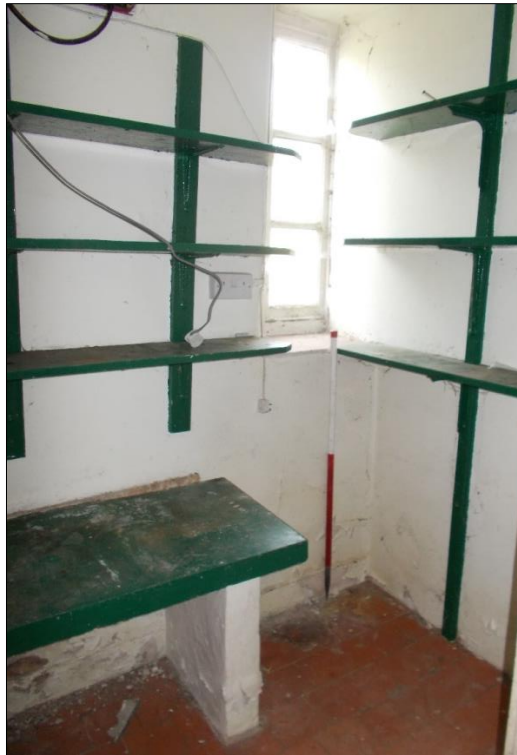
Fig 27: Room G4, the larder, looking north-east;1m scale.

The room is laid to red quarry tiles and has a stone or concrete slab, painted green, supported on brick piers in the north-west corner. Both the north and east walls have timber shelves supported on iron brackets screwed to vertical battens. Apart from the circuit-board for the electricity supply on the north wall, the room is otherwise plain with the exception of the visible half of the former two-light north window.

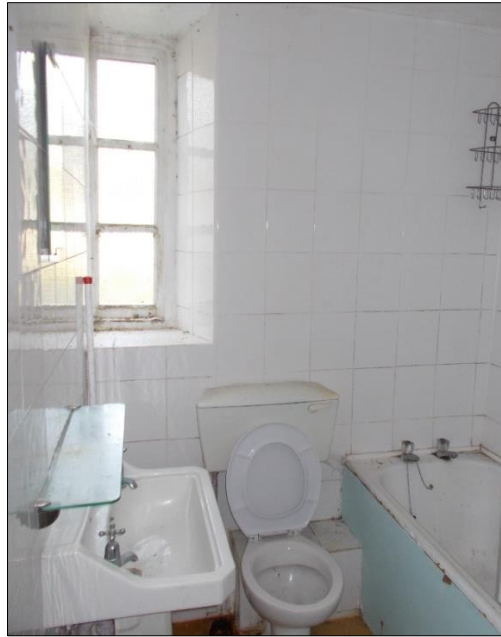
Fig 28: Room B1, the bathroom, looking north.

An entirely modern space, tiled to the height of the window lintel with plain, white tiles and containing a white enamel bath with shower over against the east wall, a lavatory against the north wall and a wash basin against the west wall with glass shelf and mirror above. The remainder of the east wall to the south of the bath contains a cupboard with the water tank. The only partly visible historic feature is the east half of the two-light north window.

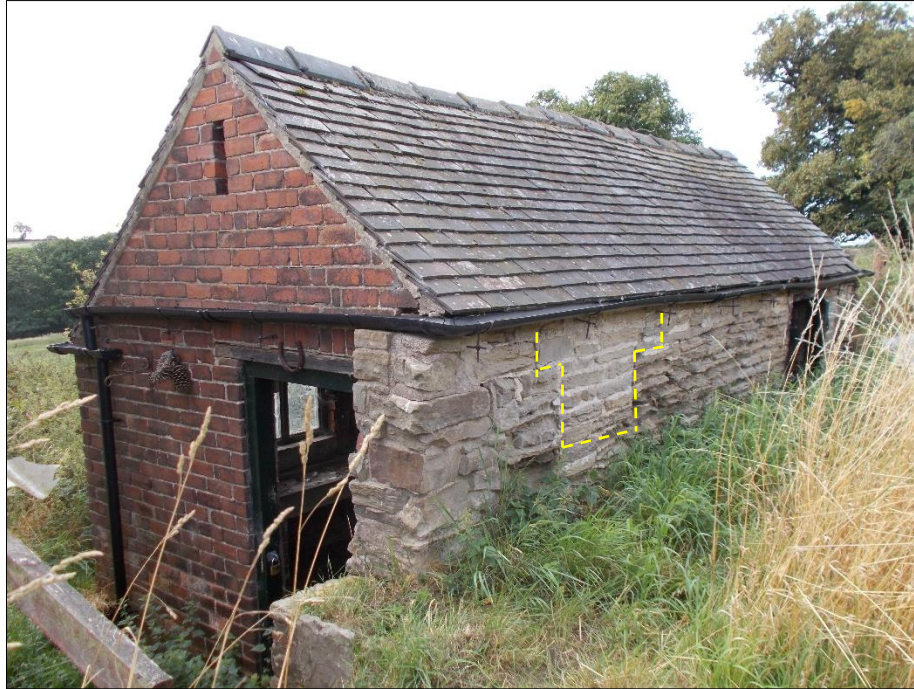
Fig 34: The wash-house east gable wall and north elevation, looking south-west.

The north wall, partly set within the ground due to the change in levels between the north and south sides of the building, contains one small opening currently, partially narrowed and fitted with a timber plank door and another opening, now infilled (see Fig 34, dashed yellow lines). This stone-walled section appears to be that indicated on the 1899 OS map and has been previously interpreted as the remains of a former farmhouse (Lott 1997). The present author feels insufficient structural remains survive to be certain of this and that it may equally simply be a stone retaining wall related to the aforementioned changes in ground level. Also, the two openings, one infilled, the other partially narrowed, both respect exactly the current ground level and the fully infilled example appears to have had a former lintel which respects the eaves of the current structure. If they were remnants of an earlier building, it seems improbable that they would both so exactly match a later topographic change.

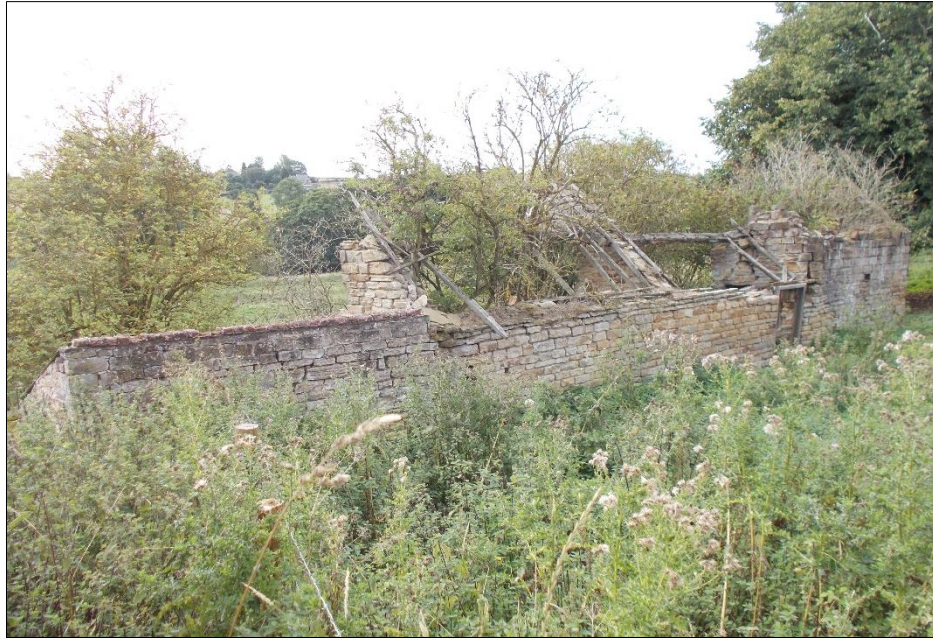
The north wall survives relatively intact with the majority extant to former eaves level.

Fig 40: The north wall of the former animal shelters, looking south-west.

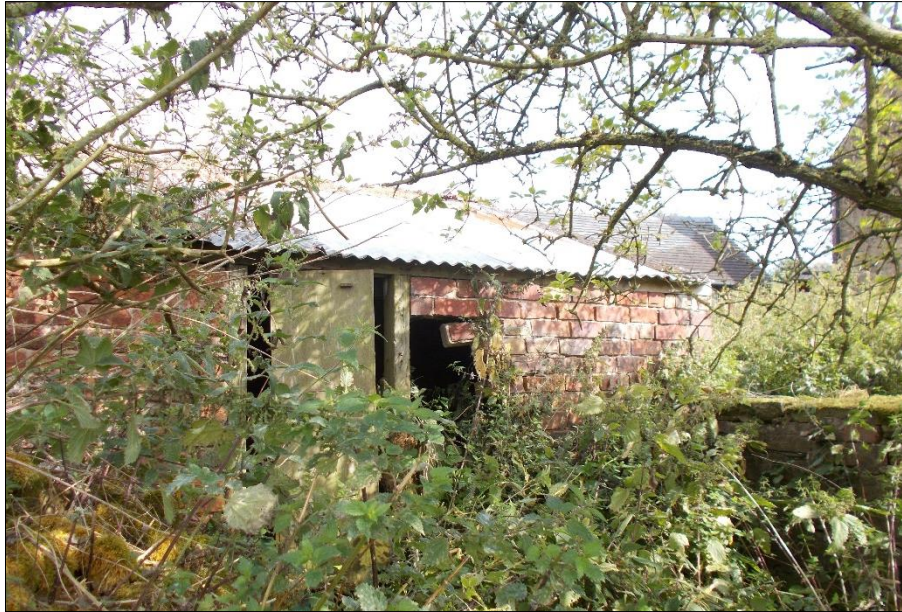
Fig 43: The pigsty at the east end of the animal shelter range, looking north-west.

The east, west and north walls are primarily built from coursed stonework, the south wall from red brick. Little else could be observed.

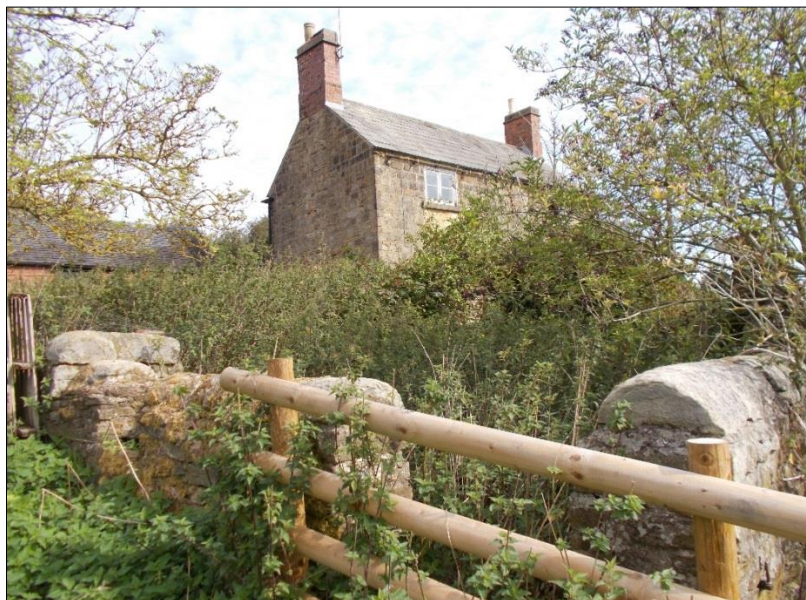
A second pigsty is located to the south of the main animal shelter range. Currently almost entirely ruinous and overgrown, only sections of walling could be glimpsed (Fig 44).

Fig 44: The detached pigsty, looking north-east towards cottage.

The walls of the pen are constructed from Hardwick stone, the pen walls having half-round coping and a feed trough incorporated into the west wall. Nothing of the sty could be seen, the roof of which is no longer extant.

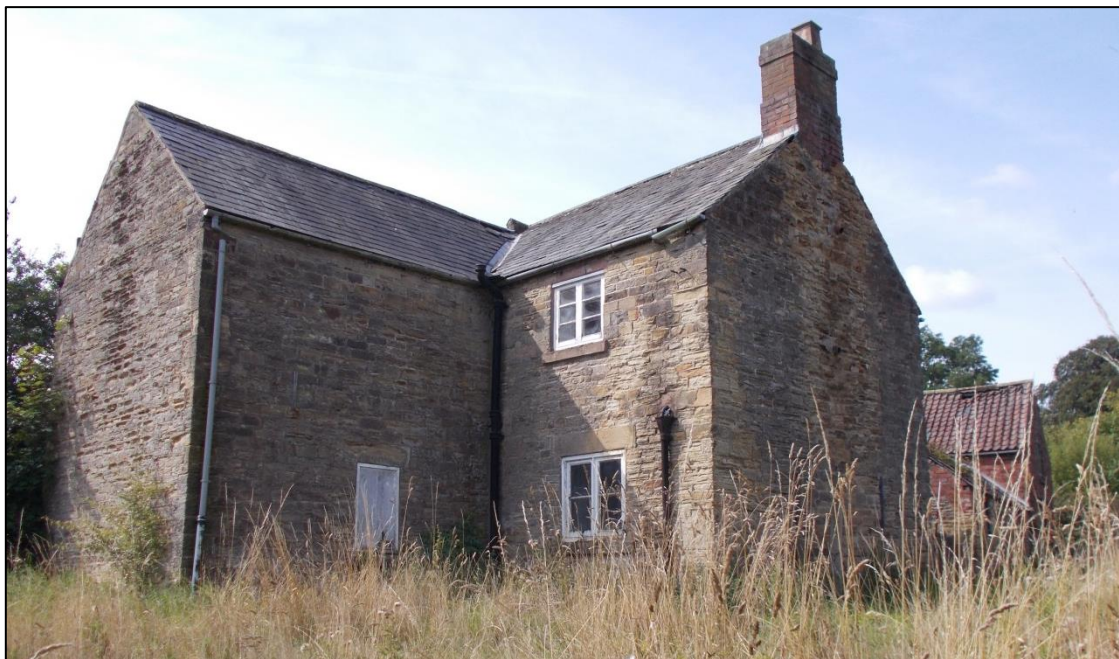
Passing further down the lane, the kitchen block of which G1 is part also looks east, out into the first field in the building's purview, confirming that it was clearly built with views outwards in mind (Fig 48), although the maturity of trees and hedges has latterly compromised this. This is part of the later expansion of the original building. The former predominance of the fireplaces in this block, probably because it had once been the kitchen with exterior farm-door and two windows, and a two-window bedroom (F3) above, mean that the fireplaces in this block have been very well used. This has resulted in some extreme stone-degradation, including some perforation through the entire wall.

Fig 48: The kitchen block also looks east, out into the field.

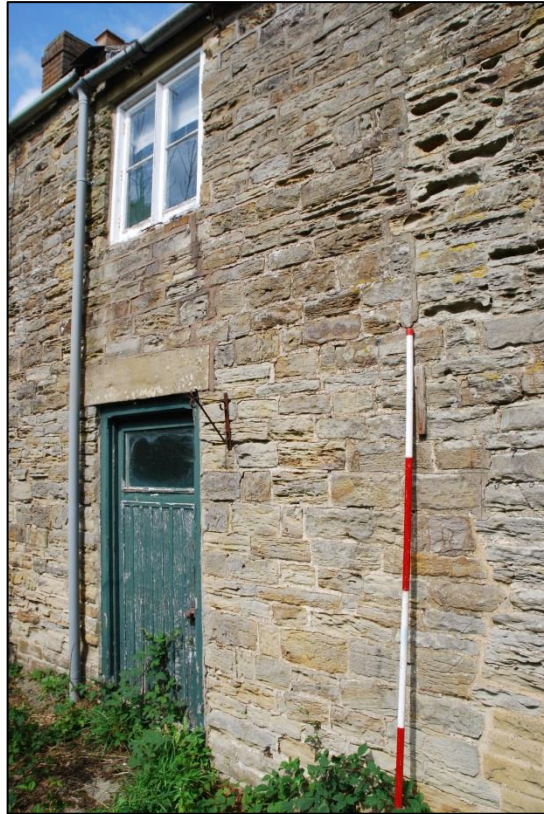
Fig 50: The butt-joint made by the addition (right) to the original building (left). The front doorway is a replacement, treated like the later windows with a stone lintel; scale 2m

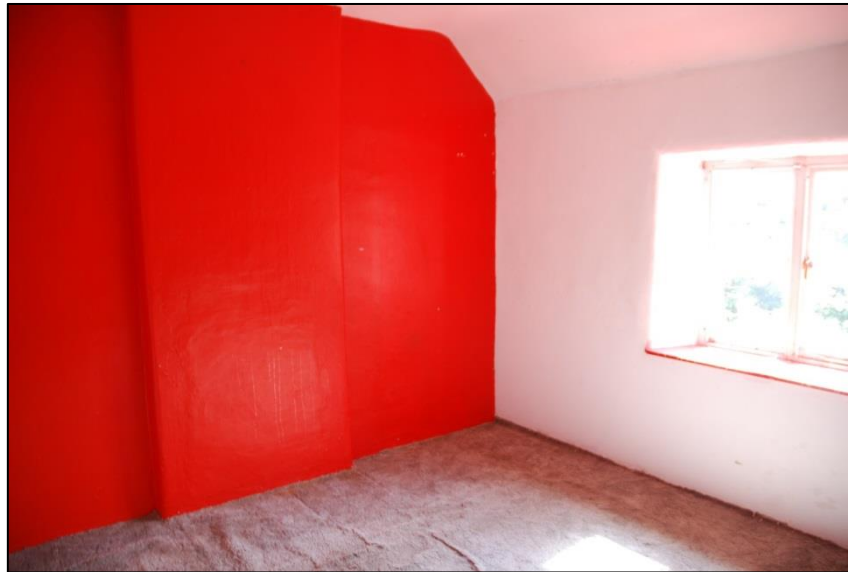
Fig 56: The almost featureless Room F1, a blocked fireplace in the end gable.

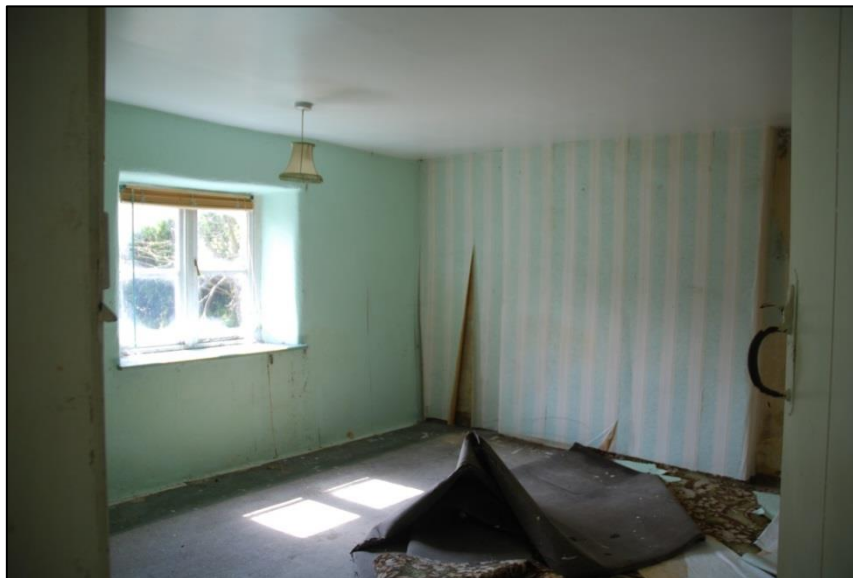
Fig 57: Room F2, with blocked fireplace in the end gable. The hearth slab survives in the floor.

Room F2 draws comment for one reason in particular, however. It appears that the floor is of concrete; not lime-ash or similar, but concrete. If so, this is probably very unusual in a small vernacular building of this age, but does beg the question: other than the chamfered and stopped axial beam in the room below, what is supporting this floor, which must be inordinately heavy? The concrete stops at the edge of the hearth-stone, and no comparable floor can be seen in either of the other first floor rooms, which appear to simply be of timber floorboards.

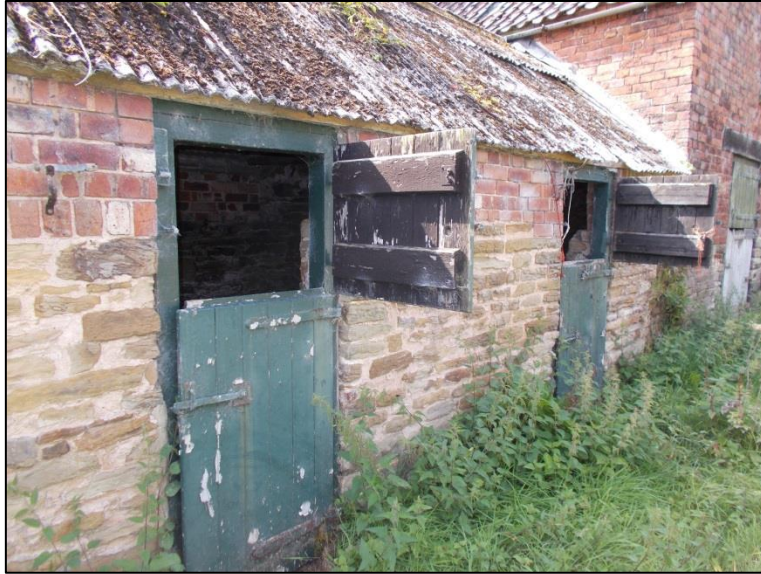
Fig 61: The stable and adjacent room with stable-style doors; note the eaves raised upwards in brick, which includes mid-20<sup>th</sup> century Flettons

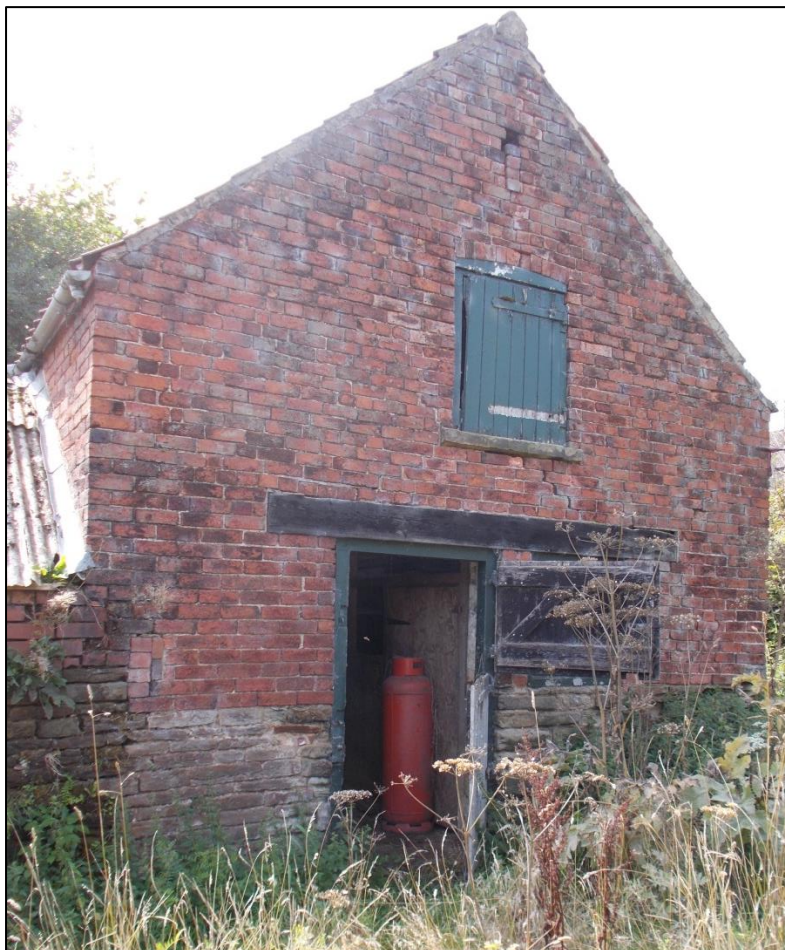
Fig 62: The animal shelter and hay loft over; again brick over stone.

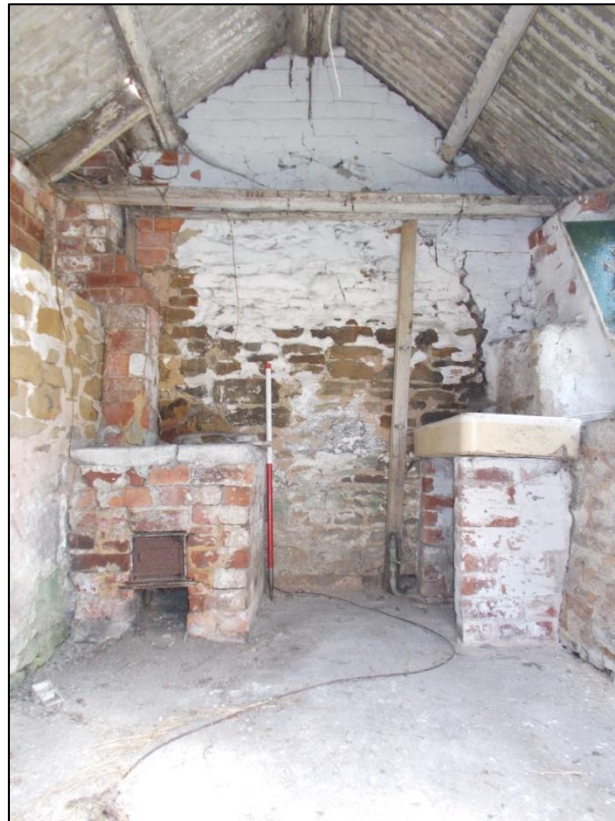
The wash-house at the eastern end of the range is a 20<sup>th</sup>-century creation, and has only probably existed since the eaves were raised. It contains an enamelled stone sink on a brick pedestal and a brick copper, still with its metal basin and wooden lid and a narrow chimney and flue (Fig 63). Here water could be heated, laundry was boiled and mash/swill prepared for the animals.

Fig 63: Inside the wash-house, looking west. Copper to the left, sink/basin to the right; scale 1m

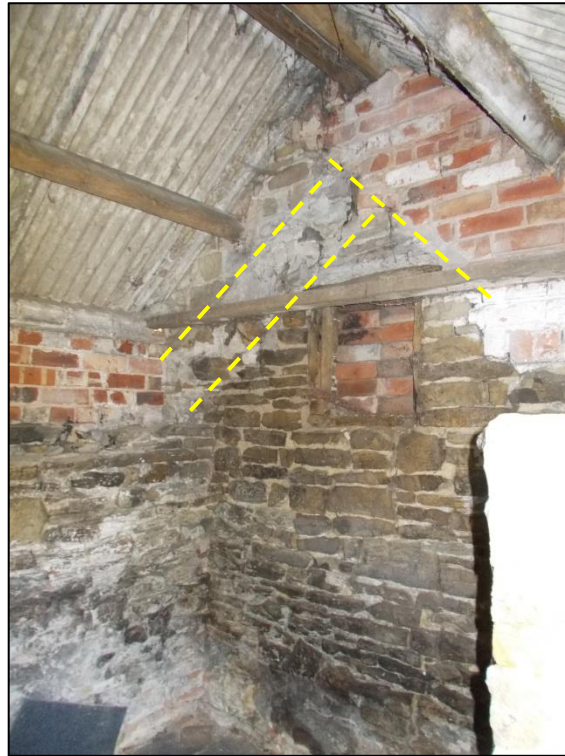
Next to the wash house was a stable with stable-style door (b in Fig 60). This would have benefited from any heat given off from the copper next door. It is a plain room, lacking detail but had a small hatch looking west, subsequently blocked, through to the adjacent building (Fig 64).

Fig 64: One of the stables (room b in Fig 60) looking west. Note the small blocked window through to the next room (c). Also note the former gable outline (marked), from when the range was narrow and open-fronted

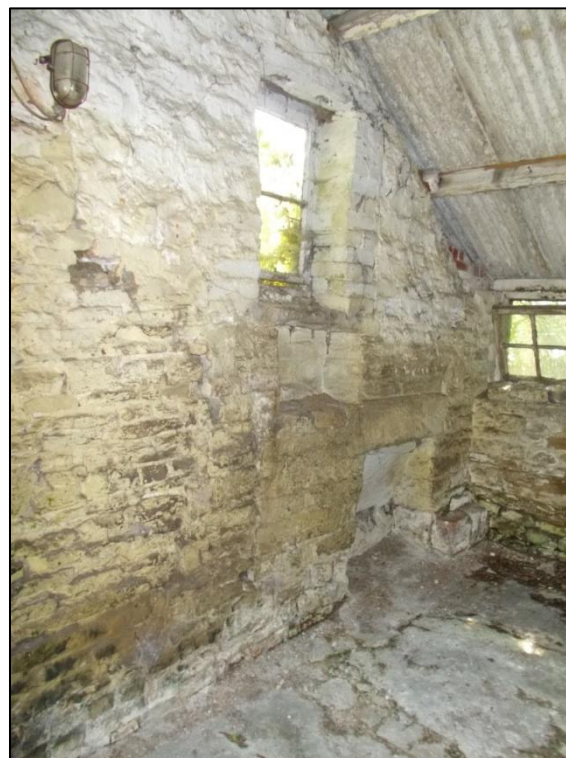
Room c in Fig 60, also with a stable-style door, has been raised and also extended southwards, although in neither case is it apparent for what purpose. The extension did provide more light however, and because the glass of the windows is not protected (as it ought to be for animals), it may be assumed it was for storage, possibly tack, which might explain a disused possible fireplace.

Fig 65: The middle room (Fig 60 c), showing windows, a cupboard and possible fireplace. Their origin is unclear

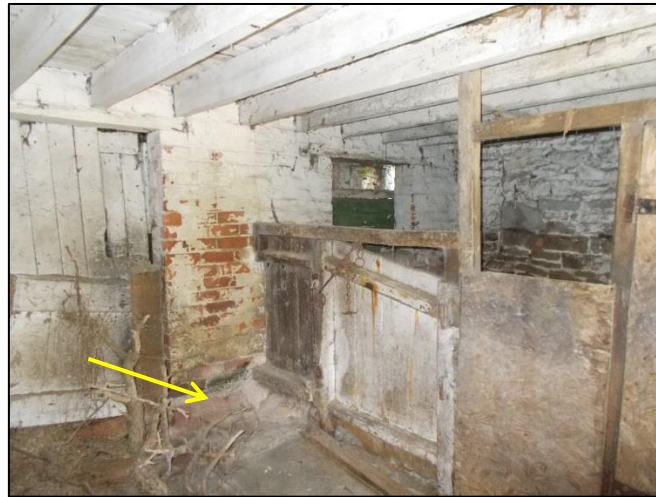
The front half downstairs may once have been at least partly open-fronted, and a row of three worn brick feed troughs are built into the floor against the middle dividing wall. A fourth has probably been lost to a connecting doorway. These may have served cattle, which were usually stalled in

Fig 66: The ground floor of the large animal shelter, front room (d in Fig 60). Three brick troughs in the floor survive against the opposite dividing wall. One is arrowed; two more lie behind a haphazard wooden barrier.
