Iain Soden Heritage Services Ltd

Historic Building Recording of Southwood Farm, Calke Abbey Estate, Derbyshire

By Joe Prentice, with a contribution by Iain Soden

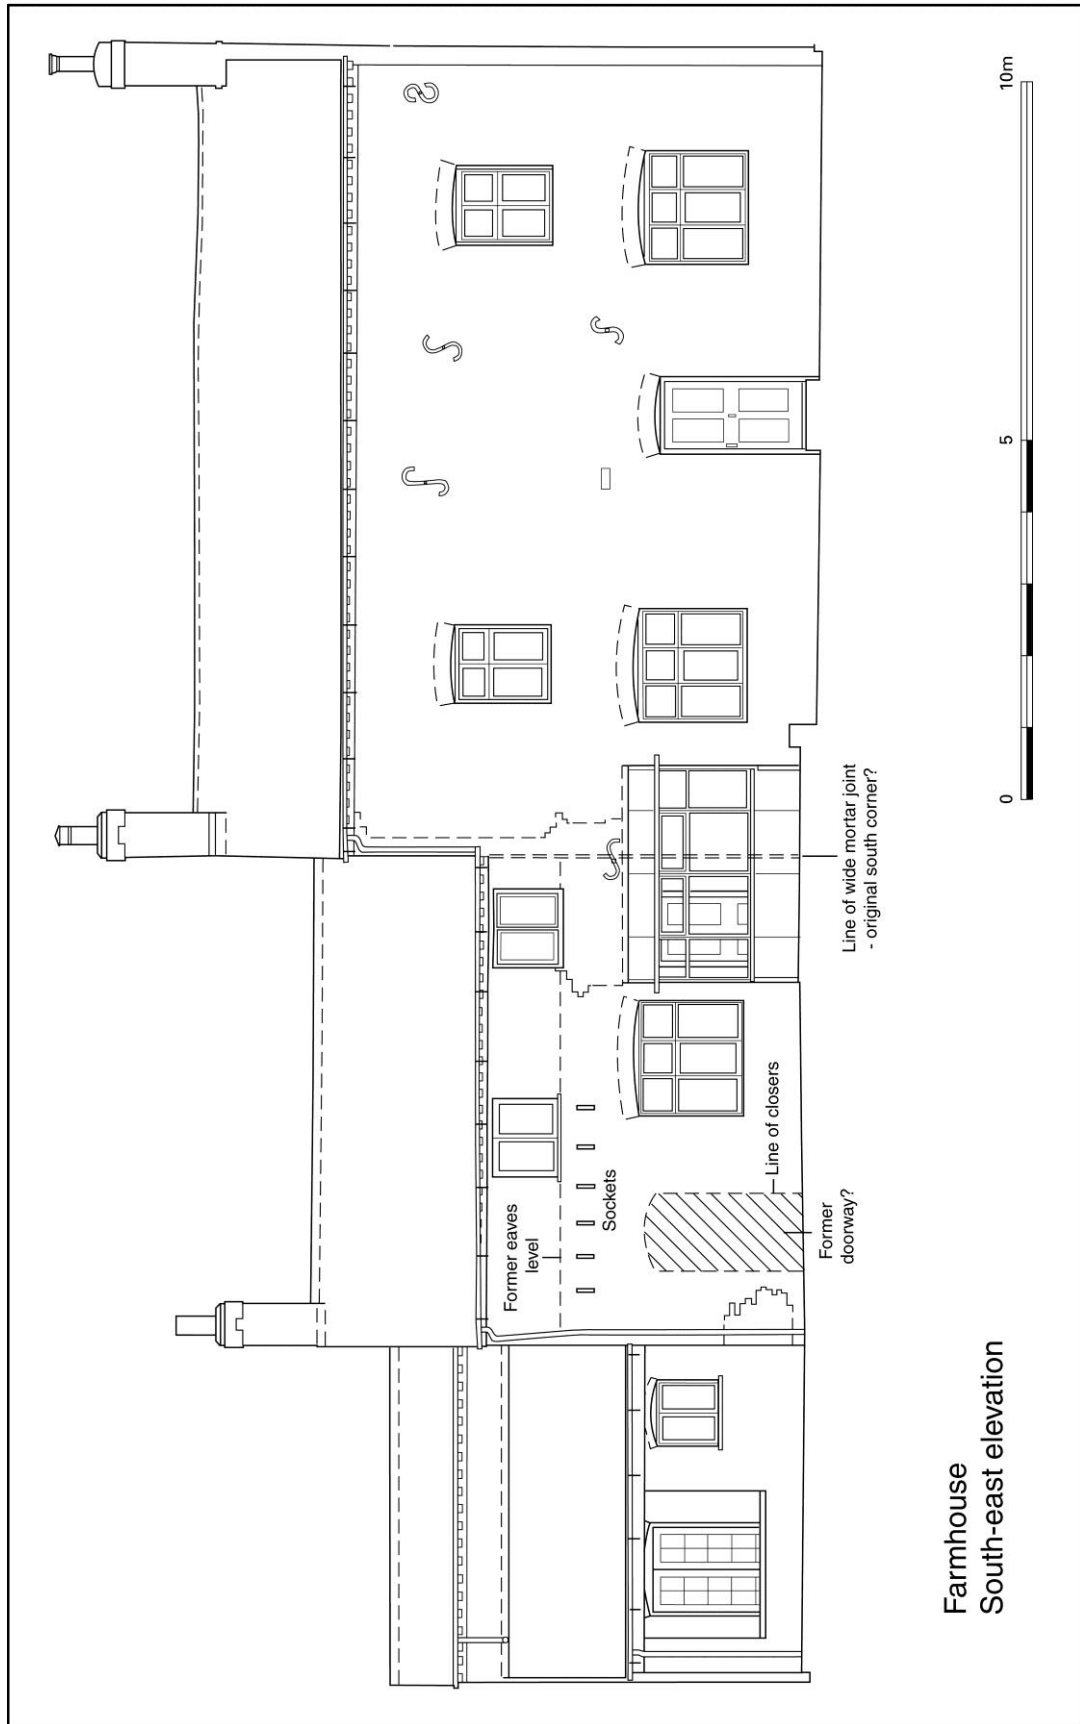
Fig 5A: South-east elevation of the farmhouse.

Close to the south-west corner of this elevation is a line of closers which suggests the former presence of a doorway (Figs 5A and 30). These closers are only present on the north-east side of the former opening and it appears that the whole of the corner of the building has been re-built in slightly different brickwork. Therefore, the original width and height of the opening can no longer be determined, but probability suggests it was of a similar size to the two remaining doorways in this elevation.

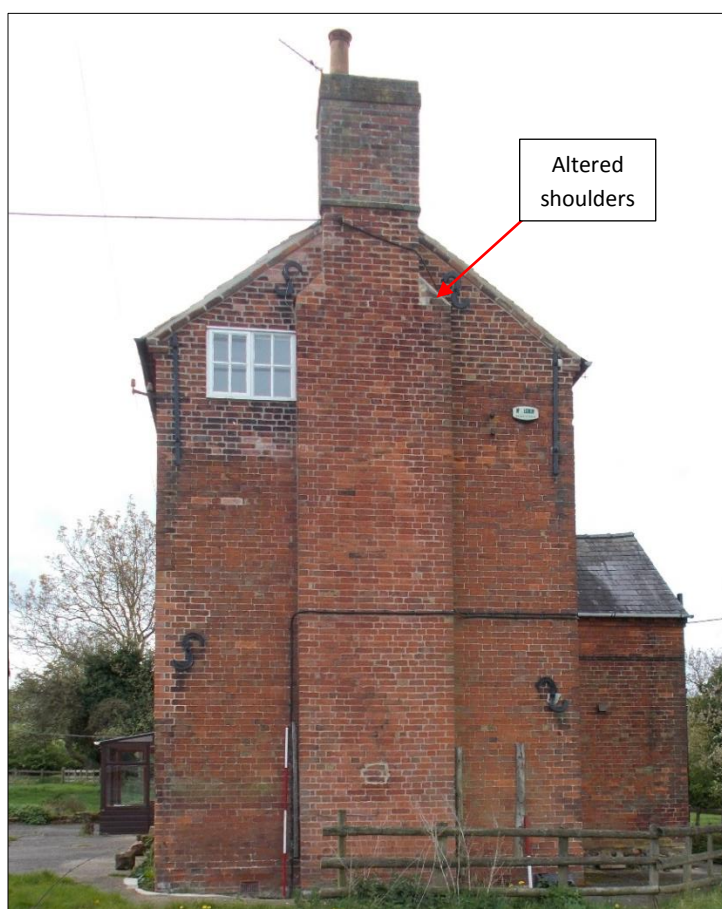
Fig 7: The north-east gable elevation, looking south-west. 1m and 2m scale rods.

The north-east gable wall is almost entirely plain and, apart from the plain but similarly inconsistent brickwork of the walling, contains only the single projecting chimney stack and one window at attic level (Fig 7).

The shoulders of the chimney stack appear to have been altered and currently comprise battered slopes with flaunching capped by slates (see Fig 7).

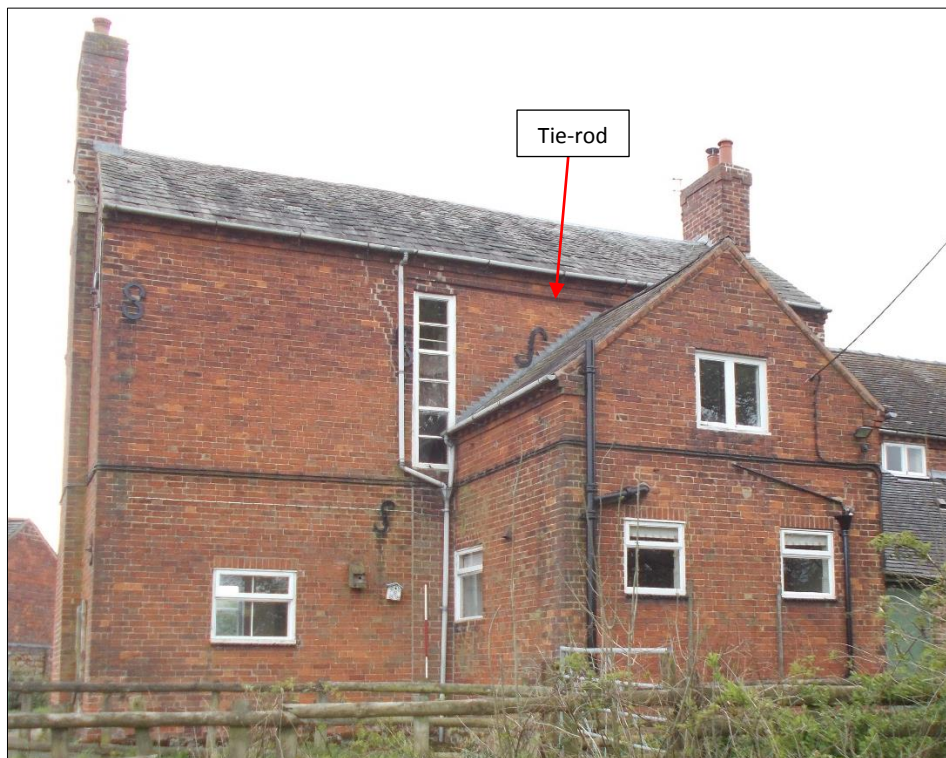
Fig 8: The rear (north-west) elevation of the 2 ½ and 2 storey sections of the farmhouse, looking south. 2m scale rod.

The north-west elevation is composed of the rear of the 2½-storey section of the house as well as the contemporary rear two-storey section (Fig 8).

To the south-west the original ground-to-eaves level stair-light has been partially infilled, perhaps due to fears that it may have compromised the structural integrity of the building since such a tall, narrow slit means that effectively the rear wall was built in two, barely-connected portions (see Figs 8 and 9).

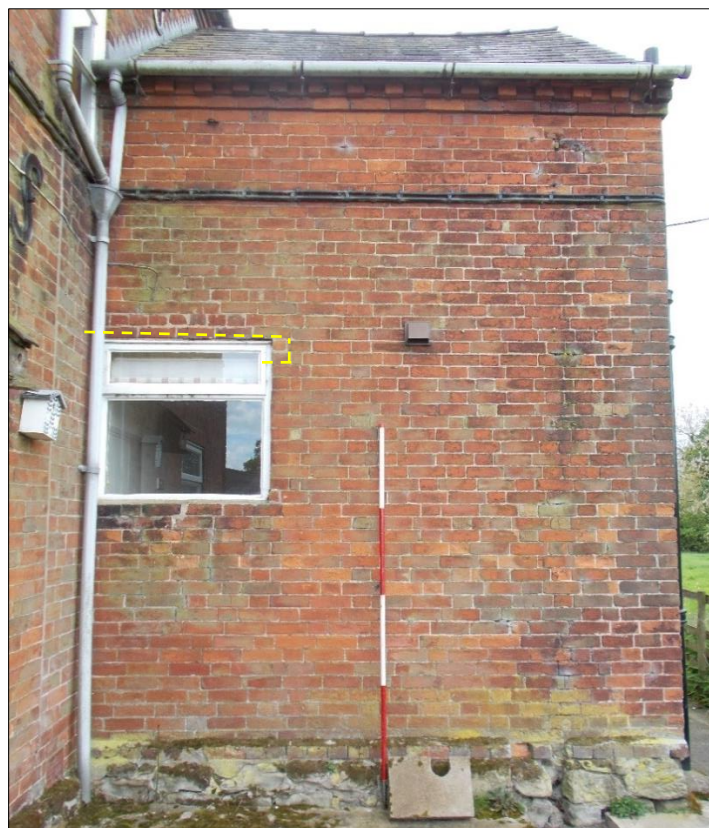
Fig 10: The north-east facing elevation of the rear wing, looking south-west. Probable outline of former timber lintel shown with yellow dashed lines. 2m scale rod

The single window appears to be set within an original opening but has lost the original timber lintel. A row of stretchers topped by a row of headers, set within a cementitious mortar appears to indicate the line of the former lintel (see Fig 10). A row of closers down the north jamb indicates that there was originally an opening in this position. The current frame and glazing are modern and comprise a two-light window with a fixed lower pane and a top-hinged upper light.

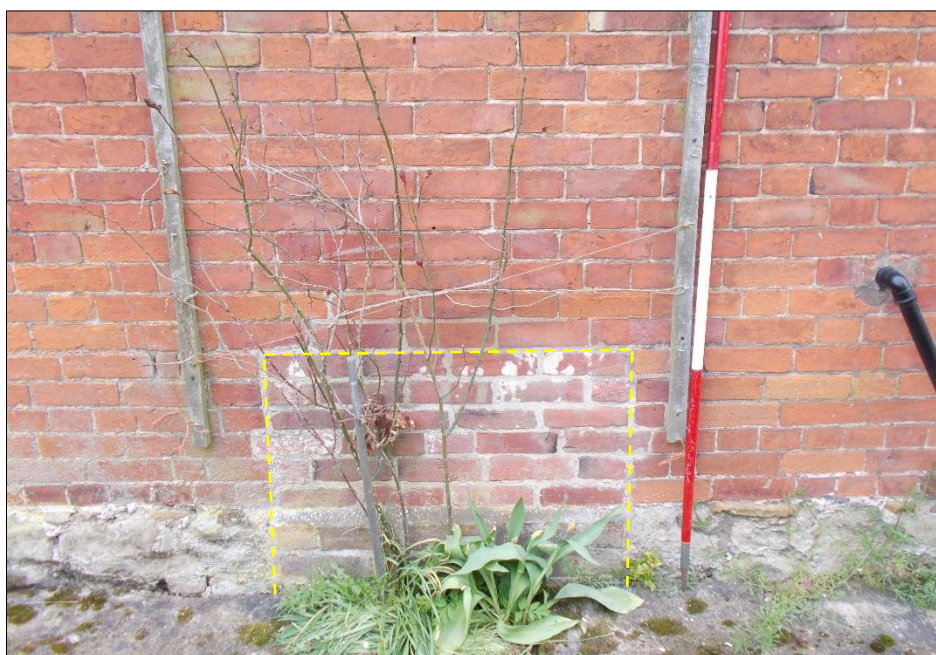
Most farmhouses and especially those in rural locations, had cellars since such a below-ground room offered the only consistently cool storage for perishable foodstuffs. The current cellar is inaccessible but the former window opening can be seen, now infilled, close to the present ground level (see Figs 4 and 12).

Fig 12: Infilled cellar window in north-west gable wall. Outline indicated in yellow dashes. 2m scale rod.

The brick infilling extends to the current concrete path surface and through the sandstone plinth at the base of the brickwork of the main elevation. There is no clear indication of a lintel but the lack of angled scars suggests a timber lintel rather than a segmental arch made from brick. It must also be assumed that there was an external light-well since otherwise little light could be admitted. There is currently no visible indication of any external access unless the infilled opening was a doorway head rather than a window.

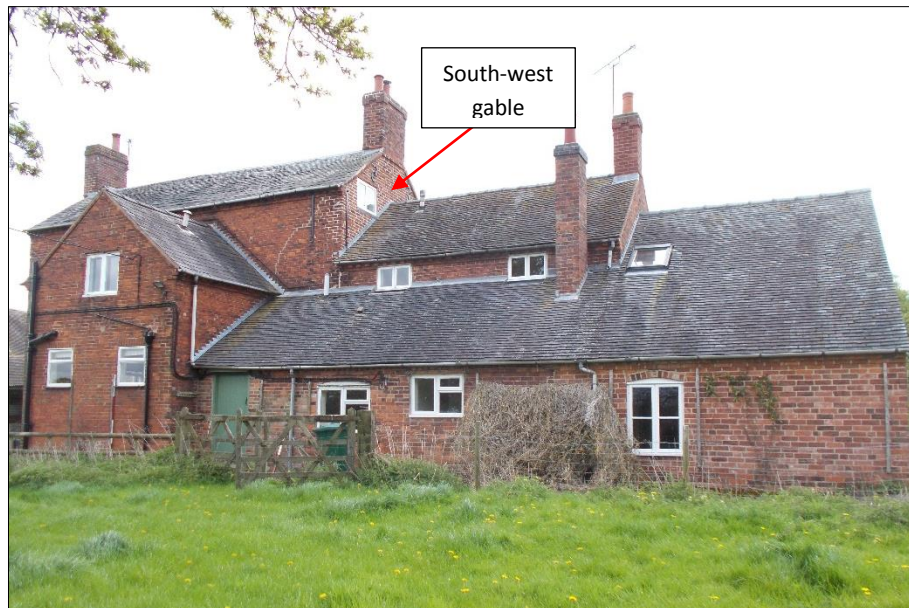
Fig 13: The farmhouse, looking south-east showing early south-west gable above later work. 2m scale rod.

Similarly, only a small part of the south-west gable wall can now be seen since the remainder is obscured by later additions (Fig 13). The section that can be seen reveals the walling to be of the same materials and bonding at the north-east gable, although here the chimney stack is flush and does not project from the wall plane. The stack which projects above the ridge has largely been rebuilt and is topped by two clay pots (Fig 14).

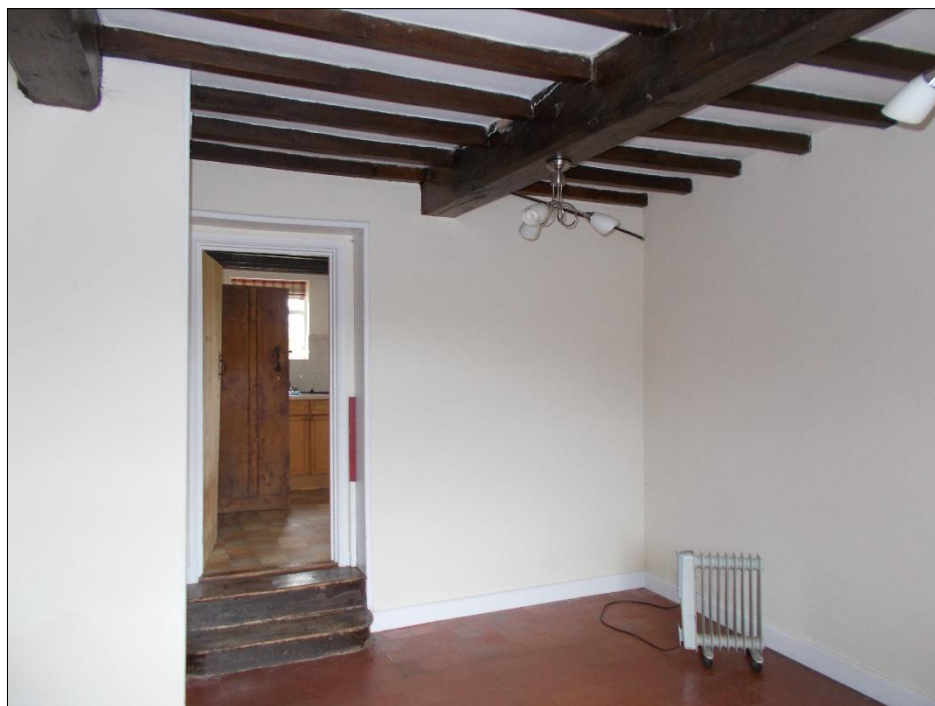
Fig 19: The north-west wall of room G4 showing doorway into G5, looking north. 1m scale rod.

The north-west side of the room contains a doorway which affords internal access to the kitchen situated in the rear wing (G5). Due to the presence of the now inaccessible cellar beneath that room, there are steps leading up into the latter (Fig 19). The risers and treads of the steps are of timber, dark-stained and possibly of elm. The door is vertically planked, ledged, but not braced. It is hung on what appear to be modern strap hinges and is closed with a simple drop latch.

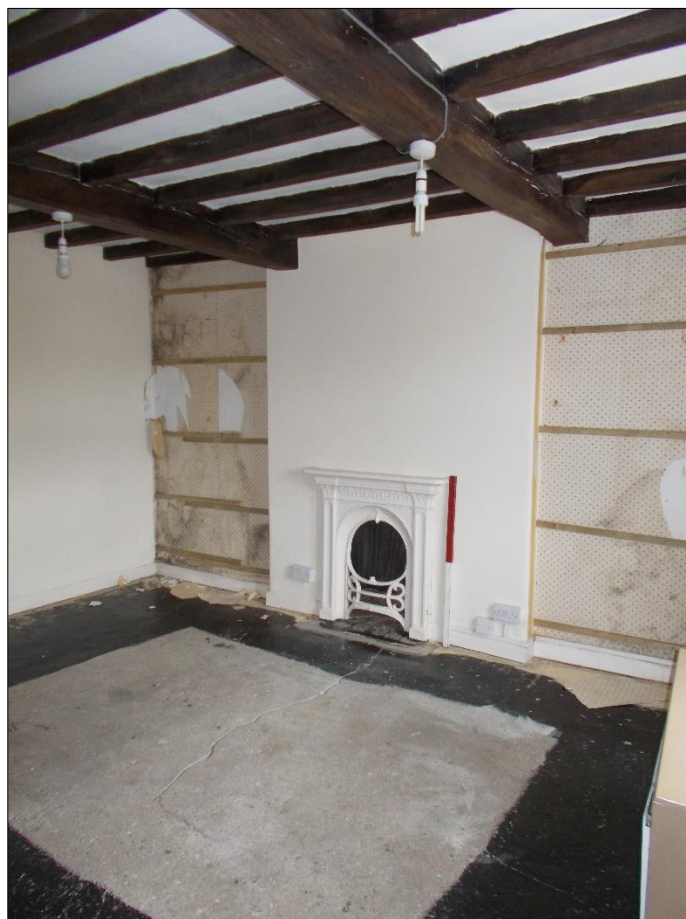
Fig 25: Room F4 looking north showing fireplace, ceiling construction and lime-ash floor. 1m scale rod.

Isaac Ware in his *A Complete Body of Architecture* (1756) remarks on "the beauty of floors of plaster mixed with other ingredients", comparing them with those of granite. The floor surface visible in room F4 is of a grey colour, resembling that of a modern concrete or cement, presumably a result of coal (fuel) ash present within the mix. Apart from some slight cracking, the floor appears to be in

remarkably good condition. The outer border of the floor is painted with black gloss paint indicating that at some stage the centre of the room was probably covered with a rug or small carpet.

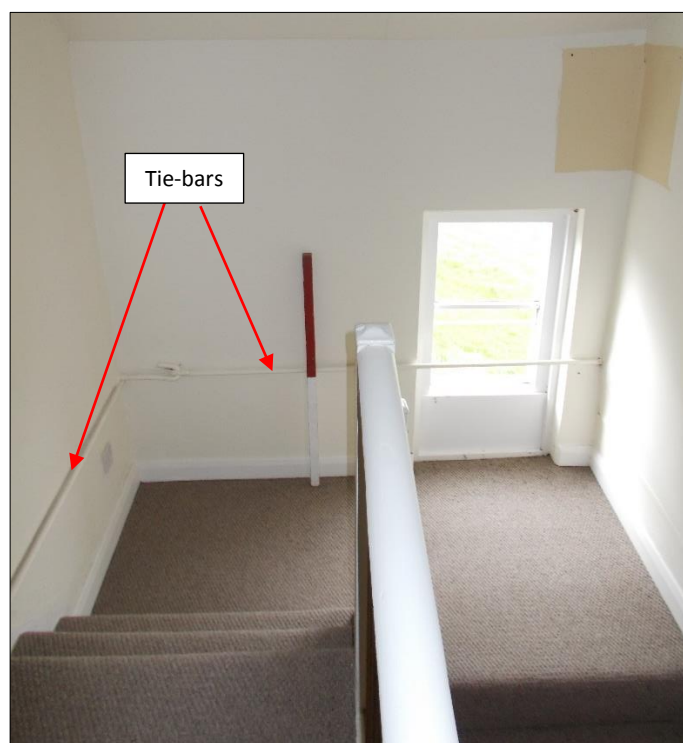
Fig 27: The upper section of the staircase, looking north-west. 1m scale rod.

There is a small half-landing lit by the upper lights of the tall, narrow staircase window (Fig 27). Iron tie bars extend cross the rear wall and window along the rear wall of the house and also through the house from the front to rear walls (Fig 27) indicating extensive concerns about structural weaknesses in both directions.

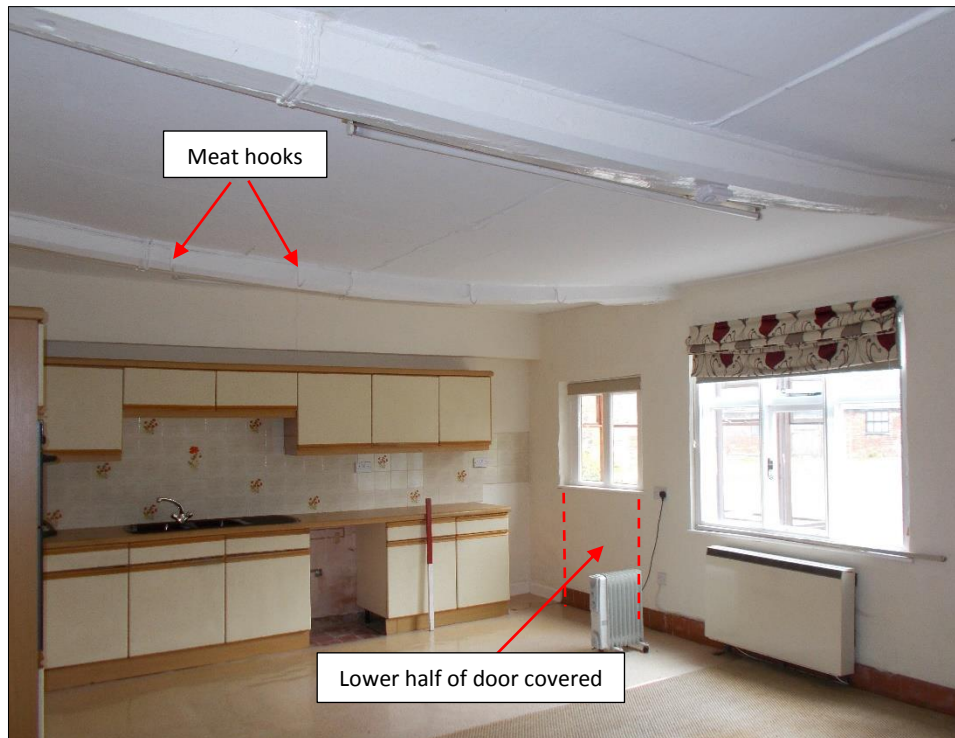
Fig 31: Room G6, the secondary kitchen, looking east. 1m scale rod.

Two lateral beams span the ceiling, both showing significant signs of sagging; the reason for that is unclear. Both have chamfered lower edges but have no stops. There are no visible joists. That to the north side of the room has a number of meat hooks fixed to both sides of the beam as befits a former kitchen.

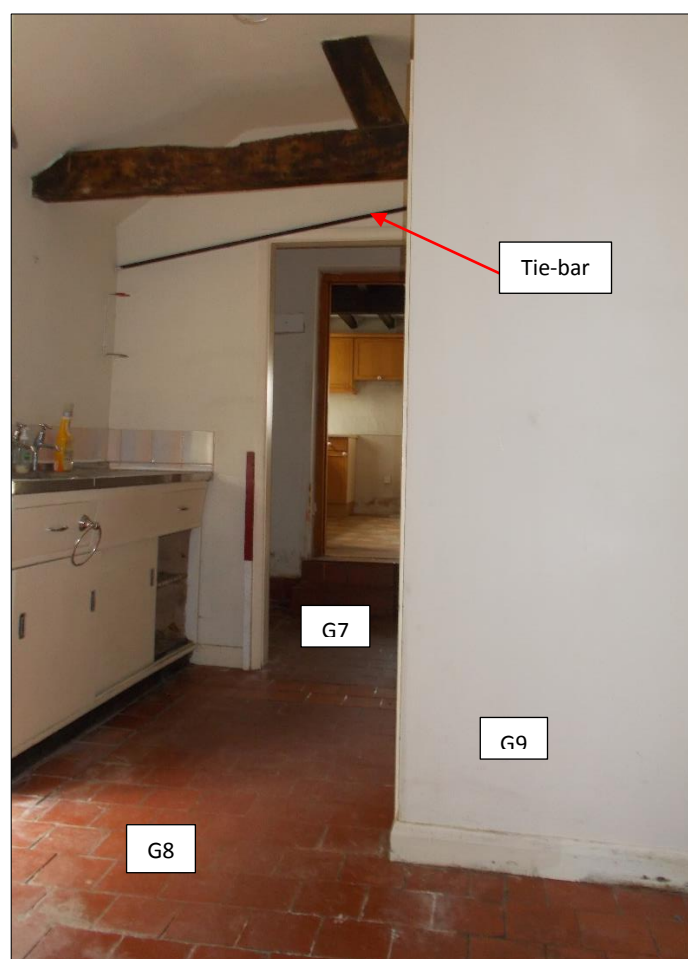
Fig 36: Rooms G7, G8 and G9 (behind wall) looking north-east. 1m scale rod.

There are no fixtures or fittings of historic value within G7 apart from the red clay quarry-tile flooring and two steps leading up into G5; the door to/from the latter has been described above (see room G5). Differential colouring of the floor tiles suggests relaying, perhaps due to excessive wear though possibly for other reasons. The two steps are clad both on the treads and risers with the same clay tile.

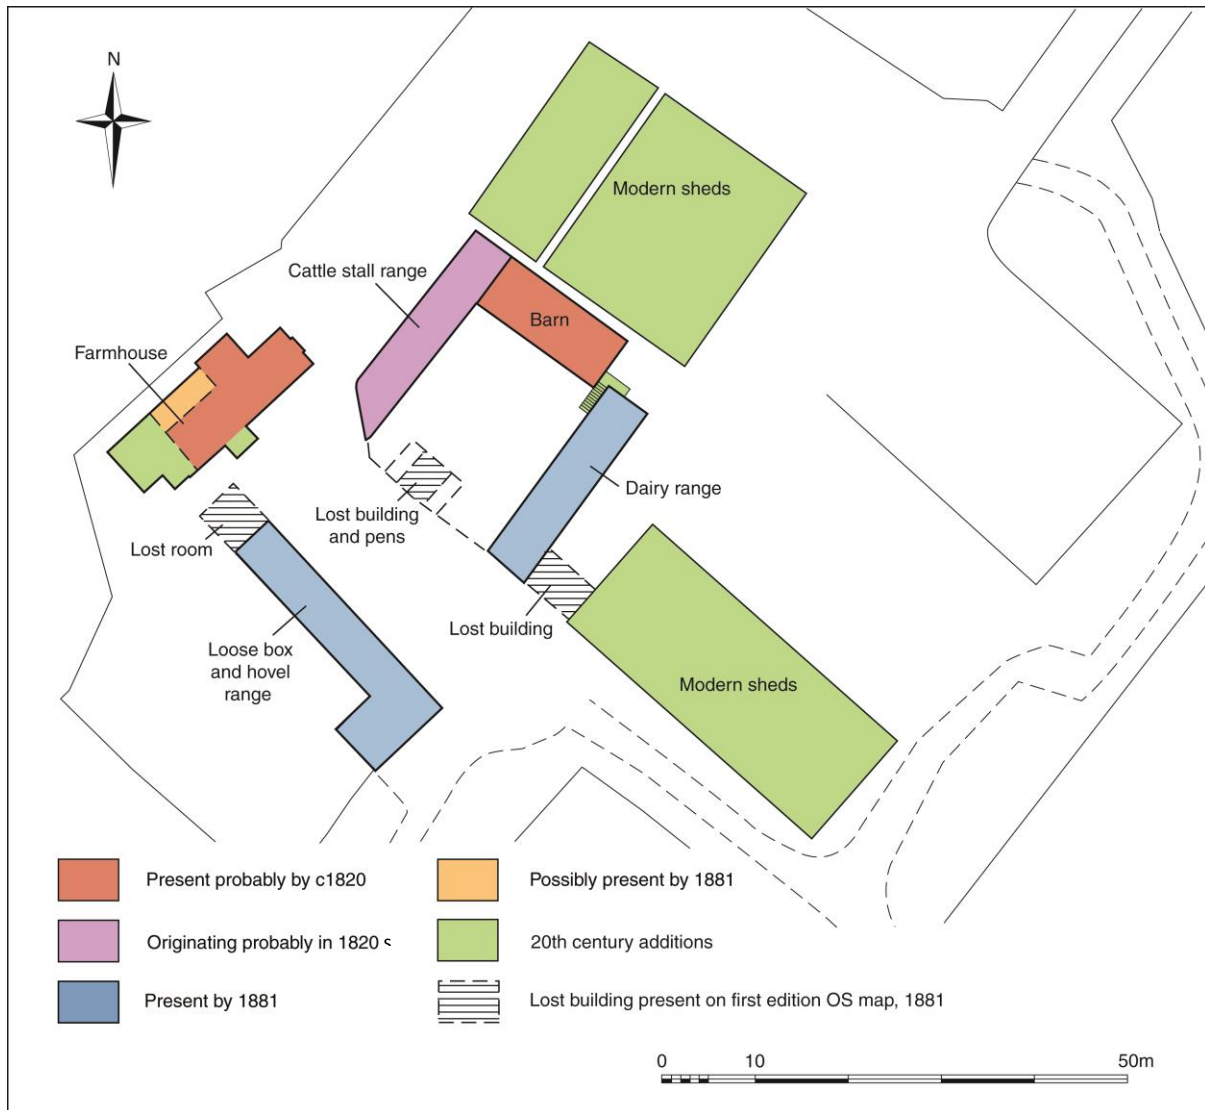
Fig 104: The buildings ensemble of the farm, phased from all evidence

The farm building group can similarly be described as heavily impacted by the equally intrusive changing needs which their use required. The large store or threshing barn is the earliest of the group, present on all maps from 1824, and it is certain that the cattle stall range has been added against it as evidenced by the butt-joints within the brickwork. It is of two sub-phases, but since the second was an increase in height, it does not show on maps. The dairy range similarly, and by the same form of evidence, shows that it began with the two-storey section and the single-storey part was added, but both before 1881. Many former openings within this latter portion show that it has undergone much change to make it function as a milking parlour which seems to have been its last incarnation.
