**An archaeological building record of former barns at
Marstan House Farm, Hannington, Northamptonshire.**

Marstan House Farm barns, Hannington

A group of farm barns located just off the A43 Kettering Road in the eastern part of the parish of Hannington, Northamptonshire has been recorded to Historic England Level 2 by Iain Soden Heritage Services for new owners prior to their proposed conversion for residential use, the work taking place in response to condition 8 of planning consent DA/2018/0967 (NGR: SP 82477 70841; Fig 1).

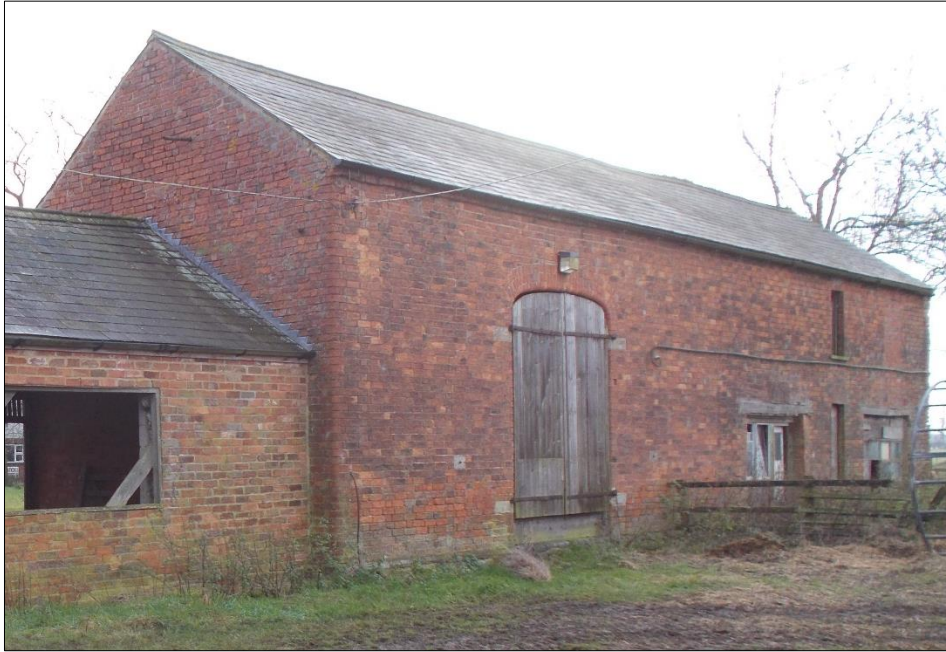
This comprises an entirely plain brick gable with bullnosed bricks at each of the external corners (Fig 5). There are currently no openings nor are there any indications that historically any were present, perhaps unsurprisingly since this gable faces north-east, a particularly cold direction and would not have benefitted from sunlight. The bricks are laid somewhat erratically in an approximation of Monk bond, but much less regular with sometimes three, but up to six, stretchers between each header.

Fig 5: The north gable (left) and west elevation of the western range, looking south-east.

The verges are plain and there are no gable springers, the whole roof line being simply finished with modern Portland cement, apparently added when the range was re-roofed.

A modern (unfinished) single-storey replacement of the corner building is constructed against this gable (Fig 5). It appears to occupy the same footprint as its predecessor (see below).

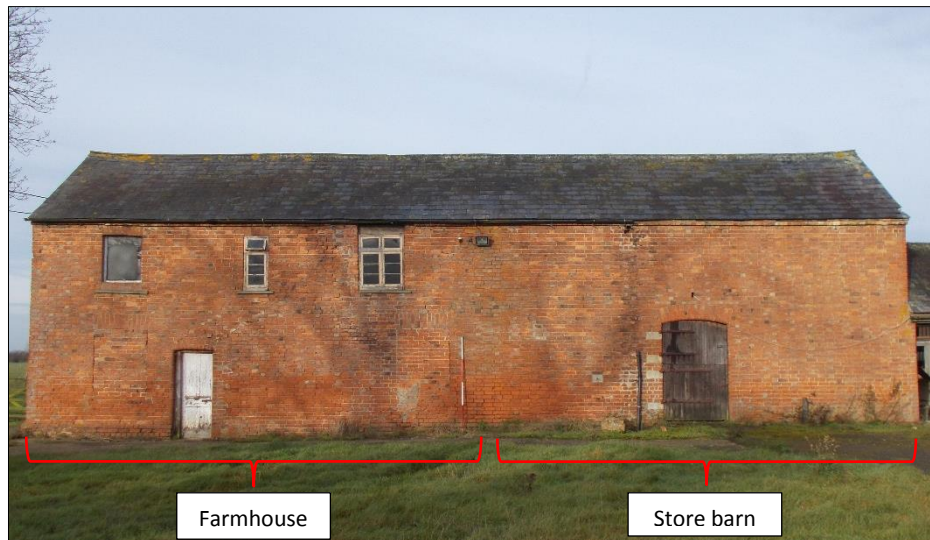
This is the principal frontage facing onto the former stockyards (Figs 3, 4 and 6). It comprises a two-storey elevation with the farmhouse occupying the southern half and the full-height store barn the northern (Fig 6).

Fig 6: The east elevation of the western range, looking west. 2m scale rod.

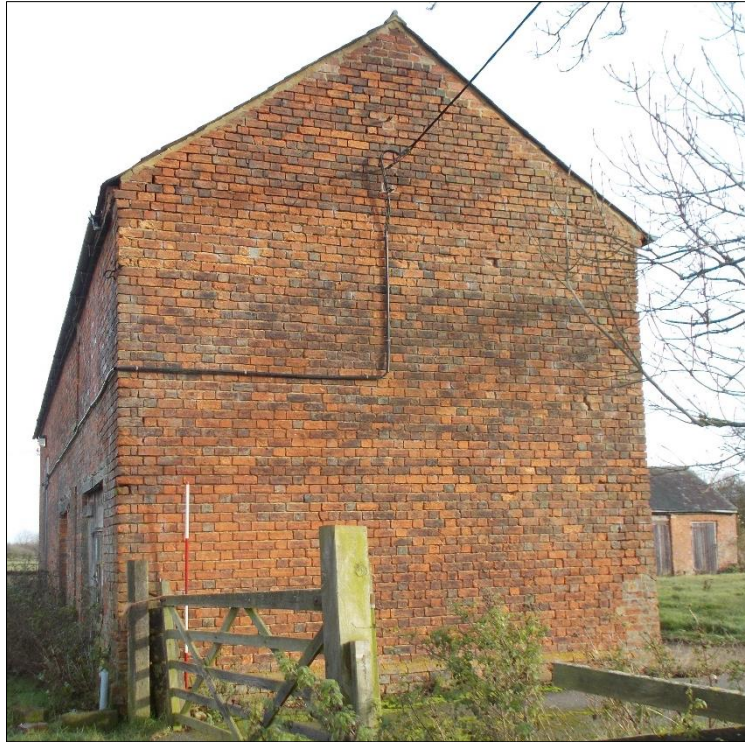
An entirely plain wall laid in a correct Flemish bond throughout, perhaps a result of the additional strength which this would have incorporated (Fig 8).

Fig 8: The south gable wall, looking north. 2m scale rod.

Apart from the simple chamfered plinth close to the ground, there is no additional detail and the verge appears to have been re-pointed in much the same way as the north gable when the roof was re-laid. There must have been a chimney stack at the apex of the gable originally though nothing now remains externally (see interior). This was presumably removed at the same date as the re-roofing, the apex of the gable shows indications of similar re-pointing. The external corners are finished with plain, not bull-nosed, bricks.

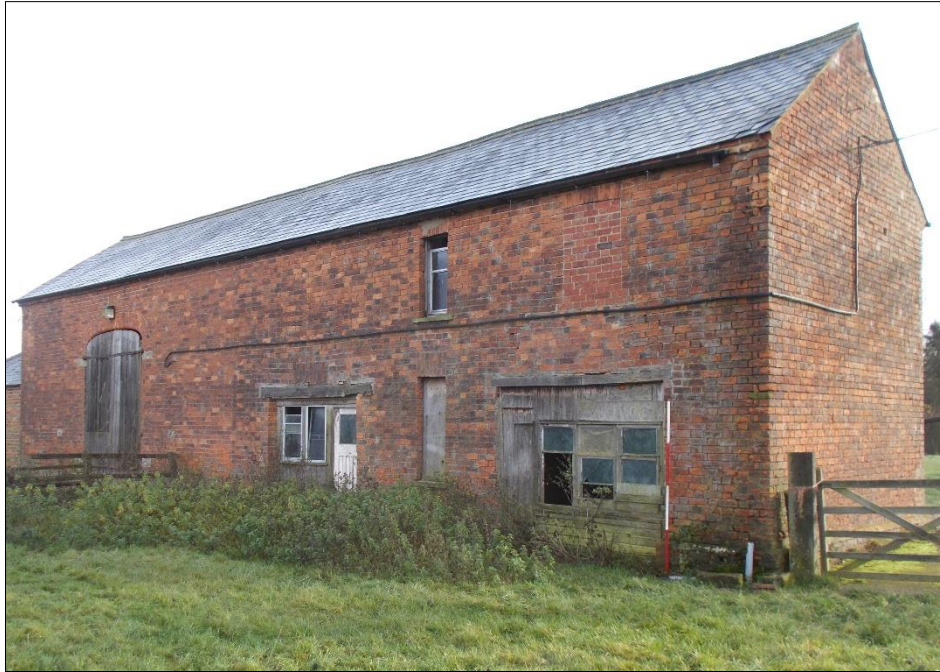
The southern end which contained the former farmhouse has been significantly altered by removal of sections of walling and infilling of former openings (Fig 9).

Fig 9: The west elevation, looking north-east. 2m scale rod.

The southern half retains only one original opening, a tall, narrow window which formerly lit an under-stairs cupboard; it is situated directly beneath a similar window at first-floor level and currently blocked with a sheet of modern plywood (see Figs 4, 9 and 10). The window retains its stone sill.

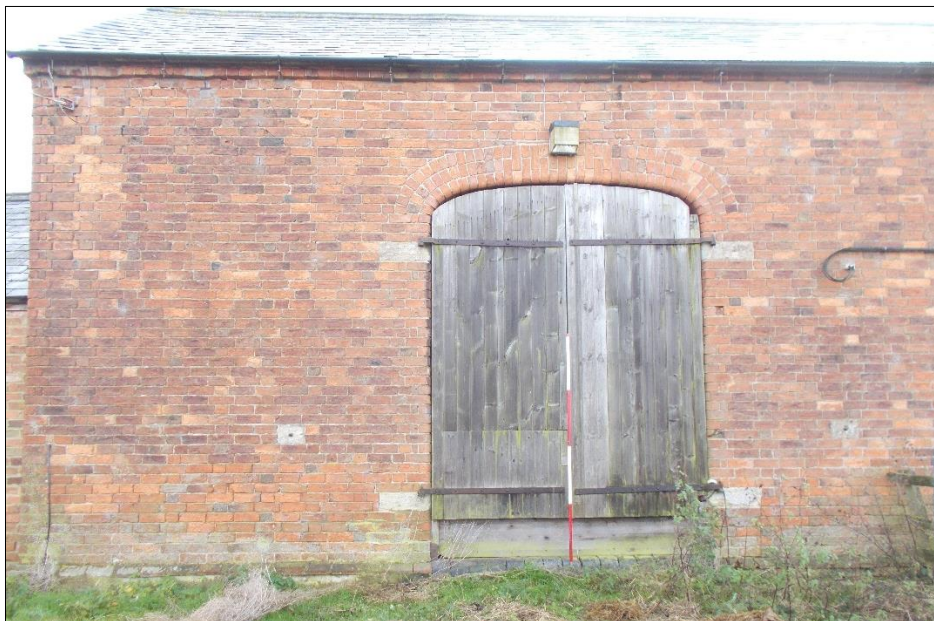
The northern part of the range - containing the store barn - retains the central full-height cart door in un-altered form (Figs 4 and 11).

Fig 11: The northern part of the western range, the store barn, looking east. 2m scale rod.

Otherwise plain, the walling is constructed in a mixture of Flemish and Monk bond as on the eastern elevation. The jambs of the cart door are formed with bull-nosed bricks as is the lower of three courses of the bricks of the compressed segmental arch (Fig 11). On either side two large limestone blocks have been inset to hold the hinge pins of the large vertically planked doors. A detached block retains a small catch to hold back the doors on both sides. The latter are ledged and braced internally (see below, interior). Externally the hinges are simple forged iron strap hinges and there is currently no form of external fixing. The lower ends of either door finish above sill level; this may be part of the original design or a result of rot. If original, the gap would have been infilled, as at

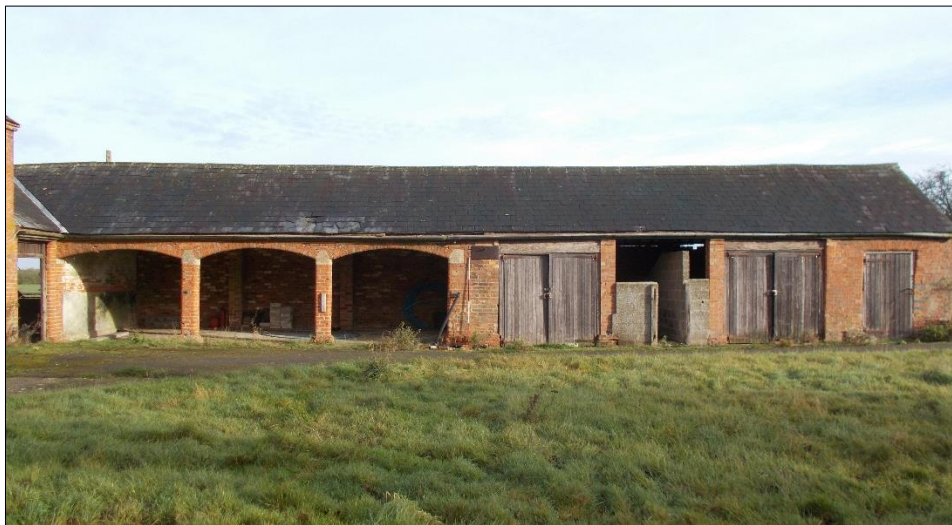
Part of the original farm complex depicted on the first edition OS map, this portion of the surviving farm group has undergone significant alteration both externally and internally (Figs 4 and 12).

Fig 12: The south elevation of the eastern range, looking north. 2m scale rod.

The western part of the range retains three arched stock-hovels whilst the eastern part has been much altered and now contains enclosed sheds. It is likely that originally there were three further arched openings in-filling the eastern portion since the spacing as far as the far-eastern original enclosed shelter is the same as the three remaining arches. If this were the case, each half would be served by a separate stockyard to the south.

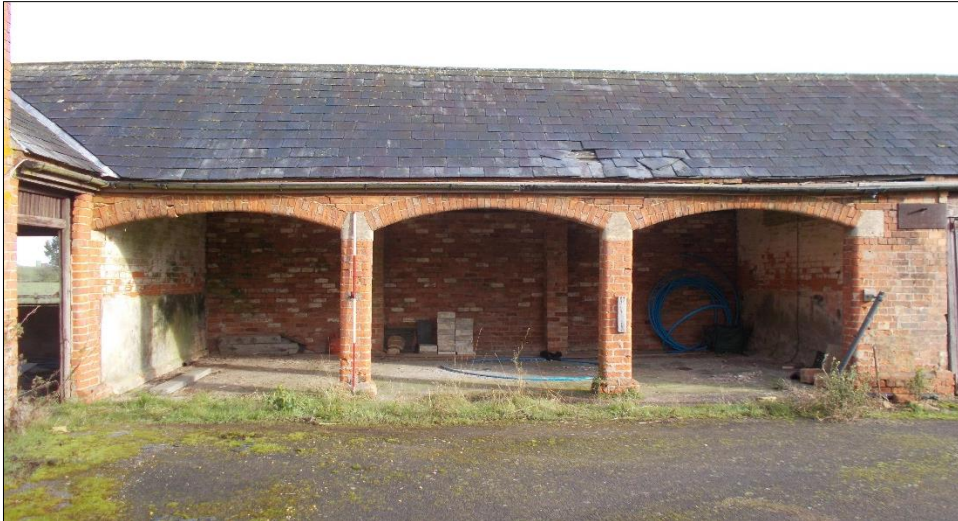
Fig 13: The three-arched western section of the eastern range, looking north. 2m scale rod.

Each bay is divided by a slender brick pier with all corners finished with bull-nosed brick. These bricks were primarily used to help prevent livestock harming itself on the sharp corners of standard bricks. The tops of the arches are sprung from limestone impostes, also with rounded edges to match those of the bull-nosed bricks beneath in the piers and within the arched spans between.

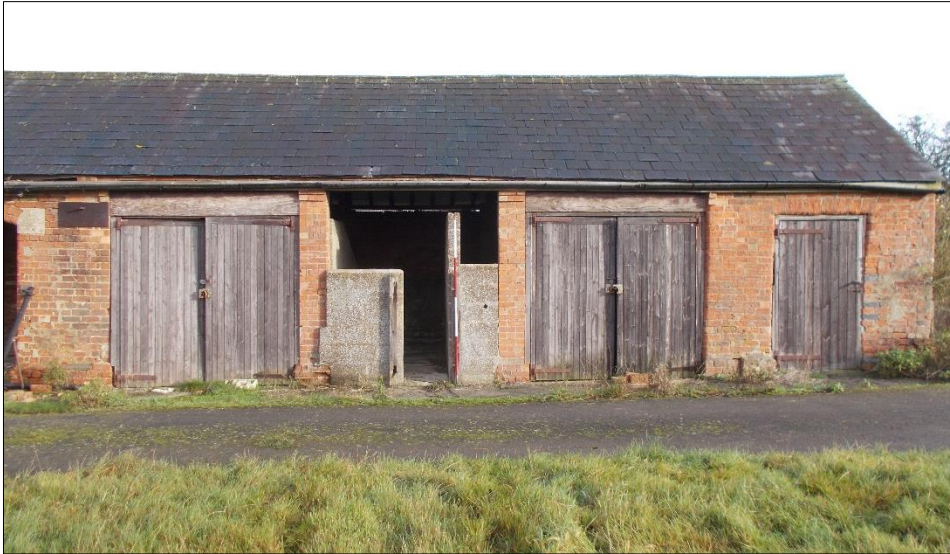
The eastern portion of the eastern range is entirely rebuilt and has a series of Fletton or common brick piers infilled with modern planked doors to form three enclosed shelters (Fig 15).

Fig 15: The south elevation of the eastern end of the eastern range, looking north. 2m scale rod.

As mentioned above, it is possible that this part was also arched though the extent of the rebuilding precludes certainty. From the west the shelters are as follows: a single shelter enclosed by modern timber planked double-doors, a partly open bay with blockwork walling, a further enclosed bay with similar timber double doors and the easternmost bay which appears to be an original fully enclosed room.

These three rooms are re-configured spaces and contain modern block-work dividing walls and modern brick piers along the south side, all fitted with contemporary timber doors or, in the case of G8, a partly open block-work wall (see Fig 15). None contains any historic detail apart from the roof structure which is the same as that visible and previously described above G6. This is partly supported on a breeze-block pier in G9 where the north wall has fallen outwards (see far right in Fig 28).

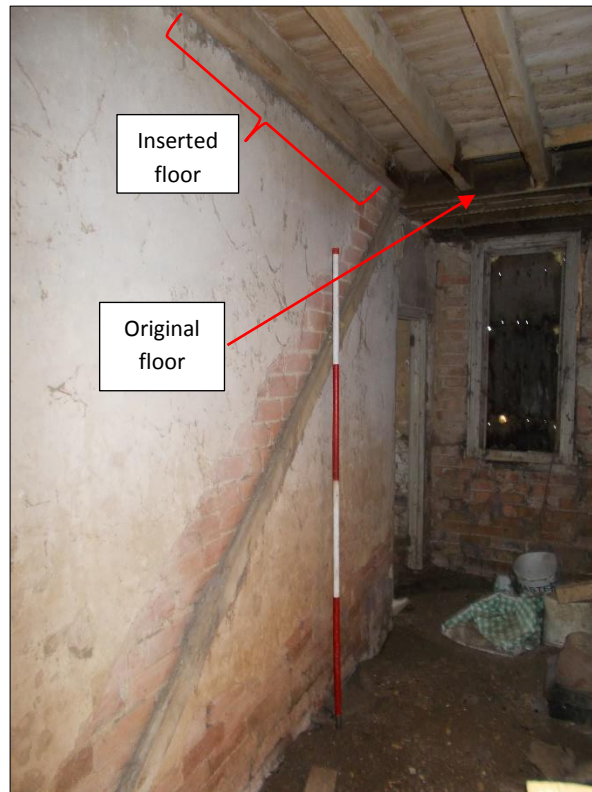
Fig 19: The former stairwell, looking west. Note timber string batten to left. 2m scale rod.

The staircase has been entirely removed although the scars of the strings can be seen in the north and south walls and on both sides a timber batten remains too (Fig 19).

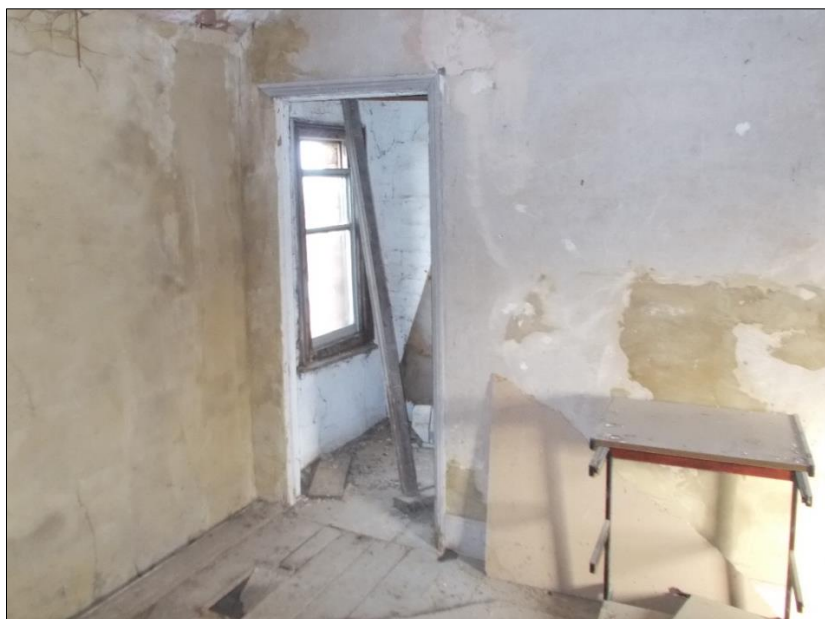
Fig 21: Room F2 looking north-west into the former top stairs landing.

There is no door surviving within the doorway between F1 and F2 although part of the architrave survives (Fig 21).

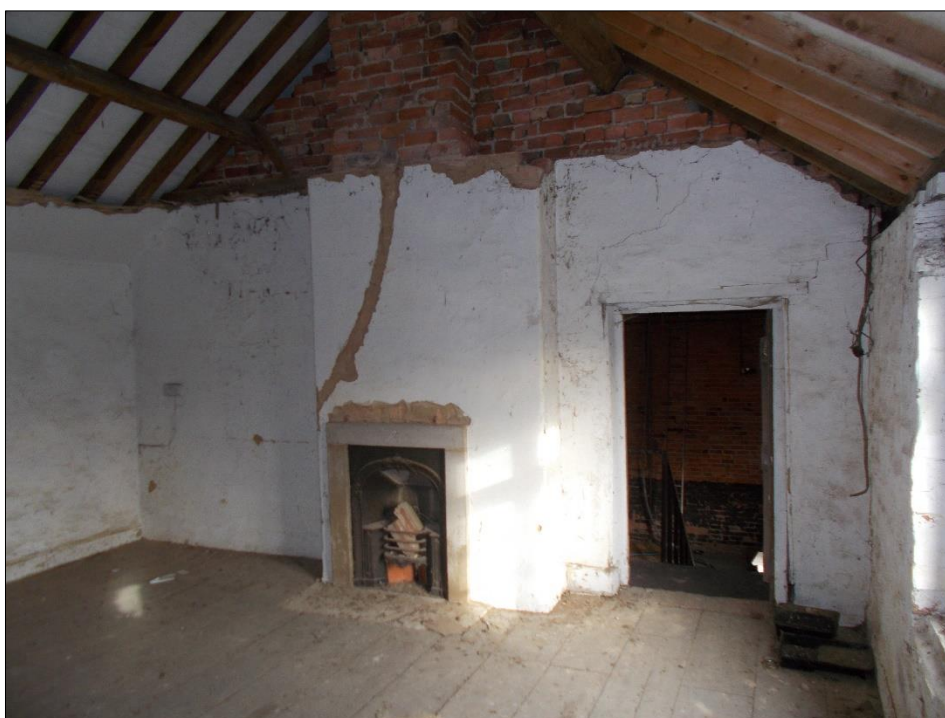
On the north side of the room a fireplace survives with the stone jambs, lintel and cast-iron grate, though any mantelpiece has gone (Fig 23). The hearth slab also survives and the brick stack continues up to the ridge of the roof where it has been truncated when the building was re-roofed. Many of the roof timbers (the common rafters) are clearly also new, though the purlins appear to be original. The slates laid are laid over a modern membrane.

Fig 23: Room F3, showing original fireplace and grate and secondary doorway in the north wall.

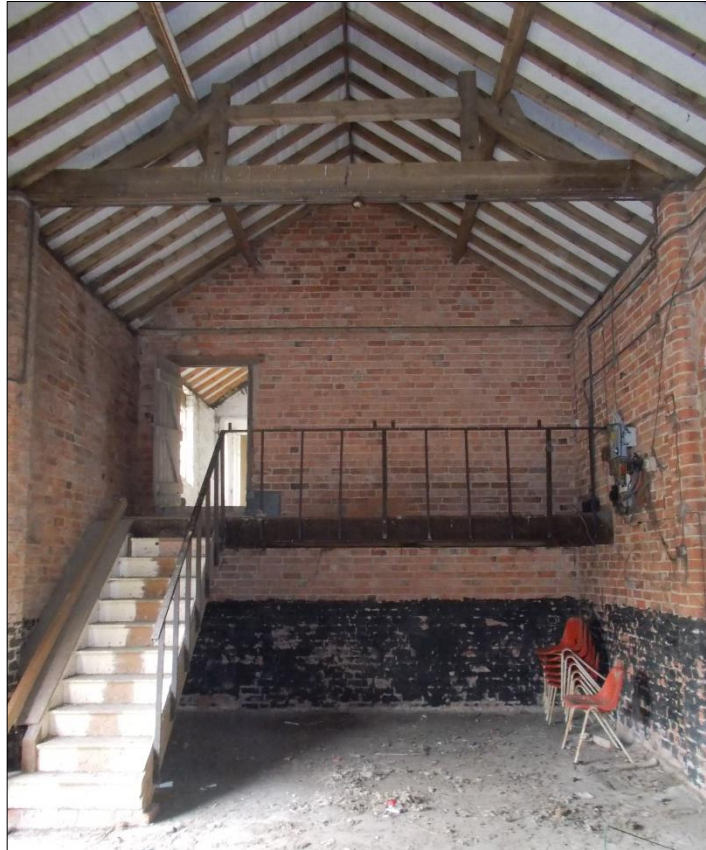
Fig 24: Room G4, looking south showing south wall with secondary stairs, balcony and doorway. Note also roof truss configuration and buttressing.

The buttresses support a pair of identical roof trusses of broadly Queen-post form, though the principal rafters only rise to the level of the collar (Fig 24). Iron bolts are fixed through the tie beam into the base of each post and the half-rafters support a single purlin on each side with substantial cleats. The common rafters appear to be original and this roof, like all the others, is laid over a modern membrane. There is a thin ridge plank at the apex of the roof.

A secondary timber staircase has been inserted against the east wall to the south of the pedestrian doorway, after the farmhouse portion became redundant (presumably, therefore, circa 1930's), rising to a balcony the full width of the south wall (Fig 24). The reason for this arrangement is unclear but must have served some purpose. It has been suggested that the timber staircase is that removed from the farmhouse portion of this range. However the lower tread is wider than the upper treads and must have therefore projected into open space (Fig 26). The narrow space present between the ground-floor rooms of the farmhouse portion of this range does not allow for such a projecting lower tread since there is neither the width nor need for such a feature.

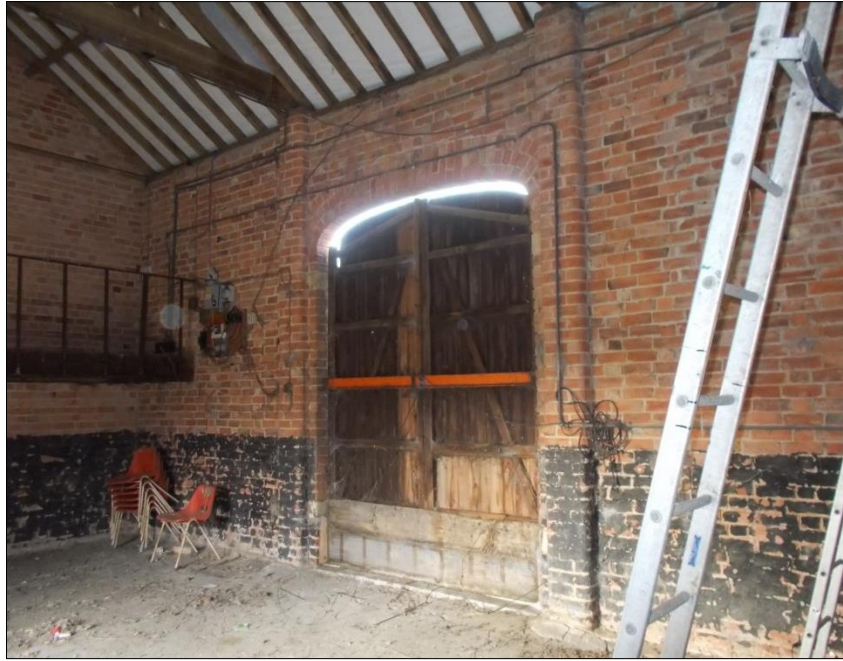
The large cart door in the west wall appears to be original and shows internally the ledges and long, diagonal bracing (Fig 25). As noted above, the lower portion is either missing or was never present.

The floor of the barn is concrete and the walls have been painted with a bituminous material, presumably for waterproofing (Figs 24 and 25).

Fig 25: Room G4, the store barn showing the inner surface of the cart door, looking south-west.

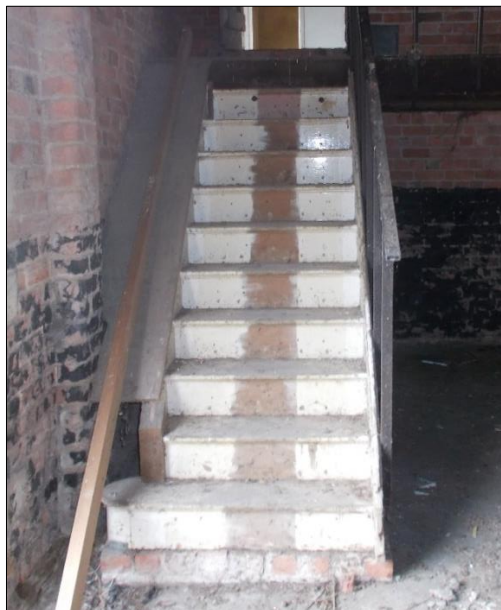
Fig 26: The inserted staircase in G4, looking south. Note rounded and projecting lower tread (left) and the paint scheme for a stair runner.

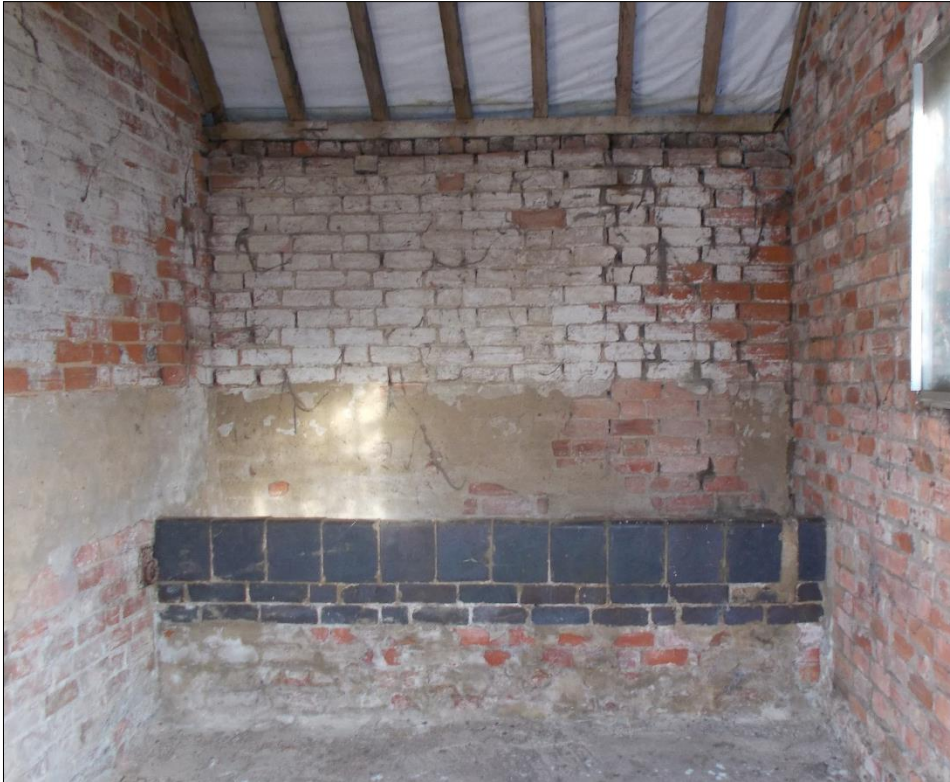
The room is a simple fitted stall but does retain a manger along the north side constructed from red- and blue-brick with blue engineering brick moulded rim pieces forming the front edge of the manger (Fig 29).

Fig 29: Room G10 showing the brick-built manger, looking north.

It is possible that there was a hay rack above, though no clear indications survive; the east wall (right in Fig 29) has been largely re-built. As described above (exterior, Fig 16), the window in the east gable wall is a modern replacement. The floor is of concrete and the roof timbers are original with a modern roof covering.
