Thorne Roughets, Anchor Lane, Dedham, Colchester, CO7 6BX

A Level II Historic Building Record

prepared for
Aden Lines and Suzanna Hooper

Colchester HER: ECC4212

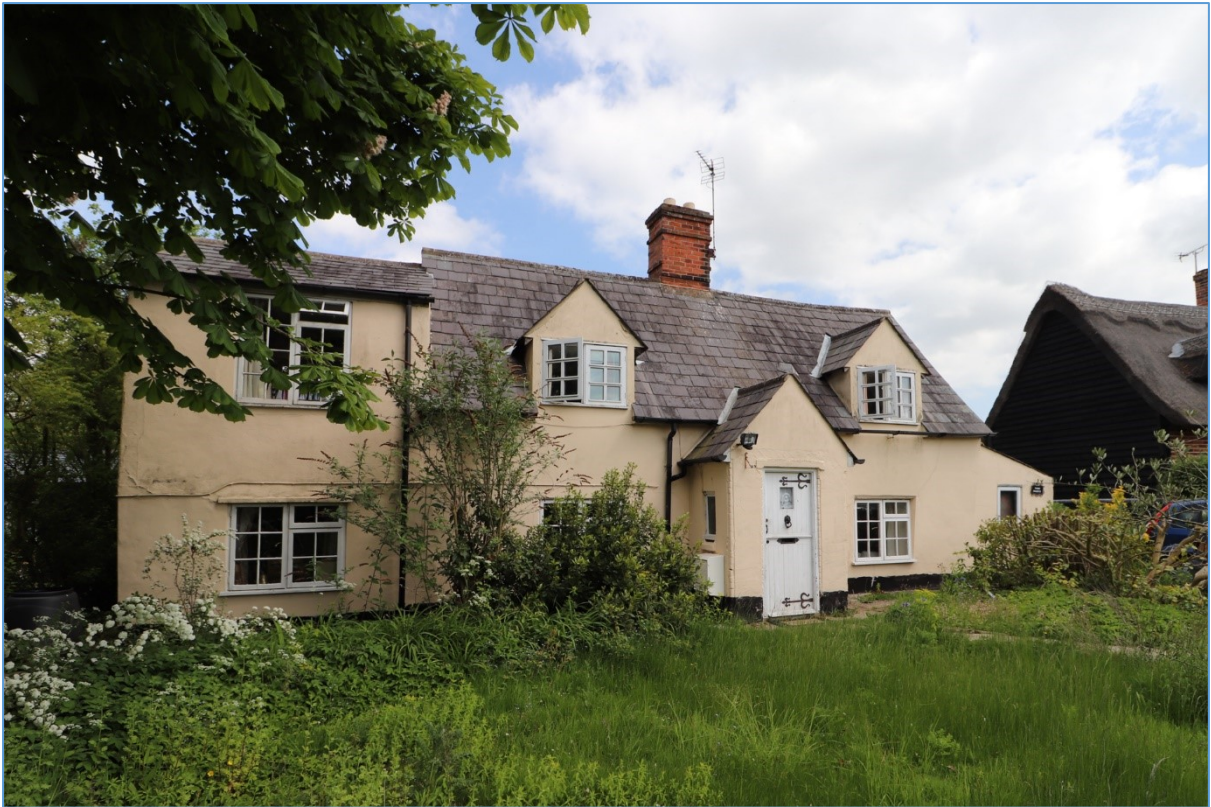
To the north is an full two-storey in-line extension, which map evidence indicates dates from the mid-19th century. The exterior face of this extension is rendered in the same fashion as the rest of the house, and the ground-floor casement window copies those of the other ground-floor openings (Plate 2). The first-floor casement window is taller than its dormer and ground-floor counterparts. The ridgeline of this extension is lower than that of the main house and the roof-pitch is very shallow, indicating the intention that this part of the building should be slate-roofed from the outset, in keeping with its later, 19th-century construction date.

Plate 2. A general view of the front of Thorne Roughets, looking south-east.

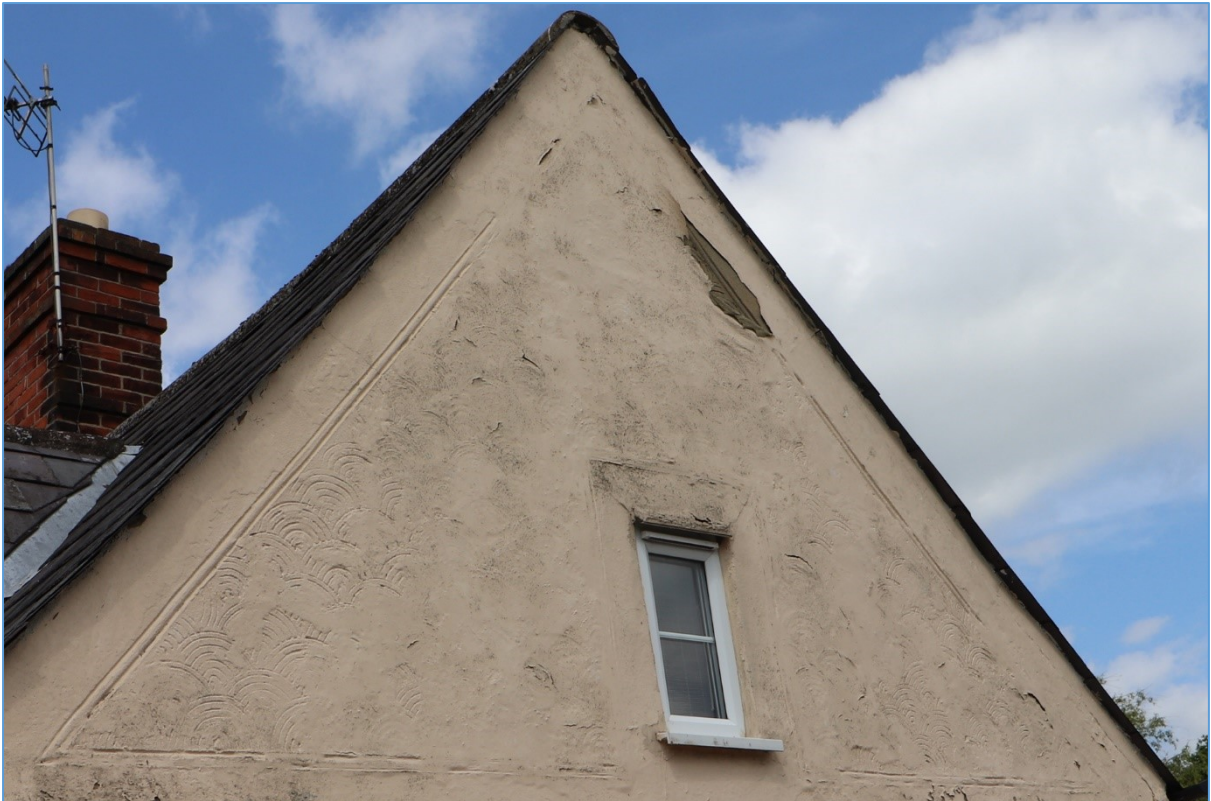
Plate 5. Detail of the southern gable, showing the decorative plasterwork beneath the paint, looking north-east.

Above the lean-to, the southern gable of the original house is visible, into which has been set a small two-light rectangular window. This lights the southern attic bedroom and must therefore be a later feature. Although the gable has been painted with a thick, impervious paint, it is still possible to discern a triangular border incised into the render of the gable, within which a pattern of overlapping swirls has been incised. Where the paint has peeled away towards the apex of the gable this decoration is still crisply preserved beneath the paint. It is not possible to suggest a date for this decorative scheme, but it must pre-date the erection of the 19th-century extension at the northern end of the property, as similar decoration can be seen on the corresponding gable, which is now inside the roof space of the extension (see below; Plate 38).

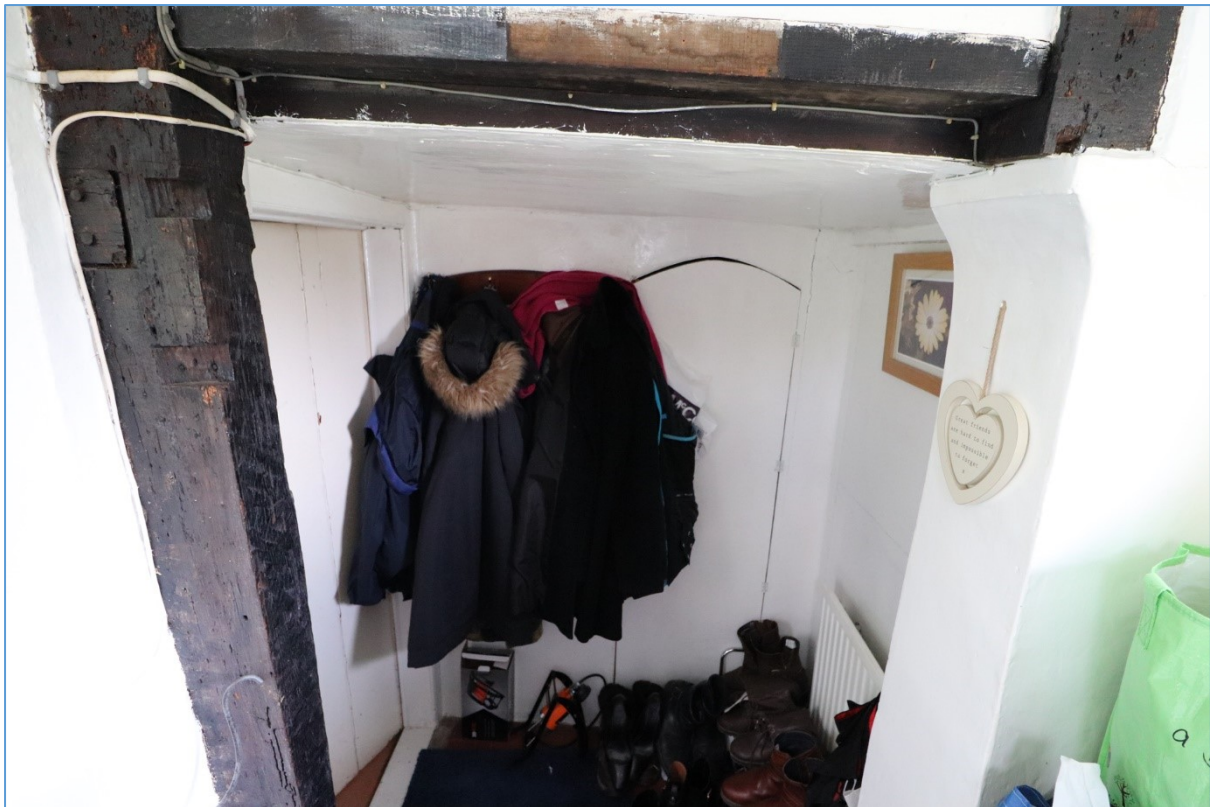
Porch/Lobby: The house is entered from the front (west) via the post-1962 porch already described, which steps down through a timber-framed doorway into the lobby entrance (Plate 8). The northern doorpost shows signs of having previously held hinges, while the doorpost to the south has been cut away and replaced with a masonry support. The two sides of the doorway represent the lines of the two central cross-frames of the building, which create the lobby and flank the chimney. The lobby is small and square, and has doors to the north and south, which lead into the two ground-floor rooms of the house. The door to the north is still functional, while the door to the south has been blocked, although it is still visible in the neighbouring room. A small, arched wooden door has been cut into the timber wall to the east in order to create a small cupboard space beneath the stairs which have been inserted to the east.

Plate 8. Interior view of the lobby entrance, showing the doorposts and extant doorway into the northern room.

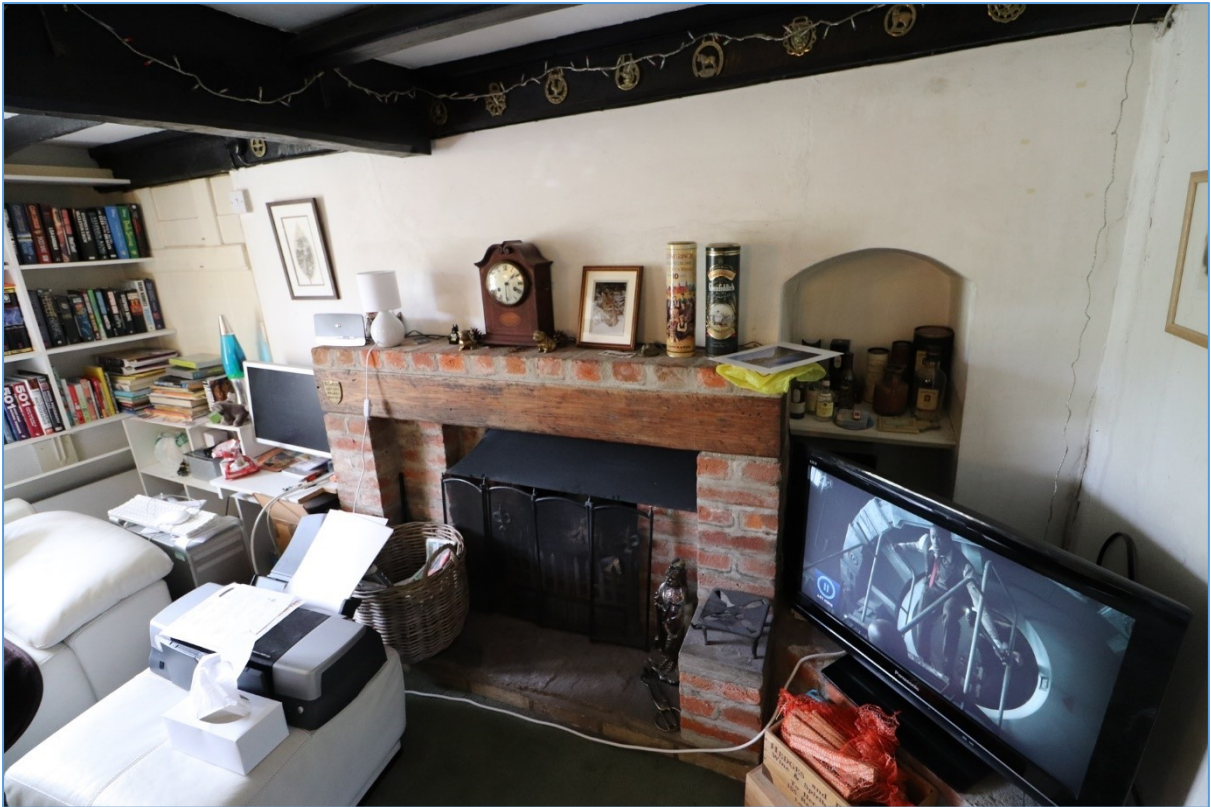
The Lounge: The southern ground-floor room, referred to as the Lounge on the plan of the building, is a small, low-ceiling space with rendered walls, many of them fitted out with bookcases. This space has been much altered, but it is possible to see traces of the original timber-framing of the building. In the north-western corner of the room is the former door leading to the lobby (Plate 9), adjacent to which on the north wall is a large brick fireplace of relatively modern construction, which protrudes into the room. In the wall plaster above the mantelpiece it is possible to discern the line of an earlier timber mantelpiece, set flush with the wall, which perhaps indicates that the remains of the earlier fireplace might lie behind the later façade. On inspection, though, it was not possible to identify traces of earlier brickwork in the fireplace itself. To the east of the fireplace is a deep, shelved alcove with an arched top, which is presumably an original feature and may be the remnants of a small cupboard or larder space.

Plate 9. Interior view of the northern wall of the lounge, showing former north-western doorway, later fireplace and alcove.

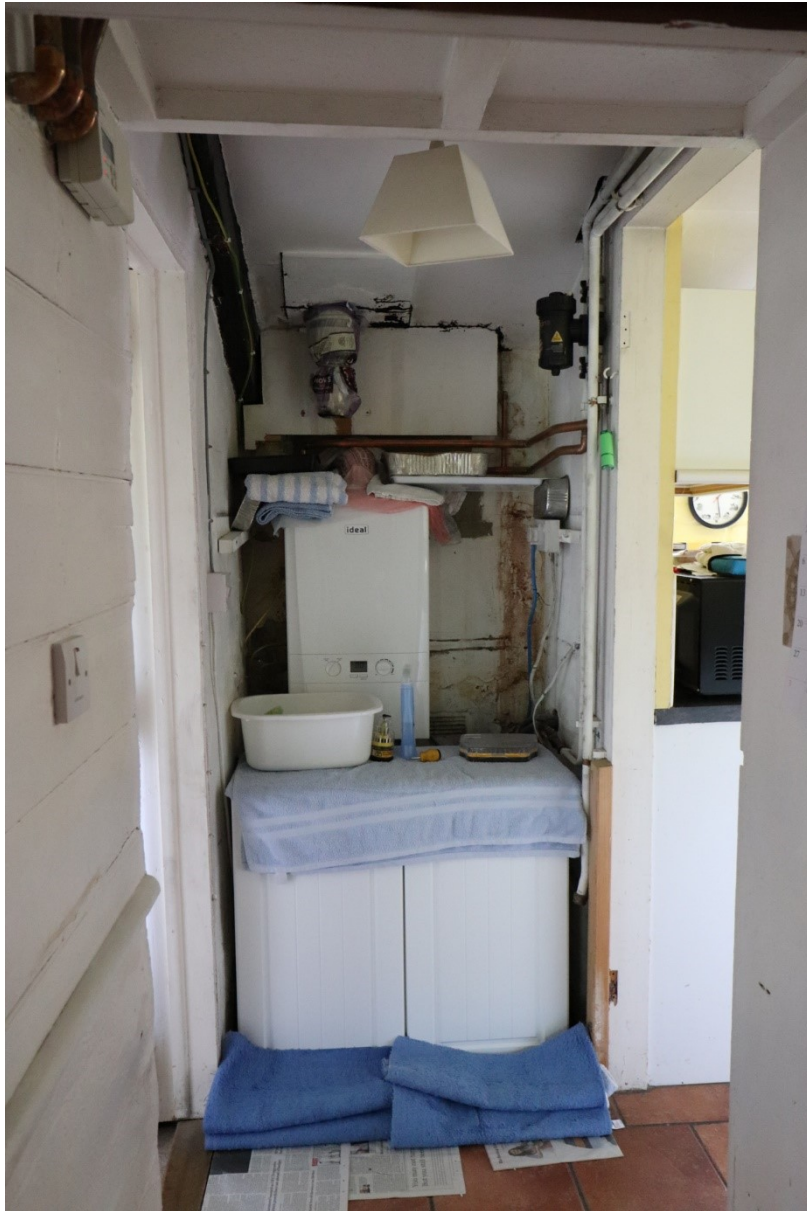
Plate 23. Interior view of the lobby containing the boiler, looking east.

At the northern end of the range is a bathroom, which features much mock-timber-frame detailing, but which is otherwise architecturally unremarkable (Plate 22). To the south of this is a small lobby connecting with the dining room, which contains a boiler and shows extensive signs of damp and water ingress (Plate 23). To the south of the lobby is a kitchen, which links to the lounge and which, with the lobby, is clearly constructed on a concrete plinth (Plate 24). As was indicated by the historic mapping, the kitchen has clearly been extended to the east with the brick-outshut described above, which contains several large windows.

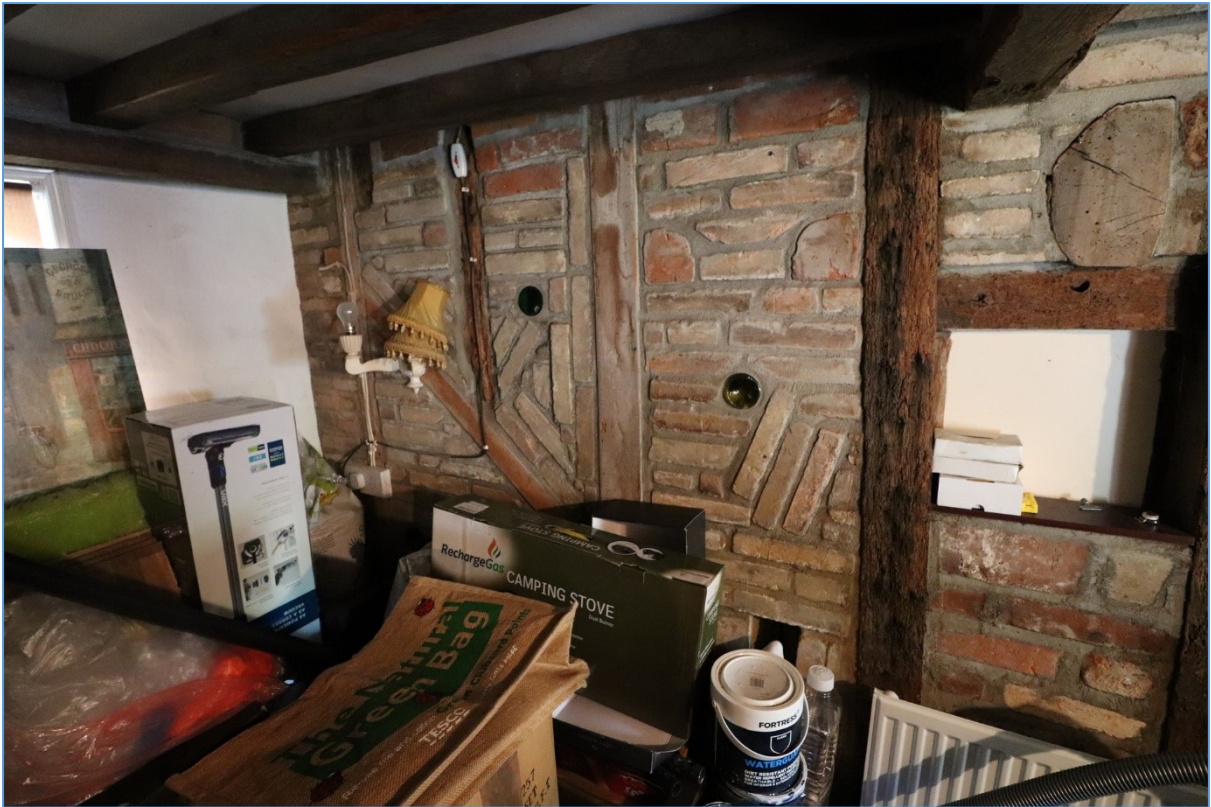
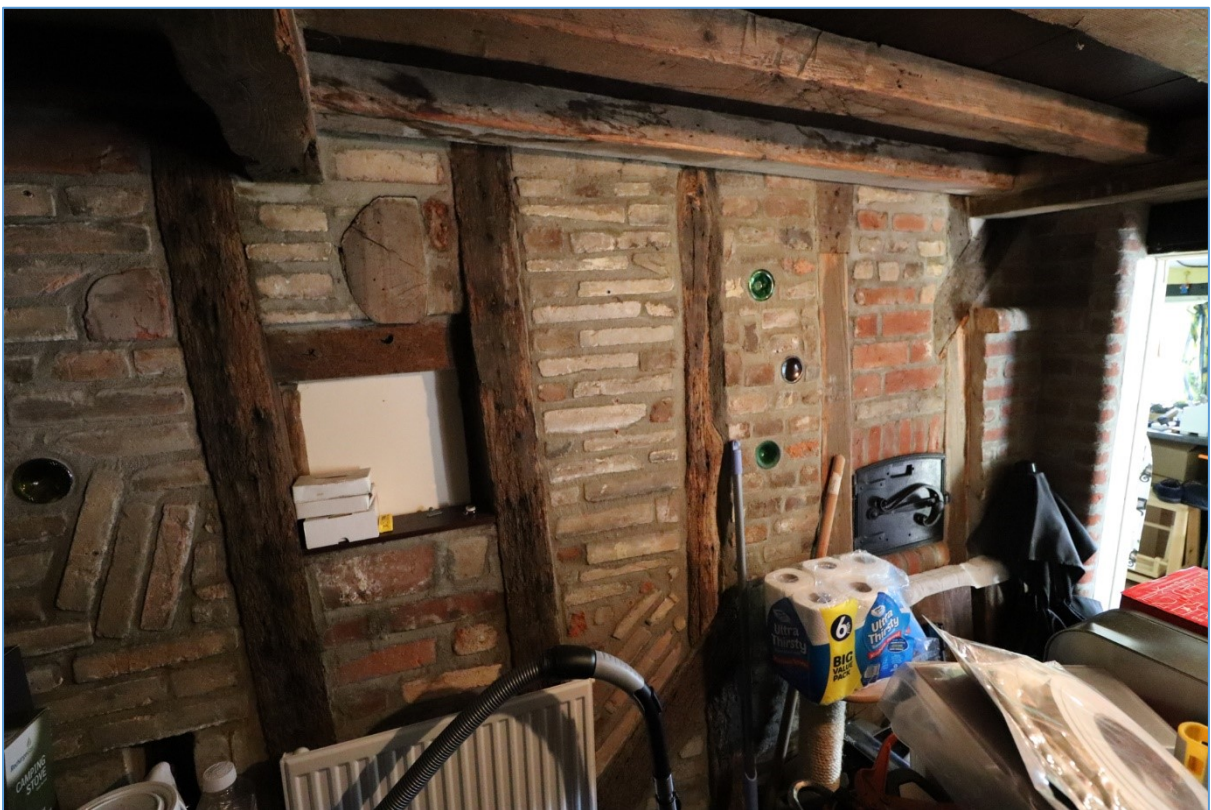
Being constructed against the southern gable end of the original house, it is possible to discern something of the original construction of the house and compare this wall with the remnants of its northern counterpart to be found in the dining room (Plates 26 and 27). Several of the vertical studs still survive, either partially or to full height, including the central pair of studs, between which is a lateral support holding the end of the bracing beam supporting the first floor. Much of the wall is infilled with a mixture of older and newer bricks laid in a variety of random patterns.

Plate 26. Interior view of the western half of the northern wall of the Bar.

Plate 27. Interior view of the eastern half of the northern wall of the Bar.

The majority of this brickwork must be of comparatively recent date, as it incorporates glass bottles and has clearly been undertaken with a view to creating an 'authentic' feel to the space. This includes the creation of an imitation oven at the eastern end of the wall, which utilises a reclaimed iron door (Plate 27). The presence of the brickwork at this end of the house raises questions about the authenticity of the brickwork visible in the dining room, and it is possible that too belongs to the same period of expansion in an 'authentic' style (Plate 18).

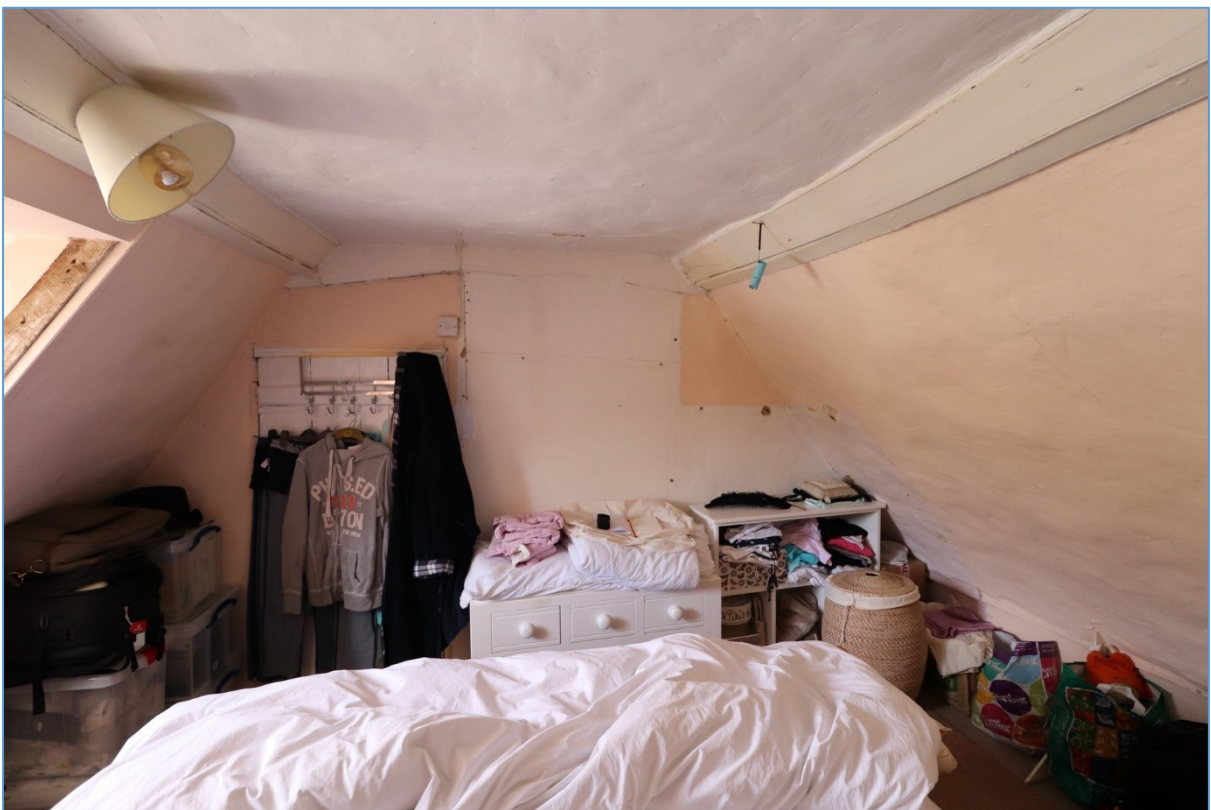
Plate 31. Interior view of the northern wall of Bedroom 1.

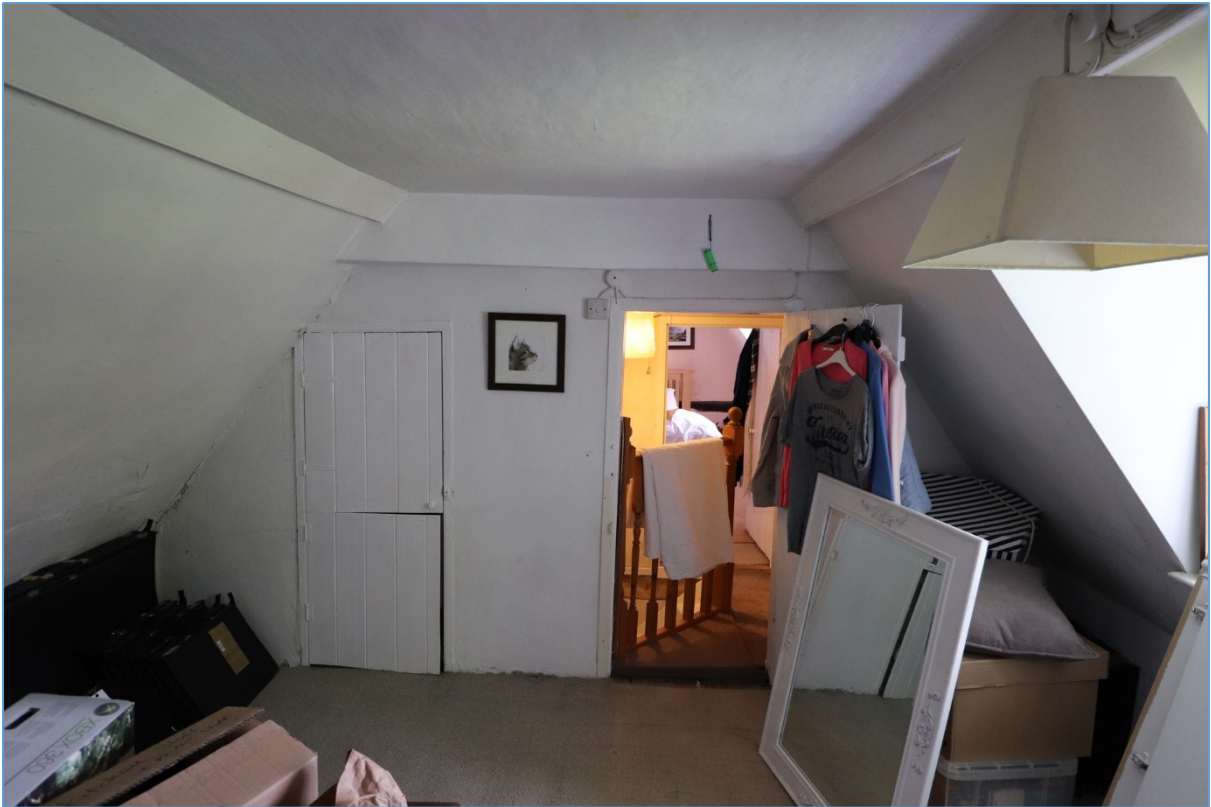
Bedroom 2: The northern attic room of the original house is referred to as Bedroom 2 and is accessed from the landing via a door in its south-west corner (Plate 32). To the east, a small cupboard with a timber stable door has been built against the chimney stack, although the interior of this cupboard is boarded and no structural details can be seen. Above the door and cupboard, the collar beam has been boxed in, as have the purlins which run along the east and west sides of the roof. The overall shape and dimensions of the room are very similar to those of Bedroom 1, with the tops of the east and west walls sitting approximately 0.45m above the floor level, and a rendered flat ceiling again being inserted above the purlins. Like Bedroom 1, this room is similarly lit by a west-facing dormer window.

Plate 32. Interior view of the southern wall of Bedroom 2.

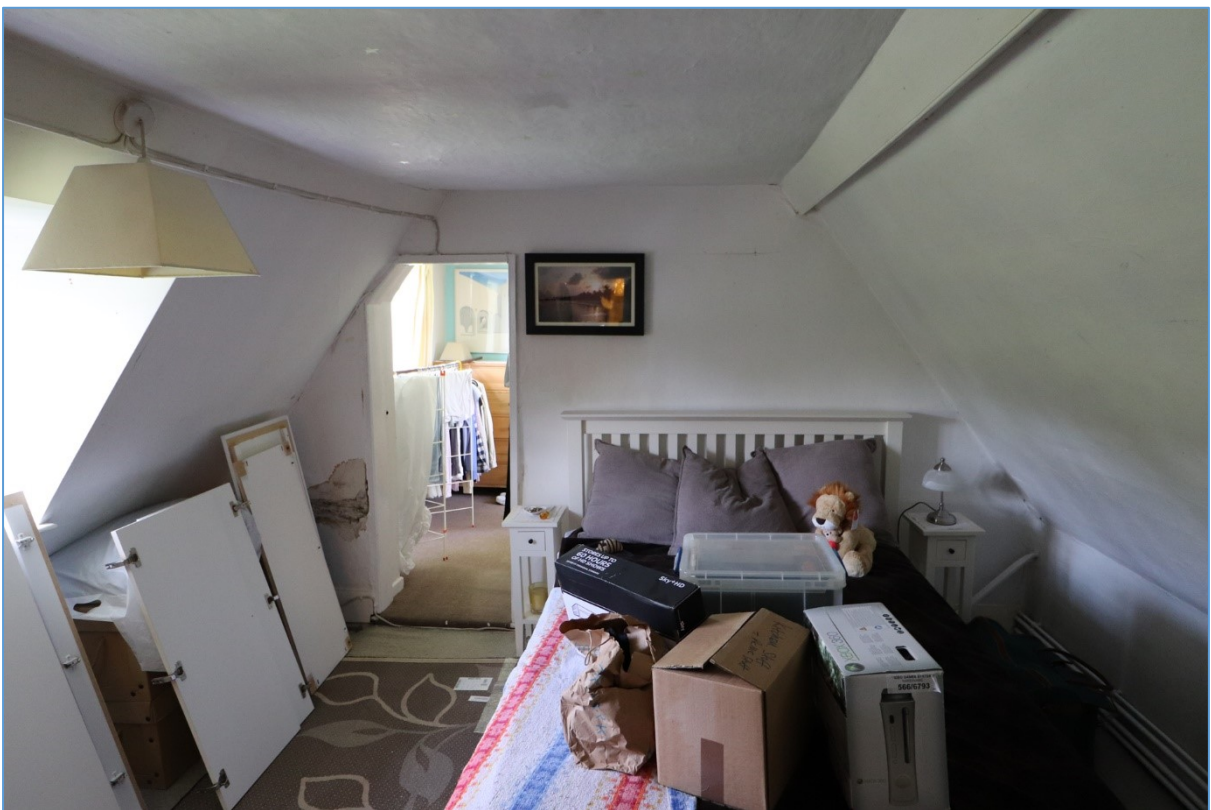
A doorway with an angled corner has been cut through the northern wall of this bedroom to provide access to the upper storey of the northern extension (Plate 33). The creation of this doorway has clearly resulted in the cutting of the tie beam, details of which can be seen behind peeling paintwork to the west of the doorway (Plate 34).

Plate 33. Interior view of the northern wall of Bedroom 2.

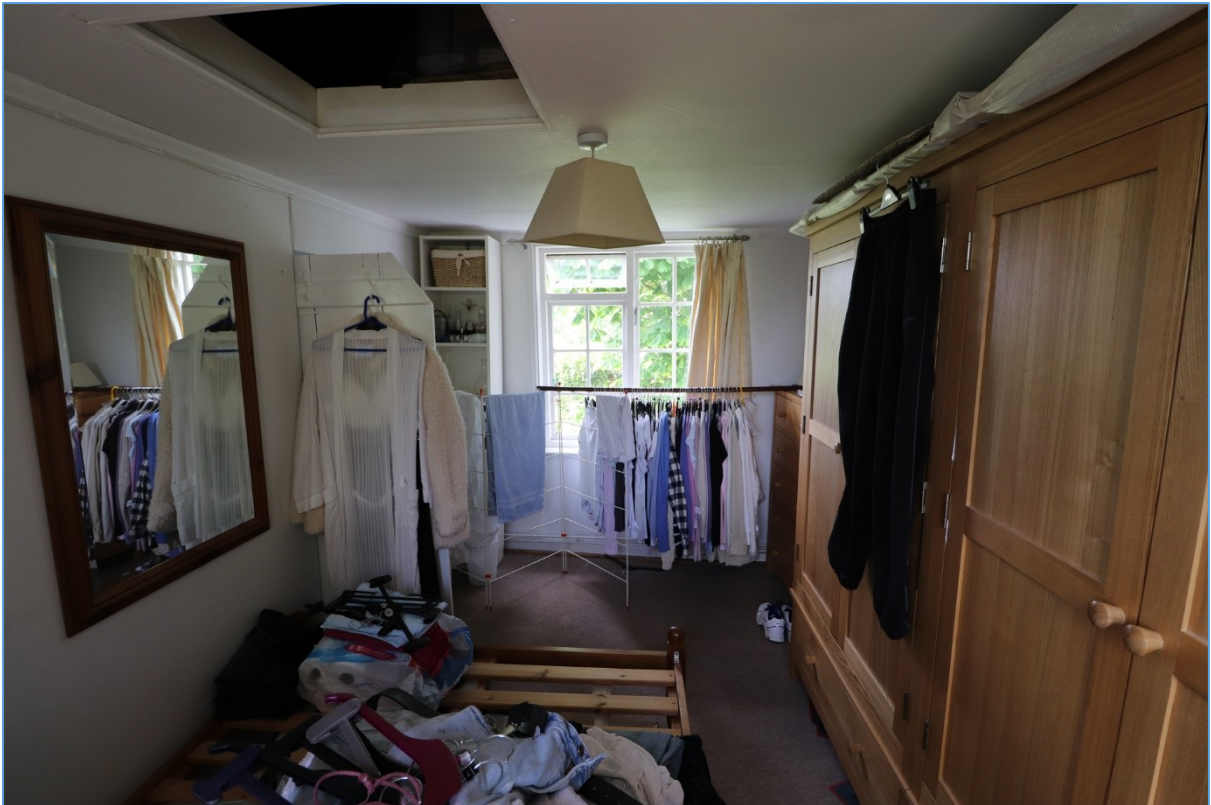
Bedroom 3/Loft: Bedroom 3 room is situated in the upper storey of the 19th-century northern extension and is accessed by a doorway leading from Bedroom 2. The room itself is architecturally unremarkable and is lit by a large casement window to the west (Plate 35) and a small casement window to the east which looks out over the roof of the rear lean-to extension (Plate 36).

Plate 35. Interior view of the western wall of Bedroom 3.

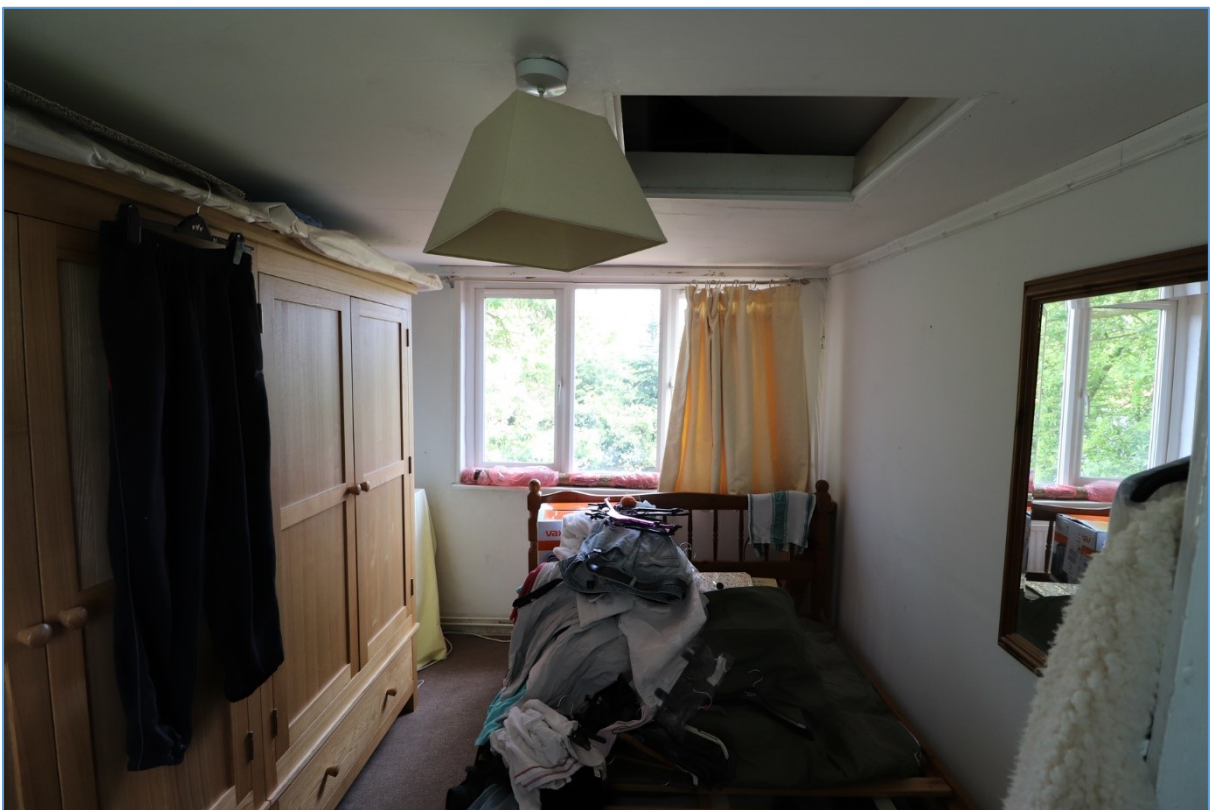
Plate 36. Interior view of the eastern wall of Bedroom 3.

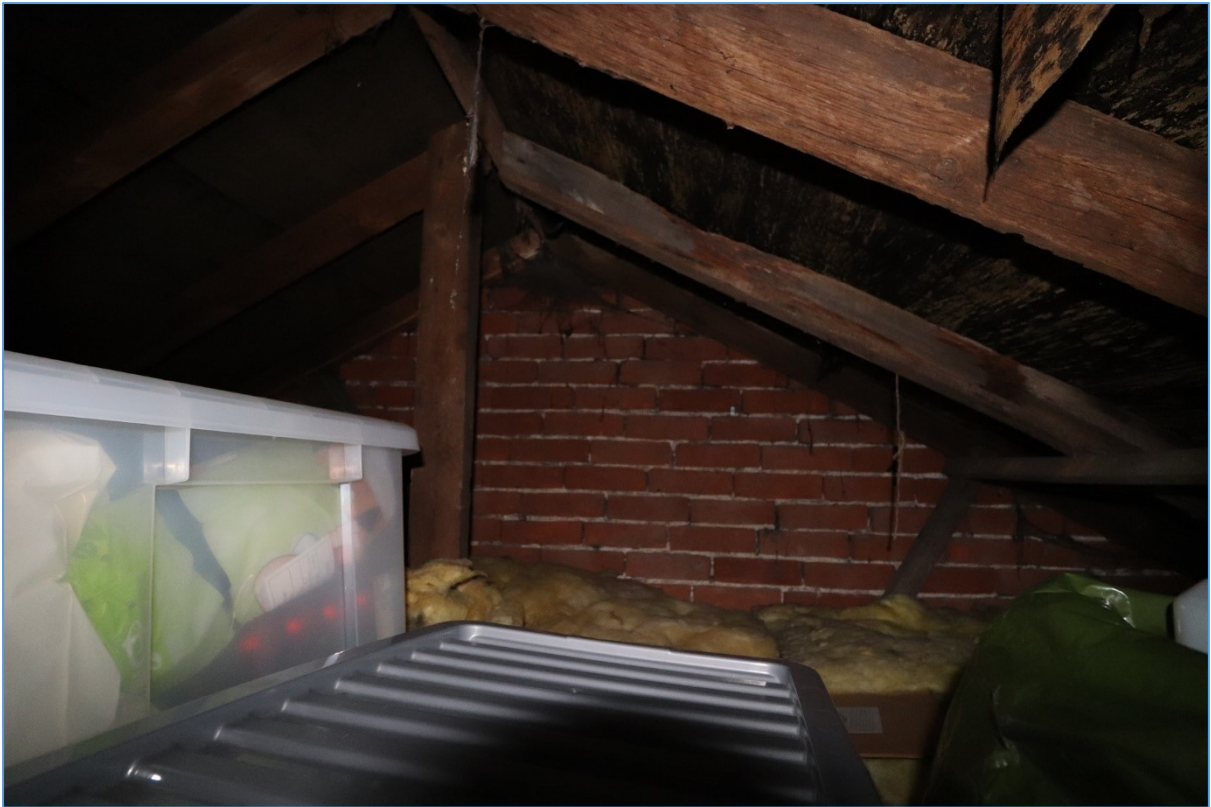
There is a more conventional attic space above the two-storey northern extension, which can be accessed via a hatch in the ceiling of Bedroom 3. Visual inspection reveals details of the brick walling of the northern gable beneath a straightforward timber roof structure (Plate 37). Of greater note, however, is the northern gable of the original house, which is preserved within the roof-space, and on the rendered surface of which survives the same incised decorative scheme evident on the exposed southern gable (Plate 38). This demonstrates that the decoration predates the 19th-century construction of the northern extension, and it is an interesting survival.

Plate 37. Interior view of the northern wall of the loft-space above Bedroom 3.

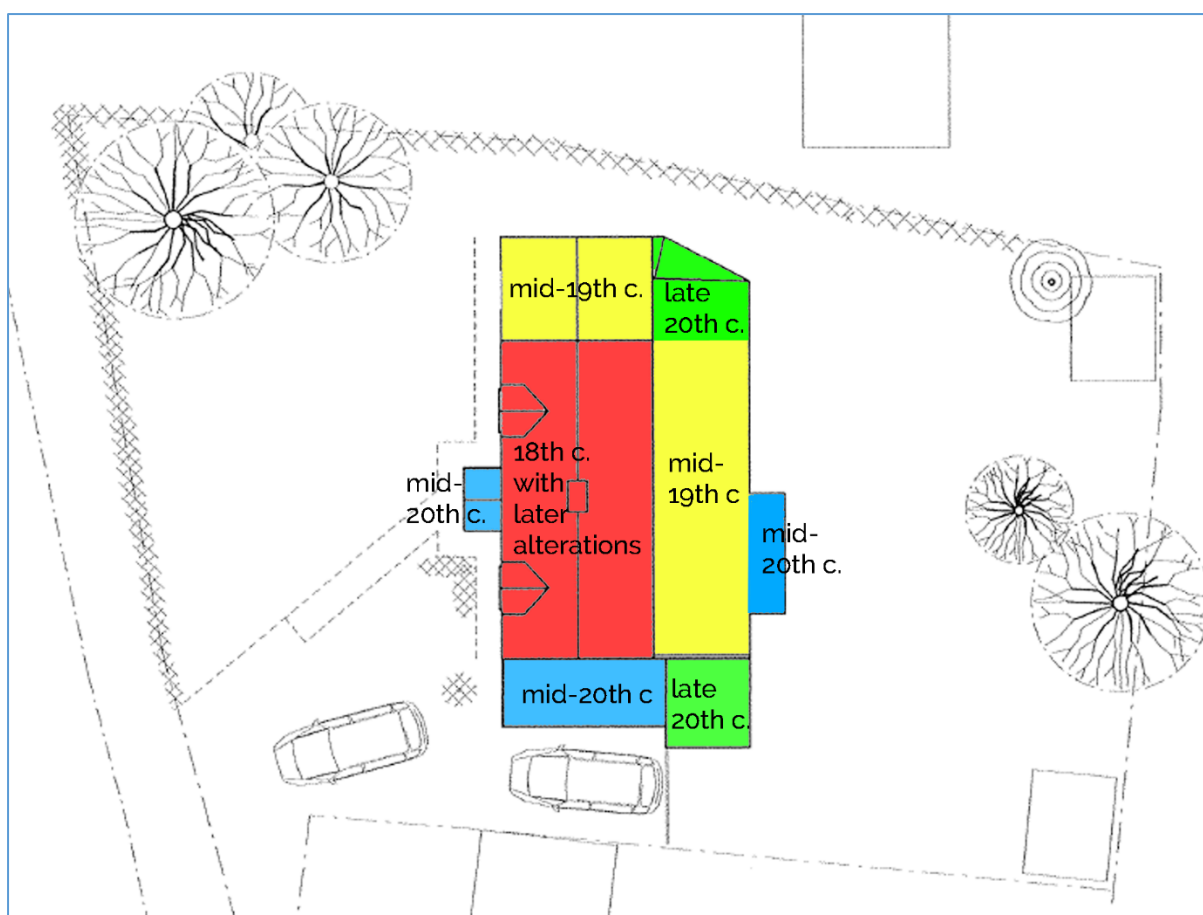
The map evidence and structural analyses indicate that the house was significantly extended in the 19th century, when a lean-to extension was built along the full length of the back of the property and a full two-storey extension with a different roof-line constructed to the north. The rear extension necessitated the creation of a new door from the northern room, while the northern extension saw openings cut through the northern gable wall at ground and first floor levels. It would appear that the original thatched roof was exchanged for slates at this point too.

The house was further altered during the latter half of the 20th century, which saw the erection of a breeze-block extension to the north-east, which links from the 19th-century extension, and the creation of a southern-lean to extension, subsequently kitted out as a bar. The porch also appears to have been added during this period, and the kitchen extended eastwards. All of these building projects appear to have occurred within a relatively short time-frame and apparently coincided with an orchestrated attempt to create mock-timber framing within the existing building to complement those elements of the frame which were still visible. There is also evidence to suggest that this work extended to the creation of faux brickwork as well as timber-framing.

Figure 7. Developmental phase plan of Thorne Roughets, showing major phases of construction and extension.
