# **Little Dale Farm**

Dale Road, Stanton, Suffolk,  
IP21 2DY

## A Level II Historic Building Record

September 2018

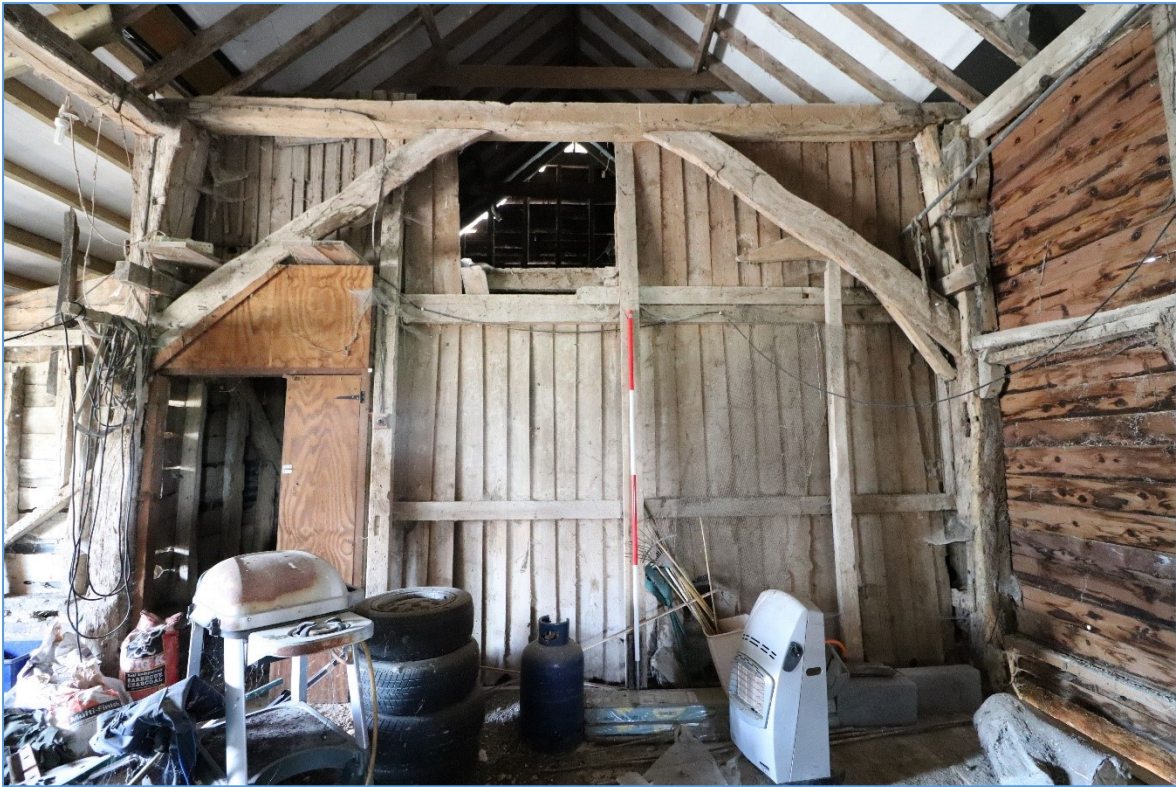
The western bay is two storeys and is divided from the central bay of the barn by a timber partition constructed from vertical planking affixed to the cross frame (Figures 16 and 17). A modern entrance has been created at its southern end.

Figure 16. The western elevation of the central bay, looking west, showing the timber partition between the central and western bays.

The upper floor of the western range is approximately 2.5m above the ground level of the barn and is faced by the same timber planking, into which an opening has been cut facilitating access (Figure 16). It was not possible to obtain access to the upper floor of the western bay during the survey due to safety reasons, but it is apparent from below that this floor is of relatively recent construction and is affixed inside the frame, although it may be a replacement for an earlier floor.

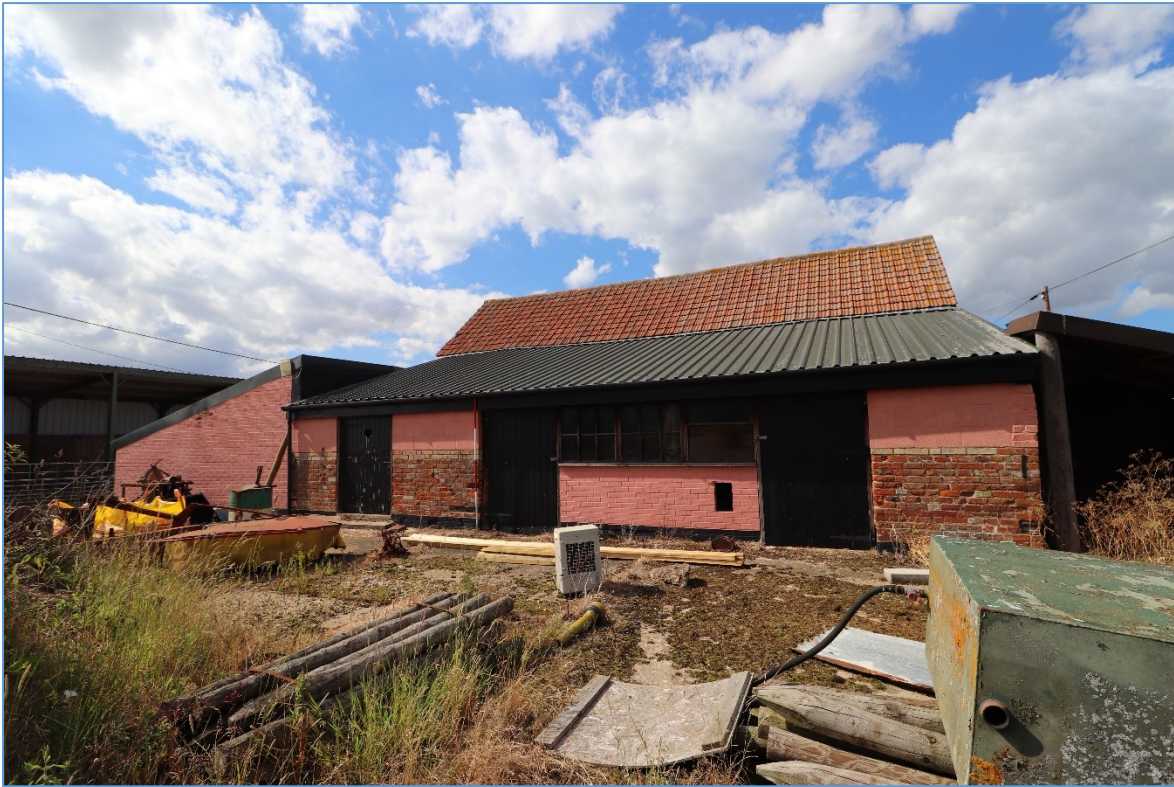
The southern wall of the central bay is punctuated by a wide timber door, with two six-light windows to its east (Figures 27 and 28). The brickwork beneath the door and windows is relatively modern, suggesting the blocking up of a larger opening, while the brickwork to the west of the door is older, and is likely to relate to earlier loose boxes constructed either side of the entrance.

*Figure 27. The southern wall of the southern lean-to, looking north, showing the various openings and different construction methods in evidence.*

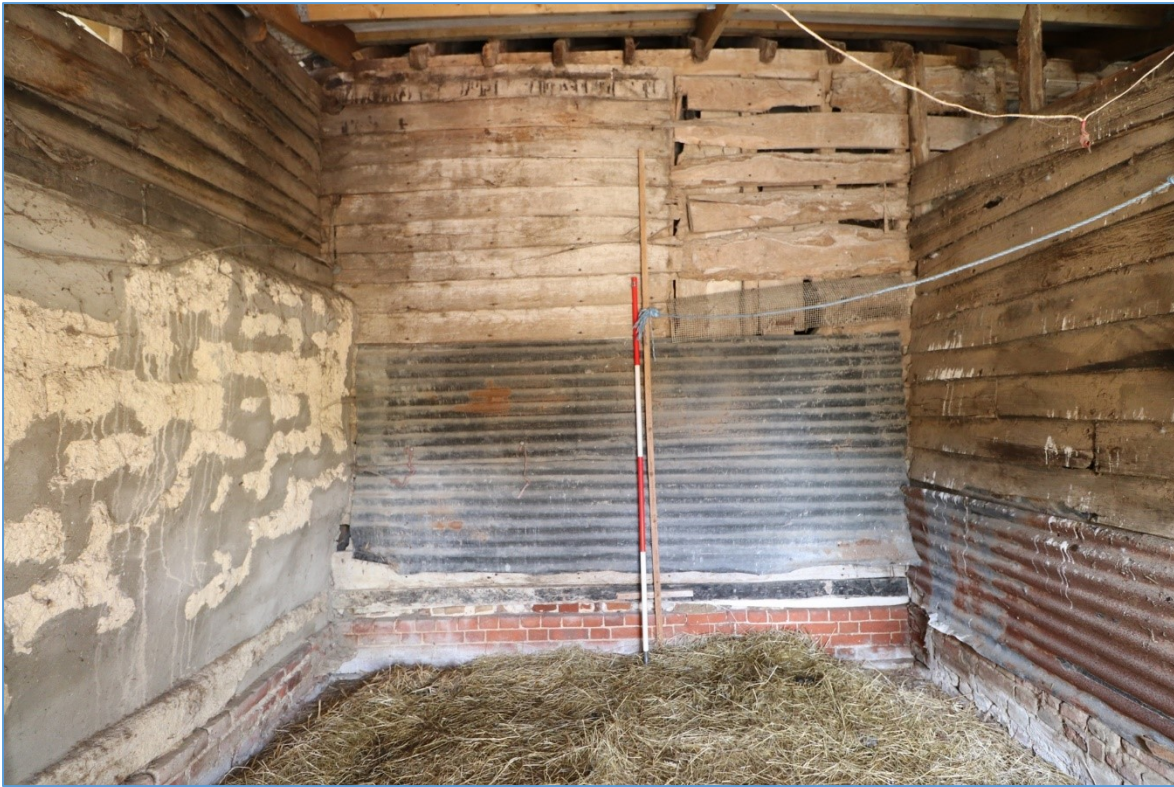
As discussed, the western bay of the southern lean-to is a later addition to the structure, with its northern wall being formed by the original southern face of the barn, albeit with a rebuilt brick plinth (Figure 31). This elevation shows signs of two phases of weatherboarding, with better-made boarding to the west and more haphazard boarding to the east. The bottom of the walls is lined with corrugated metal and the bay is still used as a loose box for livestock.

Figure 31. The northern elevation of the western bay of the southern lean-to, looking north, showing the surviving weatherboarding of the barn.

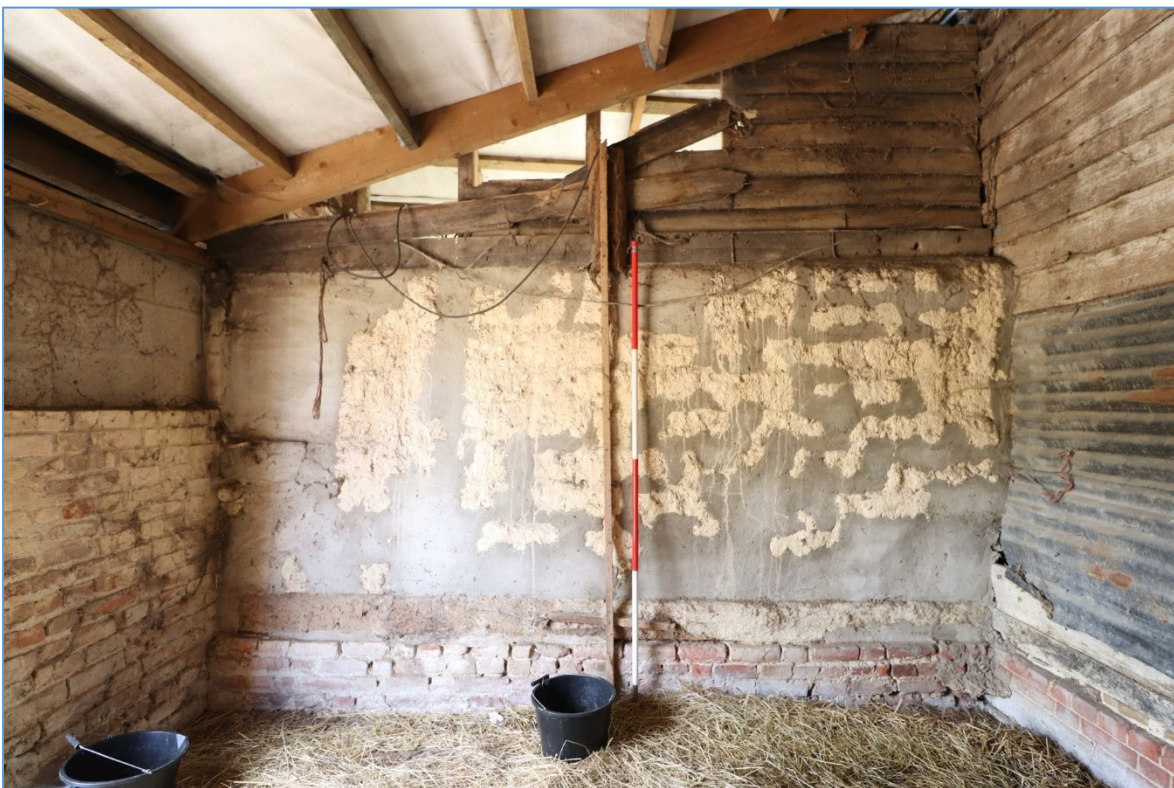
The western wall of the range not backs onto the late 1960s/early 1970s infill building, but before that formed an exterior wall in its own right (Figure 32). This comprised a brick plinth mimicking that of the original barn, above which was a height of internally rendered and externally weatherboarded timber-framing. The southern wall of the bay comprises simple brickwork for its lower courses, with concrete breeze blocks above, into which a large stable door is set (Figure 33).

Figure 32. The western elevation of the western bay of the southern lean-to, looking west, showing surviving the rendered timber-framing and weatherboarding above. .

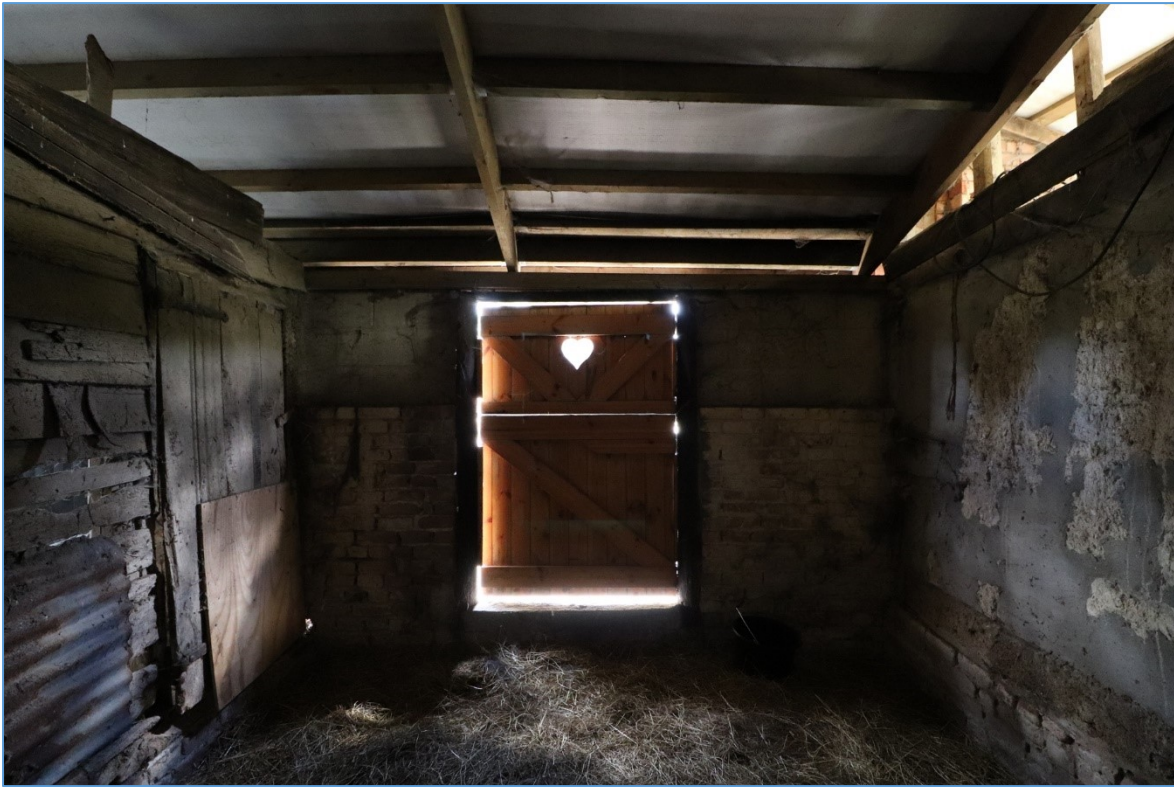
*Figure 33. The southern elevation of the western bay of the southern lean-to, looking south, showing the mixed building phases and inserted stable door. .*

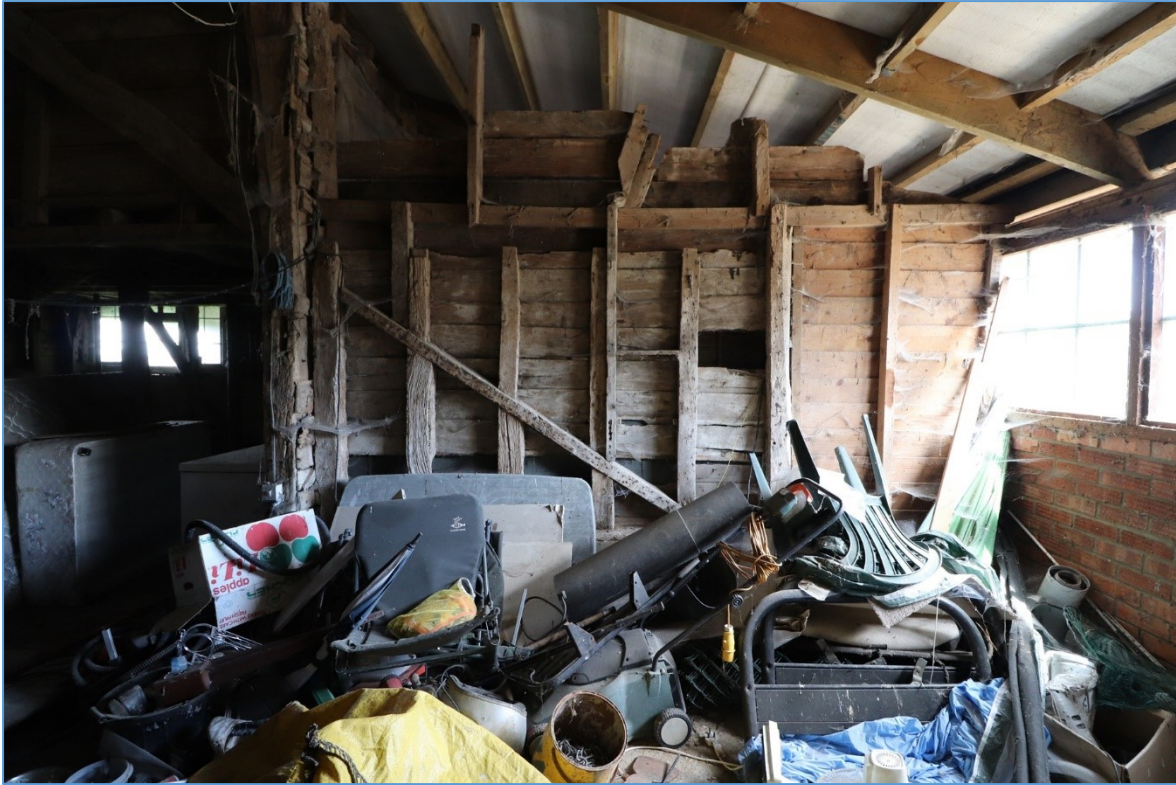
The eastern elevation of the central bay exhibits a similar arrangement of brick plinth topped by a pane of timber-framing, and is presumably also a remnant of the original porch (Figure 34). Instead of a southern doorway, this wall features a panel of later infill planking. The reverse of this wall again demonstrates the survival of a patch of original weatherboarding, flanked by later planking (Figure 35). Like the western bay, the eastern bay is a late addition, and it has been altered more than its counterpart. While the northern wall preserves original weatherboarding behind corrugated metal sheeting and plastic (Figure 36), the eastern wall has been completely replaced in modern timberwork, set atop an earlier sill beam and brick plinth (Figure 37). Likewise, although the eastern end of the southern wall mirrors that of the western end, its western half has been rebuilt in modern brickwork and incorporates a large door, window and fittings for extractor fans (Figures 27 and 35).

Figure 34. The eastern elevation of the central bay of the southern lean-to, looking east, showing surviving timber-framing from the original porch of the main barn.

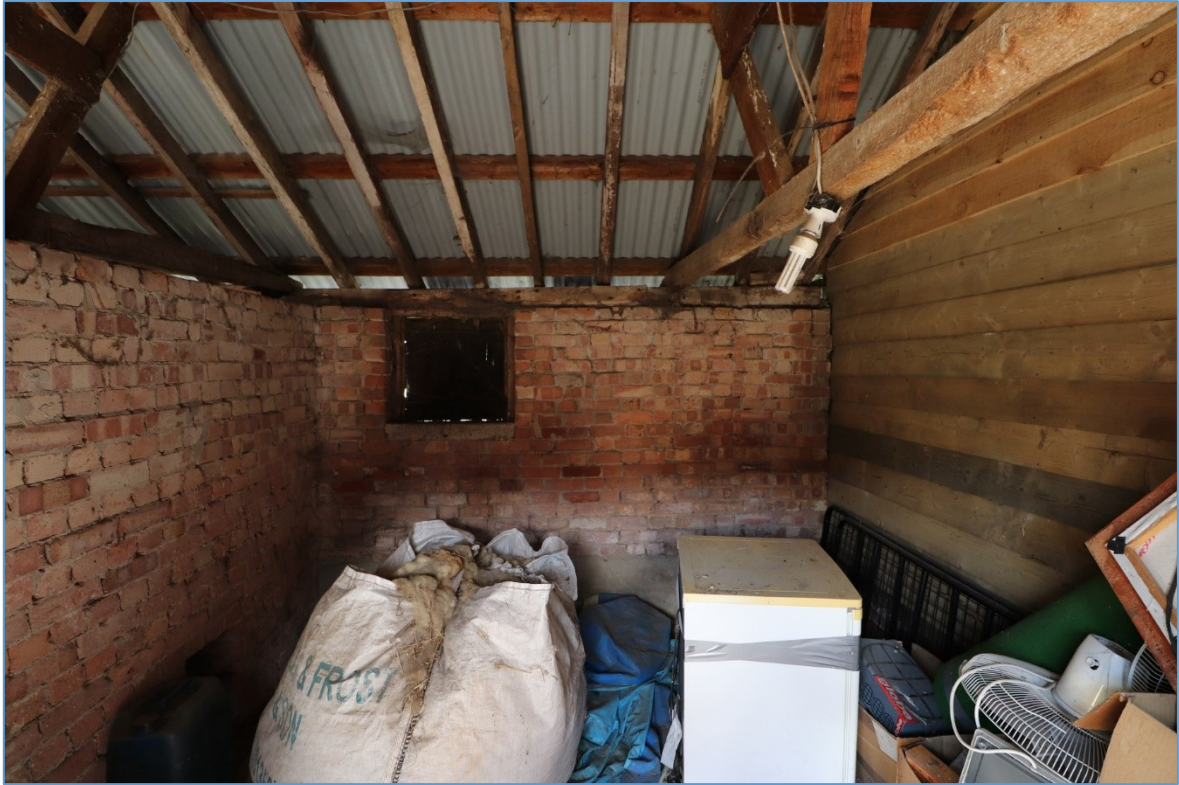
*Figure 42. The interior of the southern cell of the northern extension, looking east.*

The southern doorway leads into a single loose box, which corresponds with the window in the eastern wall, which is built from 19th-century brickwork, and which has a brick partition to the north. The southern wall comprises the modern weatherboarding of the main barn (Figure 42).

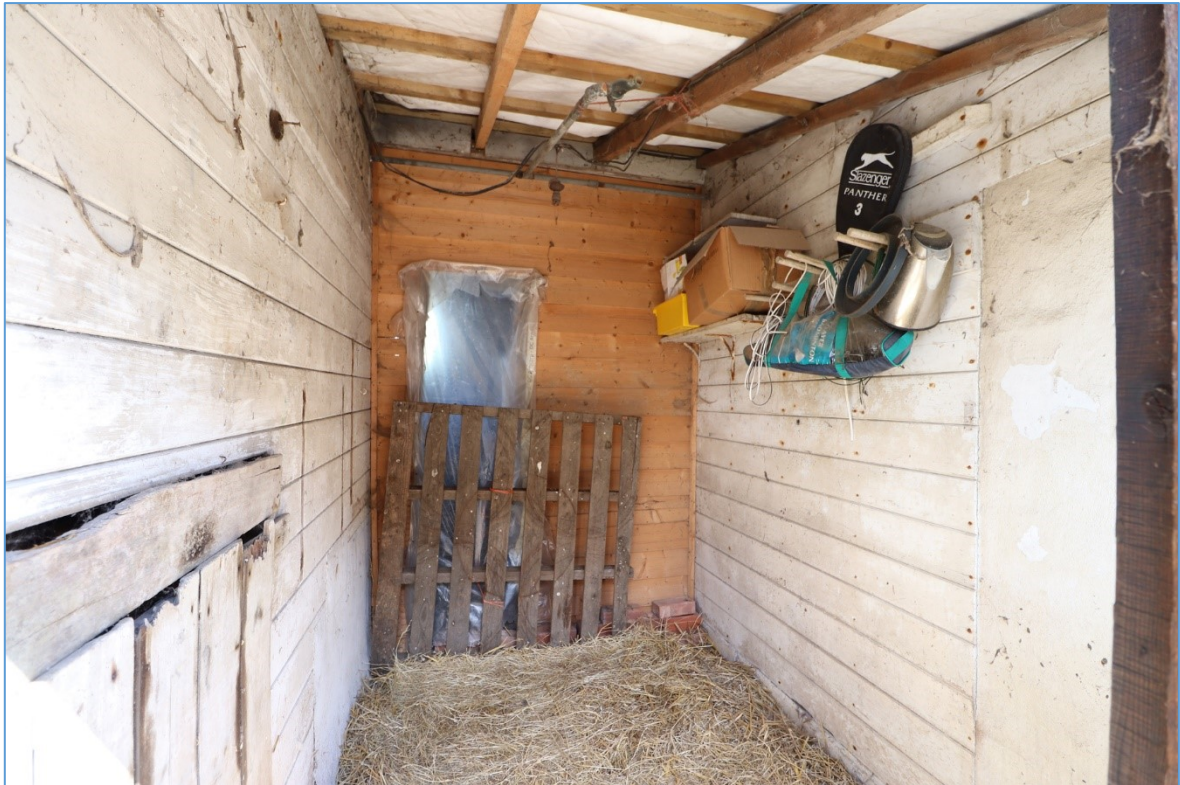
The northernmost extent of the wrap-around infill extension comprises a small, single loose box constructed from timber, weatherboarded on its exterior and accessed via a stable door from the yard (Figure 51).

Figure 51. The interior of the loose box at the northern end of the south-western infill, looking east.
