# Village Farm

Market Weston, Suffolk

## A Level 2 Historic Building Record

August 2021

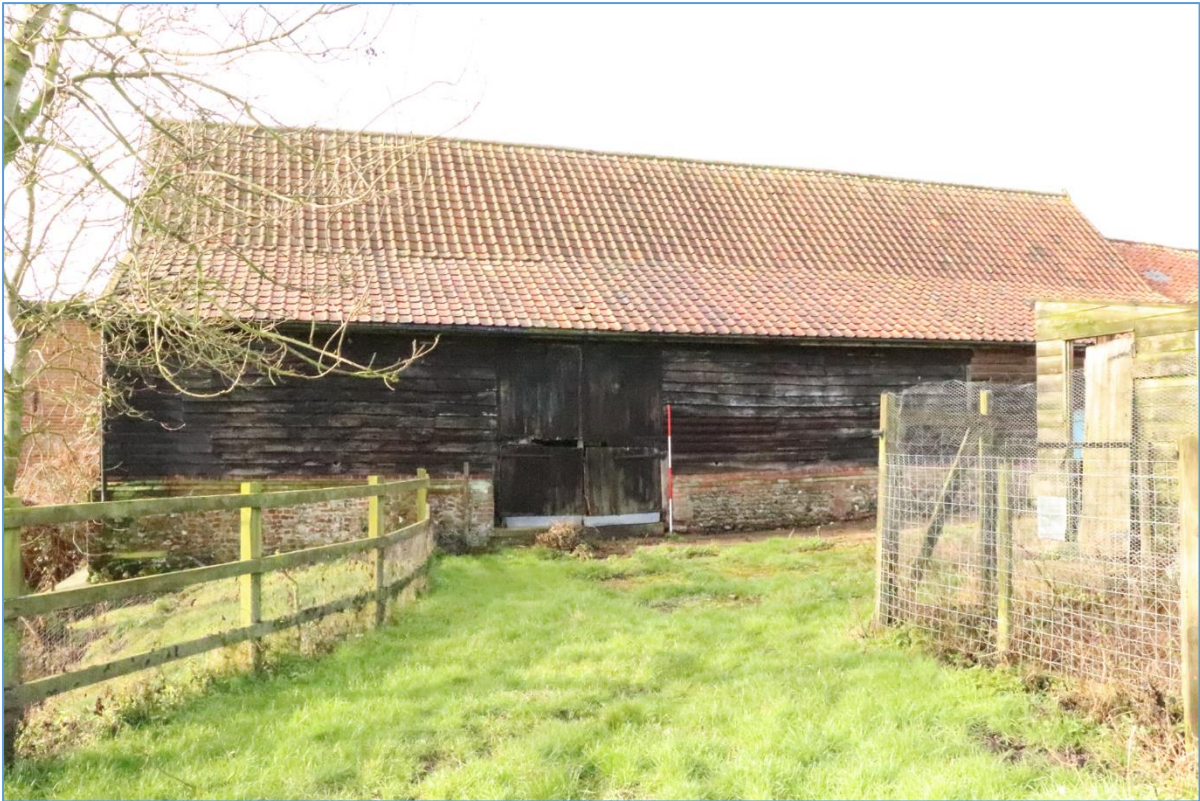
*Plate 9. The eastern elevation of Building A, looking west.*

The eastern elevation of the barn features an aisle which runs the full length of the building and appears to be a 19th-century addition. There is a marked break of slope in the roof as it passes from the barn to the aisle (Plate 9). Again, the wall of the barn comprises black weatherboarding above a brick-capped flint and brick plinth wall, and features a large pair of full-height timber doors. These are set opposite the doors in the western elevation in the typical configuration for a threshing barn, enabling a laden cart to be driven into one side of the barn, unloaded and driven out of the other.

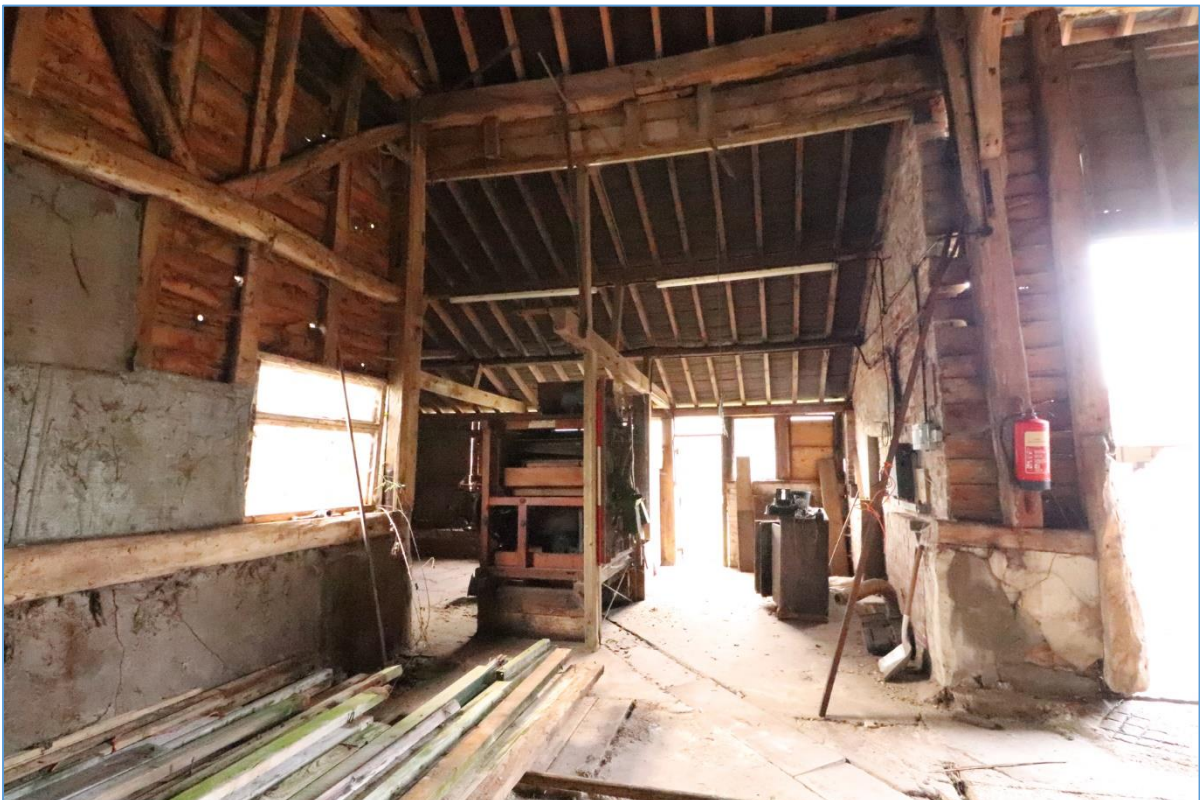
*Plate 10. The interior of the southern bay of Building A, looking west into the south-western lean-to.*

At the southern end of the western elevation is a projecting brick lean-to under a catslide roof, the northern elevation of which shows evidence of its 19th-century origin (Plate 7). This elevation also exhibits many phases of repairs in late 20th-century brick and concrete. The western elevation of this outshut extends beyond the southern elevation of the principal barn and comprises a modern brick infill with timber door and four mis-matched timber windows to the north, with a large pair of timber double-doors served by a concrete access ramp to the south (Plate 8). The southern and western elevations of this building are of relatively modern brickwork. The roof of this lean-to is of modern timber and it currently houses a grain dressing machine (Plates 10 and 11).

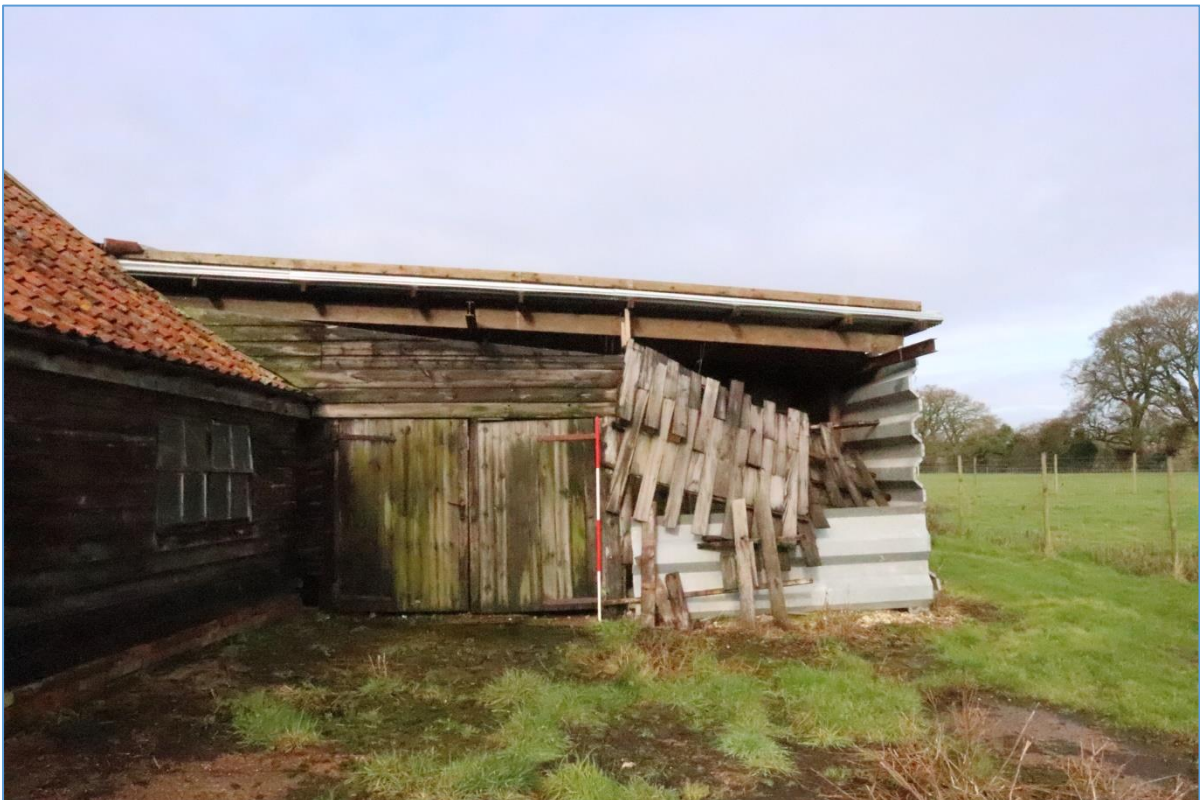
*Plate 22. The southern elevation of the lean-to structure north of Building B, looking north.*

The northern gable end of Building B is also of black weatherboarding, with a small opening set in the apex of the gable, but the majority of the elevation is enclosed within an extensive open-sided metal structure containing cow pens, which is due to be demolished as part of the approved scheme (Plates 4 and 22).

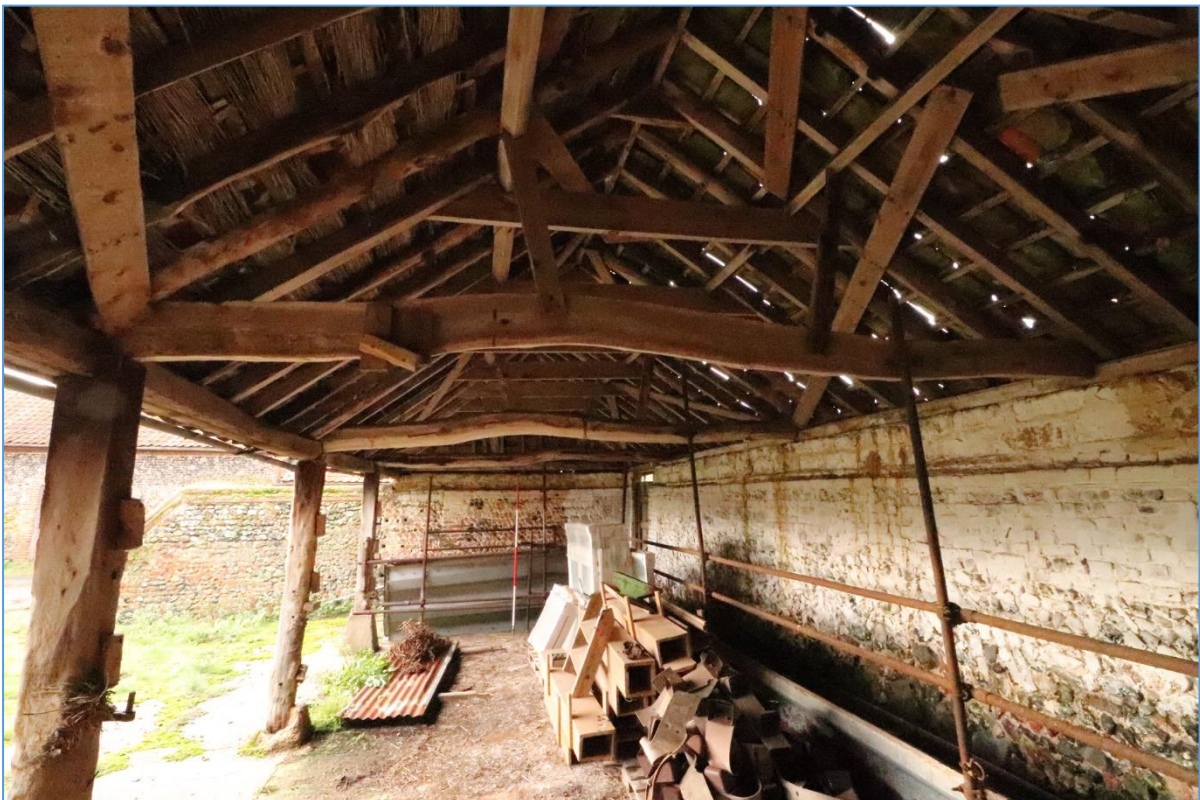
*Plate 38. Interior of Building C, looking west.*

Internally, this range is open and the timber uprights and tie beams appear to be original 19th-century timbers. Above the tie beams, though, the roof structure is a largely modern replacement (Plate 38).
