**THE ARCHAEOLOGY CO.**

Old Market Hall, Bacup  
Historic Building Survey

April 2016

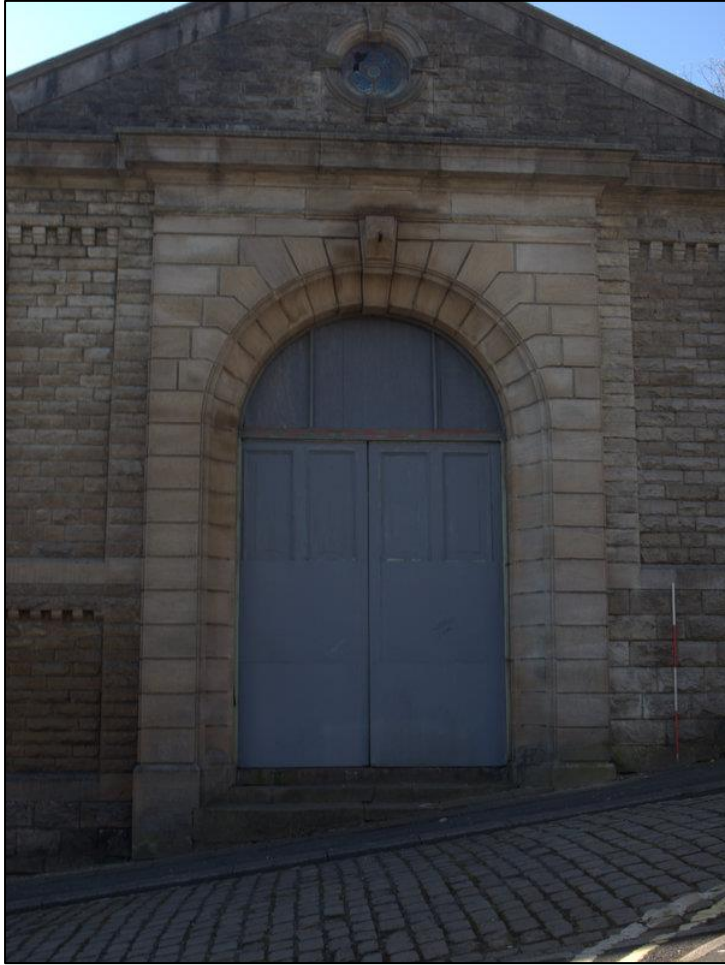
Plate 3: Detail of northern doorway

- 6.2 North elevation (Plates 1 - 4). This forms the main frontage of the building, with the first bay being three stories and the third two stories, due to the sloping ground. The central bay contains a large doorway with sandstone steps leading up to it. Two large timber doors are hung. The lintel is a large rounded arch. The jambs are segmented dressed sandstone, which runs continuously around the doorway, taking in the lintel with a projecting keystone. Above this a projecting sandstone cornice runs across the top of the face. Above this is a sandstone gable with a single circular window within, containing stained glass. To the east the bay contains a pair of tall portrait windows at ground and first floor levels, each with rounded lintels. The surrounds are sandstone with dressed sandstone cills and lintels. To the west are two decorative recesses reaching from ground floor to first floor. At lower ground floor level the recesses continue, although are broken by a sandstone string course. Blind windows also lie at this level, below the windows above. The third bay matches that of the first, but without the lower ground floor features.

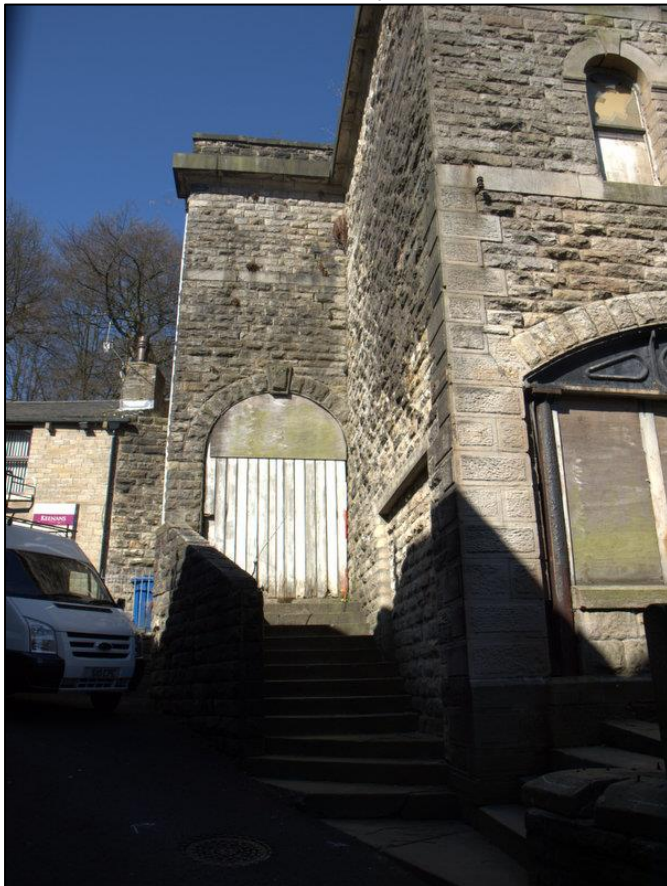
Plate 10: Blocked doorway at recessed southern end of east elevation

- 6.3 East elevation (Plates 5 - 11). This forms the nine bay frontage of Lord Street, although the southern bay is recessed from the rest of the face. The Lower ground floor contains a shop front in each of the remaining eight bays. These are formed below a large depressed arch lintel of sandstone with an ornate cast iron beam filling the arch. This is supported on cast iron stanchions at each corner as well as a central one. At the northern end of each is a personnel doorway with a narrow portrait window to the south, up to the central stanchion. South of this is a larger window. The windows have dressed sandstone cills. At second floor level each bay contains two pairs of narrow portrait windows. The first and eighth bays only contain a single pair and match those on the north elevation, whereas the others have depressed arched lintels, rather than rounded. At ground floor level the first and eighth bays again have matching windows, although this time with fake keystones. The remaining bays all have decorative recesses with dogtooth decoration at the top. Nine stone chimneys rise from the top of the wall along the face. At the far southern end the face is stepped back for bay nine and accessed

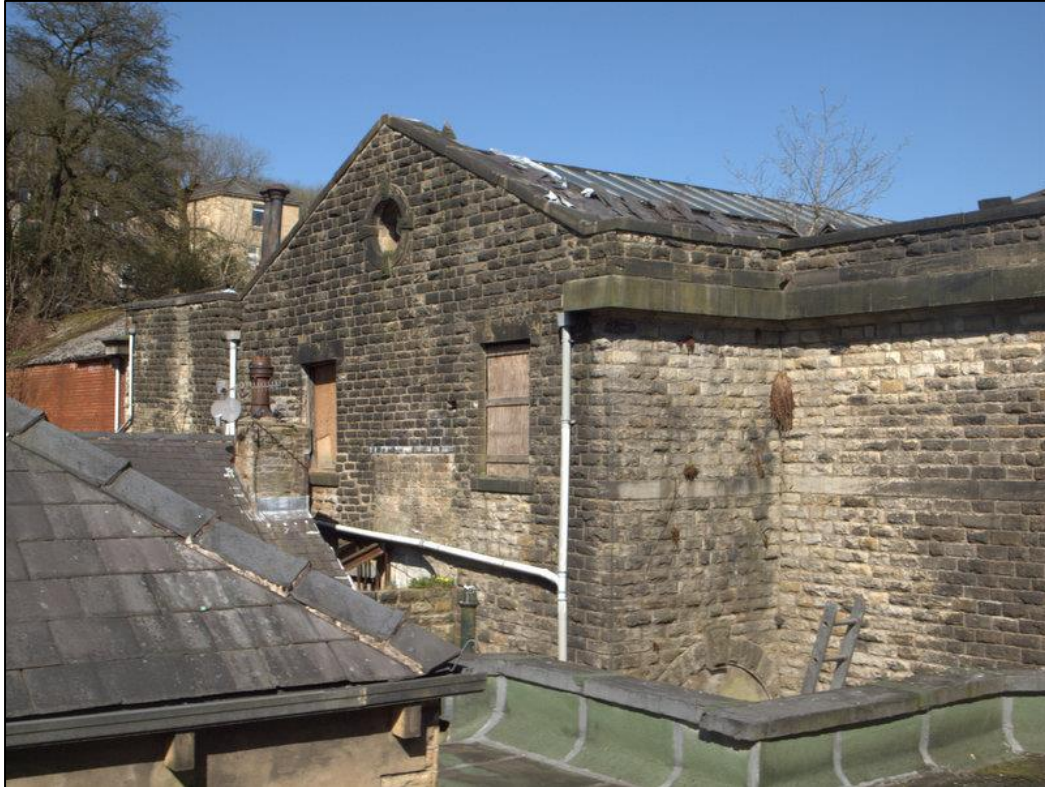
Plate 13: Detail of central bay in south elevation

6.4 South elevation (Plates 12 - 16). This face is partially obscured by the housing which adjoins it. At the eastern end, the bay is stepped back. At the base of the steps, is a blocked loading doorway with dressed sandstone lintel. Above this the face is featureless. To the west the face protrudes as the gable end of the central bay. In the centre of the face at ground floor level the rounded arch of a lintel is visible, above which is the ghost of a removed structure. At first floor level are two portrait windows, flanking the lower doorway. Each has a dressed sandstone cill and lintel. Above these, in the centre, is a circular window containing stained glass, matching that on the north elevation, although broken. To the west the final bay is featureless, with the exception of a large depressed lintel visible at ground floor level. This has become damaged as the building has begun to slump between the two bays.

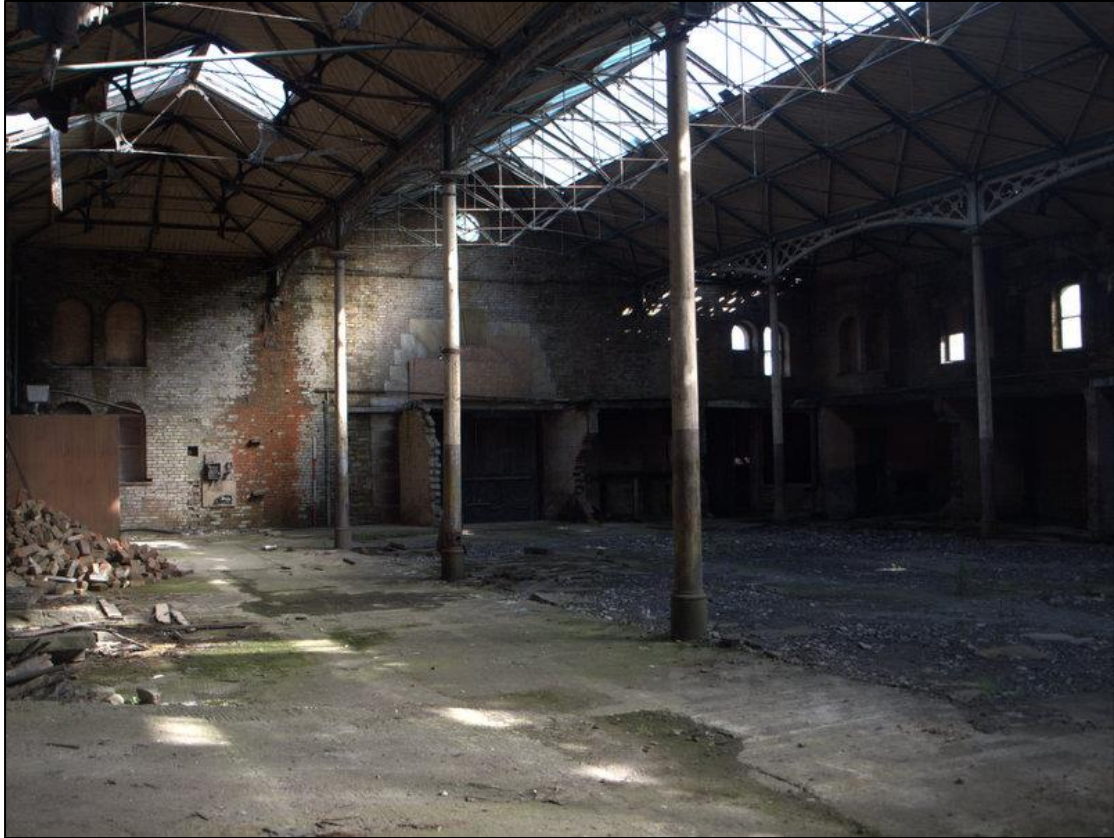
Plate 23: General shot of interior

6.6 The interior (Plates 23 - 40) mainly consists of a single open space, with a few rooms to the north and east, although very badly damaged. In the centre of the north wall is the large entrance (Plates 24 & 35). Although the internal walls are

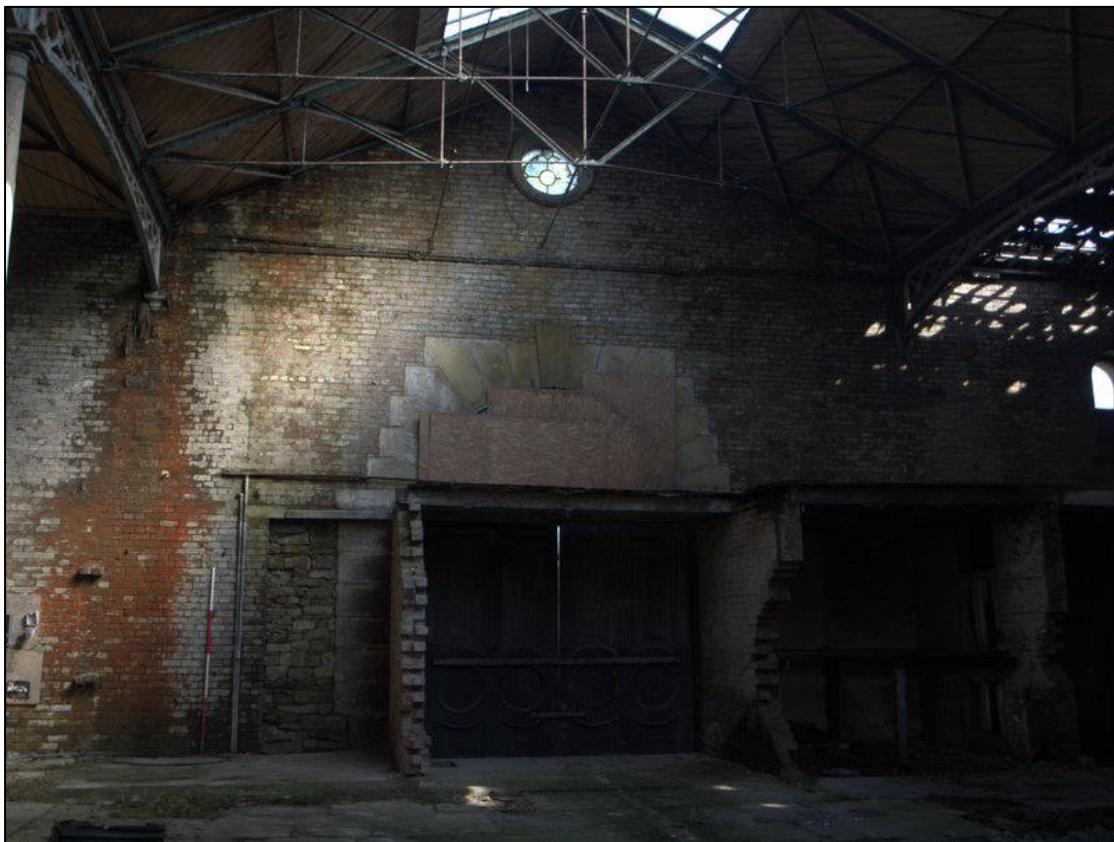
Plate 24: Detail of doorway in north elevation

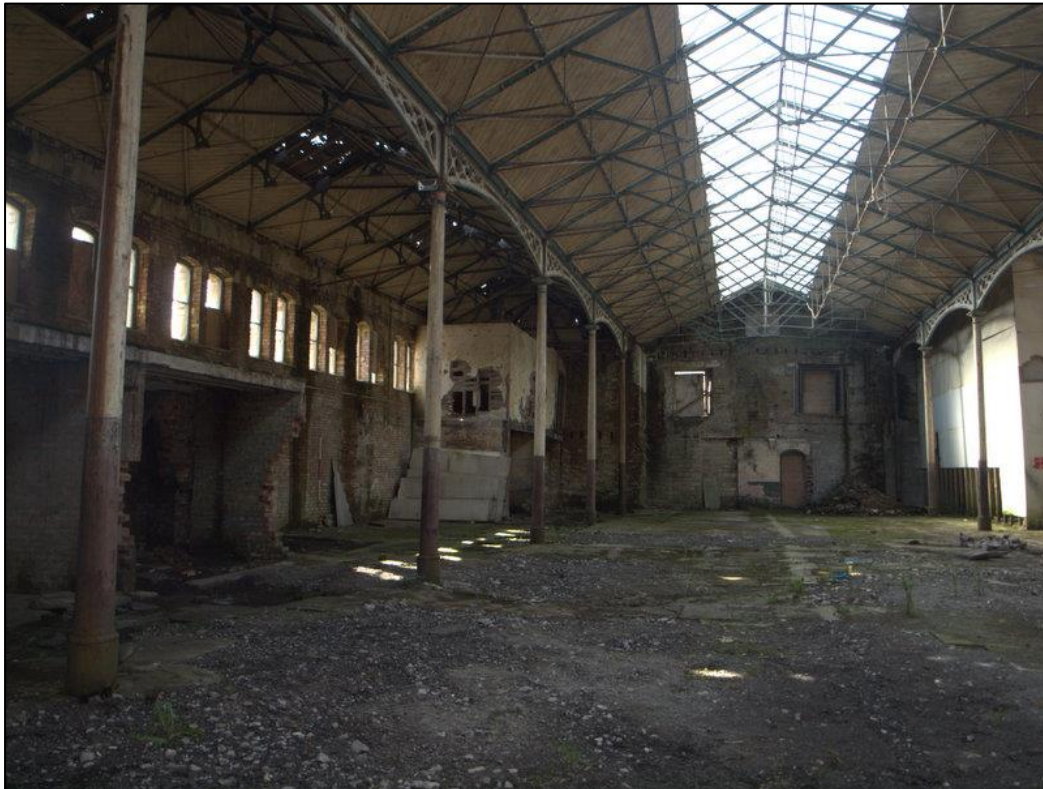
Plate 28: General shot of interior looking south

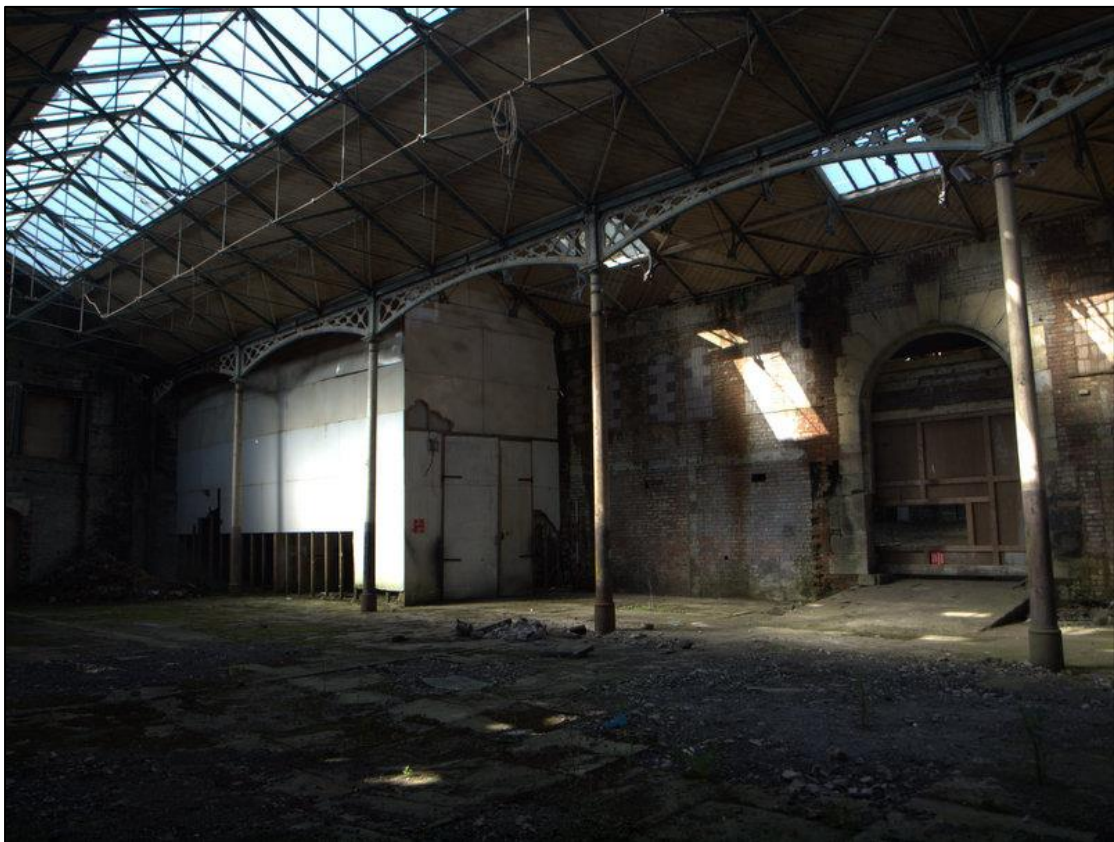
Plate 32: General shot showing modern unit in southwest corner and doorway in west wall

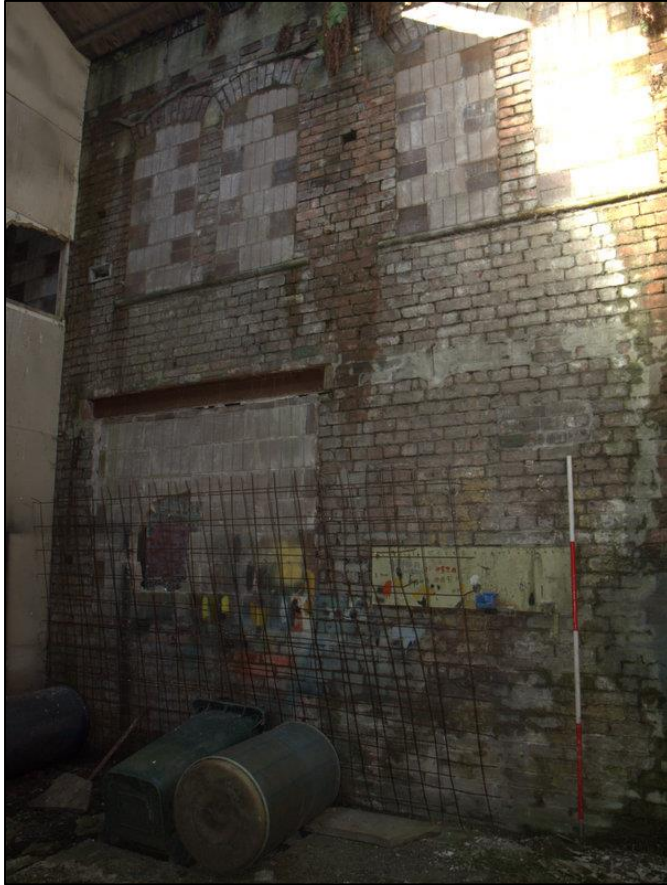
Plate 33: Blocked window and RSJ lintel in west elevation

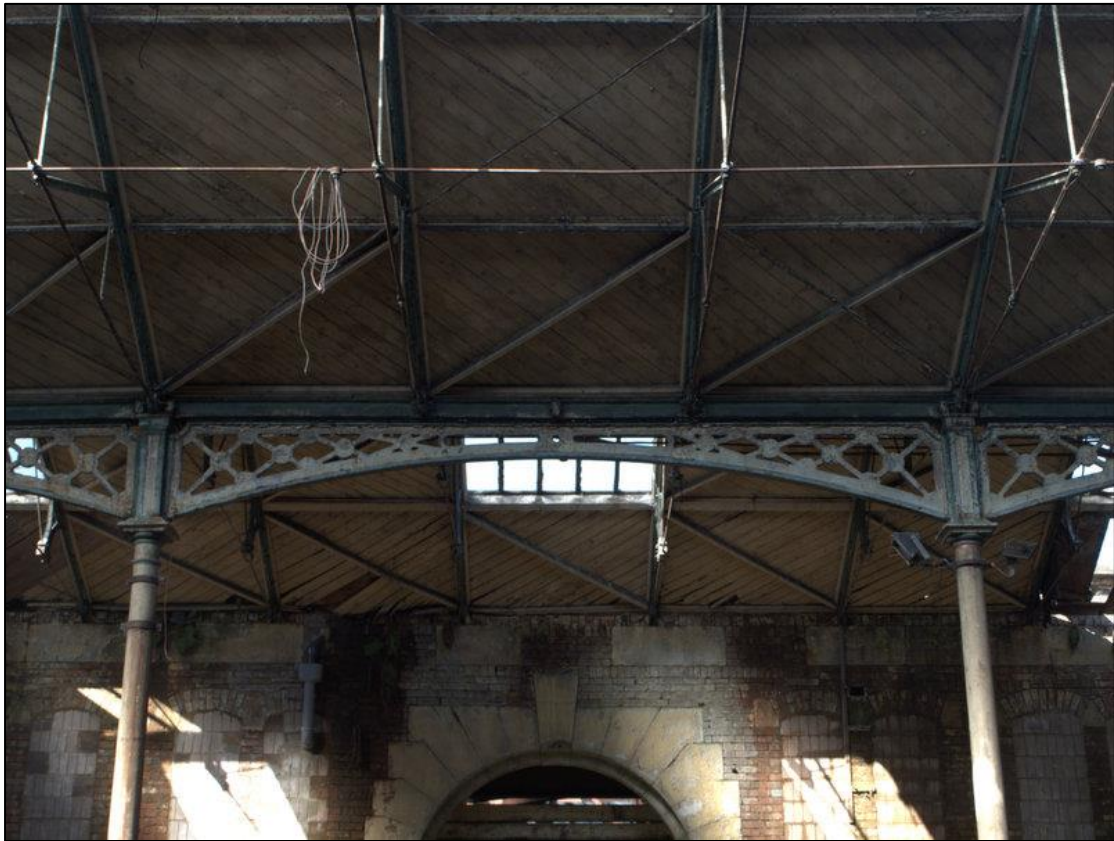
- 6.7 The roof structure (Plates 37 – 40) is supported by 12 cast iron stanchions aligned in pairs running north – south. Between these, also running north south, are ornate tie beams attached to the square capitals of the stanchions. Running east – west between the tie beams are a series of nineteen thin iron trusses, supporting the pitched roof containing a long central skylight on each side. The situation is mirrored to the east and west bays, although the trusses are smaller.
- 6.8 The lower ground floor units (Plates 41 – 46) are comprised of a single open space with access via the doorway in the east wall. The ceilings are formed of brick arches and the walls are painted brick. In the south wall of the north unit a narrow doorway has been inserted, leading to the unit beyond. This also has a doorway inserted through the southern wall into the next unit.

Plate 37: Detail of cast iron tie beams with western door beyond

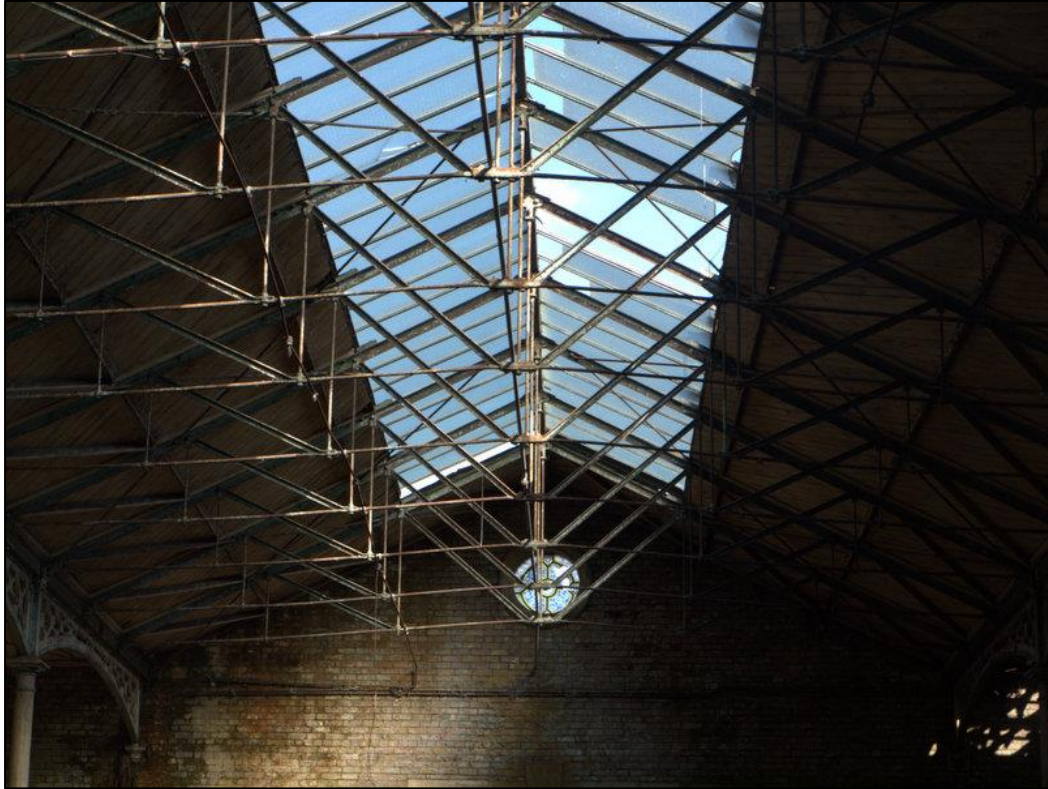
Plate 39: Detail of roof structure of central bay

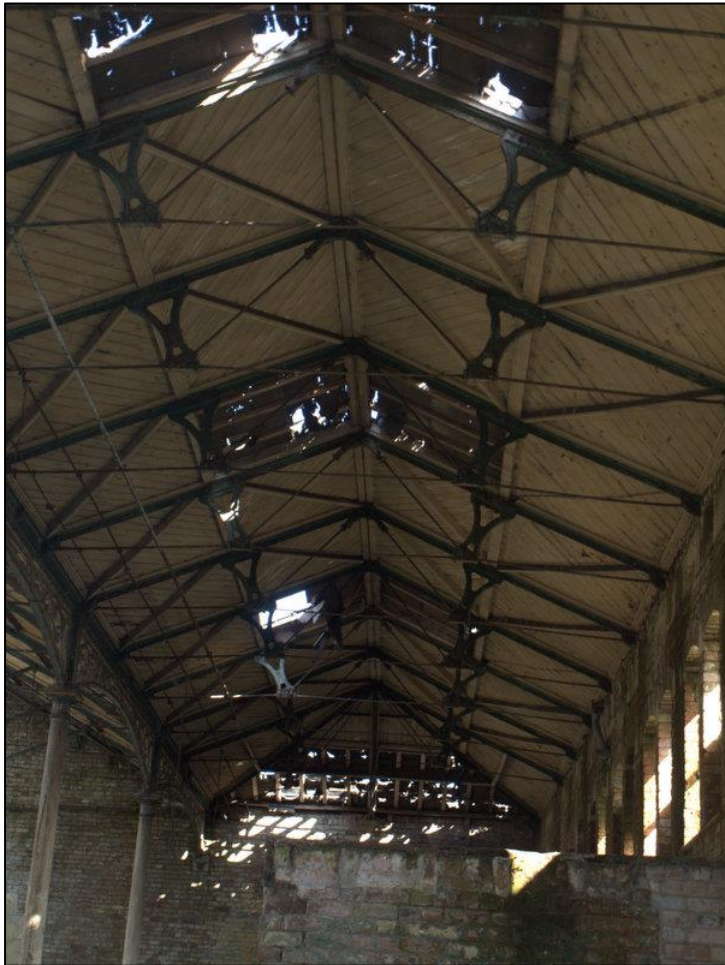
Plate 40: Detail of roof structure of eastern bay

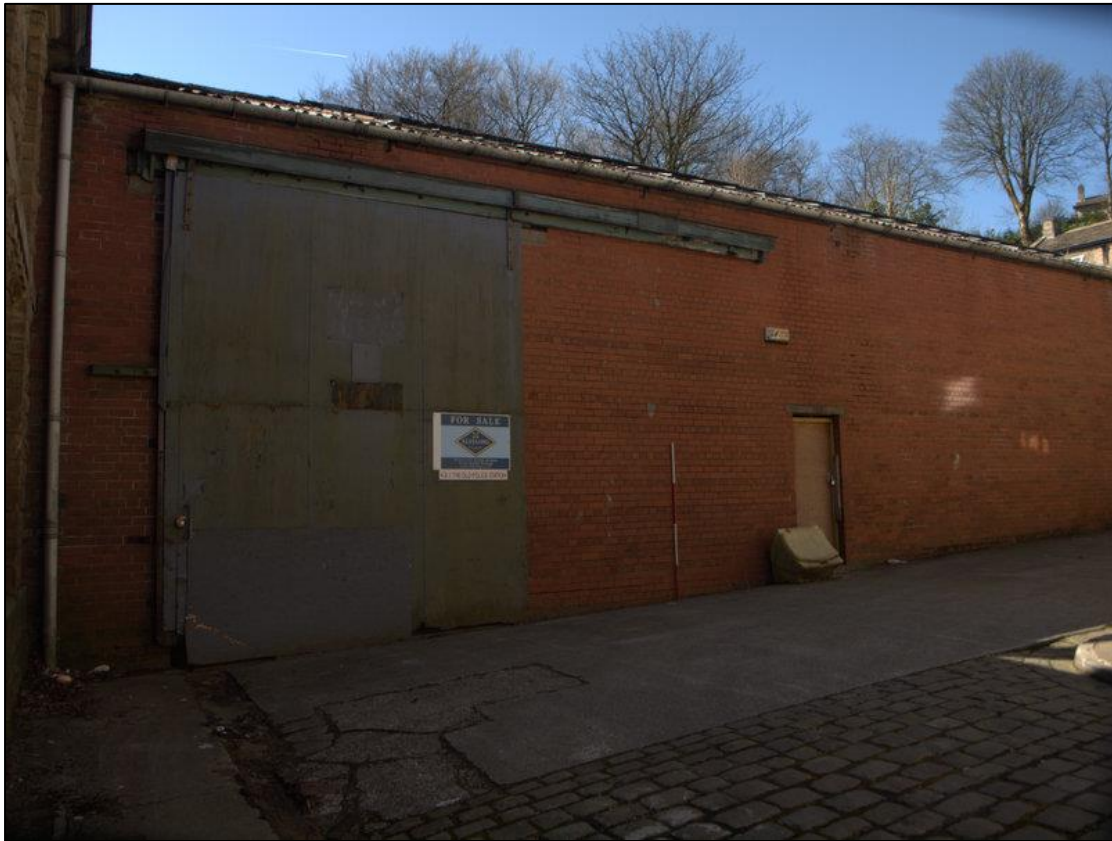
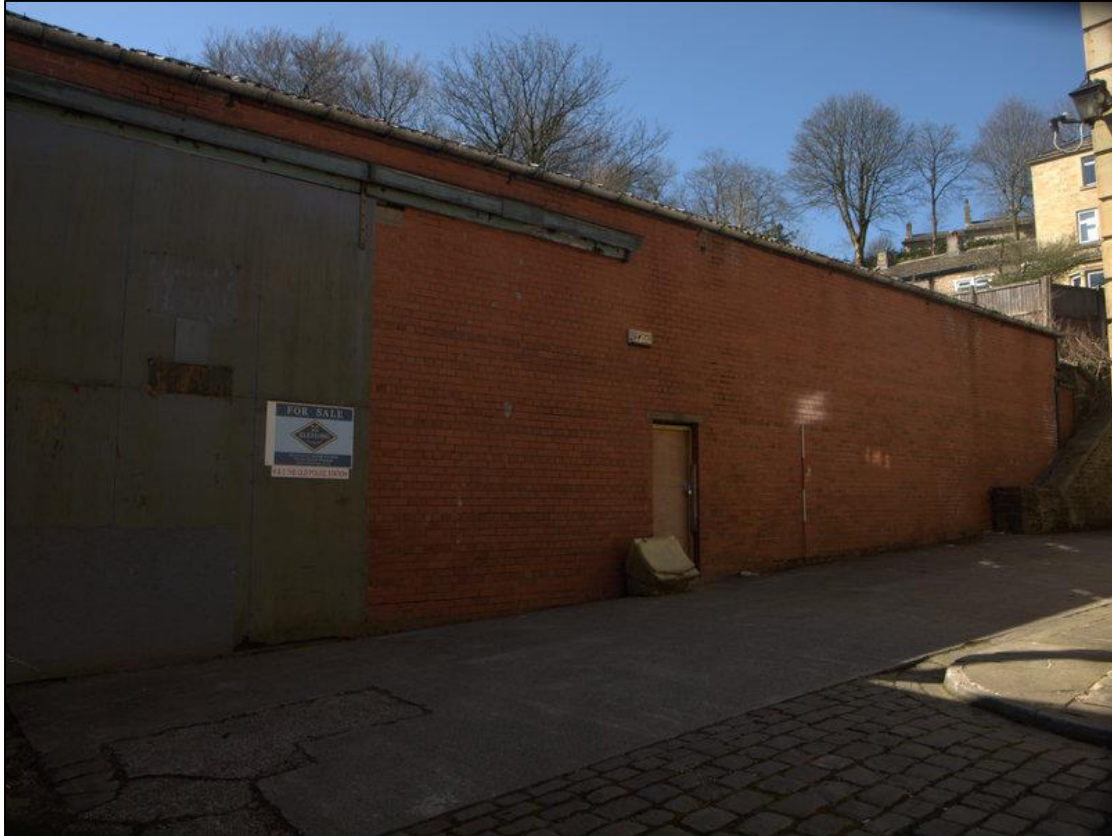
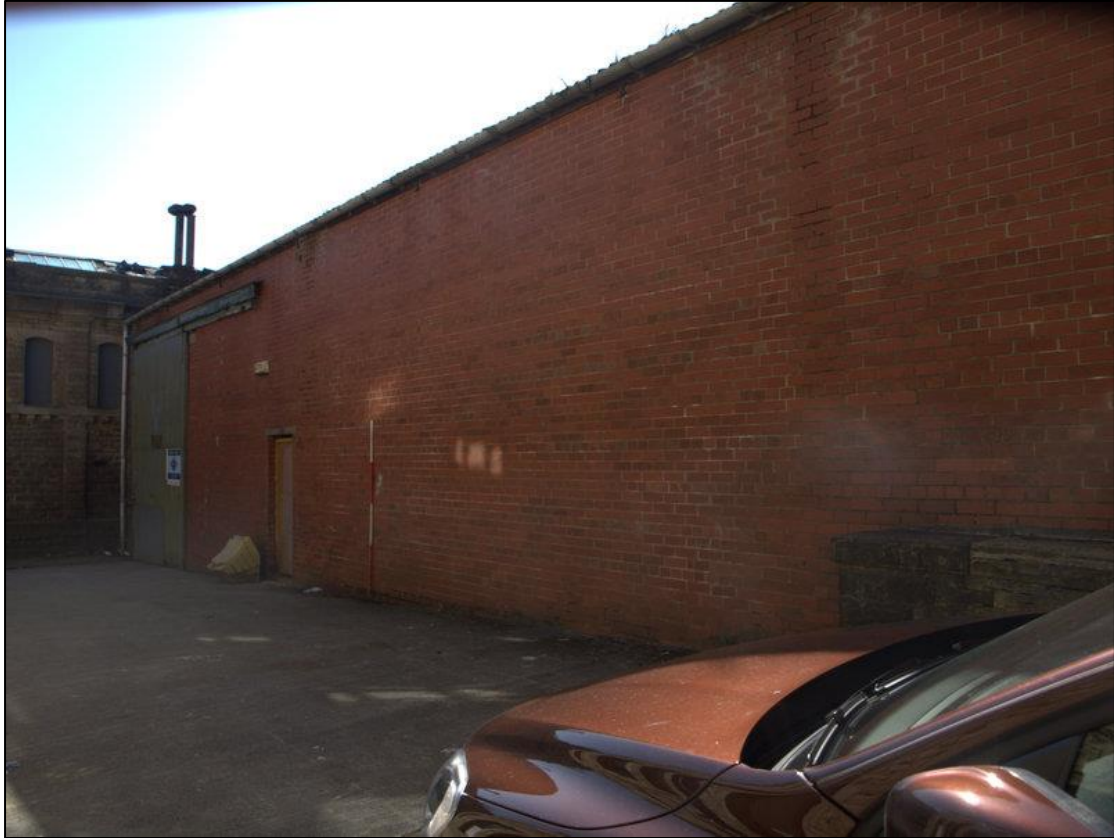
- 6.9 North elevation (Plates 47 - 49). This faces onto the southern end of Dale Street and is brick built in English Garden Wall bond (3:1). At the eastern end is a large sliding timber loading door. West of this is a small personnel doorway with sandstone lintel. The remainder of the face is featureless and runs up to the stone boundary wall at the western end
- 6.10 South elevation (Plates 50 - 51). As with the north elevation this face is constructed in English Garden Wall bond although with stretcher bond above. The face is featureless with the exception of a blocked loading doorway and blocked personnel doorway at the eastern end. Both have concrete lintels.
- 6.11 West elevation (Plates 52 – 54). This is formed by the boundary wall and is not visible due to the rising ground level. From this side however, the roof is visible.

Plate 47: North elevation of extension

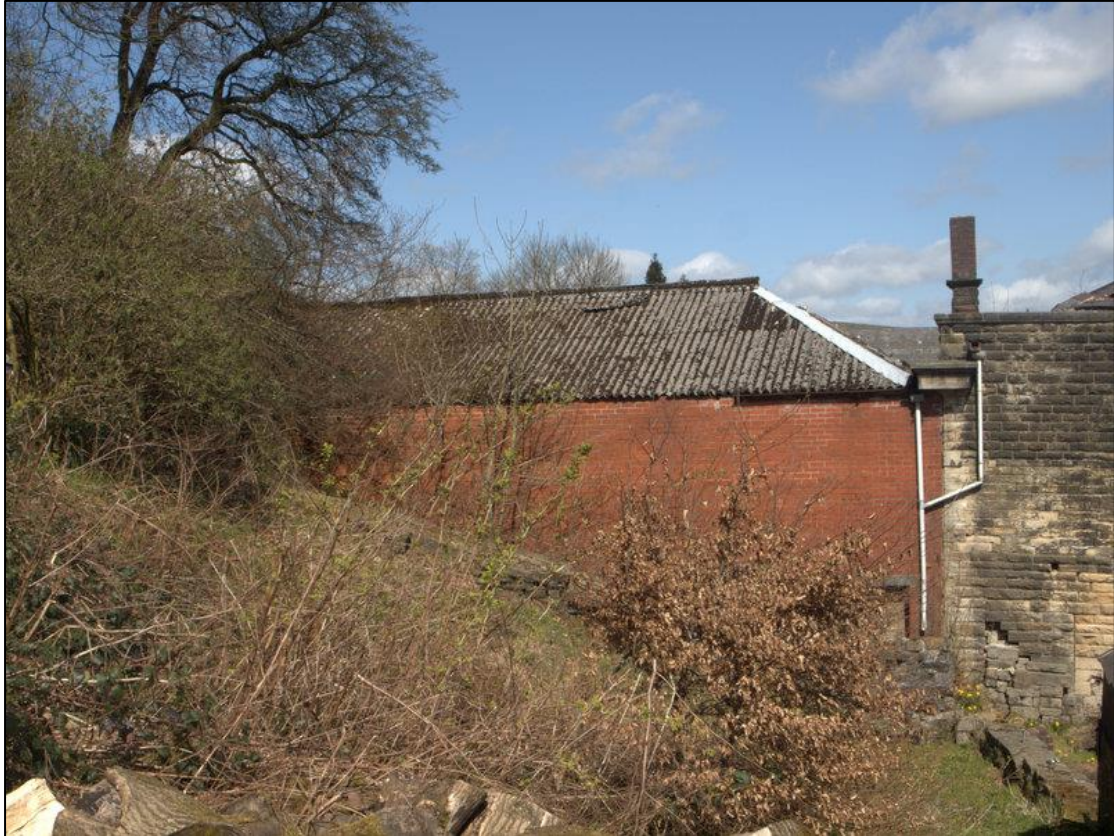
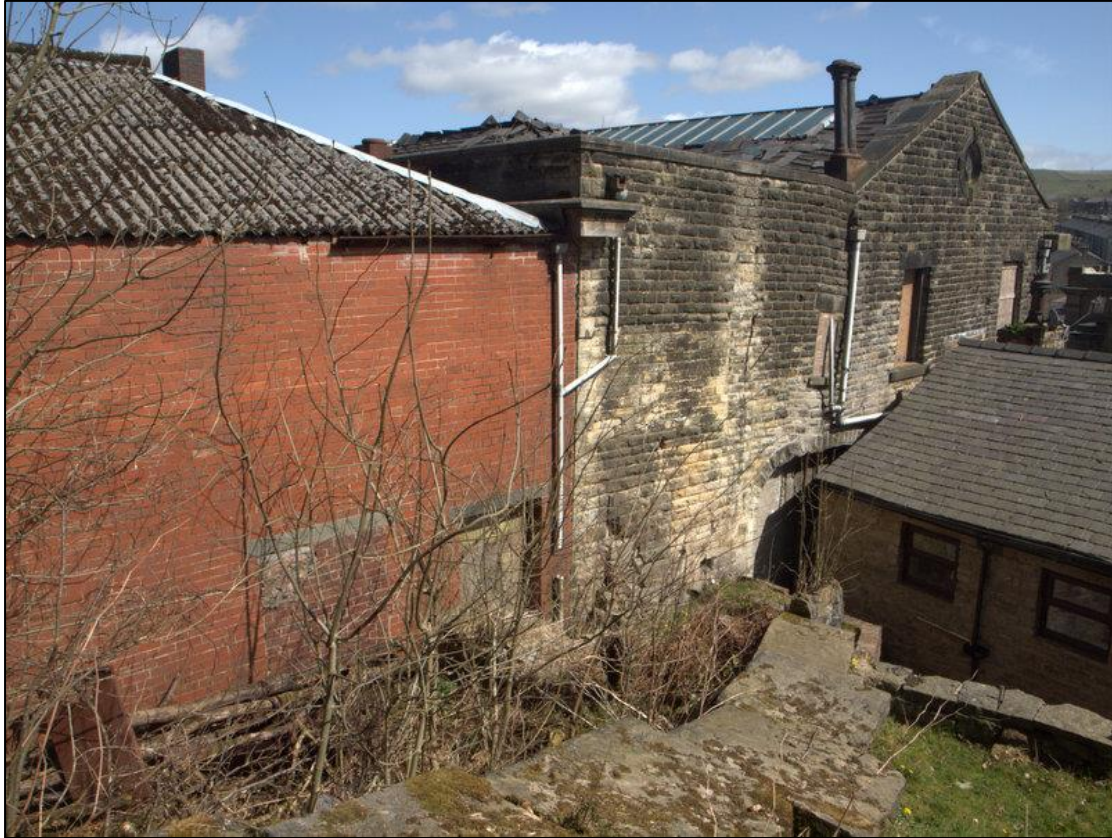
Plate 50: Southern elevation of extension

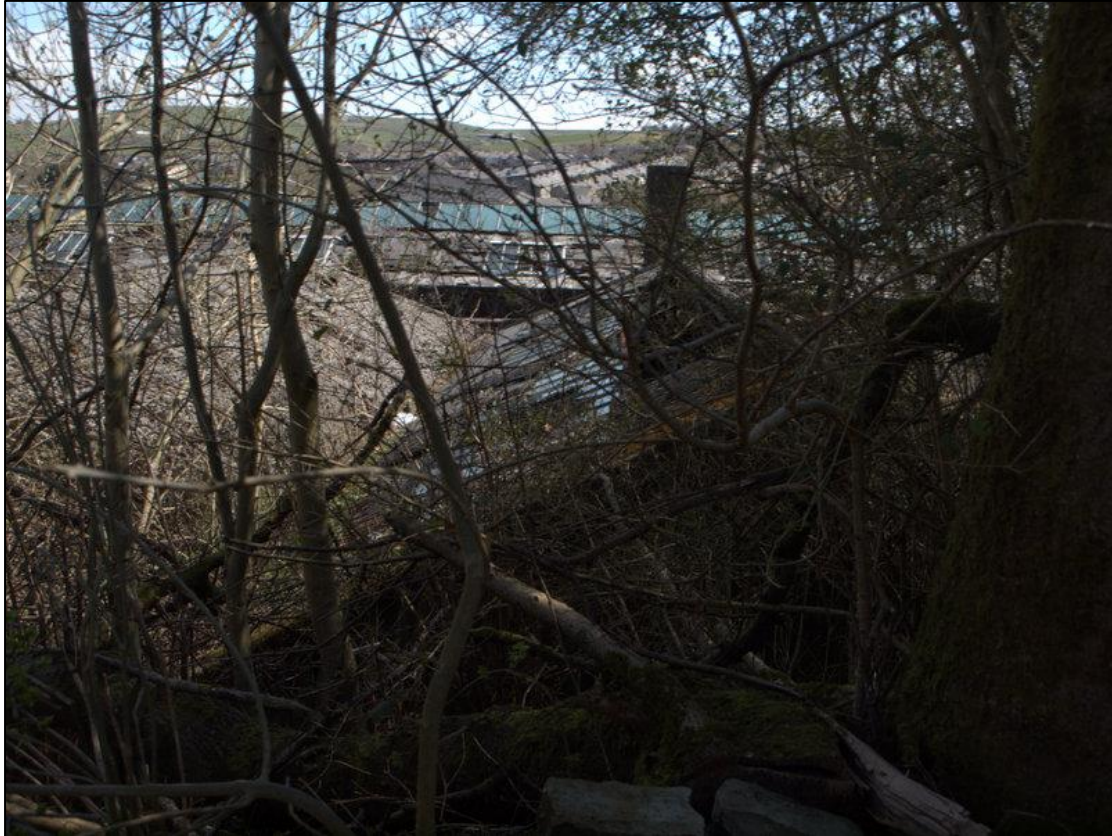
Plate 52: Extension viewed from the west showing roofs and market hall beyond

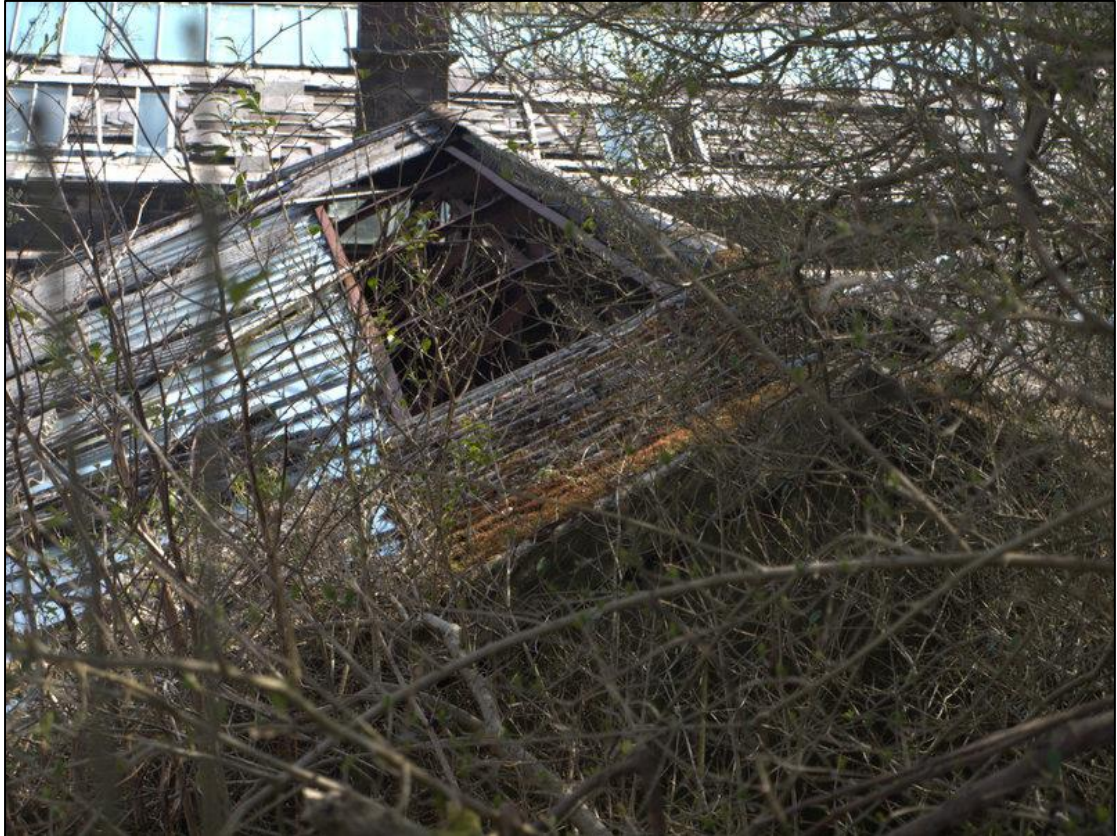
Plate 54: Detail of roof
