Duke of York, Burnley Historic Building Survey

June 2018

1.1 Steven Price of The Archaeology Co. has been commissioned to prepare a level 3 historic building survey of the Duke of York, Colne Rd, Burnley BB10 1DT. Planning condition 4 of application APP/2017/0140 states that:

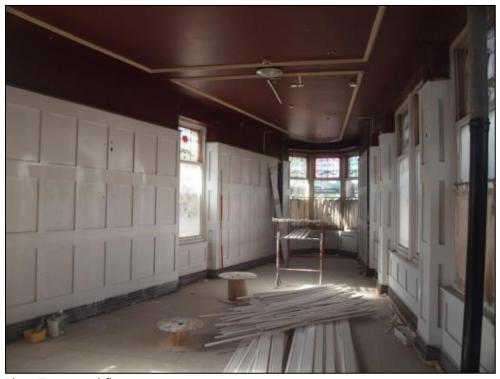
Plate 7: Ground floor room 1

- 6.5 The ground floor is divided into seven areas. At the southern end is room 1, a triangular room at the southern end of the building (plates 7 10). This has been completely refurbished in the early 200's, after the firebomb attack. The timber panelling along the walls hides the external door visible externally at the southern end of the Southeast elevation onto Briercliffe Road. The windows have likewise been replaced along with the floor and ceiling.

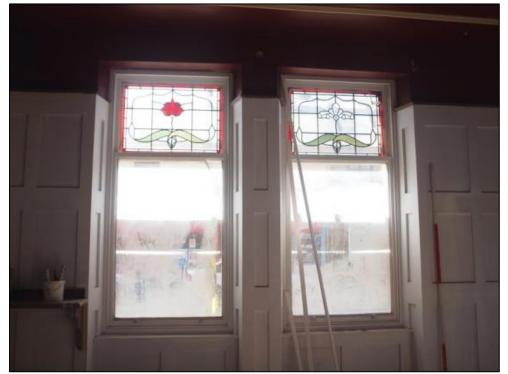
Plate 10: Ground floor room 1 windows

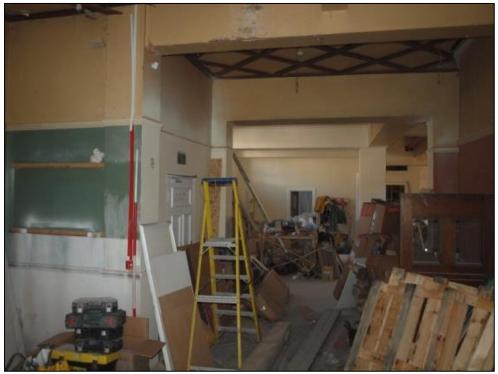
Plate 11: Ground floor room 2

- 6.9 North of room 1 is room 2 (plates 11 15), the large (former) dining area. Accessed from the southern room via a large opening in the wall the, the main entrance to the building is also located along the west side. This was inaccessible due to the presence of asbestos however. The whole room had been modernised although a plaster cornice ran around the room between the beams and denote 5 separate areas. At the east end of the north wall to the room is a cast iron fireplace with tiled surround. Opposite this is the entrance to the main staircase, room 3. To the west of the fireplace is a large opening in the wall leading through to the lounge (room 4) and the northern corridor (room 5), with access to the kitchen (room 6) further to the west via an inserted opening.

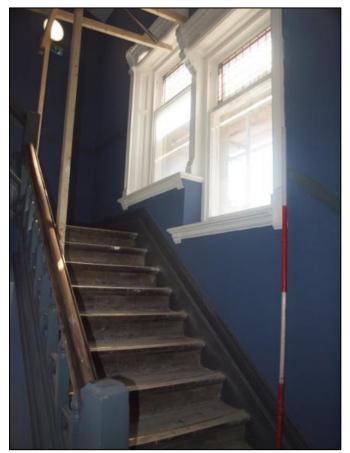
- 6.10 Room 3 (plate 16) is the main staircase and also the rear entrance to the building, from Briercliffe Road. The staircase has a moulded timber handrail and carved timber balusters with a simple square newel post. A timber staircase to the basement is also accessed here.

Plate 16: Ground floor room 3 – Main staircase

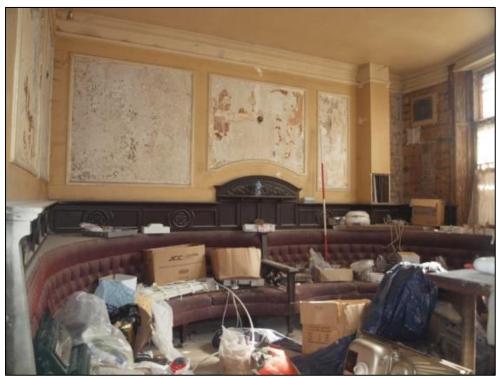
Plate 17: Ground floor room 4

- 6.11 Room 4 (plates 17 20) is the lounge, with a tiled fireplace with timber surround set in the southern wall, backing onto the fireplace or room 2. Built in seating lines the west, north and south walls, with decorative timber panelling above. The wall above this is plastered with moulded timber 'frames' across. A picture rail runs around the room at a high level, as a part of a cornice, which s different to the cornice found in the rest of the ground floor.

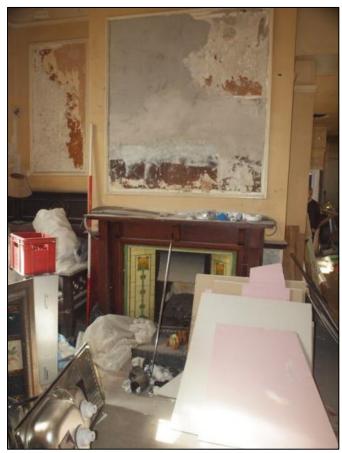
Plate 19: Ground floor room 4 fireplace

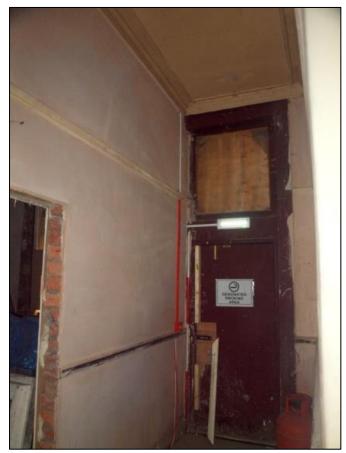
Plate 21: Ground floor room 5

- 6.12 Room 5 (plate 21) is the northern corridor. This 'L' shaped, running north before turning east to run behind the lounge to the fire exit door. The walls are plastered and a picture rail runs around the walls, along with a cornice which continues from room 2. At the northern end of the west wall an inserted doorway leads through to the northern end of the kitchen (room 6) and a doorway in the west end of the north wall leads into the disabled toilet (room 7).

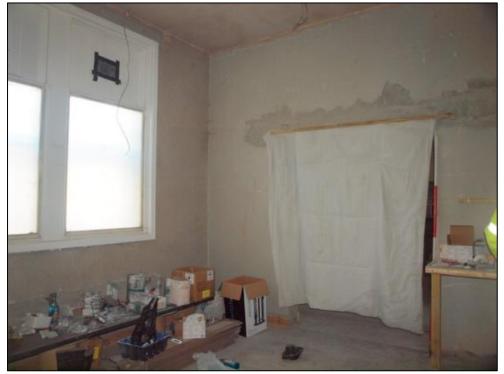
Plate 22: Ground floor room 6

- 6.13 Room 6 (Plates 22 & 23) is the kitchen, accessed via room 2 through an inserted opening through a former fireplace. The room is divided into a southern and northern area, with a wide inserted opening in the adjoin wall. In the southern part, a doorway in the northern end of the east wall leads through to the northern corridor, with a similar although inserted, doorway at the southern end of the same wall in the northern section. The room has no skirting, cornice or picture rail and been completely stripped. A doorway in the north end of the east wall gives access to the stone staircase to the basement.

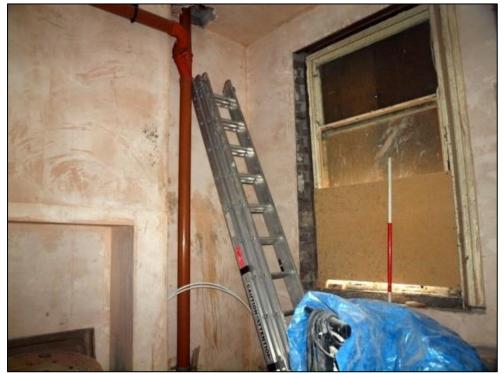
Plate 24: Ground floor room 7

- 6.14 Room 7 (plate 24) is the former disabled toilet, accessed via the northern corridor. The room has been stripped and re-plastered, although the remains of a fireplace are in the west end of the north wall.

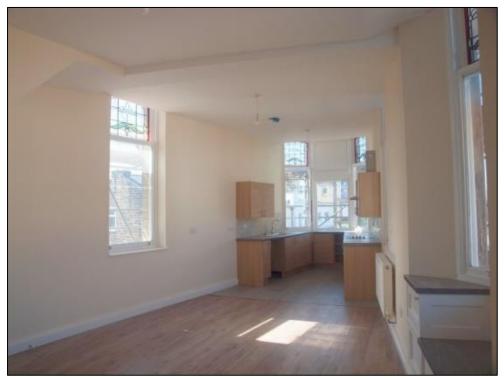
Plate 25: First floor southern end

6.15 (Plates 25 – 65) Both of these have been extensively modified and altered to create a series of 4 flats at each floor. Little has been retained, with fireplaces blocked and any skirting, rails or cornicing having been removed. However, a few of the windows still retain the decorative moulded timber surround and panelling (Plates 42 – 43).

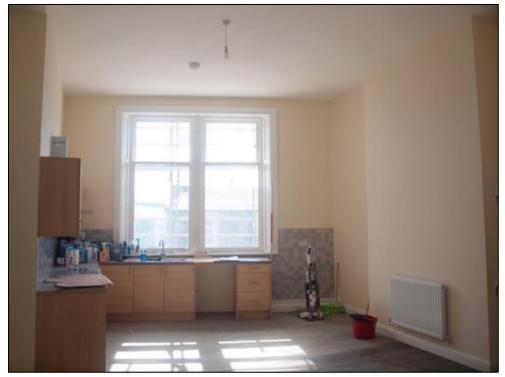
Plate 37; First floor room

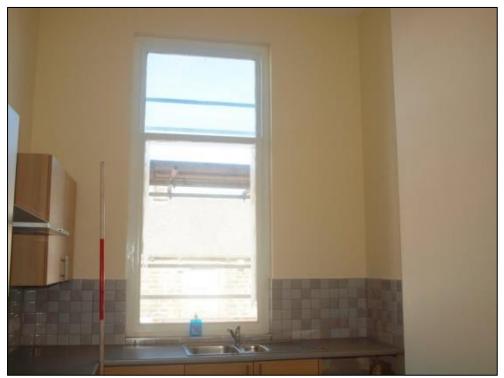
Plate 41: First floor sash window

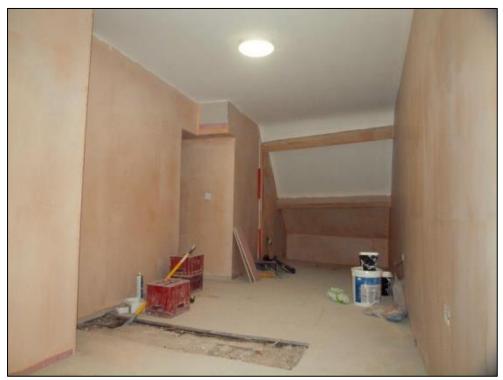
6.16 (Plates 66 – 73) Much as the first and second floors, this has been altered to create upstairs rooms for the second floor flats below. As such the former double pitched roof structure has been altered. No trusses remain visible, although machine cut timber purlins are still present.

Plate 67: Converted attic space

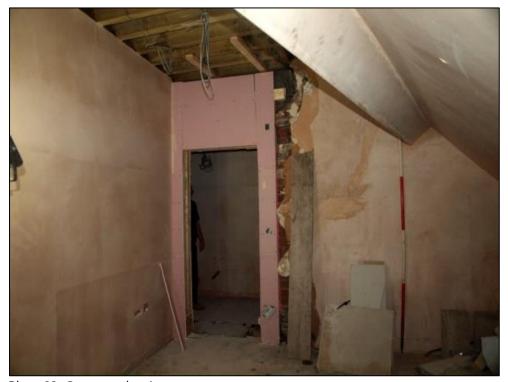
Plate 68: Converted attic space

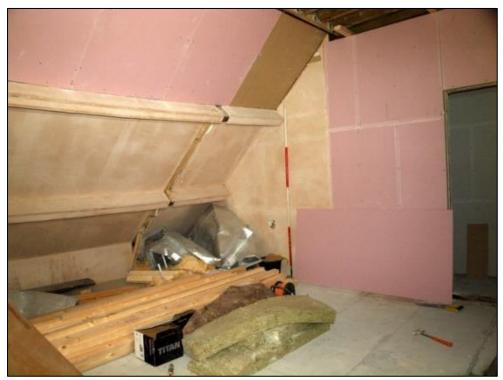
Plate 69: Converted attic space showing purlins

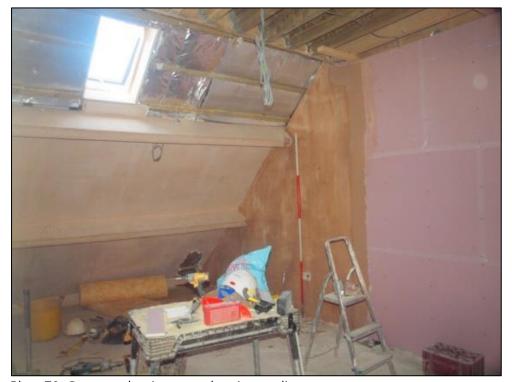
Plate 70: Converted attic space showing purlins
