THE ARCHAEOLOGY CO.

Lawns Farm, Orrell
Historic Building Survey

July 2018

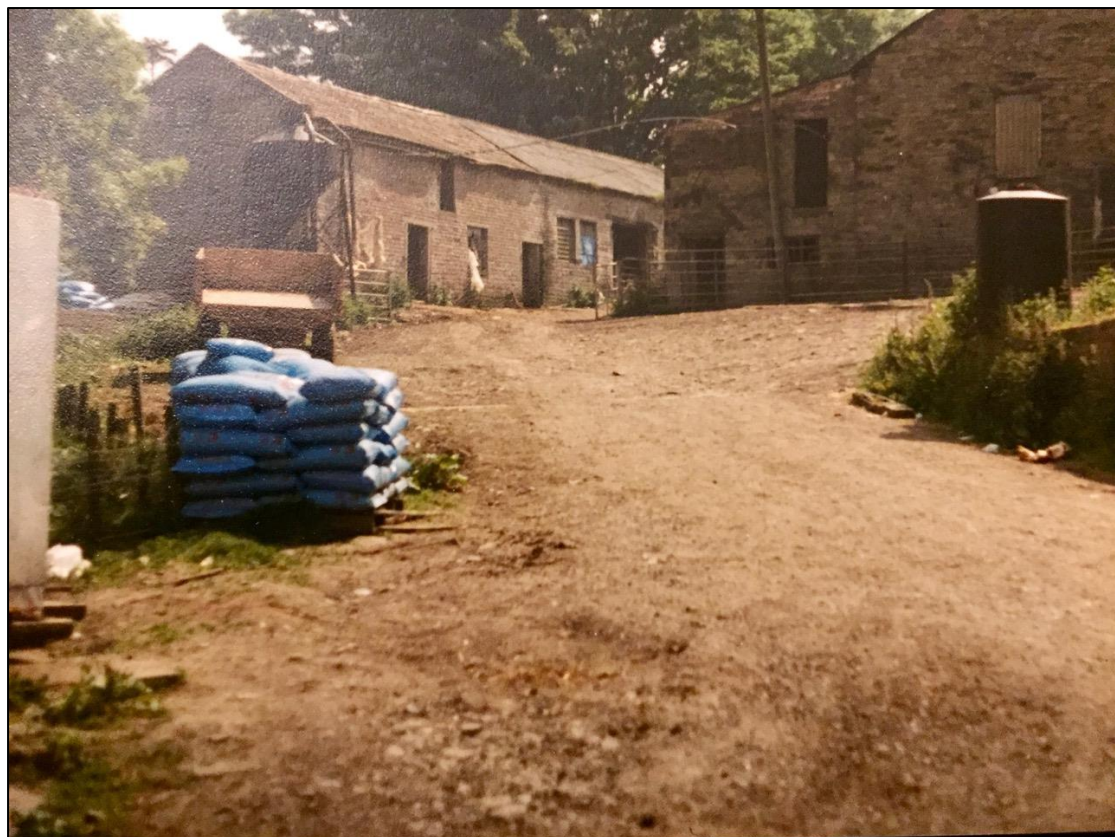
- 7.2 Barn 2 was erected in the second half of the 19th century. The building has been substantially altered both internally and externally, making analysis difficult. However, the long rectangular shape suggests that it may have been used for storage initially. The OS maps show that it was divided into many more rooms than it is now and may have been used for both agricultural and industrial purposes. However, it is apparent that it was later converted for use as a shippon, with a long feeding passage inserted down the southeast side. This may have been done before the Quakers occupation, being blocked up again for use as workshops in the 1930's. The southwestern end of the building appears on 1890's OS mapping, although the physical evidence suggests that this was in the form of a lean-to, rather than a part of the original building. The Dutch barn was erected by the time of the 1970's OS mapping and replaced some of the former building. Figure 8 shows this end of the barn before the Dutch barn was erected, but after it was shortened to make way for it. The frontage can be seen to be very different to how it is at present.

Figure 8: Undated photo showing barn 2 (left) and barn 1 (right). Note how different the frontage to barn 2 is to how it is shown on plate 1.

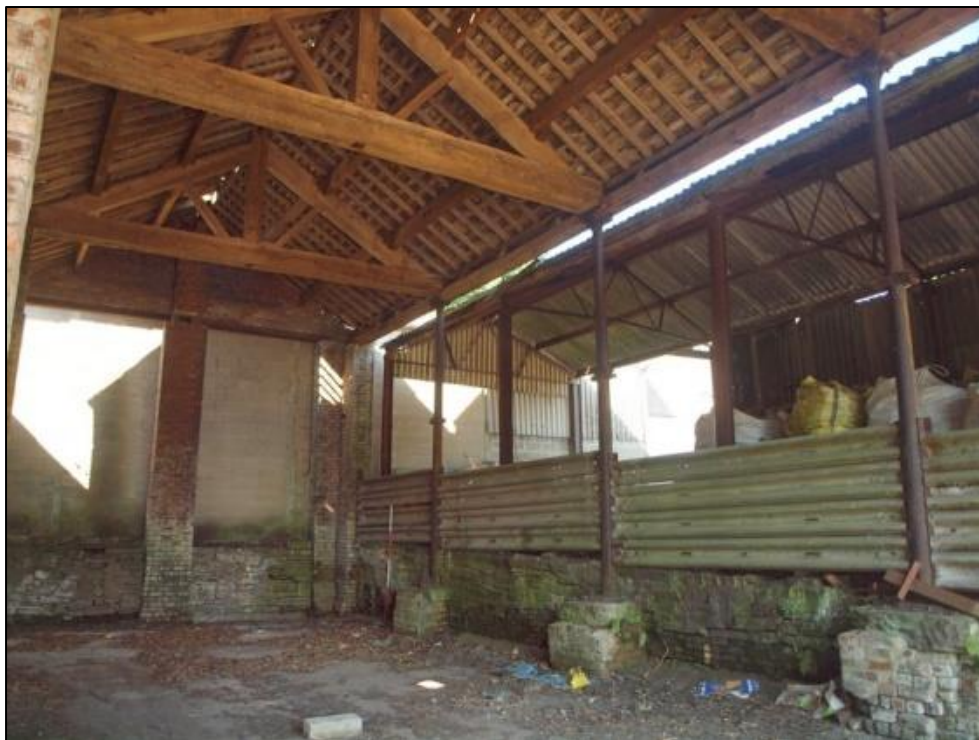
Plate 14: Interior of Dutch barn

- 6.10 (Plates 12 - 15). The Dutch barn is constructed from a series of brick piers on all side supporting three machine cut timber king post trusses. The exception to this is the northwest side, which has cast iron stanchions set on brick bases supporting the trusses. Between the brick piers on the south west and northwest walls low stone walls have been inserted. The southeast wall is the former external elevation of the barn. This has an inserted landscape window at the southerwestern end without a frame. To the northeast is a large doorway blocked with concrete blocks. A rail above shows where a sliding door once hung. This doorway is set within a much larger blocked opening, the blocking here being of a rough sandstone rubble and marking the location of a former barn door. A timber lintel remains across part of the top.

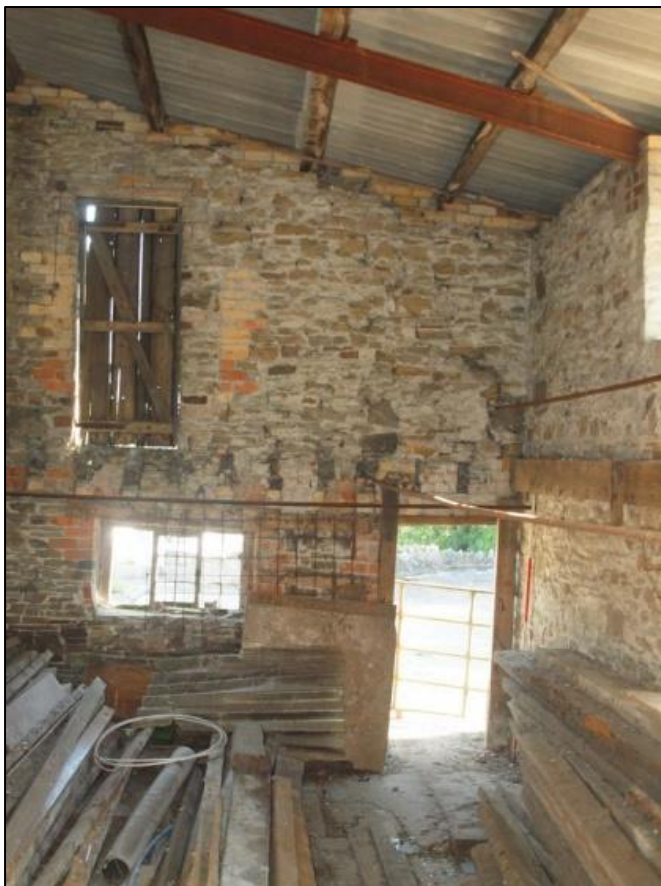
Plate 22: Eastern lean-to room

- 6.12 (Plates 22 - 25). The eastern lean-to room is accessed externally via the door in the northeast elevation. The floor to the room is stone flags and the roof is supported

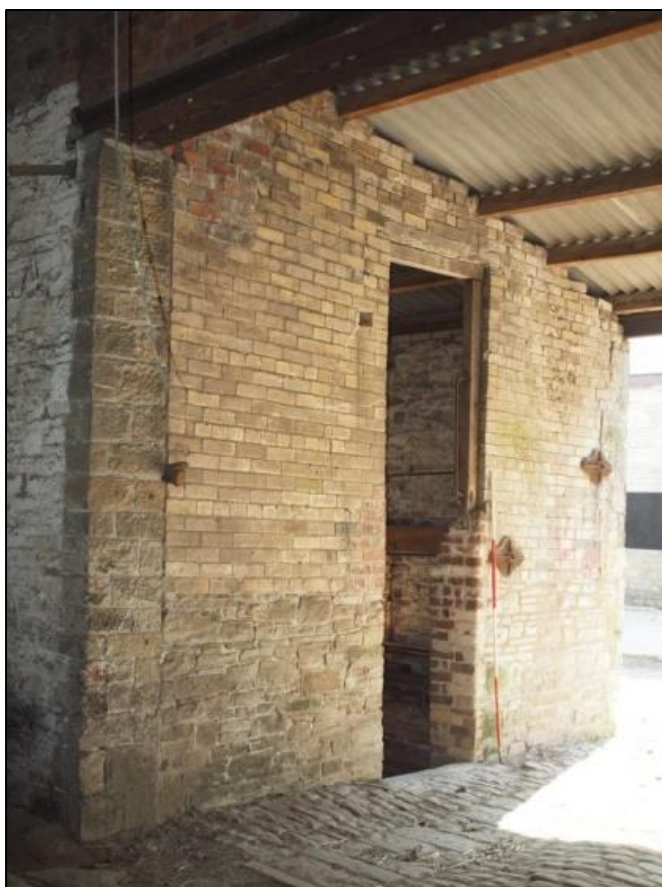
Plate 26: Passageway showing entrance eastern lean-to room

- 6.13 (Plates 26 & 27). The passage lies between the two rooms of the lean-to and runs from the former barn door. The northeastern wall is that to the eastern room. This is stone built at the base with brick above and the tall inserted doorway is visible. To the northwest the wall butts against the stone built jamb of the barn door. The southwest wall is that to the southern lean-to room. This has a partial concrete block wall butting the jamb of the barn door and the rest of the face is open with a large metal gate hung.

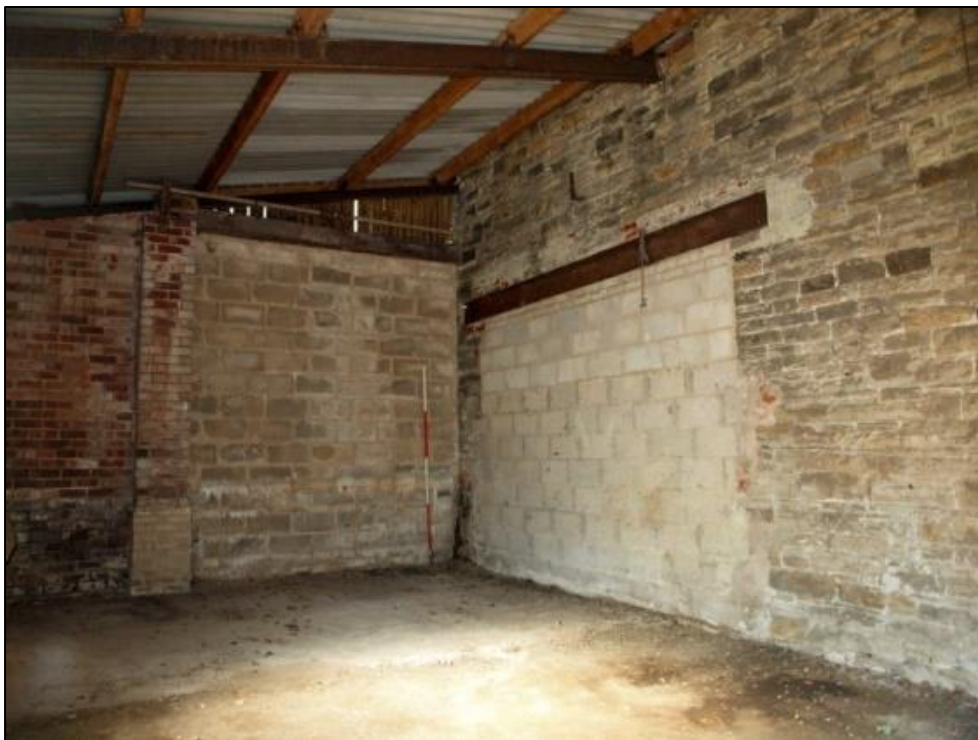
Plate 28: Southern lean-to room

- 6.14 (Plates 28 & 29). The southern lean-to room is accessed via the large metal gate in the passage. Internally the northwest wall shows the blocked loading door evident within the barn. The southwest wall also shows a similar situation to the exterior, although here the concrete block can be seen to be filling the gap between a brick pier and the barn wall. Again the southeast wall is similar to that seen externally and the roof is supported by RSJ beams.

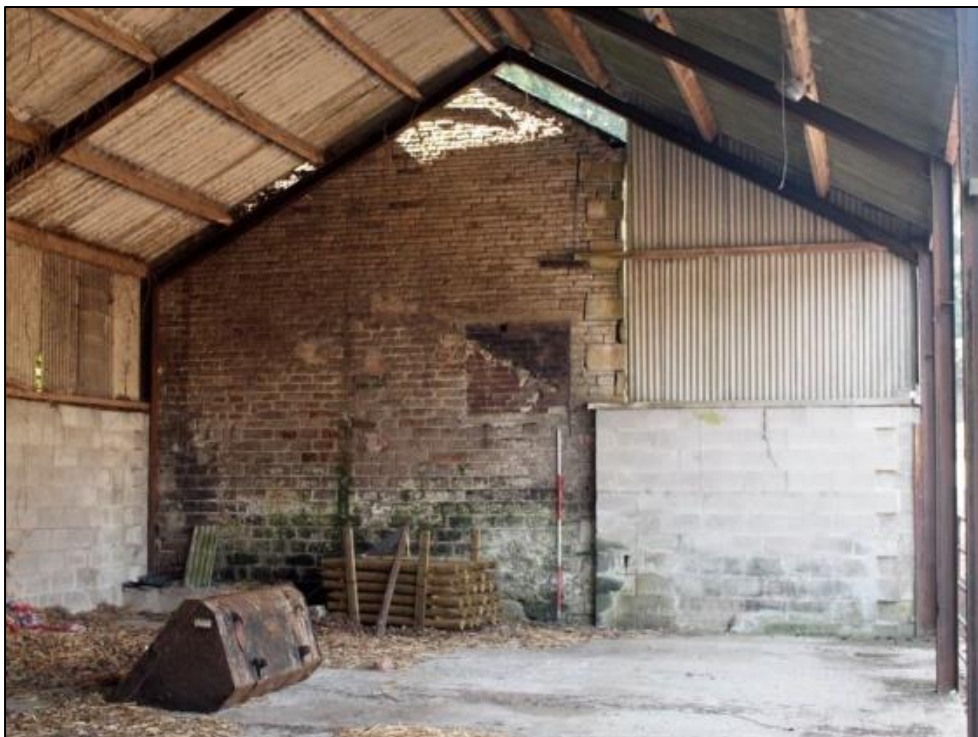
Plate 30: Northeast elevation

- 6.15 Northeast elevation (Plate 30). The northeast gable of the barn lies within the Dutch barn extension. The face is constructed of watershot sandstone blocks at low level, above which it is shaped and courses sandstone. To the north side of the face a square window with dressed sandstone lintel has been blocked. Another window lies at first floor level, mostly hidden by the roof of the Dutch barn. The

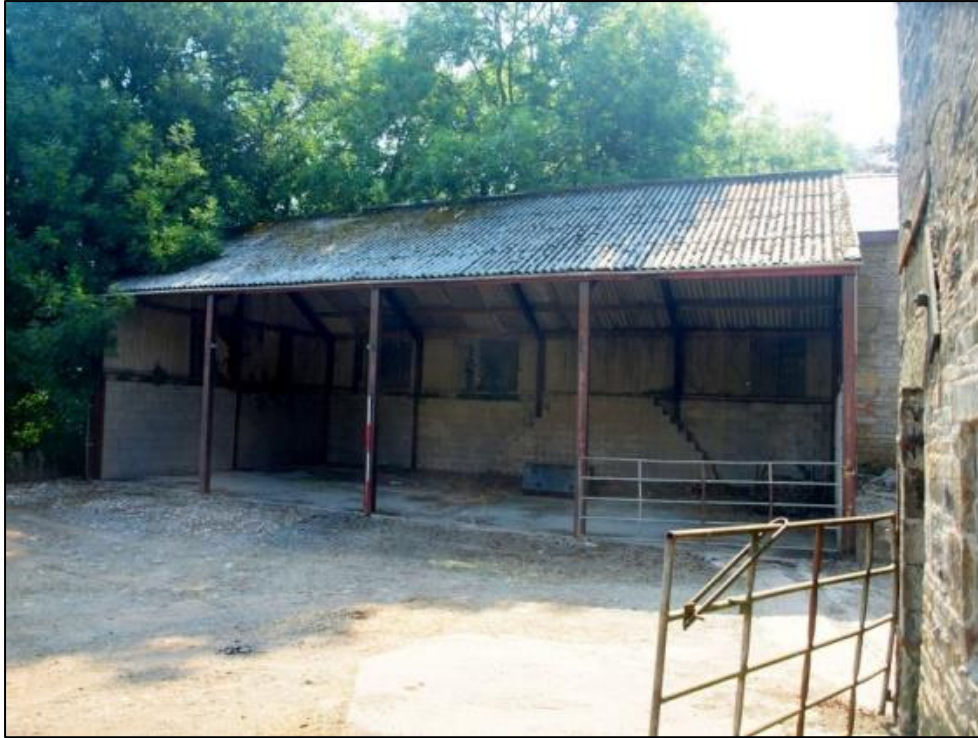
Plate 31: Northwest elevation showing Dutch barn

6.16 Northwest elevation (Plates 31 - 35). This is the main long frontage of the building and can be divided into 11 bays. At the eastern end a rough joint is barely visible, marking an area of rebuilding in bay 1 across the first floor up to bay 3. Bay 1 contains an inserted square window and bay 2 an inserted personnel doorway with large window in the rebuilt first floor section. The whole face of bay 3 has been rebuilt, containing a square window and large doorway. To the right bay 4 contains a short section of original wall before being rebuilt again, containing a pair of landscape windows. Bay 5 again has the whole of the face rebuilt and contains a doorway and square window. To the right of the window the wall is once again original, although a straight joint at the junction with bay 6 shows where the face has once again been rebuilt. This bay also contains a square window and doorway. Bay 7 contains a doorway and the wall appears to be original. Bay 8 is once again rebuilt and contains a doorway and square window. A pair of matching windows lies in the rebuilt face of bay 9. Bay 10 is rebuilt, although featureless and the rebuilding continues to bay 11, which has a wide doorway and square window. None of the doorways or windows has frames.

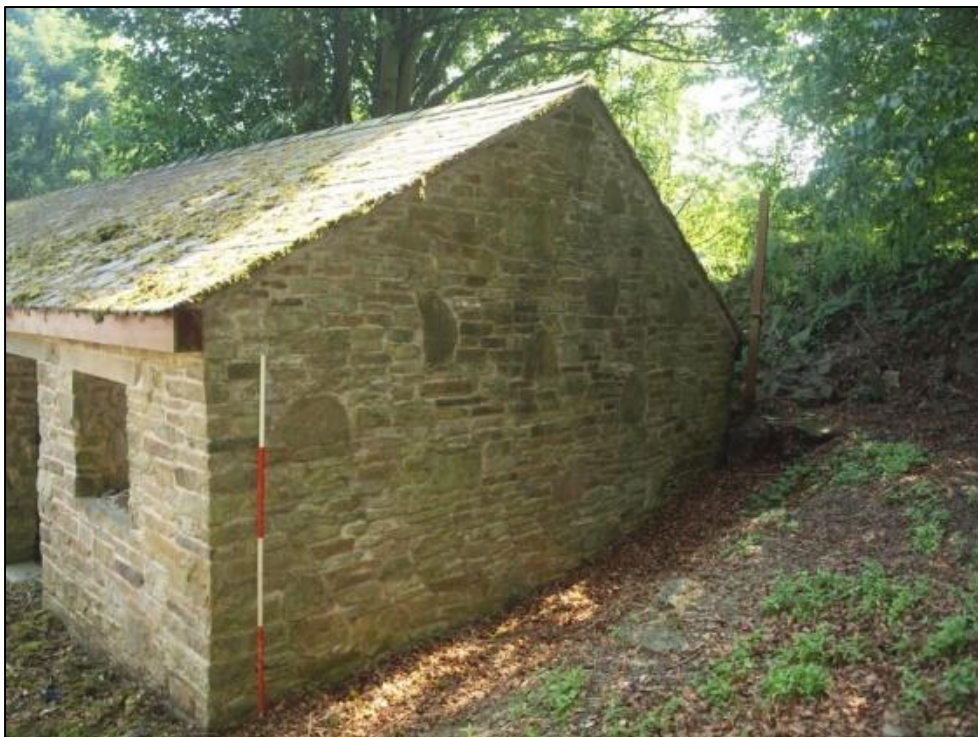
Plate 36: Southwest gable

6.17 Southwest elevation (Plate 36). This is the rebuilt gable end of the barn and is featureless.

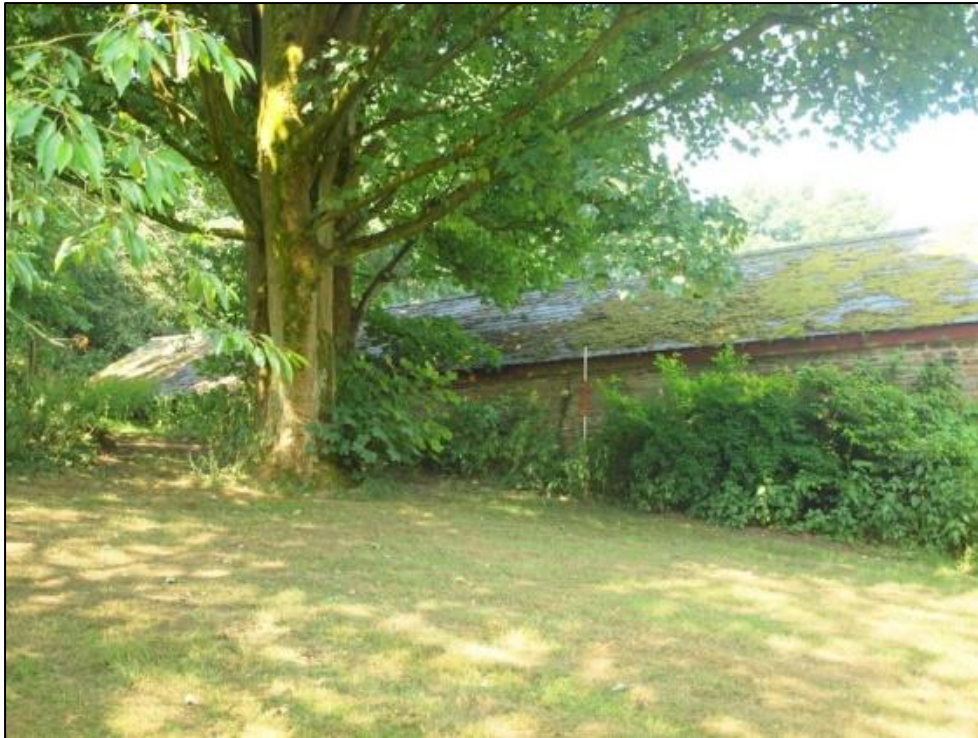
Plate 37: Southwest elevation west end

6.18 Southeast elevation (Plate 37 - 39). This elevation is constructed of sandstone rubble occasionally brought to course. It is featureless except for a blocked window in bay 11 and another across bays 7 and 8.

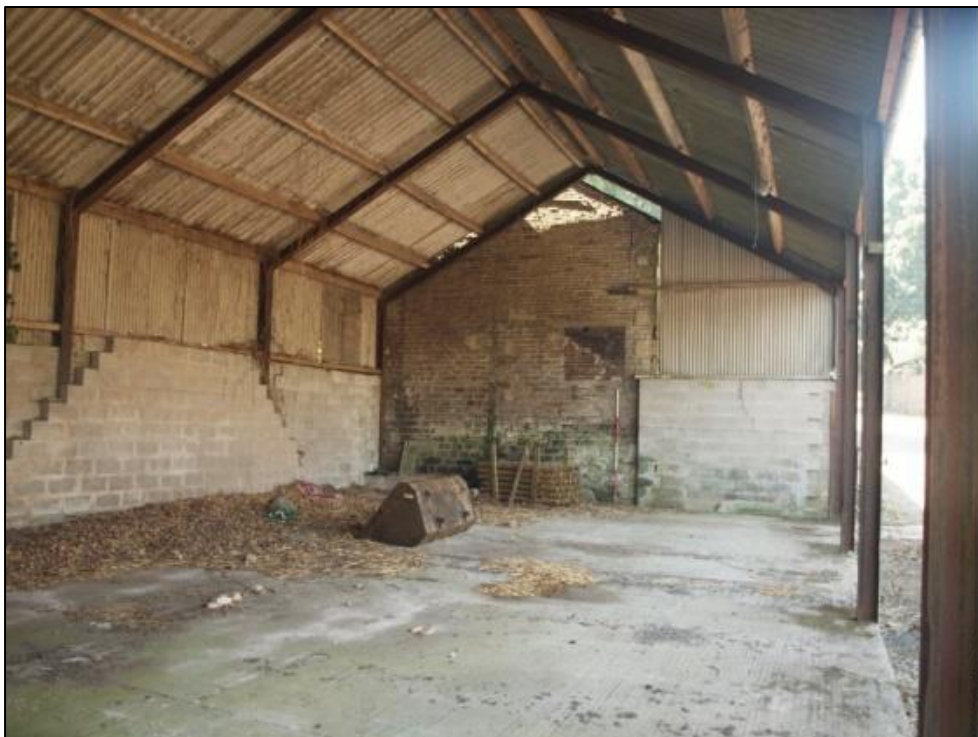
Plate 40: Dutch barn interior

6.19 The interior is comprised of 5 rooms, along with the Dutch barn. The latter is constructed of RSJ beams and concrete blocks with a corrugated sheet roof (plate 40). Room 1 (plates 41 - 43) lies to the northeast end of the barn and comprises bays 1 - 3. The room is open to the two machine cut timber king post trusses supporting the rebuilt roof and the floor is concrete. The northeast gable is much

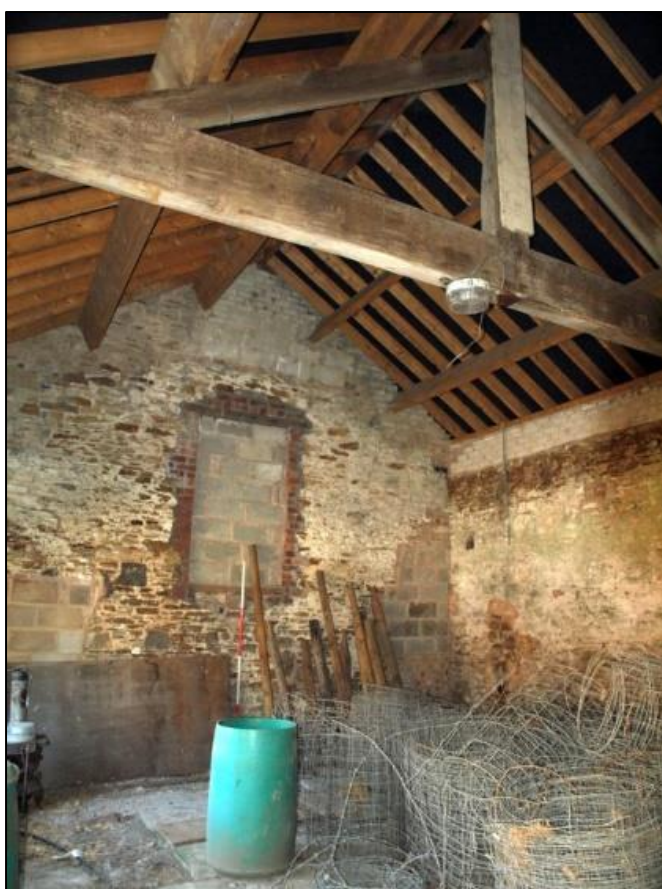
Plate 44: Room 2

6.20 Room 2 (plates 44 - 46) takes in bays 4 and 5 and has a single king post truss supporting the rebuilt room and a stone flag floor. The doorway at first floor level from room 1 is visible set within the stone wall and the surrounding brickwork shows it to have been inserted. The southeast wall is again stone, although the top part has been rebuilt in brick for the new roof. The southwest party wall to room 3 is again stone, although a straight joint to the southern side marks an area of blocking for an opening, which then extends up to the roof. The northwest wall is again mostly rebuilt, showing a concrete block construction, although the original stone is present at the eastern end, at first floor level.

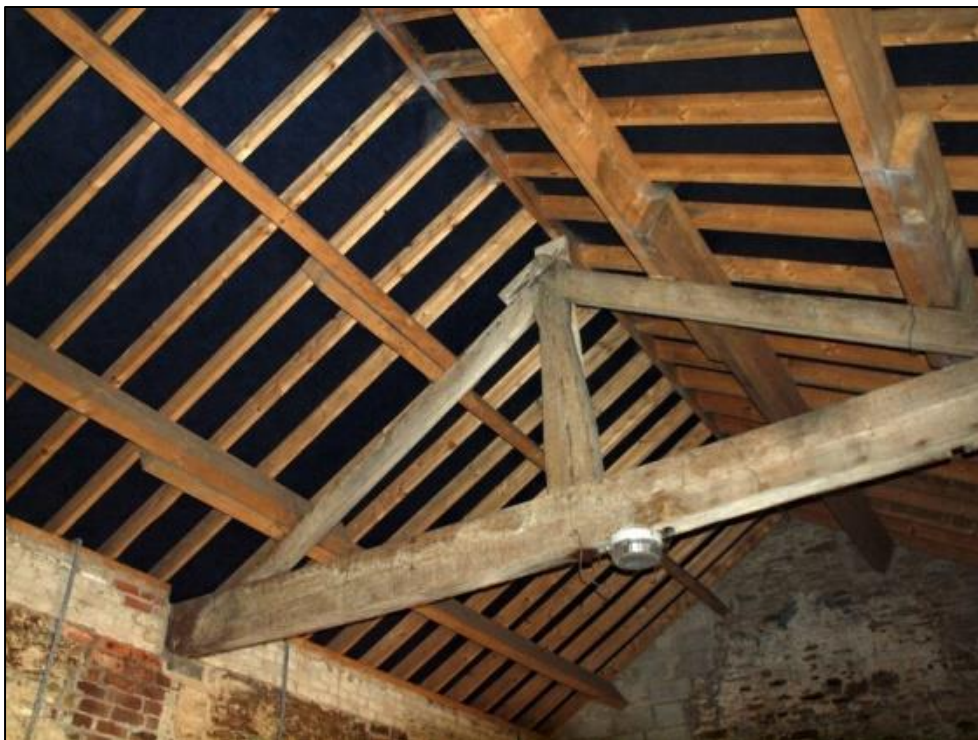
Plate 46: King post truss in room 2

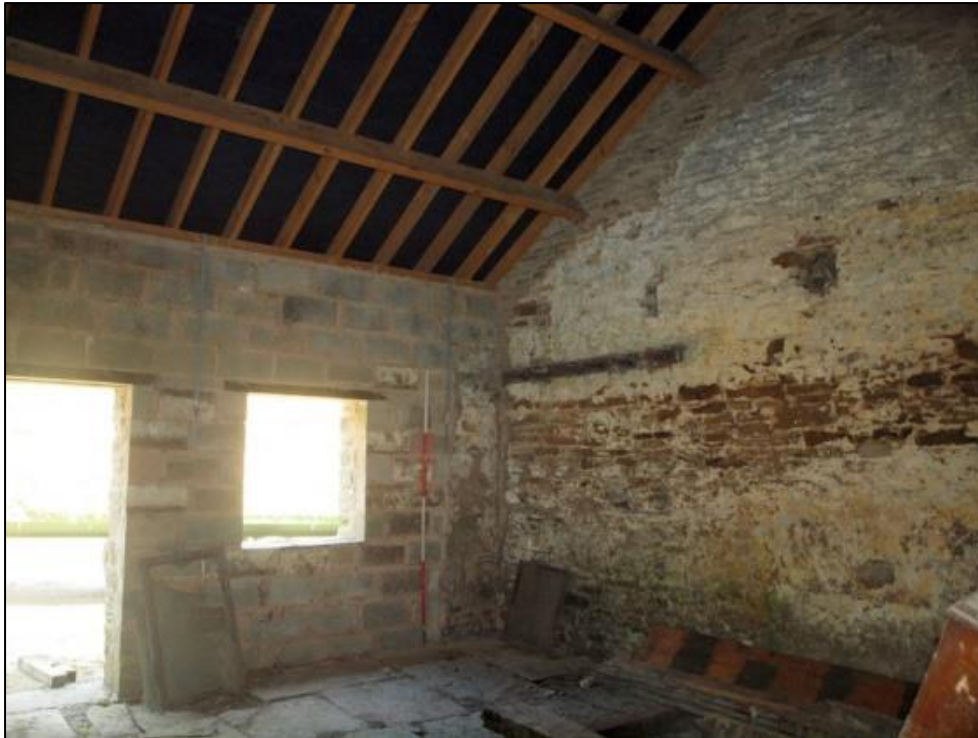
Plate 47: Room 3

6.21 Room 3 (plates 47 - 49) takes in bay 6. The eastern party wall is stone, whereas the western is stone at the base and rebuilt above in concrete block. A blocked opening again lies at the southern end. The southeast wall is again stone and the northwest wall concrete block, with a small area of stone to the east side. The floor is stone flags and a pair of stone drains run along it aligned northeast - southwest.

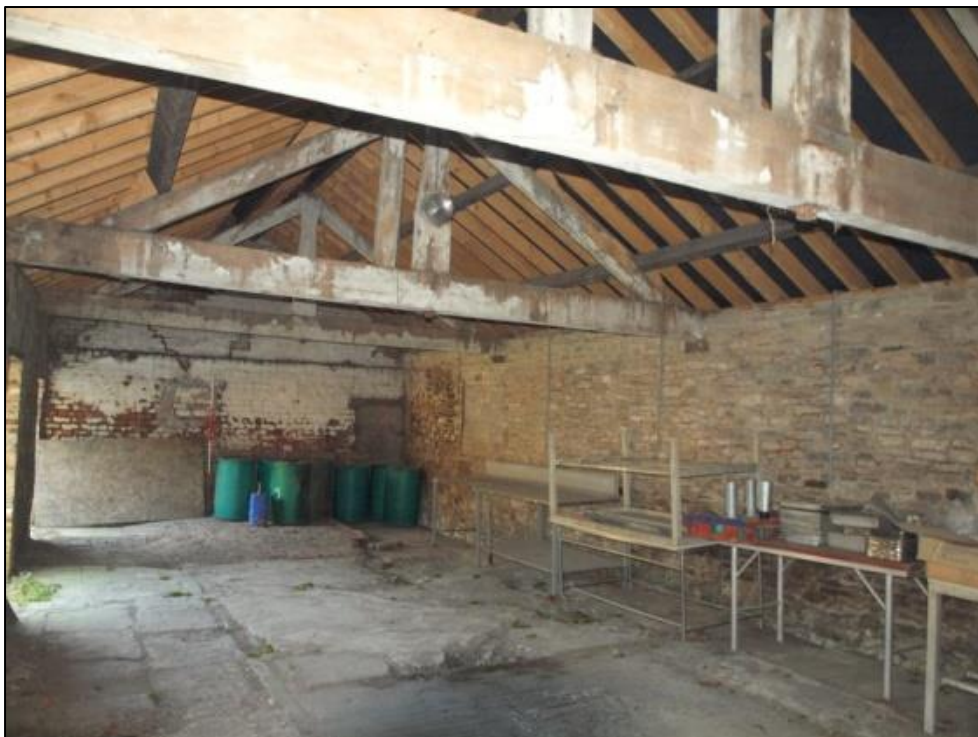
6.22 Room 4 (plates 50 - 52) takes in bays 7 - 10 and has three machine cut king post trusses supporting the rebuilt roof. The floor of the room is different, with a flagstones walkway running down the southeast wall and an area of brick to the northeast, appearing to overlay flagstones. The rest of the room has stone flags again, although partially covered in concrete render. A series of 3 lines of brick are set within this, aligned northwest - southeast and mark the location of stalls. The northeast wall is brick and a blocked doorway is visible at the end of the flagstone walkway. In the opposite wall is a similar doorway, although this one is open to

Plate 50: Room 4

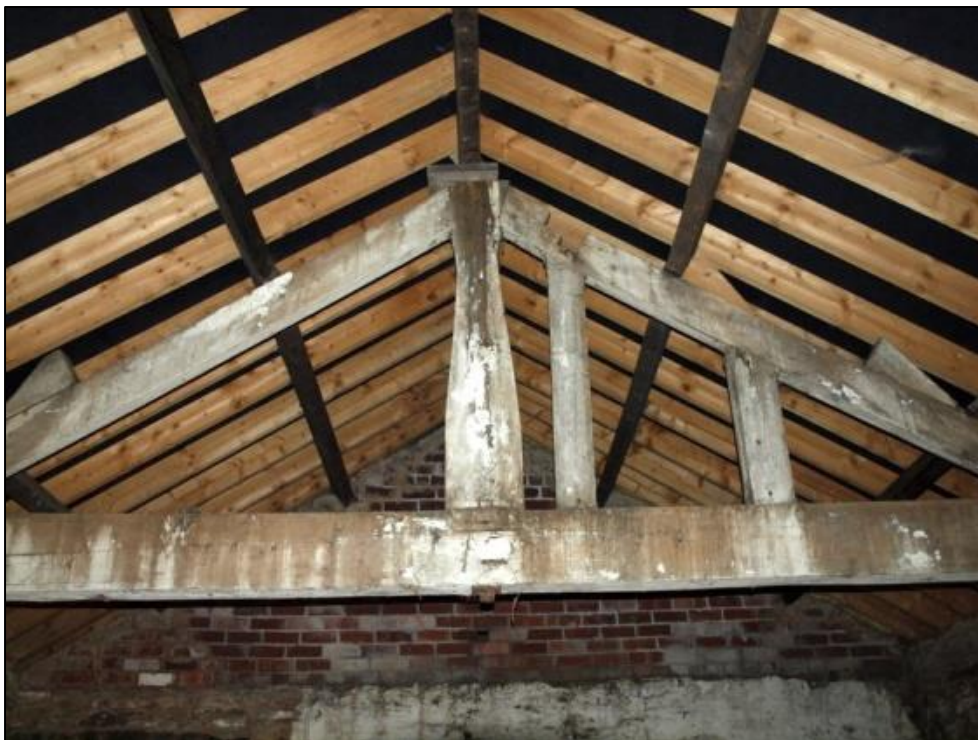
Plate 52: King post truss in room 4
