Myerscough Inn, Balderstone Historic Building Survey

July 2018

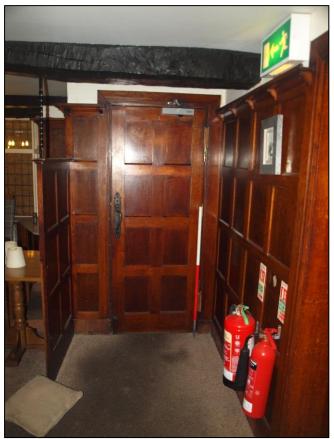
Plate 13: Entrance porch

6.6 The building was originally accessed via the doorway between bays 1 and 2 in the southeast elevation. The door is timber with a timber panelled porch internally (plates 13 & 14). This leads into the main area of the building, made up of bays 2 and 3, the dividing wall having been removed (plates 15 – 18). The line of the wall is marked by a pier with RSj beam spanning the width of the building, hidden within a false beam. Several further beams have been inserted, with a timber covering, although some original timber beams remain. Within bay 2 the central and southern beams are original, running northeast – southwest. To bay three are three remaining original timber beams, although these are aligned northwest –

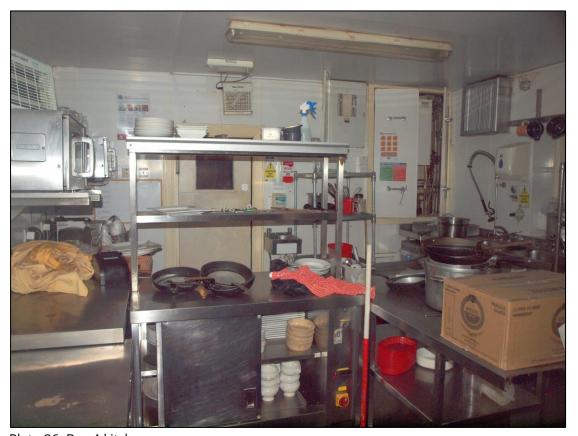
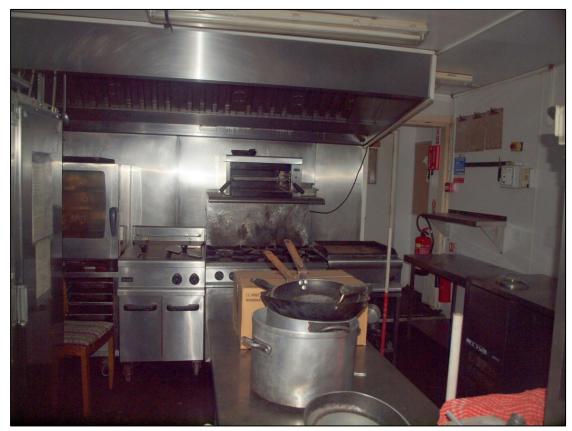
- 6.7 At the southeastern end of bay 1 is a small room (plates 19 22) accessed via doorway in the wall separating it from bay 2. This contains a fireplace in the southwest wall, with a woodburning stove inserted. The bays window in the southeast wall is spanned by a modern timber beam and an adze cut timber beam spans the room from southeast to northwest. The northwestern room of bay 1 is also accessed via bay 2. This is has been fitted out as a WC (plate 23) at the northern end with an access corridor to the southeast. In the northern corner of the bay a set of stone sets have been inserted leading down to the cellar. These steps are accessed via the corridor. To the northeast are the steps to first floor level and the rear porch (Plates 24 & 25). Bay 4 is accessed through doorways in the party wall with bay 3. To the northwest the room has been fitted out with a modern kitchen (plates 26 & 27) and to the southeast the room is a modern bathroom (plates 28 & 29).

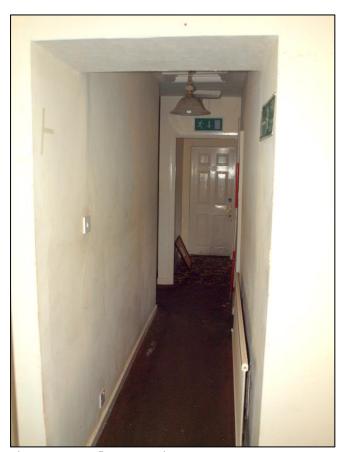
Plate 30: First floor corridor

- 6.8 The first floor is accessed via a set of timber steps inserted in the northern corner of bay 2. The steps lead onto the southwestern end of a corridor which runs the length of the building (plates 30 & 31), with rooms accessed from it to the northwest and southeast. At the southwestern end of the corridor a doorway leads into bedroom 1, but to the northwest of this, at the top of the stairs, a wall scar marks the location of a removed wall. To the northeast an inserted opening to bay 3 continues the corridor into this bay. Here however, the whole corridor has been shifted to the northwest. A set of steps run up the corridor to the northeast leading to an inserted opening into bay 4.

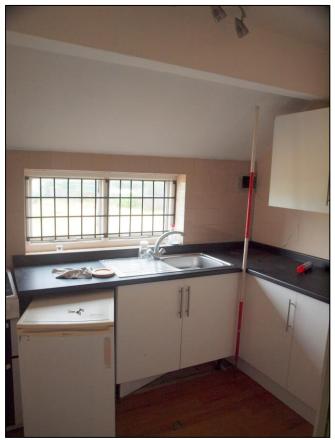
Plate 35: Kitchen

- 6.9 On the northwest side of bay 2 is a kitchen (plate 35), the window in the northwest wall being a later insertion to rise above the level of the counter tops. To the southeast is bedroom 3 (plates 36 & 37). This is larger than bedroom 2 and has a bathroom inserted in the northern corner. A bay window is once again in the southeastern wall and a blocked fireplace lies in the northeast wall. Bay 3 contains a large bedroom to the southeast once again (plates 38 & 39), with a bay window and inserted bathroom to the northern corner. The doorway to this room lies in the western corner of the room, the corner doorway formed from the shifting of the corridor to the northwest. On the other side of the corridor are a pair of toilets (plate 40) to the eastern end and a bathroom (plate 41) to the west. Bay 4 has had a wall inserted to create two separate rooms. To the northwest is a larger room (plates 42 & 43) with a fireplace in the northeast wall. To the southeast is a smaller room (plate 44). The southwest wall of the bay protrudes, showing it to have been an external stack and the central corridor from bay 3 cuts through it. The attic (plates 45 & 46) was visually accessible in bay 2 where no truss was found, the purlins resting on the internal brick walls. The purlins were found to be hand cut timber to the northwest and machine cut timber to the southeast.

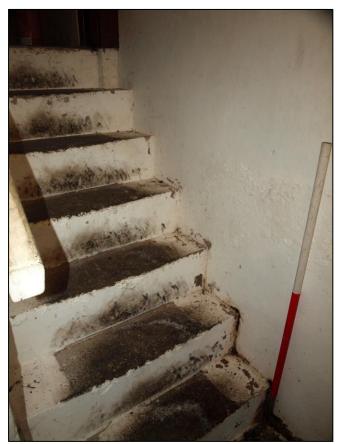
Plate 47: Cellar steps

- 6.10 The cellar (plates 47 53) is accessed via the stone staircase in its western corner. The stairs lead into a large room which lies below the northwestern end of bays 2 and 3. The walls are rendered, the floor is concrete and the timber boarded ceiling has a machine cut timber beam spanning the room from northeast southwest. In the northwestern wall is an alcove containing a timber ladder leading up to a hatch. In the northeast wall a doorway leads through to a small storage space comprised of two small rooms.
