5 - 9 Queens Road, Chorley  
Photographic Building Survey

December 2018

## **NON-TECHNICAL SUMMARY**

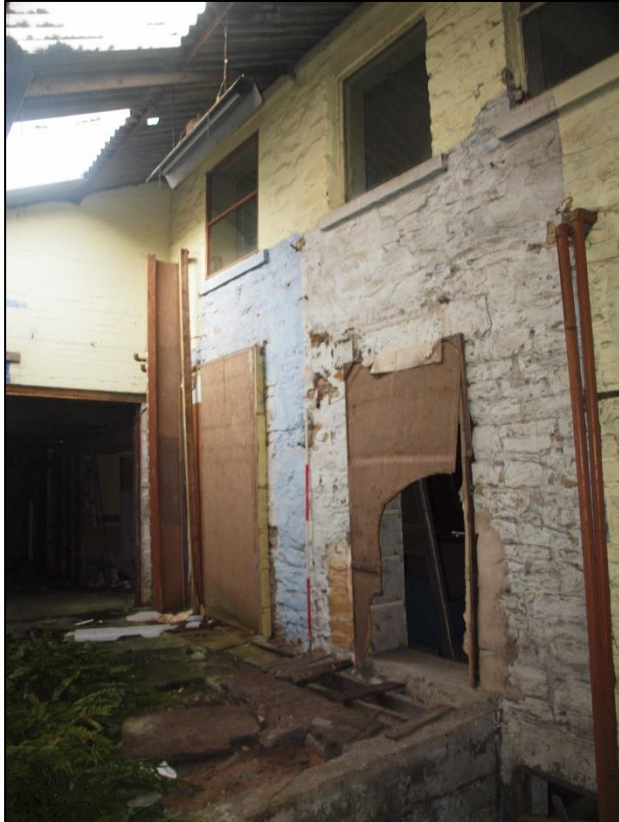
Plate 29: Former rear wall of number 5 showing blocked inserted doorways

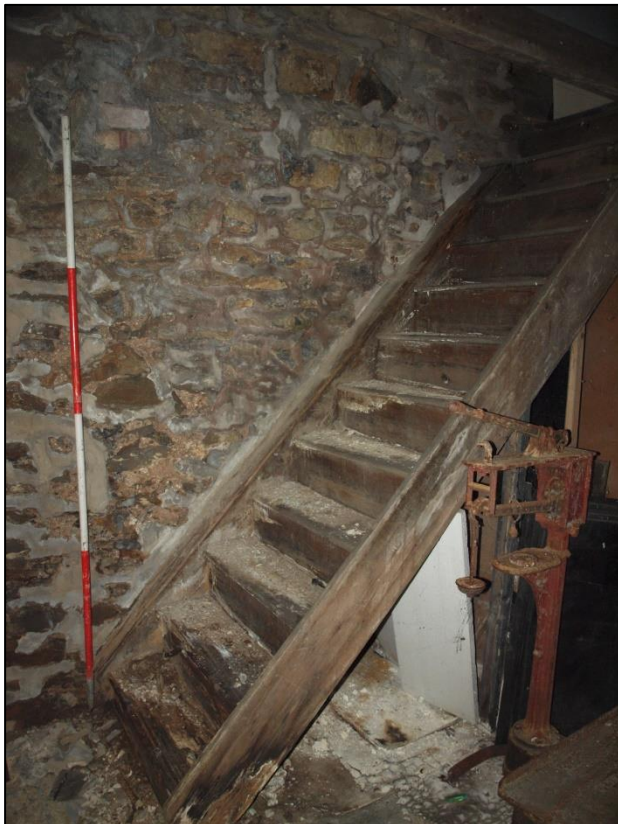
Plate 42: Staircase to first floor in Workshop

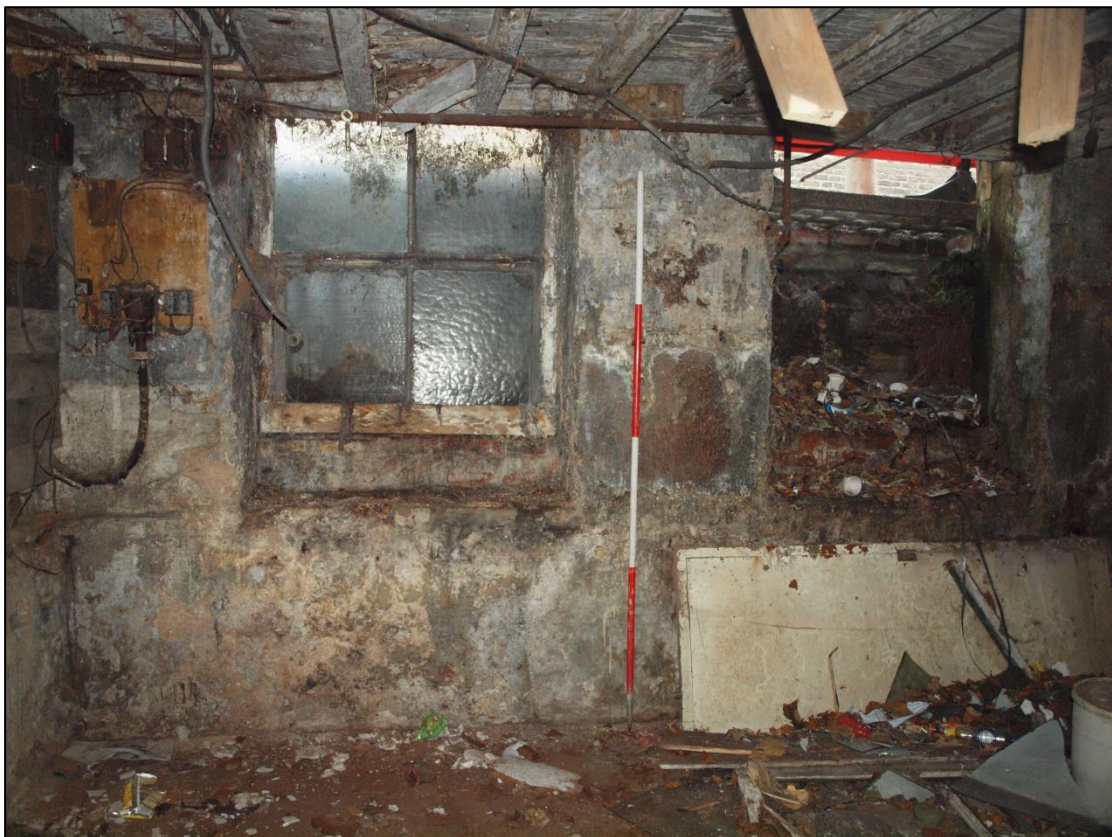
Plate 46: Detail of cellar windows

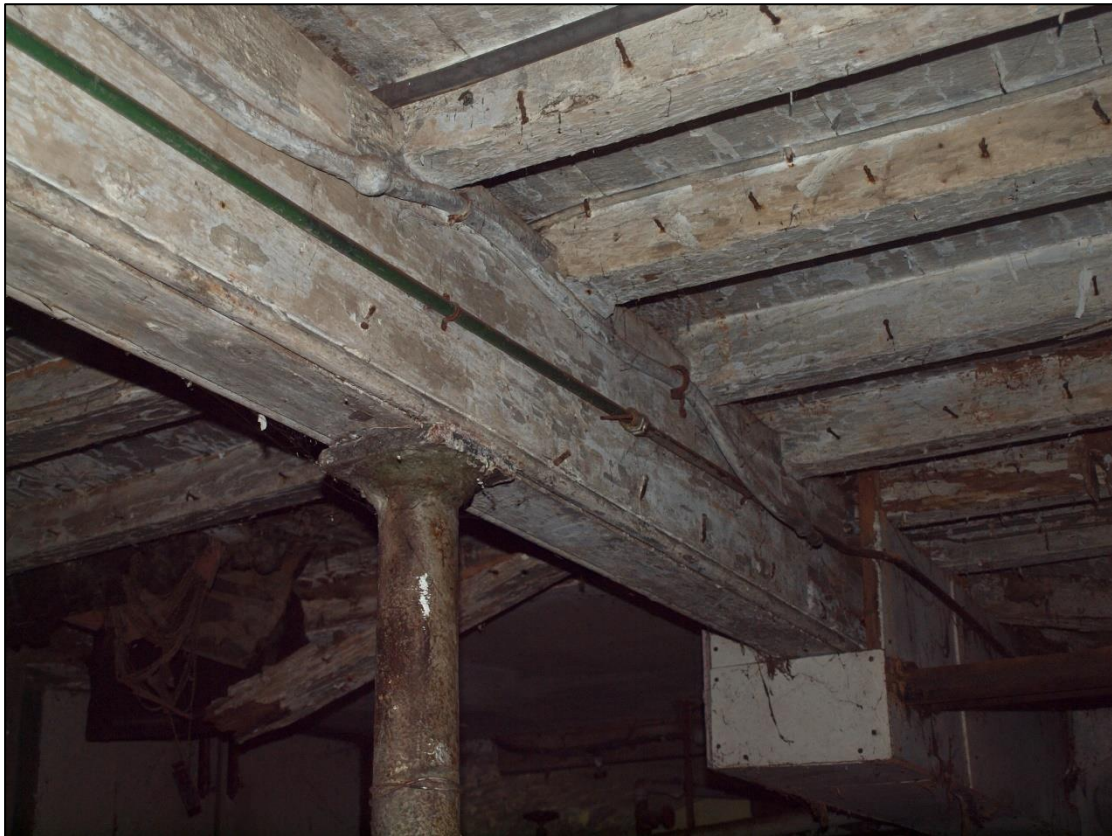
Plate 47: Detail of moulded timber beam in cellar

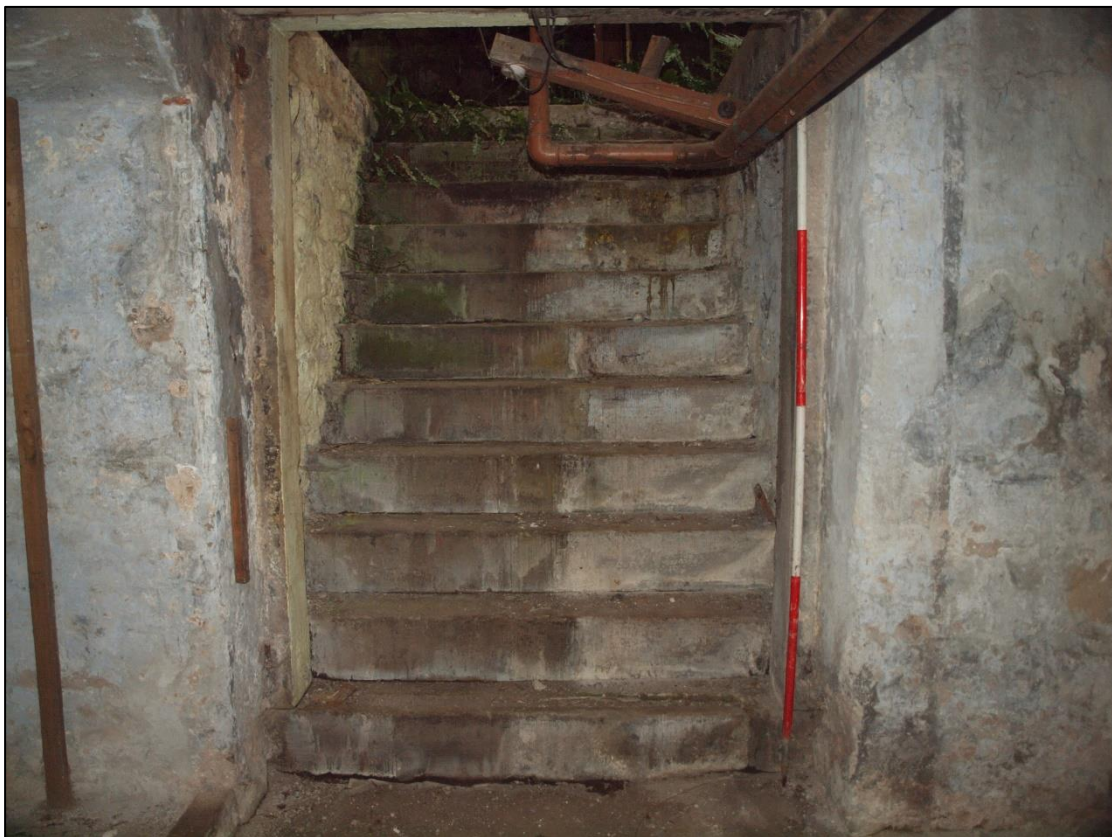
Plate 52: Concrete cellar steps

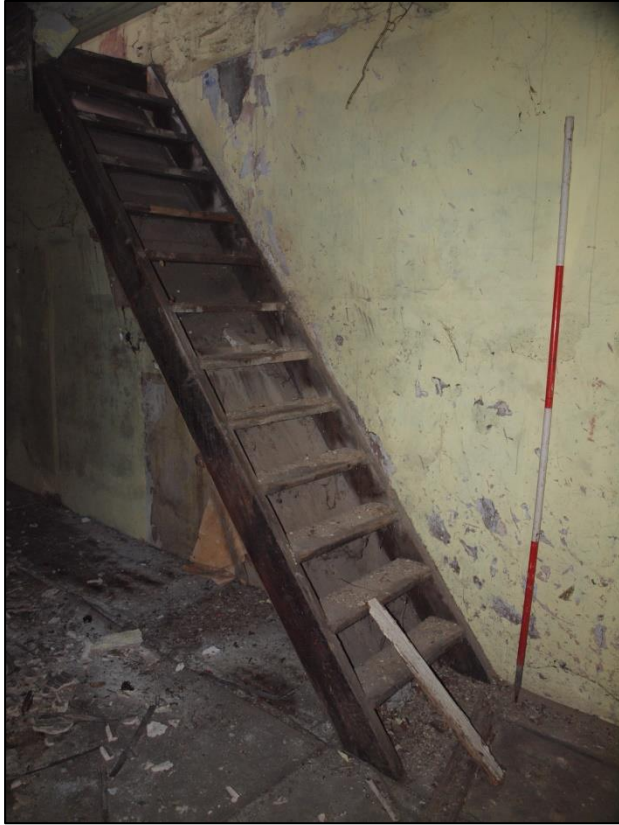
Plate 55: Staircase to attic

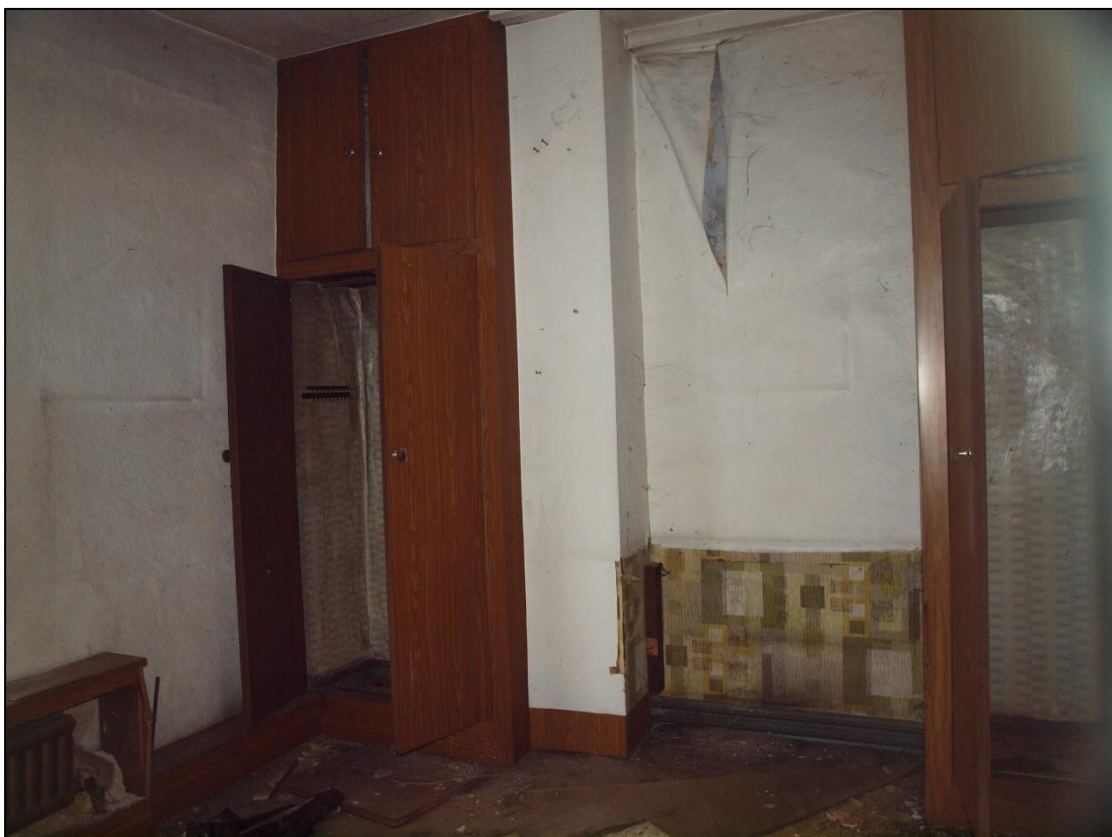
Plate 60: Livingroom at north end of number 5 first floor

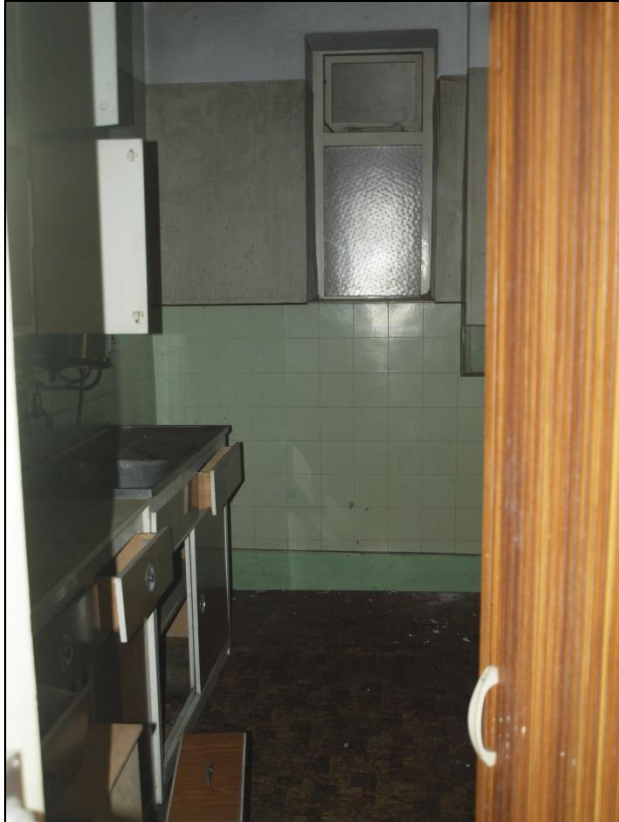
Plate 61: Kitchen at north end of number 5 first floor

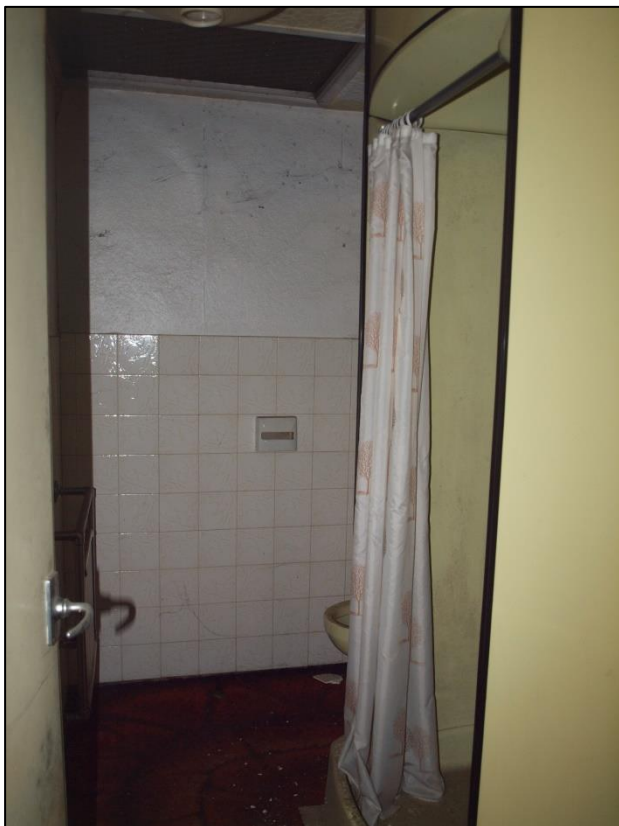
Plate 62: Bathroom at north end of number 5 first floor

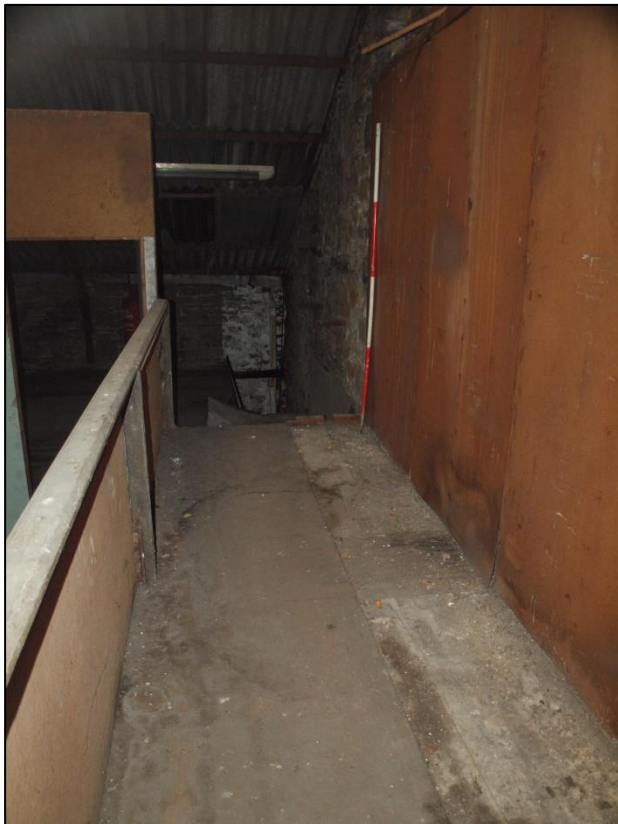
Plate 66: Walkway at first floor level

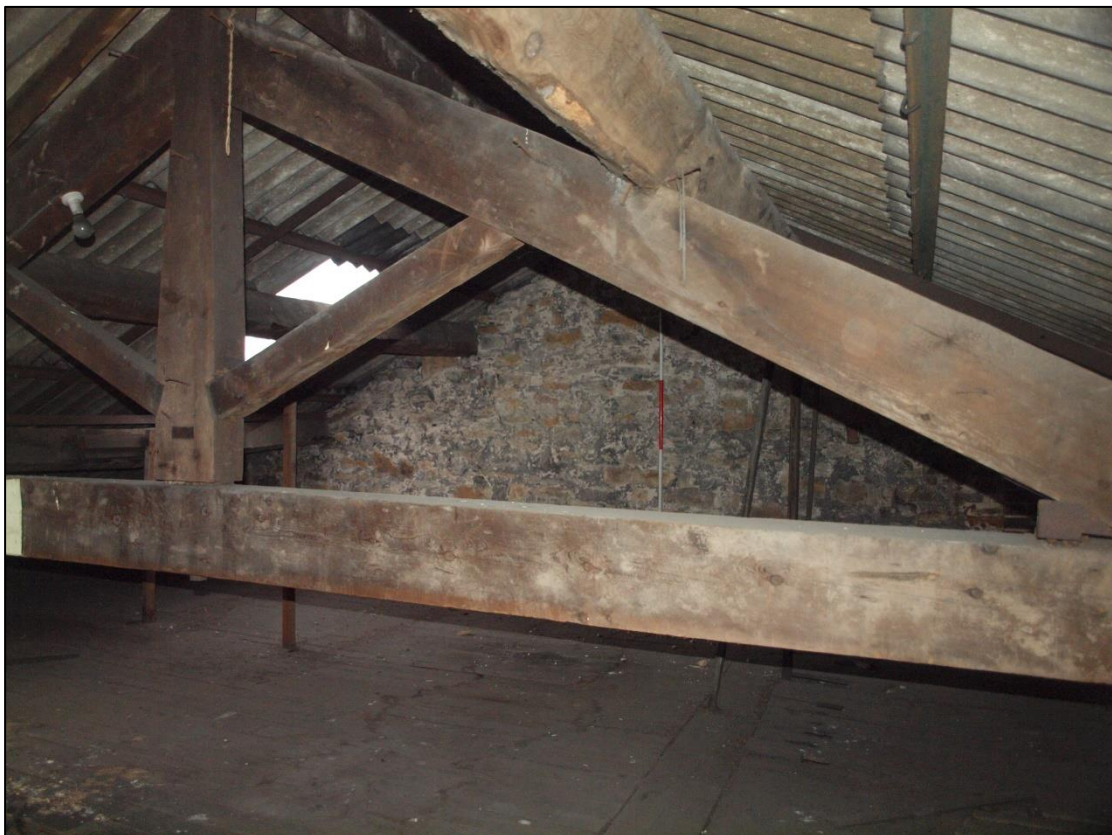
Plate 72: General shot of attic

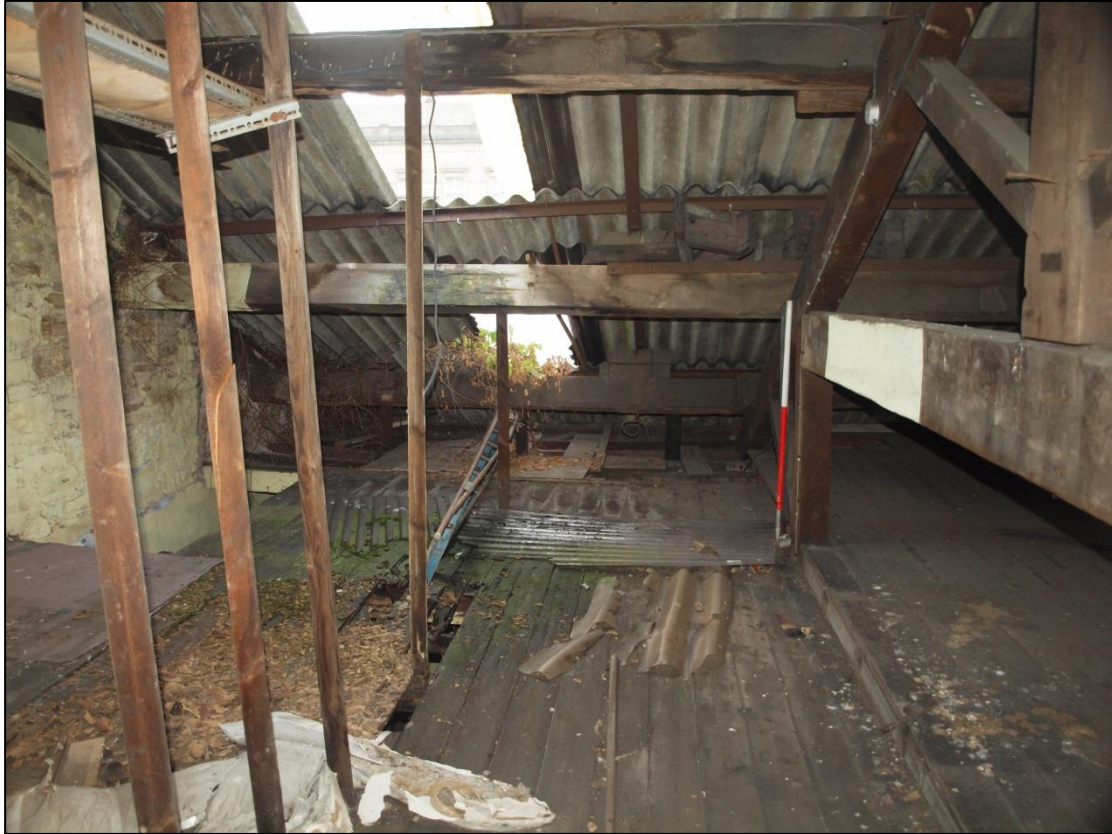
Plate 73: General shot of attic

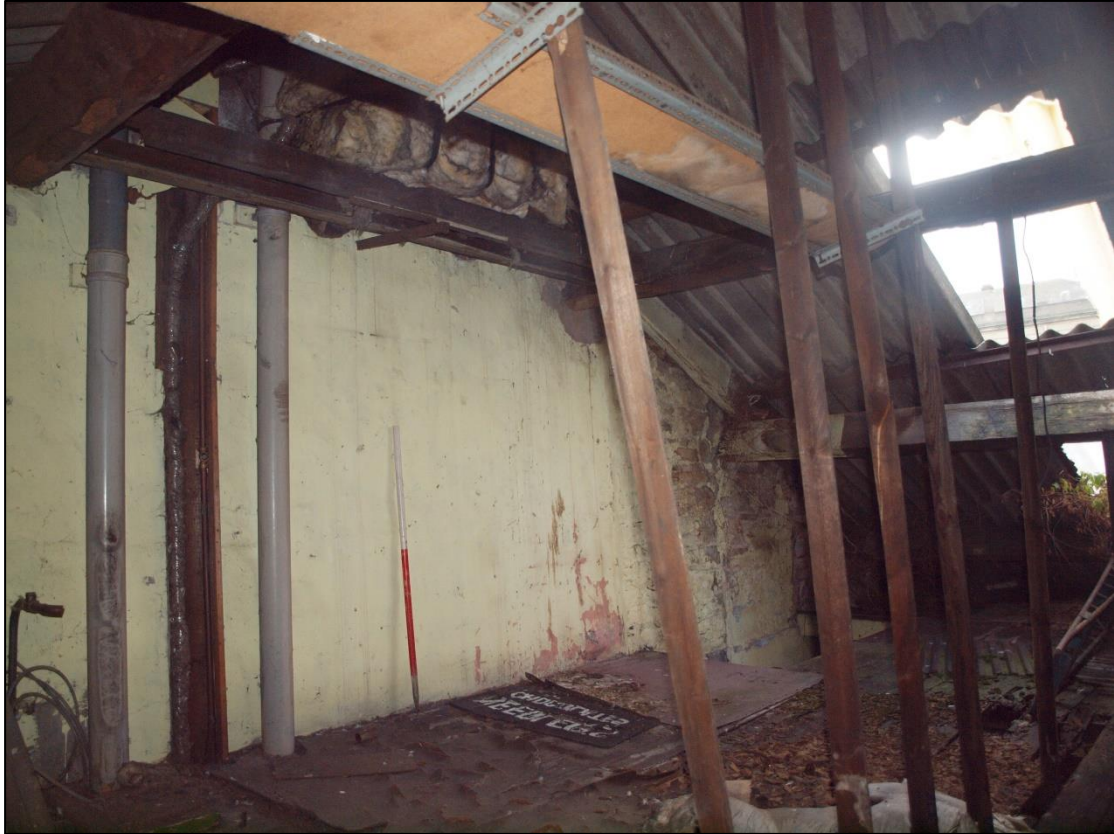
Plate 77: East gable in attic
