**THE ARCHAEOLOGY CO.**

Naychurch Farm, Upper Hulme

Historic Building Survey

December 2020

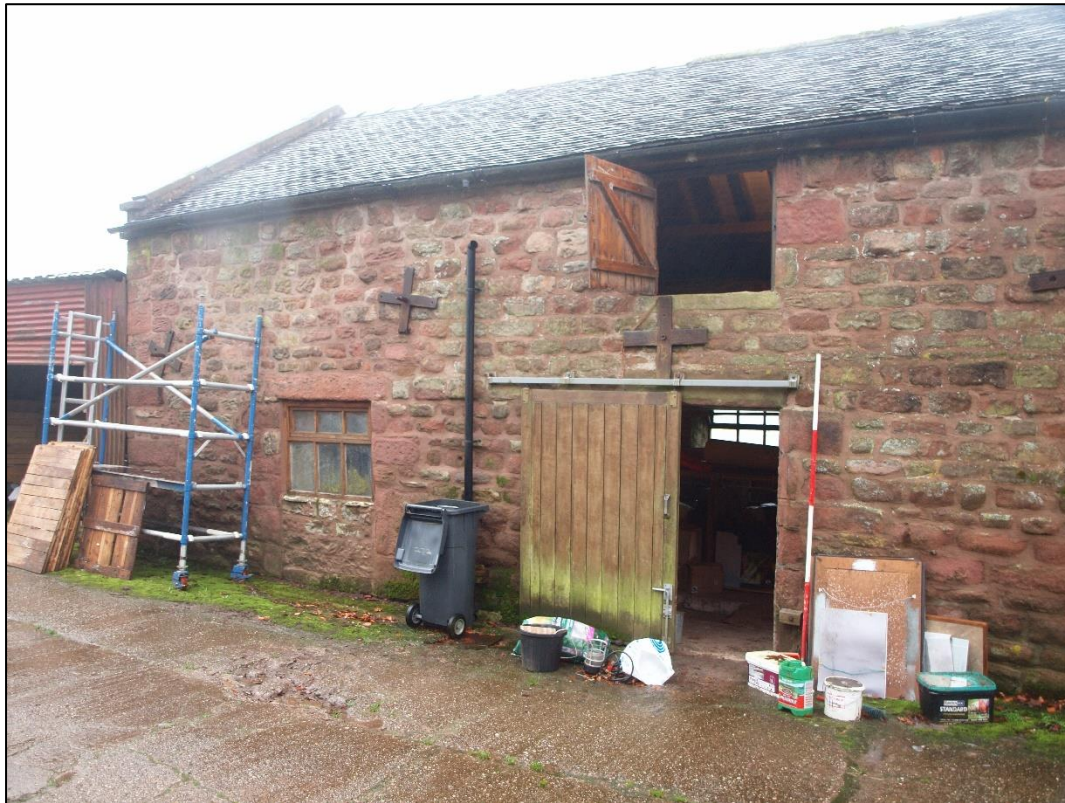
Plate 7: East end of north elevation showing bays 1 and 2

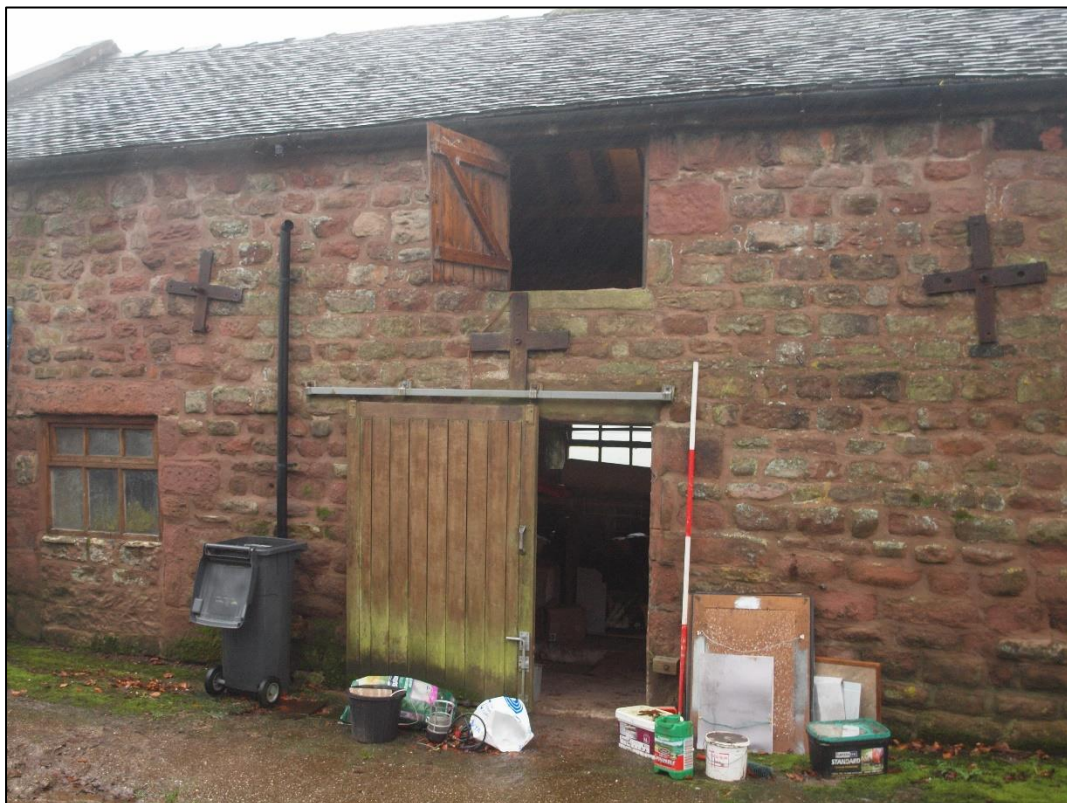
Plate 10: Doorway to bay 2 with pitching eye over

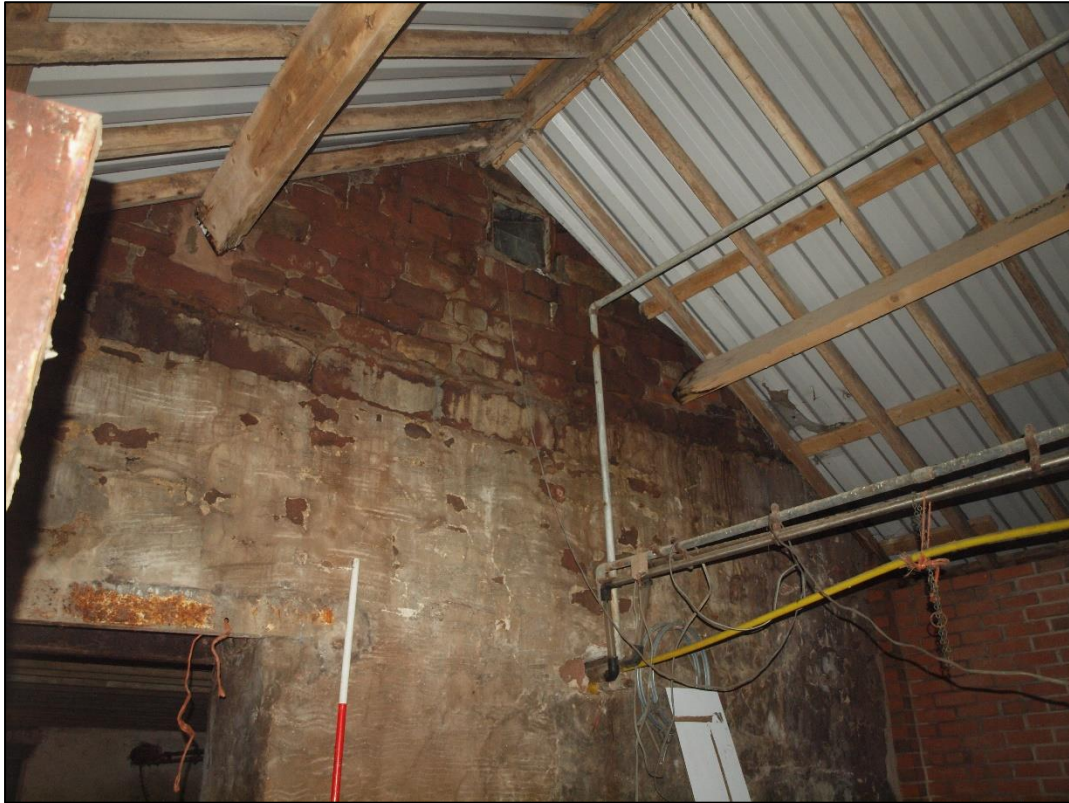
Plate 19: As above showing small window to first floor

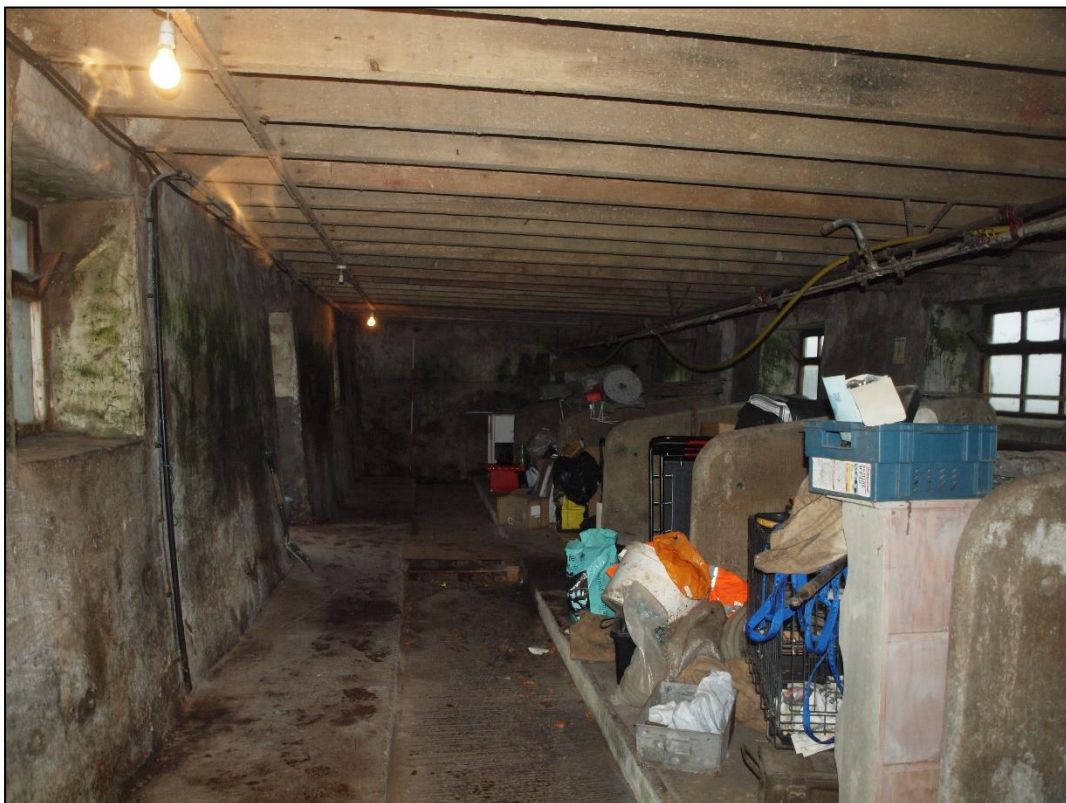
- 6.6 (Plates 34 – 47) The interior is fitted out as a modern cattle shed, with the former internal cross walls removed, replaced by RSJ supports. One cross wall remains towards the west end, which is the former gable of the original building. This has had a large opening inserted with RSJ lintel. Concrete bays are in place for 21 cattle. The walls are fully cement rendered and the floor is concrete. The northern end shows a drainage channel running east and a feeding passage runs east – west along the southern side. There is no doorway in the existing cross wall linking these

Plate 34: General shot of ground floor interior showing manure passage and concrete boskins

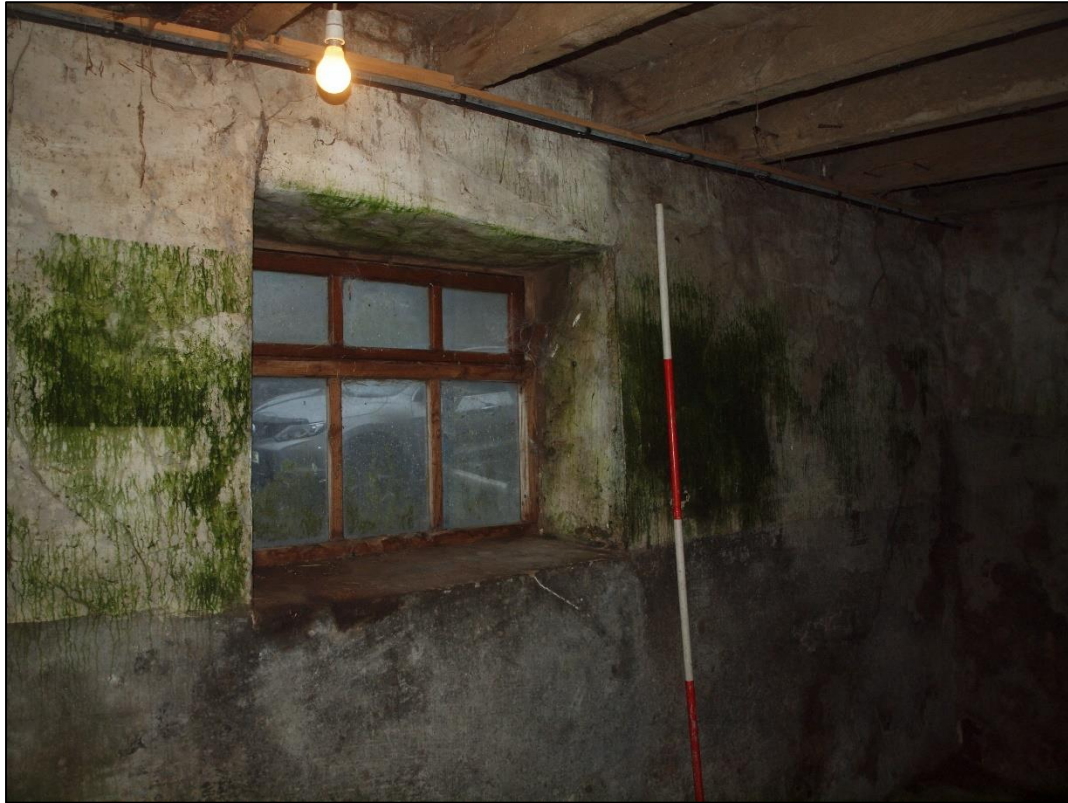
Plate 39: Detail of inserted window to north wall

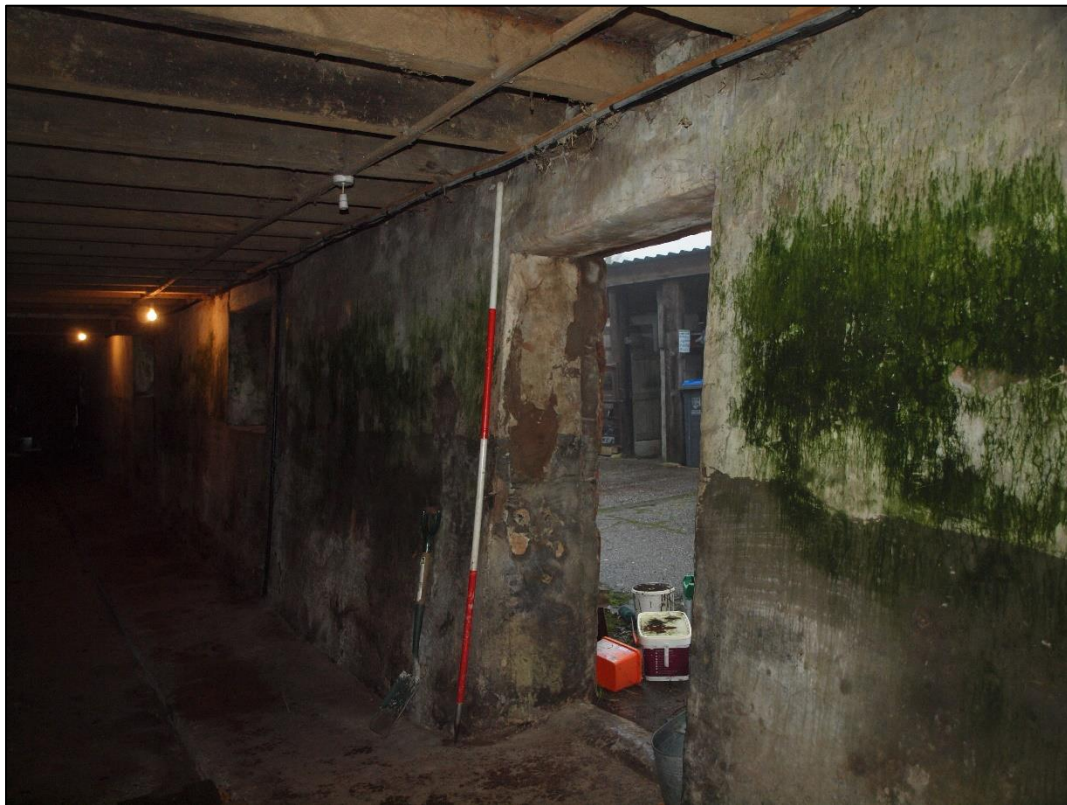
Plate 41: Detail of doorway to bay 2

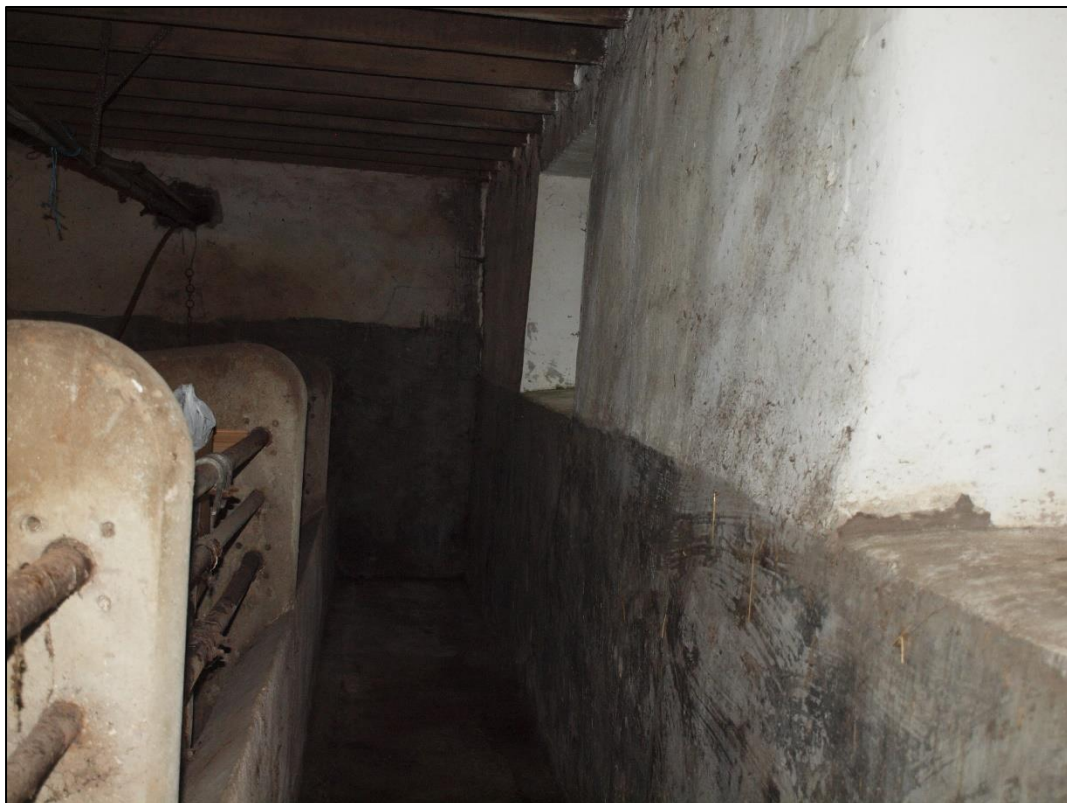
Plate 42: View down feeding passage in west extension

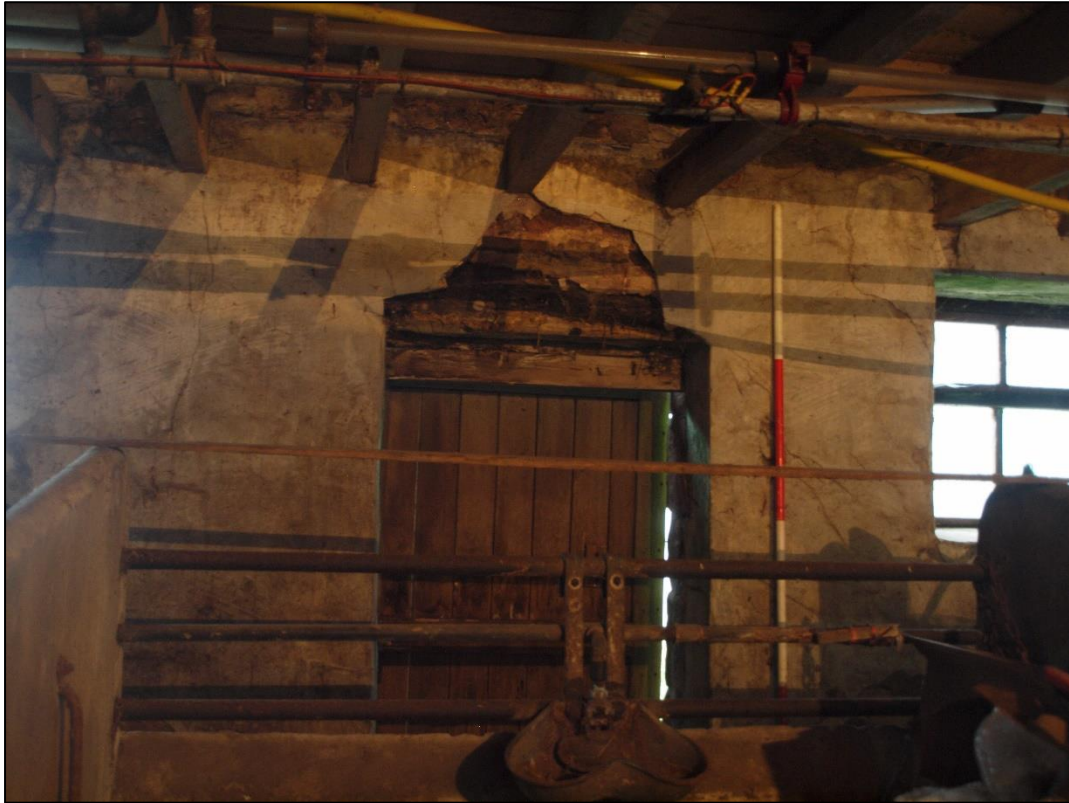
Plate 45: Doorway in south wall to bay 2

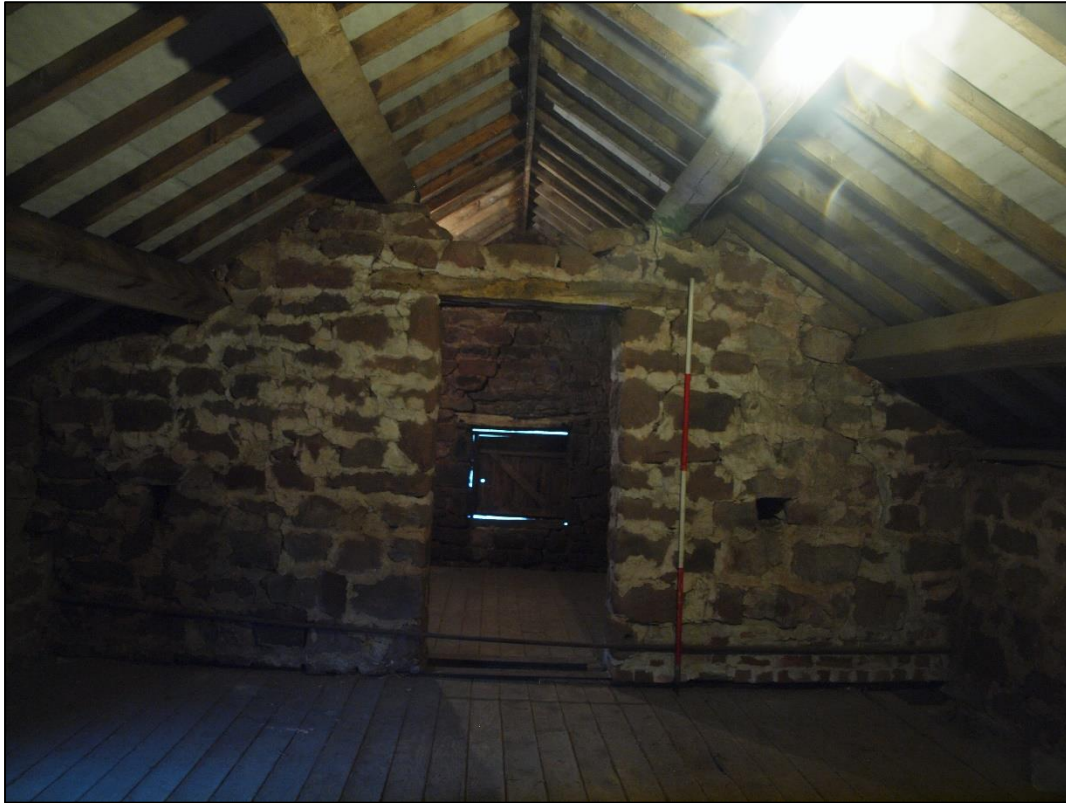
Plate 51: Surviving cross wall at first floor level between bays 1 and 2

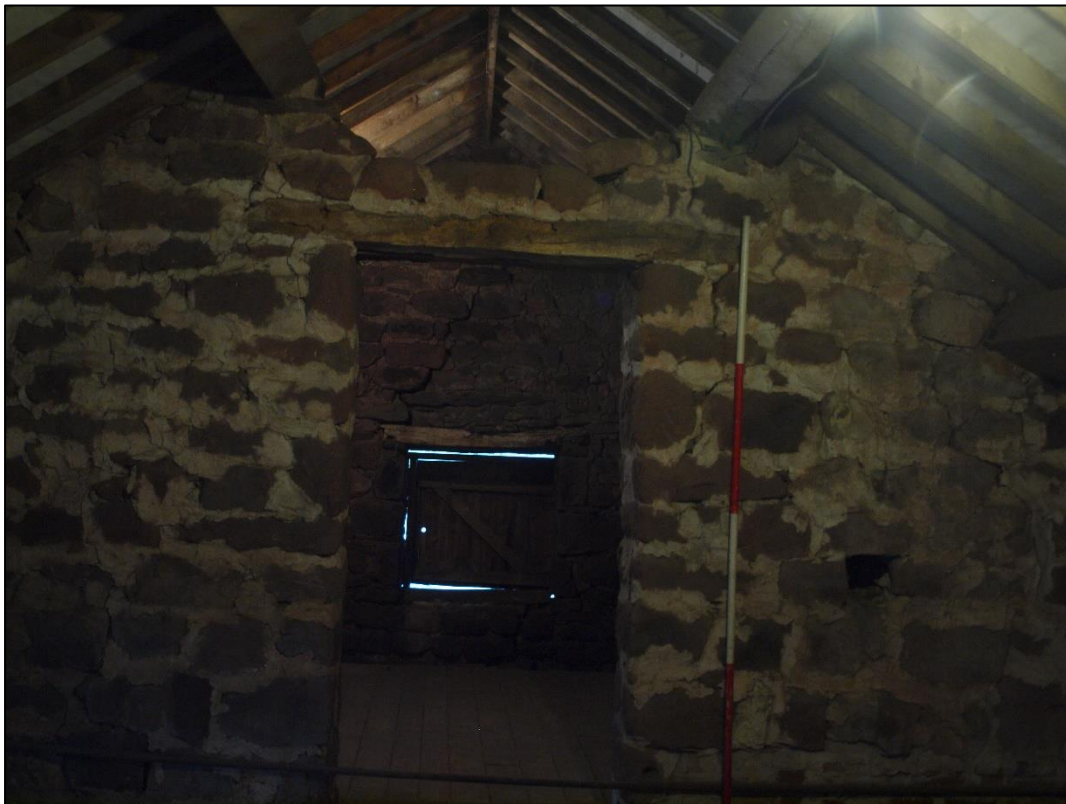
Plate 52: Detail of doorway

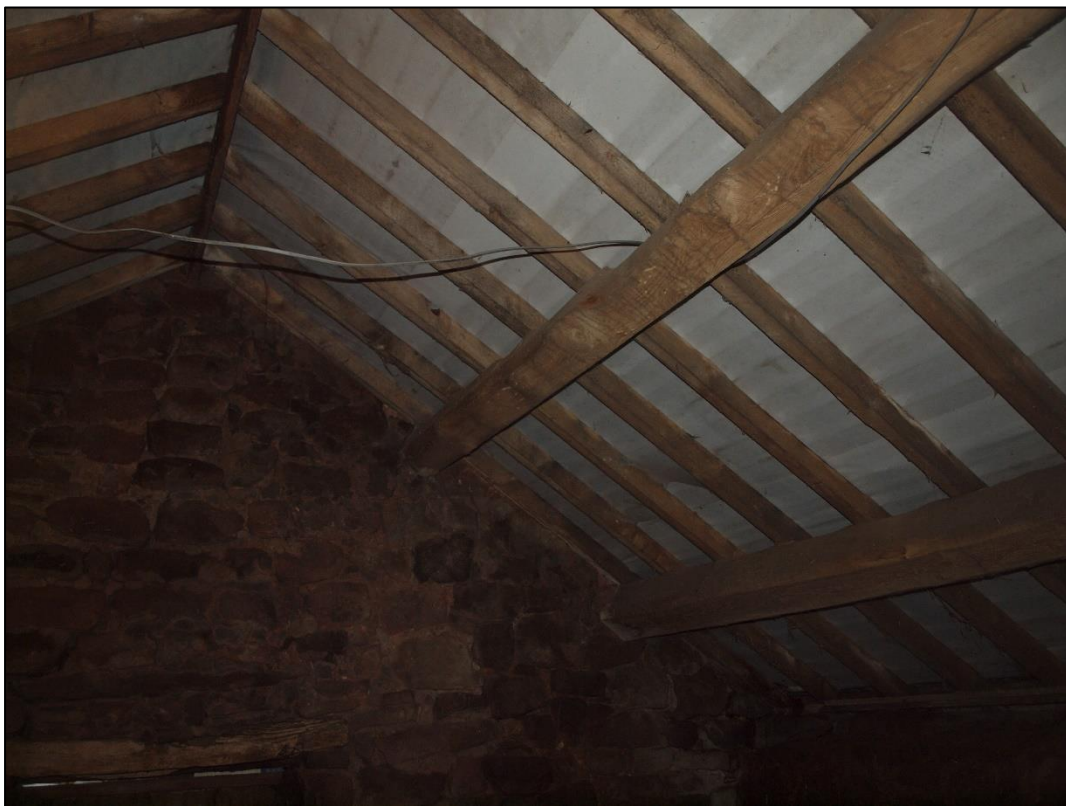
Plate 54: Purlins to bay 1

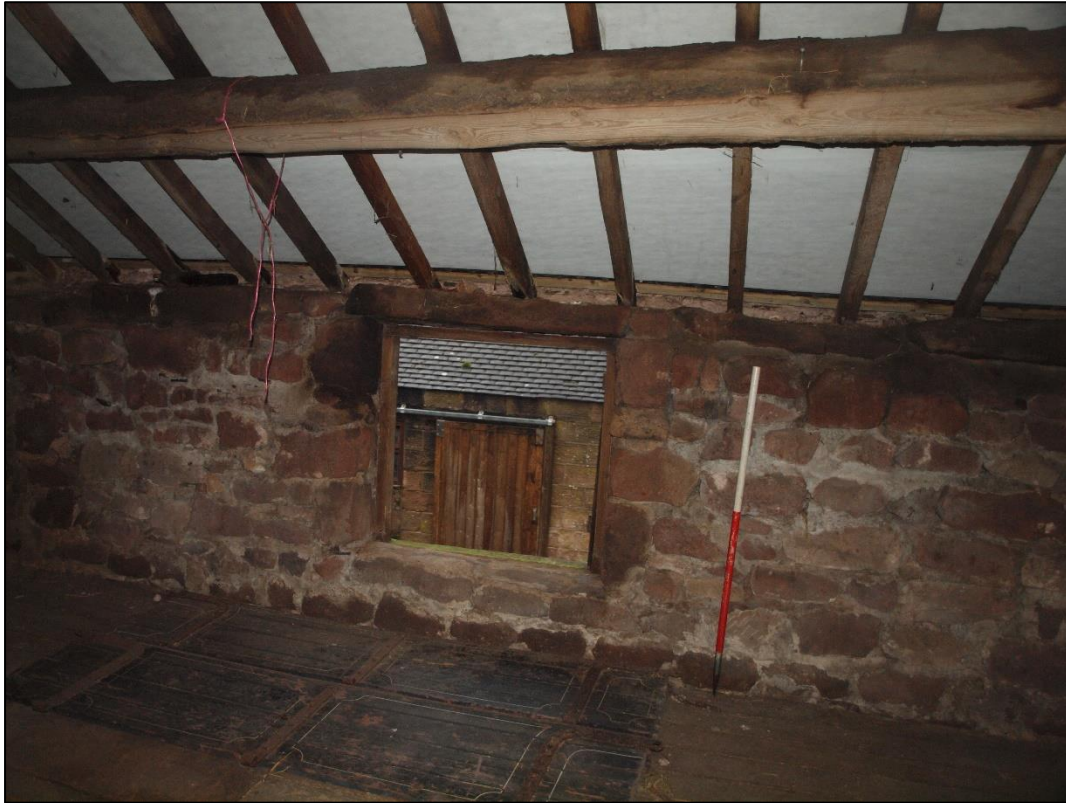
Plate 55: Pitching eye to north elevation from the inside

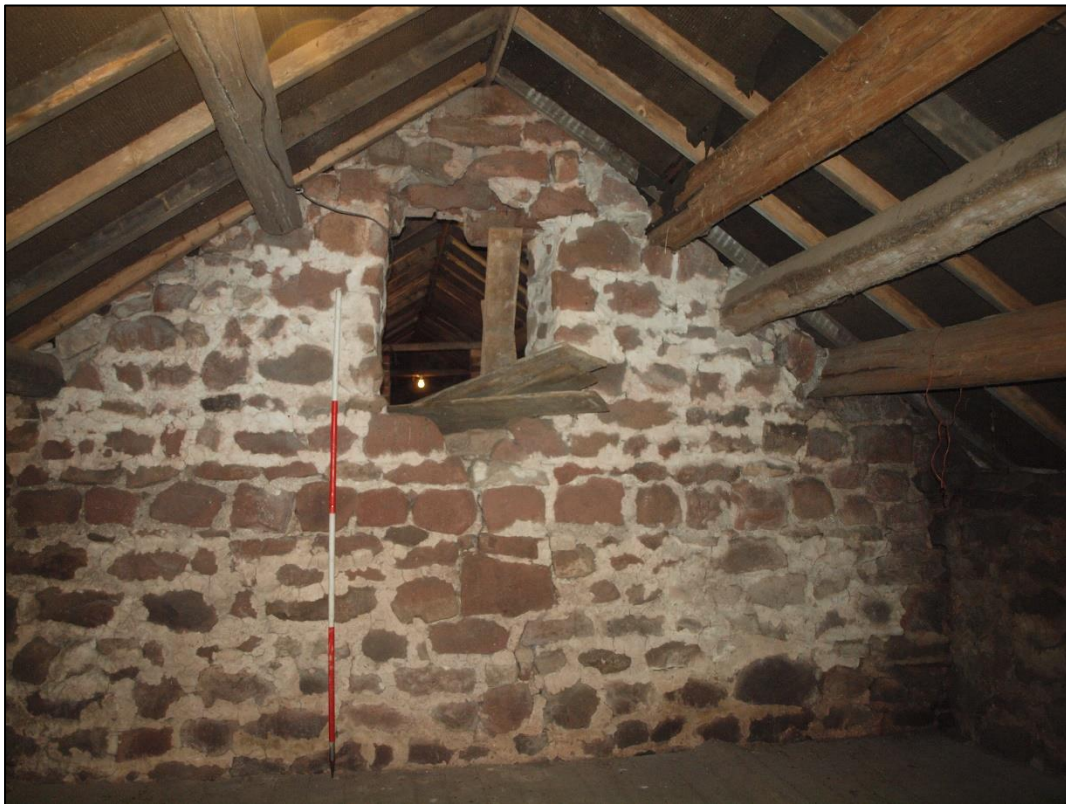
Plate 56: Former end gable wall with pitching eye to bay 4

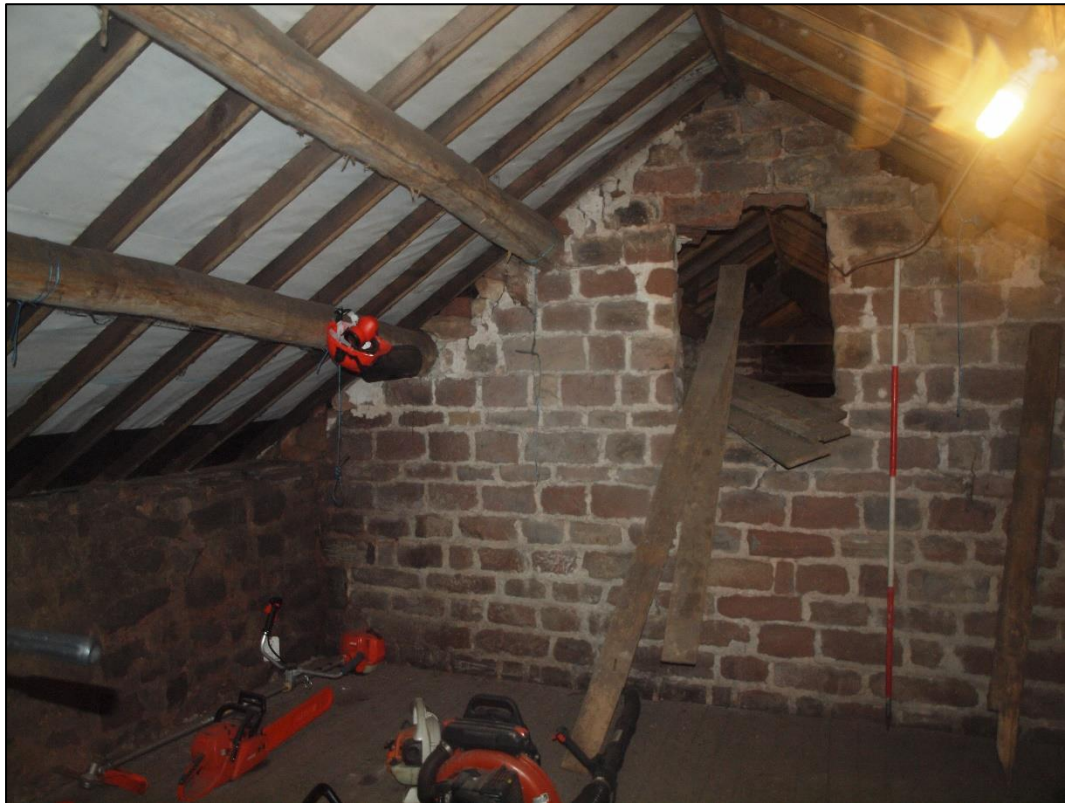
Plate 57: As above from bay 4 in west extension

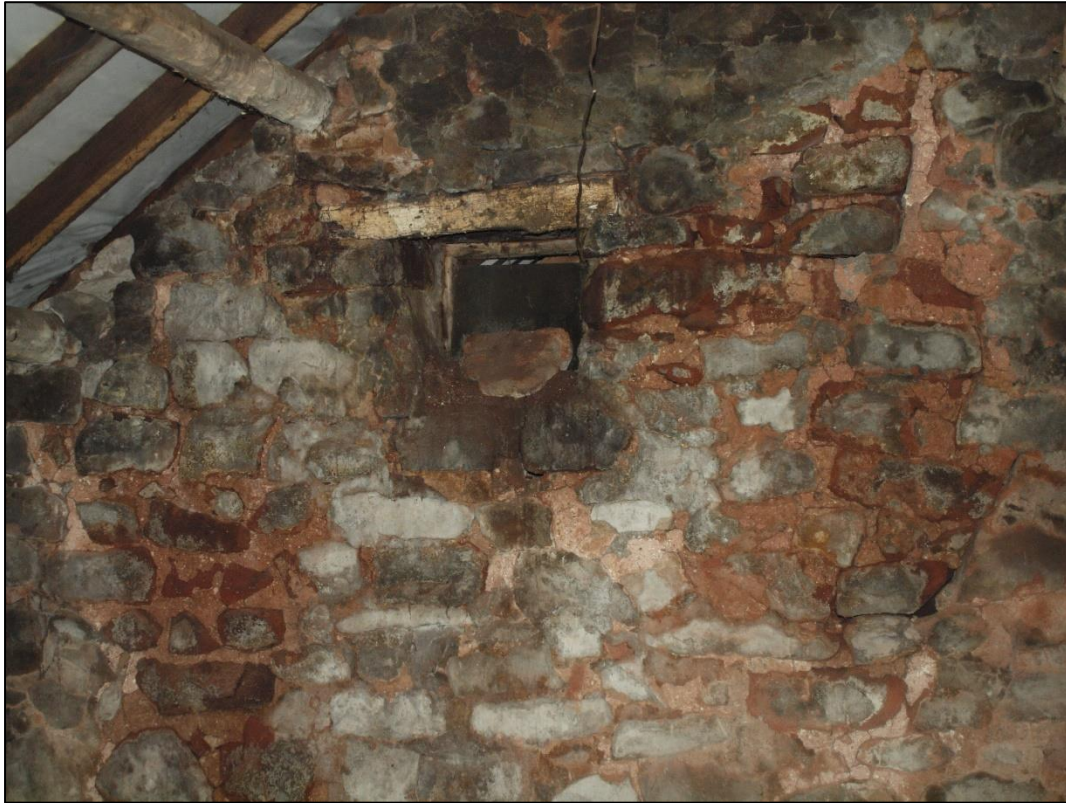
Plate 61: Detail of window above
