THE ARCHAEOLOGY CO.

Dean Gate Farm, Bolton
Historic Building Survey

May 2022

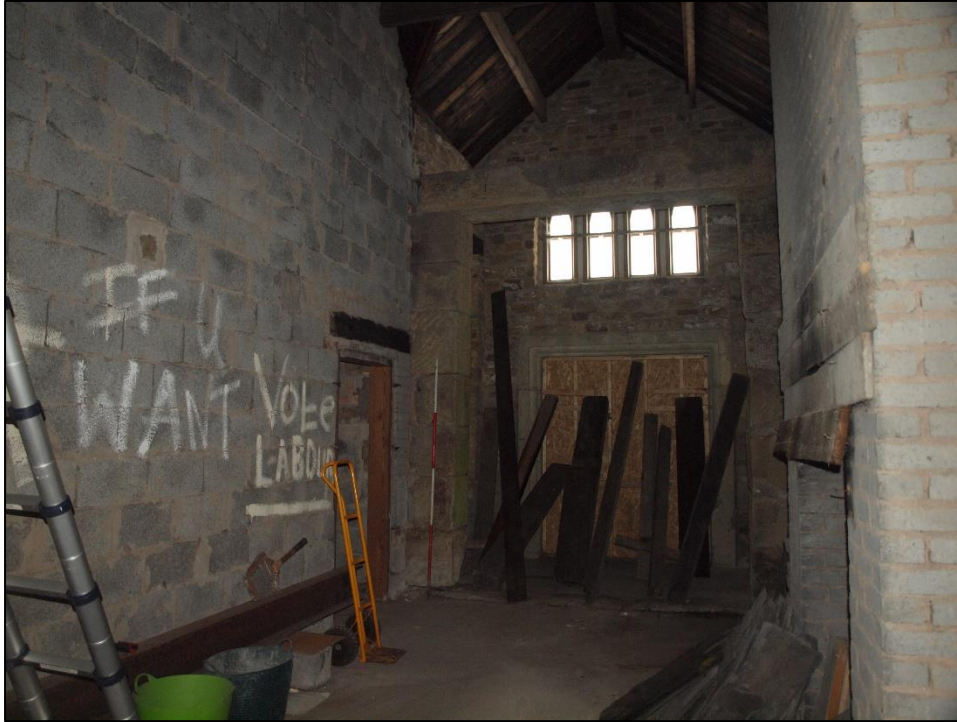
Plate 33: Central corridor showing entrance porch

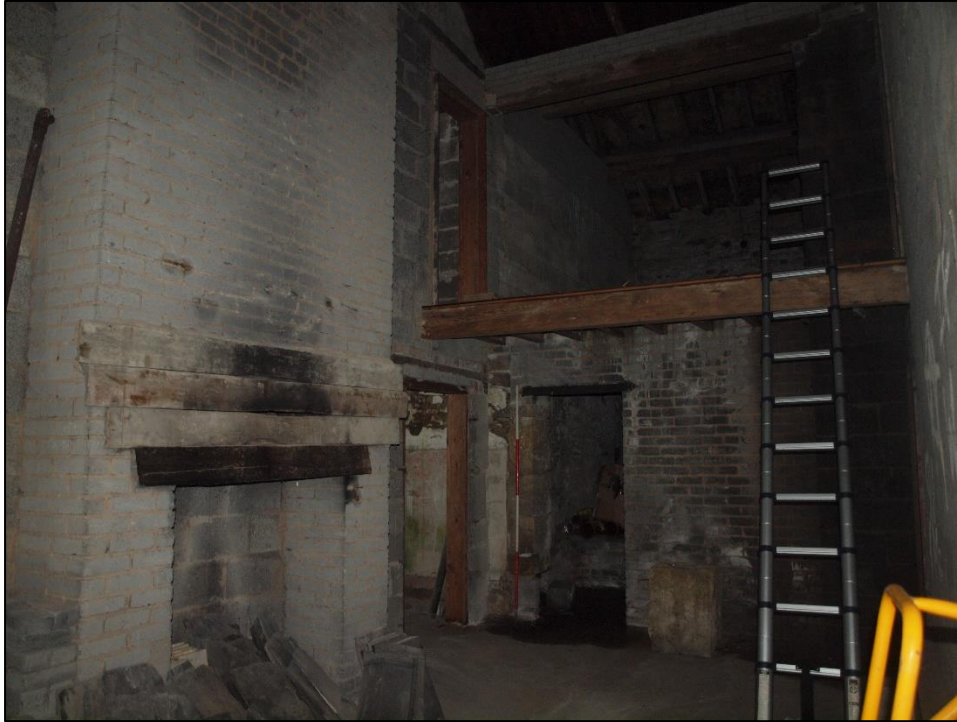
Plate 35: Corridor looking north

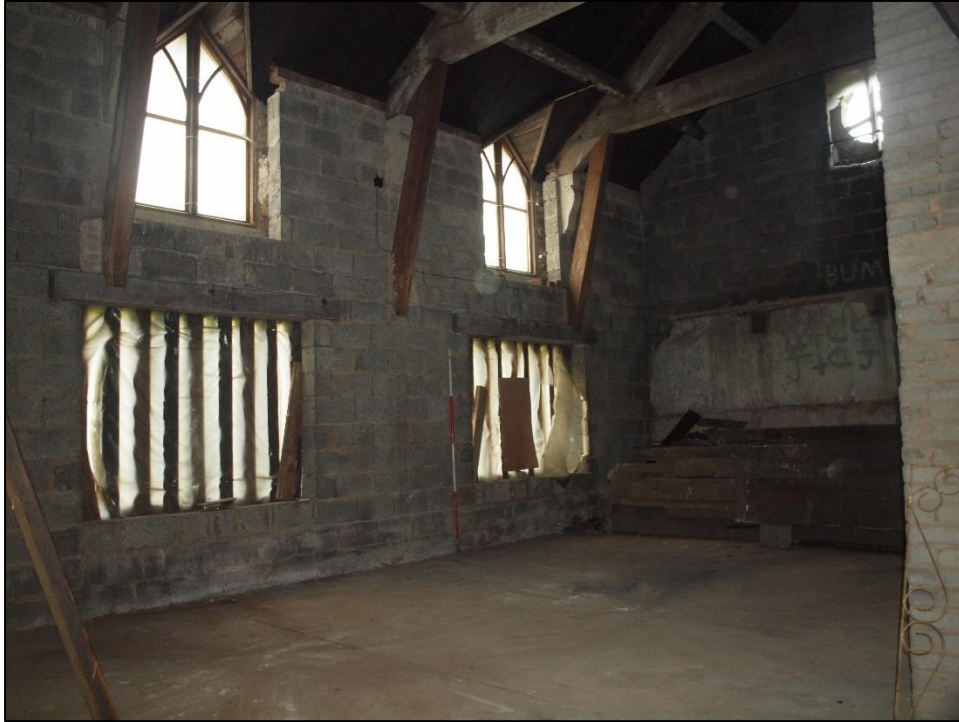
Plate 41: Large room to southwest corner

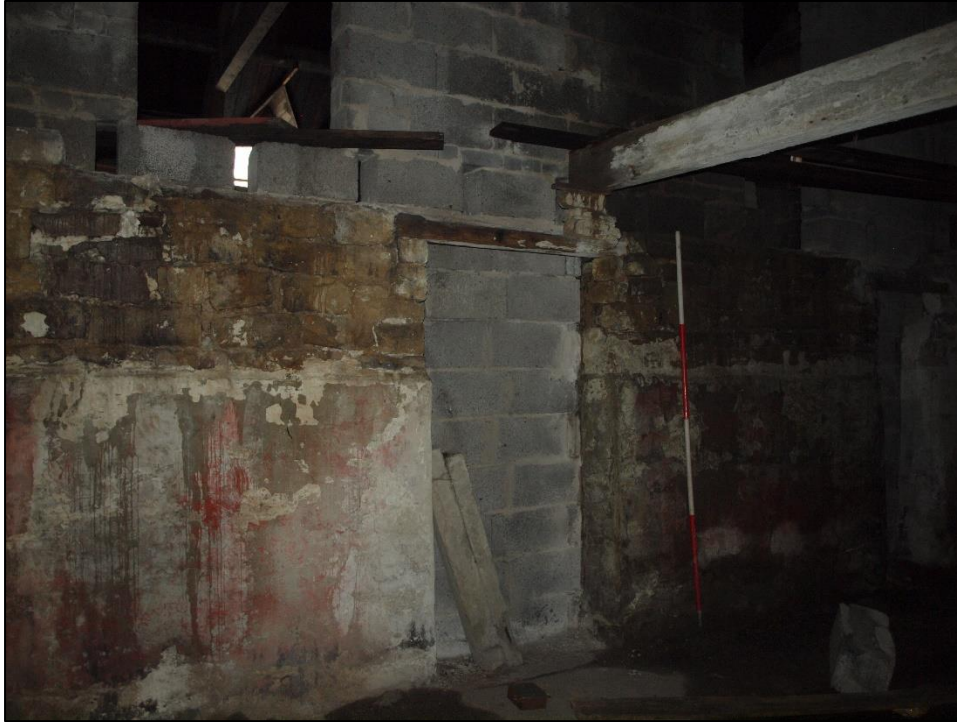
Plate 49: Blocked doorway at eastern end

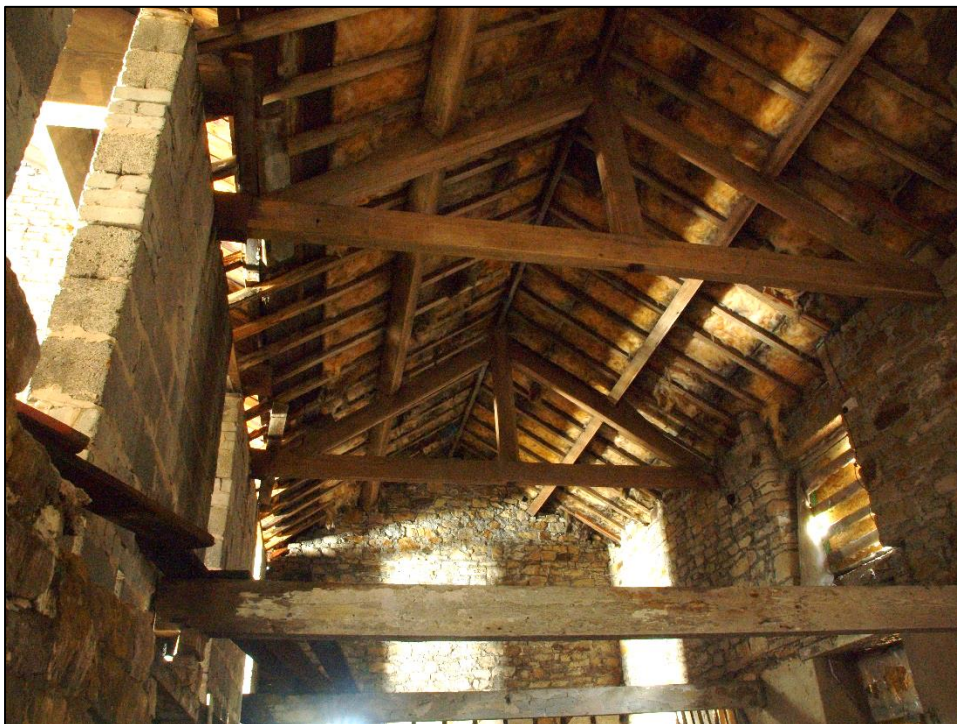
Plate 50: Machine cut timber king post trusses

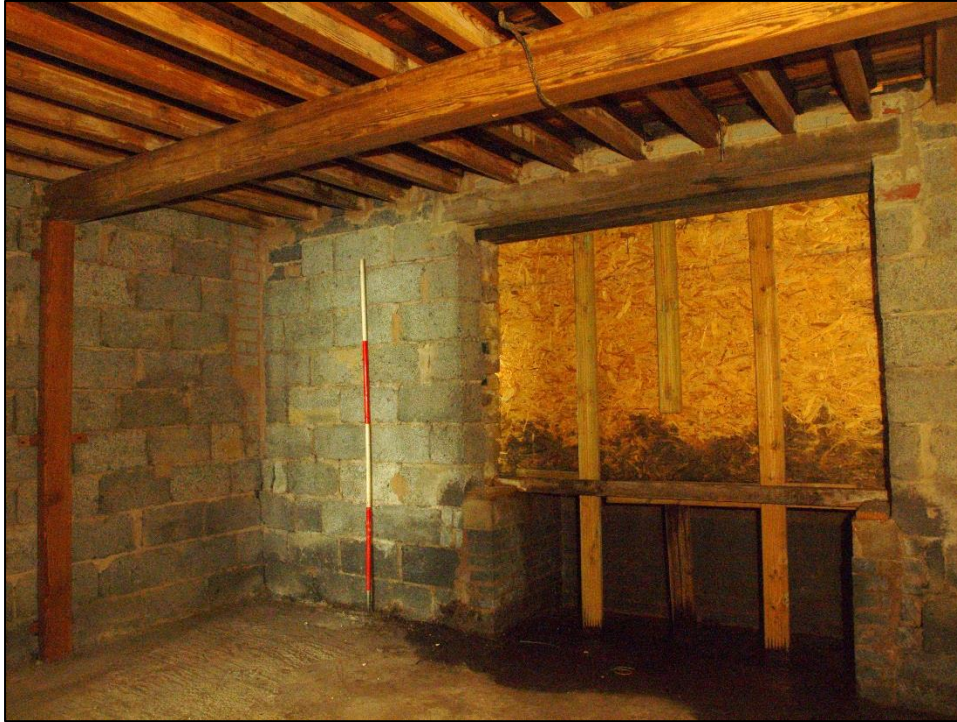
- 6.7 To the east side of the building is a corridor running east from the central corridor. This has a pair of rooms to the north side. The western (plate 51) has concrete block walls to each side, with the exception of the eastern party wall.

Plate 51: Inserted room northwest of east - west corridor

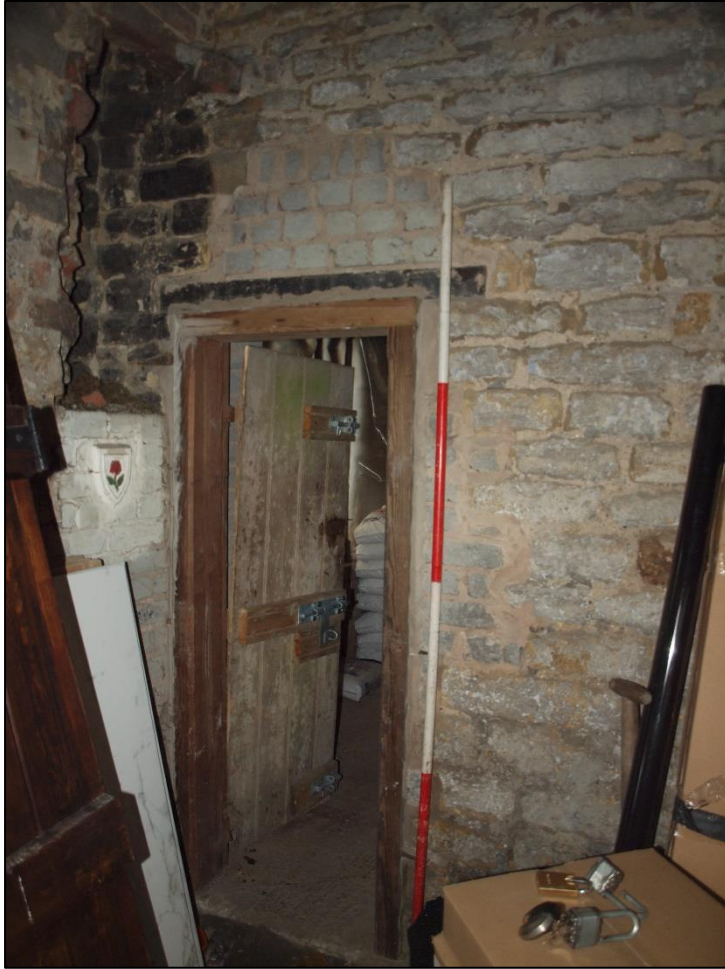
Plate 63: Inserted doorway to house

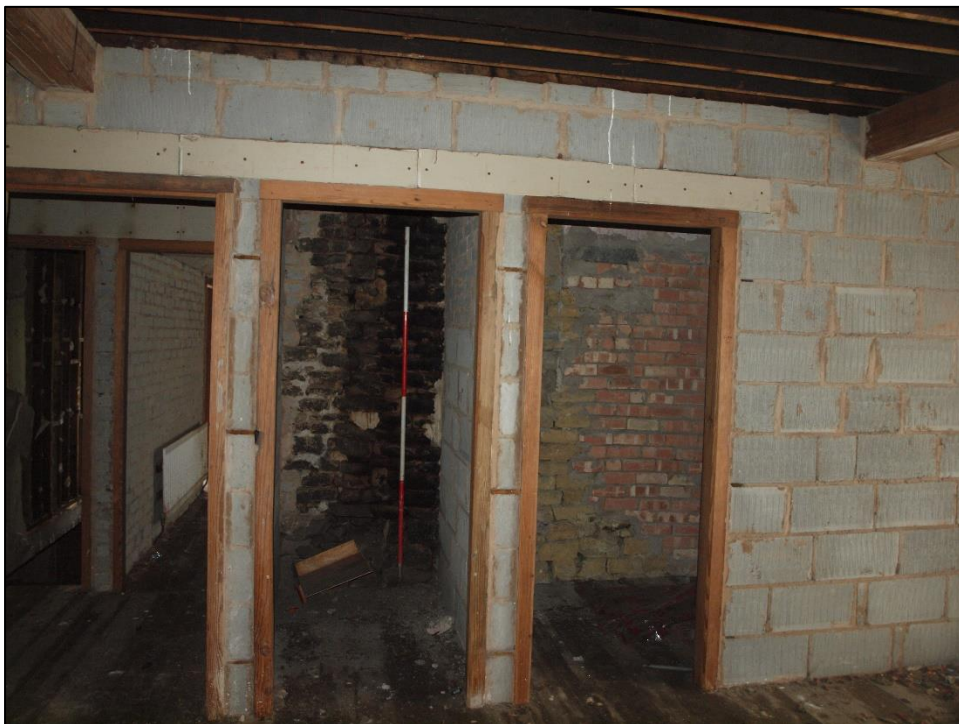
Plate 66: Inserted wall to east side showing stone and brick walls beyond

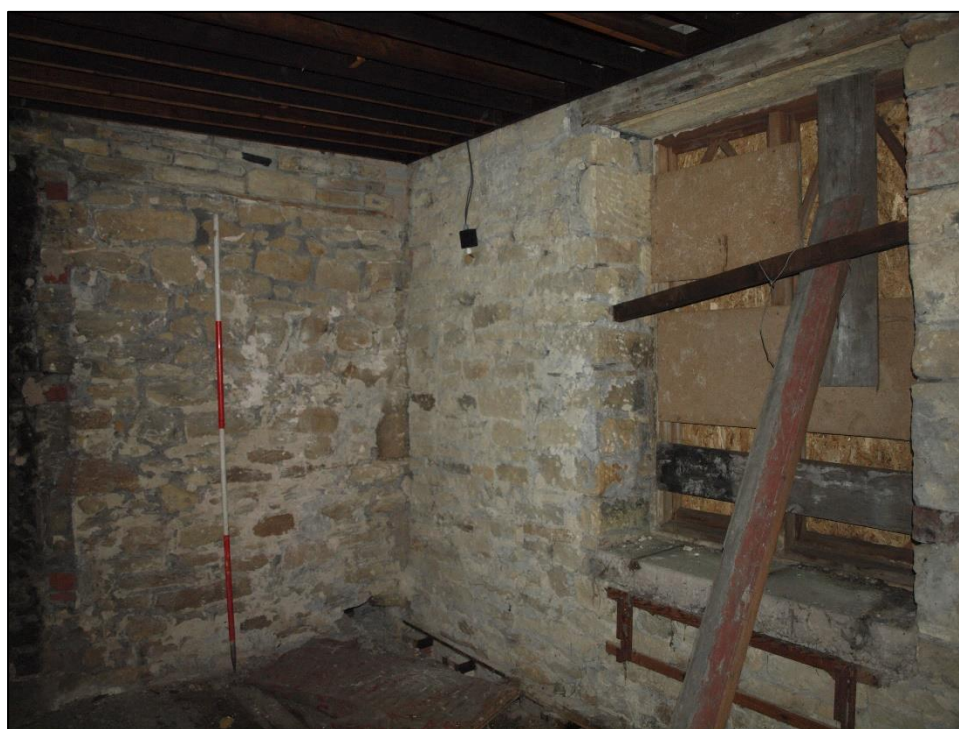
- 6.8 (Plates 64 - 72) The first floor is only present at the eastern side of the building, having been removed elsewhere and matches the layout of the ground floor, with a few inserted stud walls. The east – west corridor (plate 64) leads to a pair of rooms to the north side. The western is formed of concrete block, with the eastern showing stone construction. A wide landing lies at the eastern end, with modern timber posts supporting the machine cut timber trusses (plates 70 – 72). To the south of the corridor the large room has been divided by a concrete block wall with openings to the north and south (plates 65 – 67). At the east side stud walls have been inserted to provide a wc and bathroom. The stone work is visible here in the east wall, although has been replaced with brick to the south. To the east, in the 6th bay is a single room with landing and removed staircase to the north. The southern room contains a fireplace in the east wall. This is stone although has been modified with brick and later blocked (plates 68 & 69).

Plate 69: Stone fireplace, blocked with brick and plastered over
