Ling Villa Barn, Mickleton
Historic Building Survey

January 2023

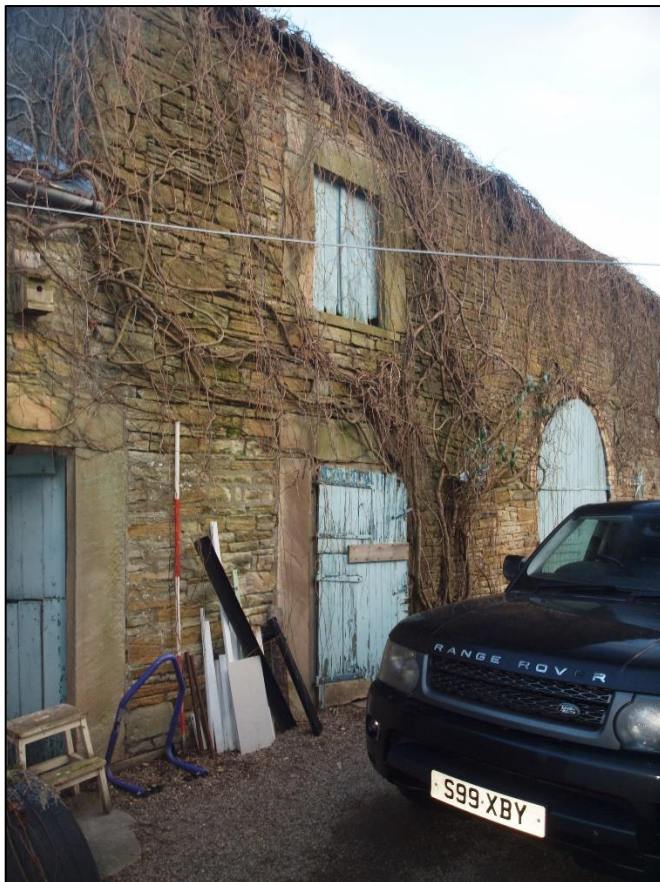
Plate 4: General shot of western end of south elevation showing bays 2 - 5 looking northeast

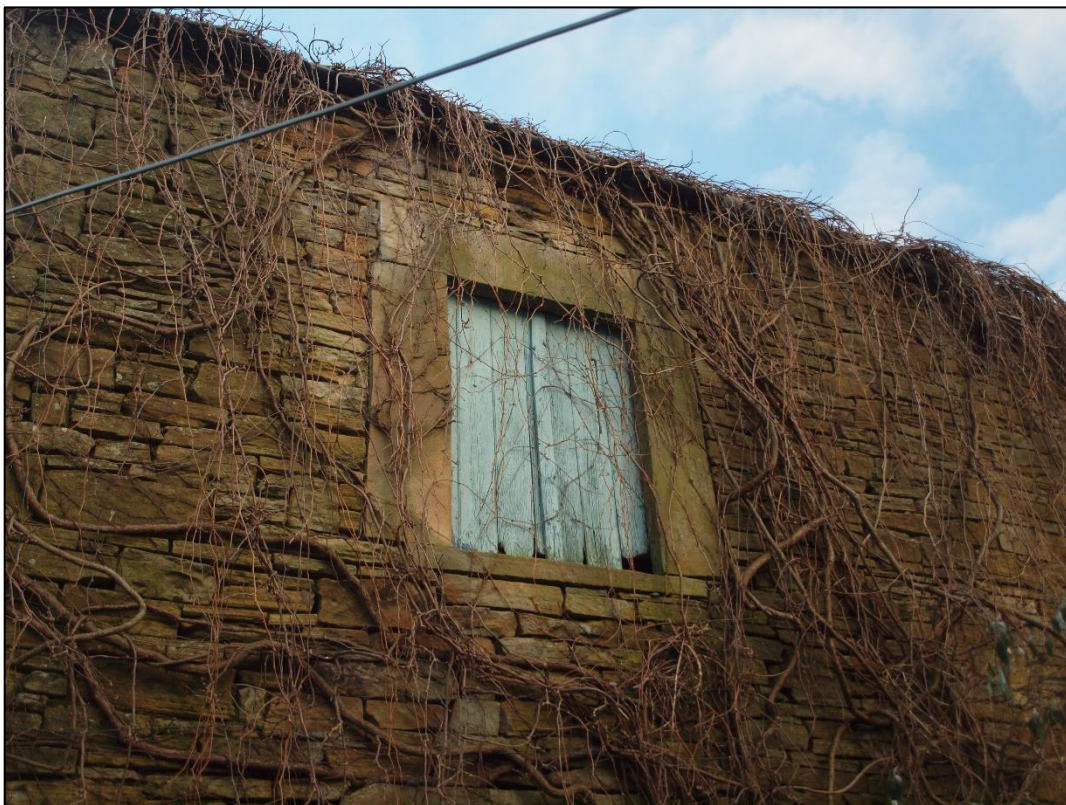
Plate 6: Pitching eye at first floor level, bay 3 looking northeast

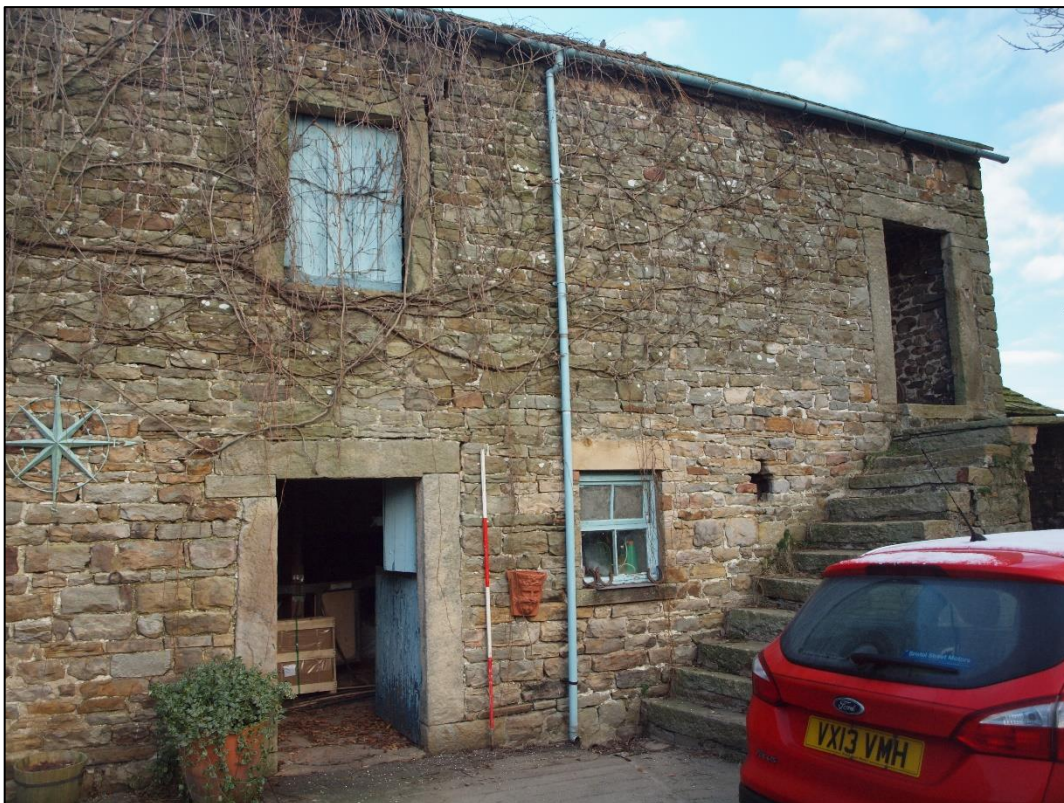
Plate 10: General shot of east end of barn showing bays 6 – 10 looking northeast

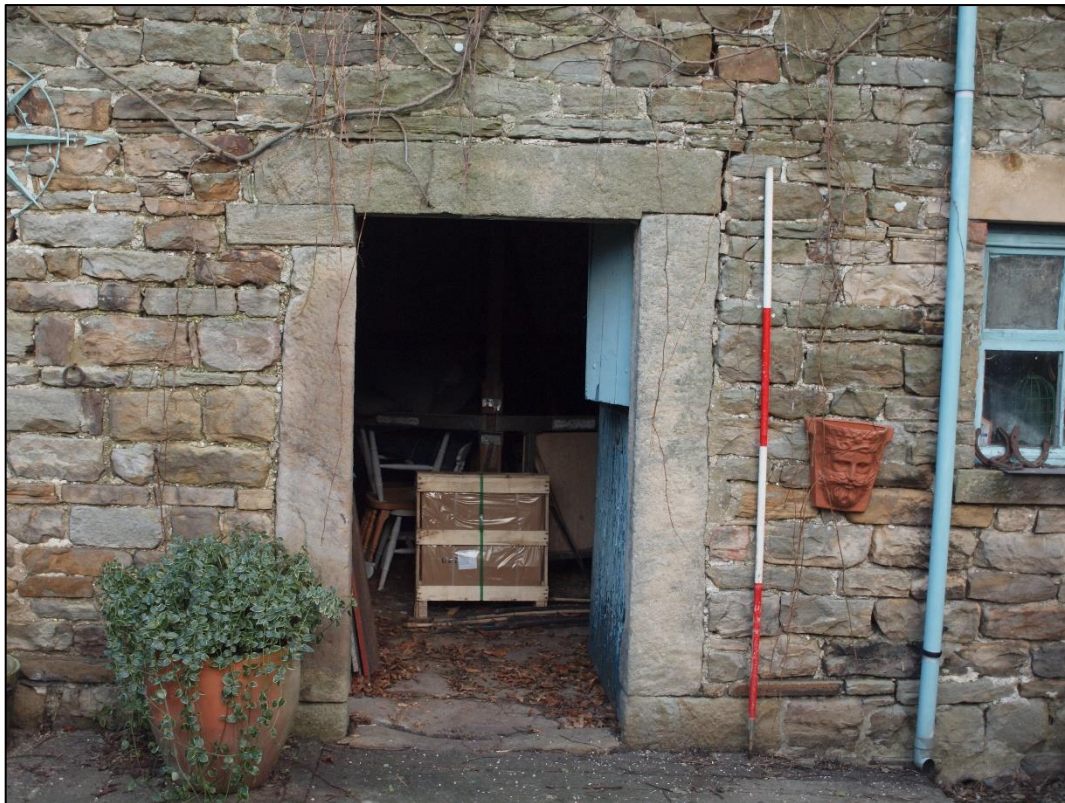
Plate 11: Doorway to bay 7 looking north

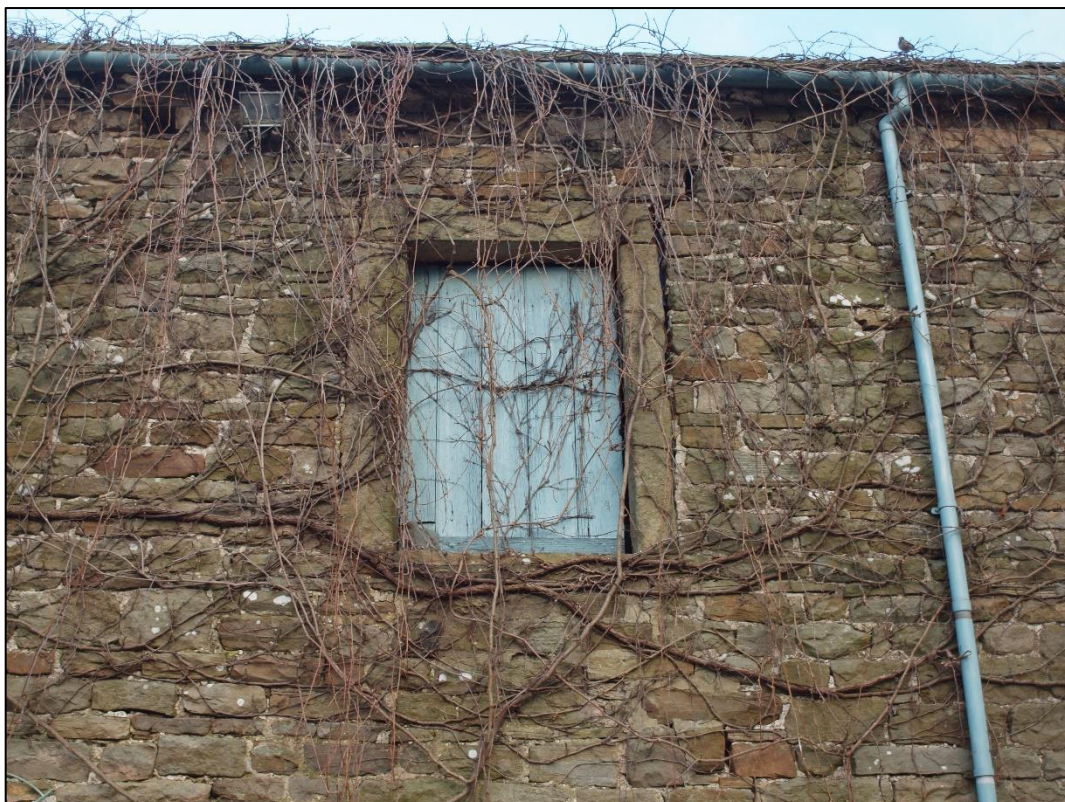
Plate 12: Pitching eye to first floor level in bay 7 looking north

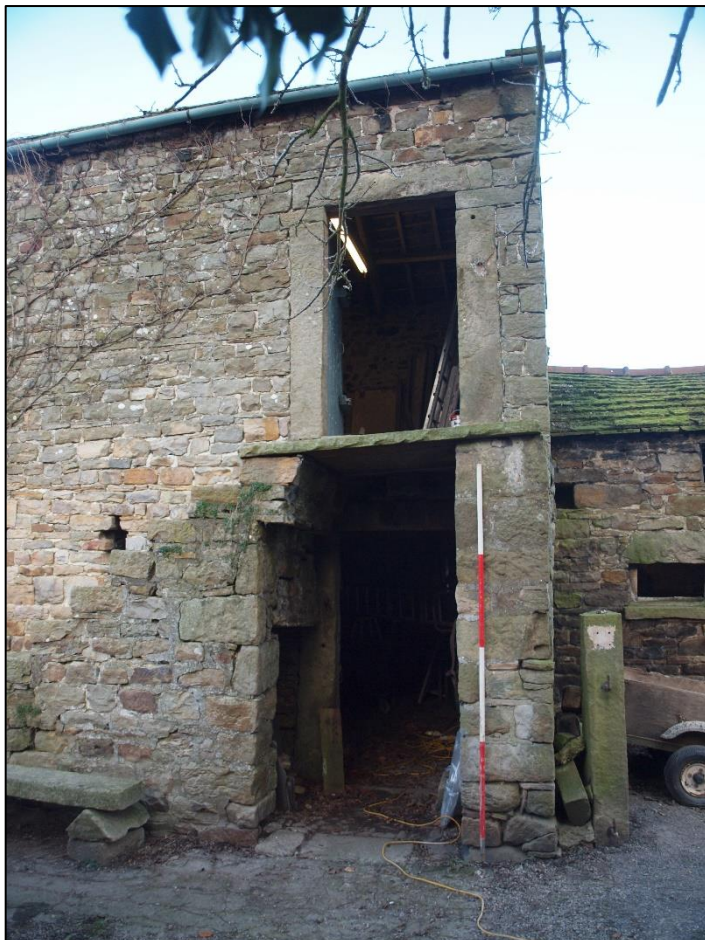
Plate 14: Bays 9 and 10 looking north

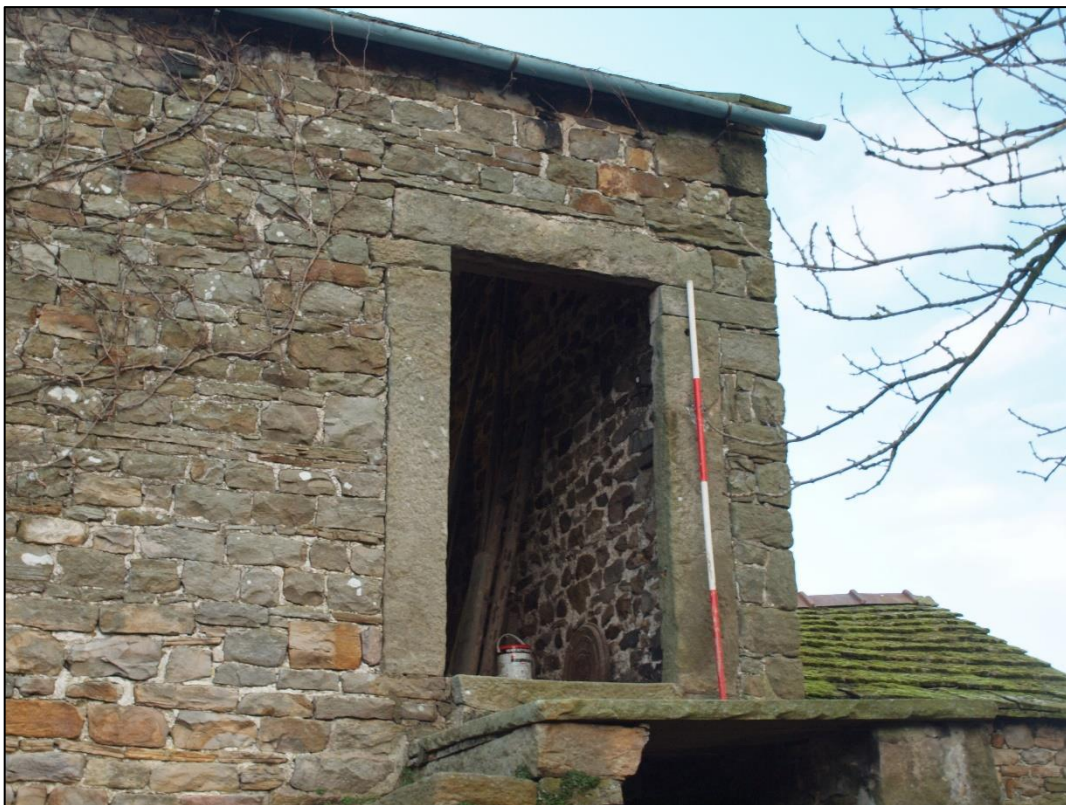
Plate 16: First floor doorway to bay 10 looking north

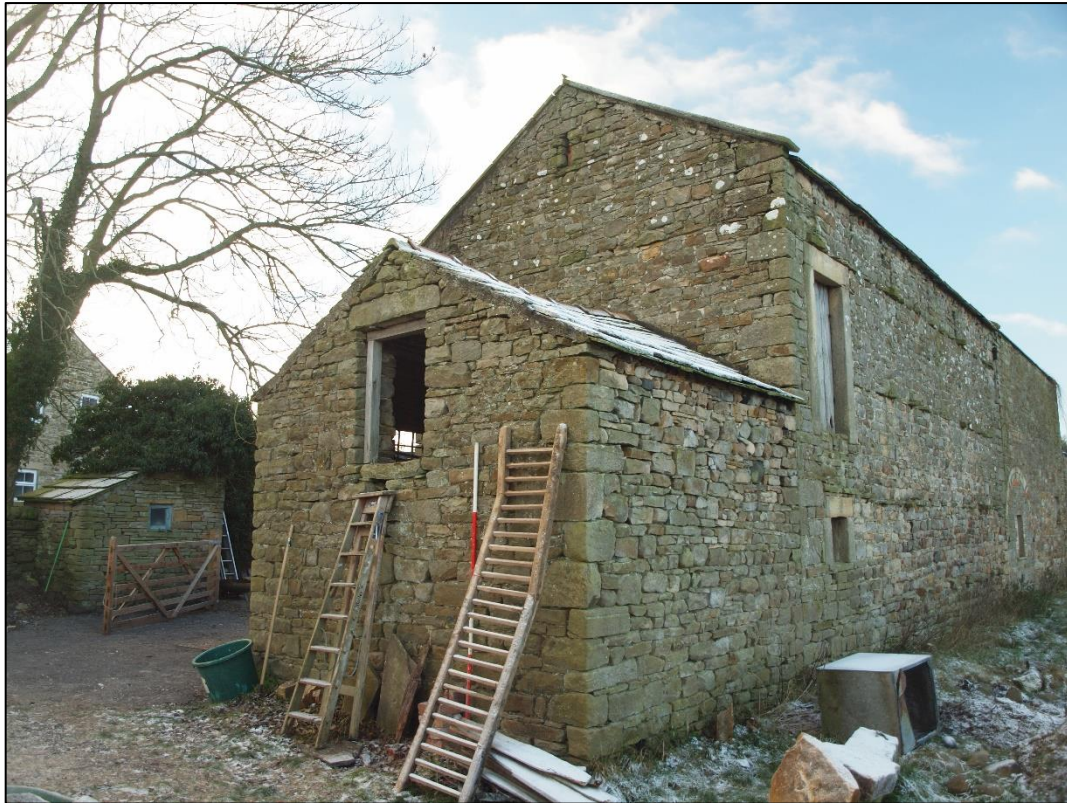
Plate 21: East gable looking west

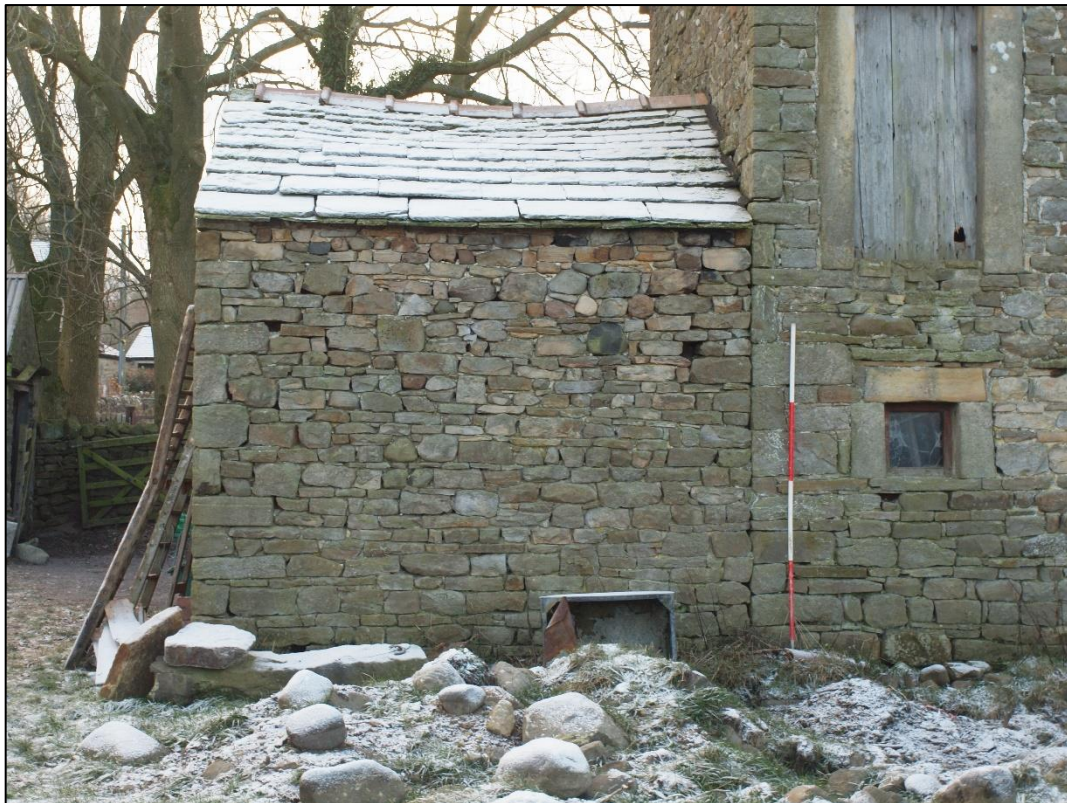
Plate 23: North elevation of eastern extension looking south

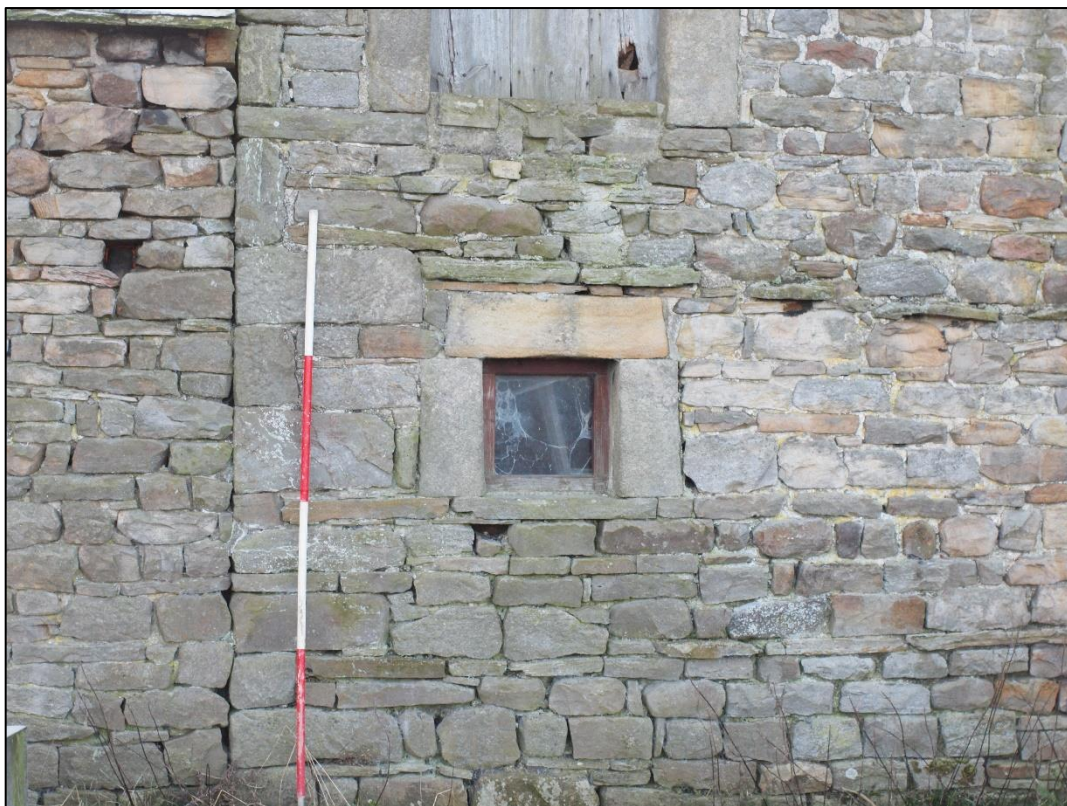
Plate 24: Ground floor window to bay 10 looking south

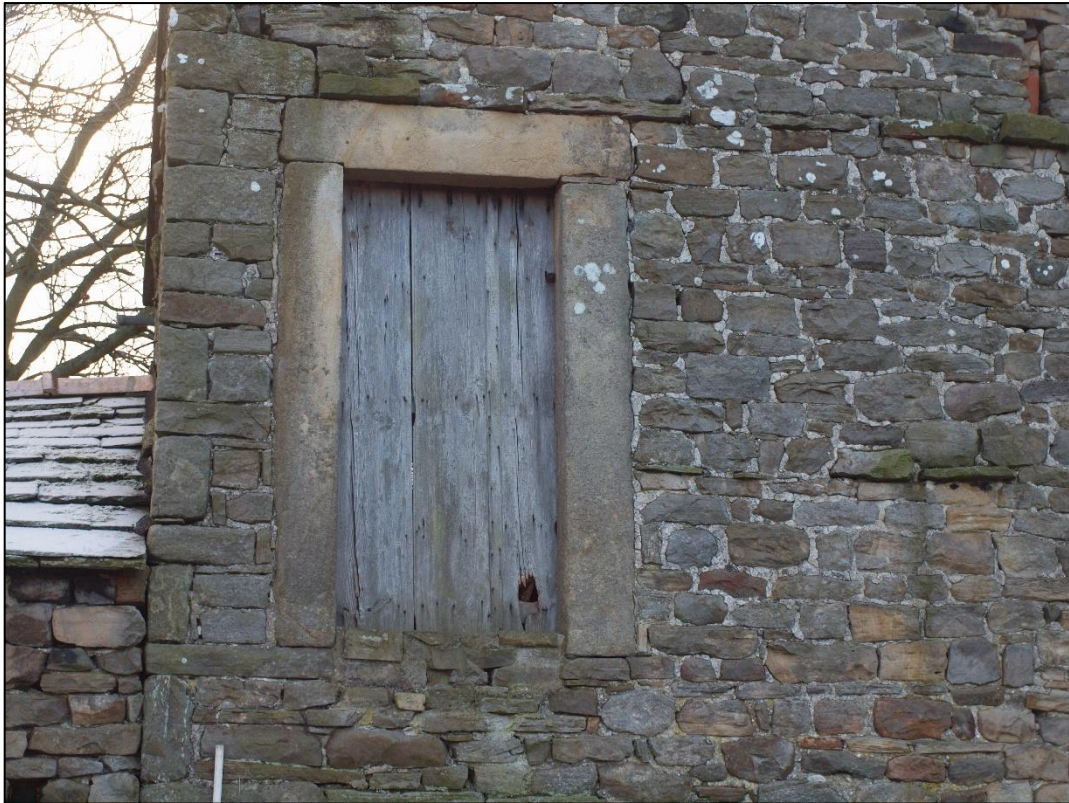
Plate 25: First floor doorway to bay 10 looking south

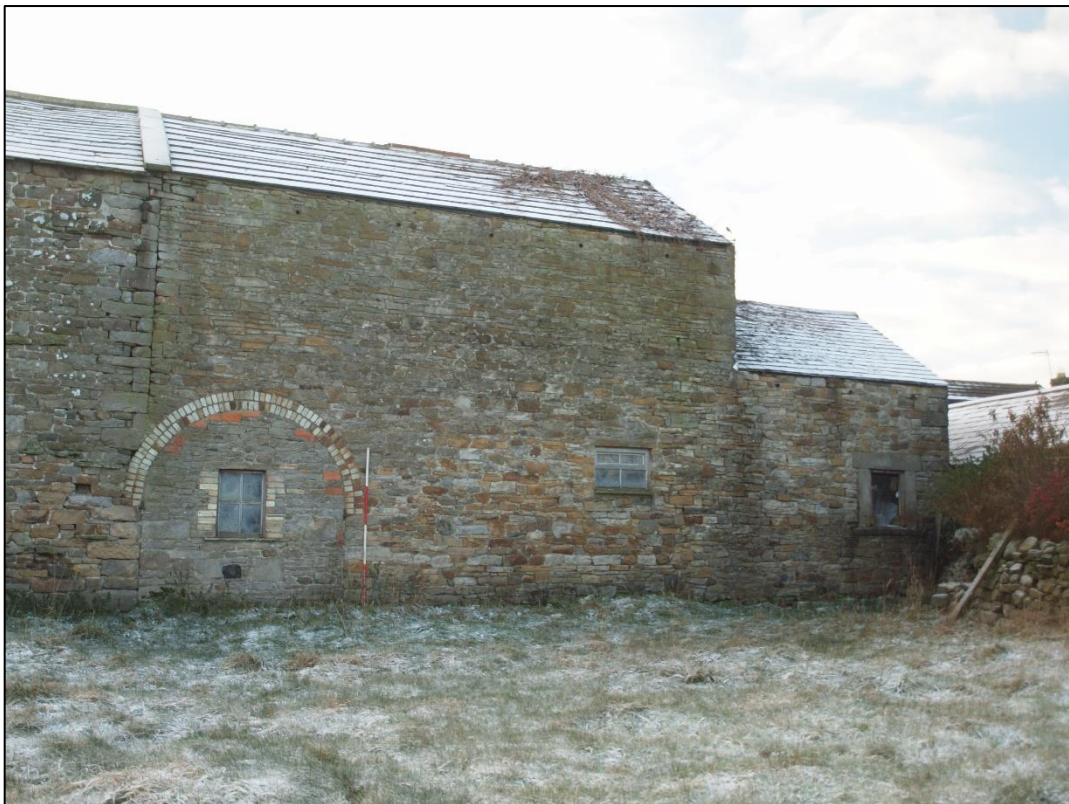
Plate 26: West end of elevation, bays 1 - 5 looking southwest

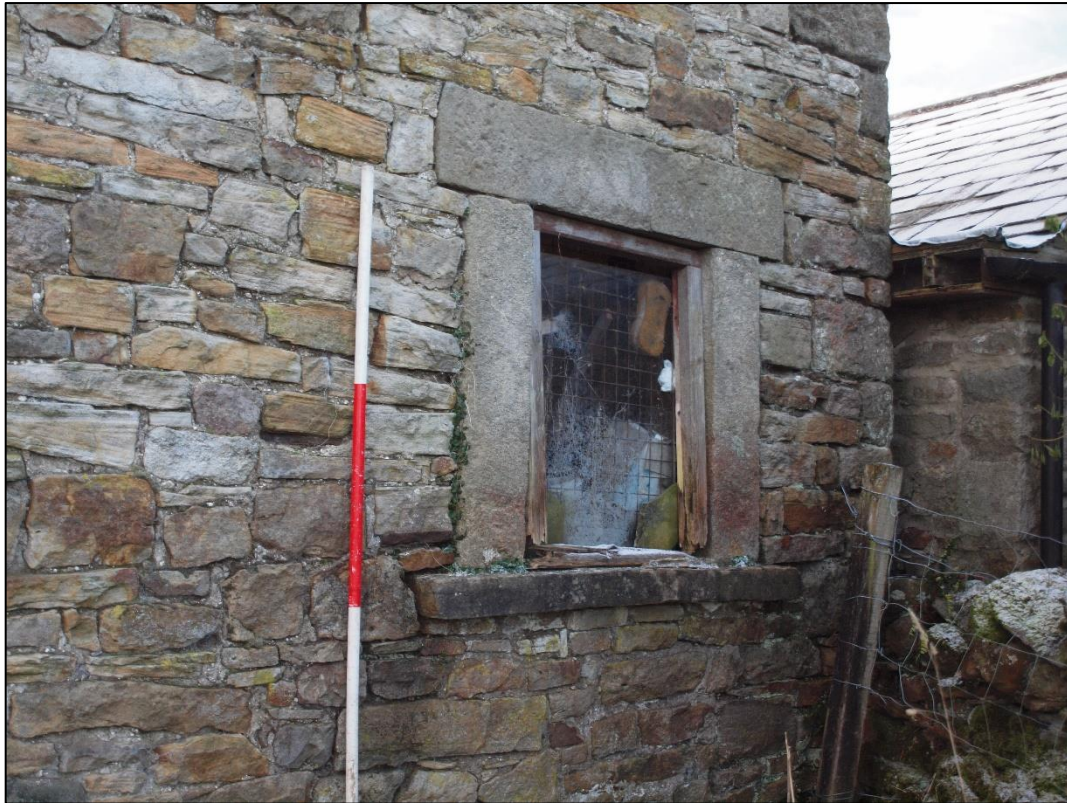
Plate 29: Window to bay 1 looking southwest

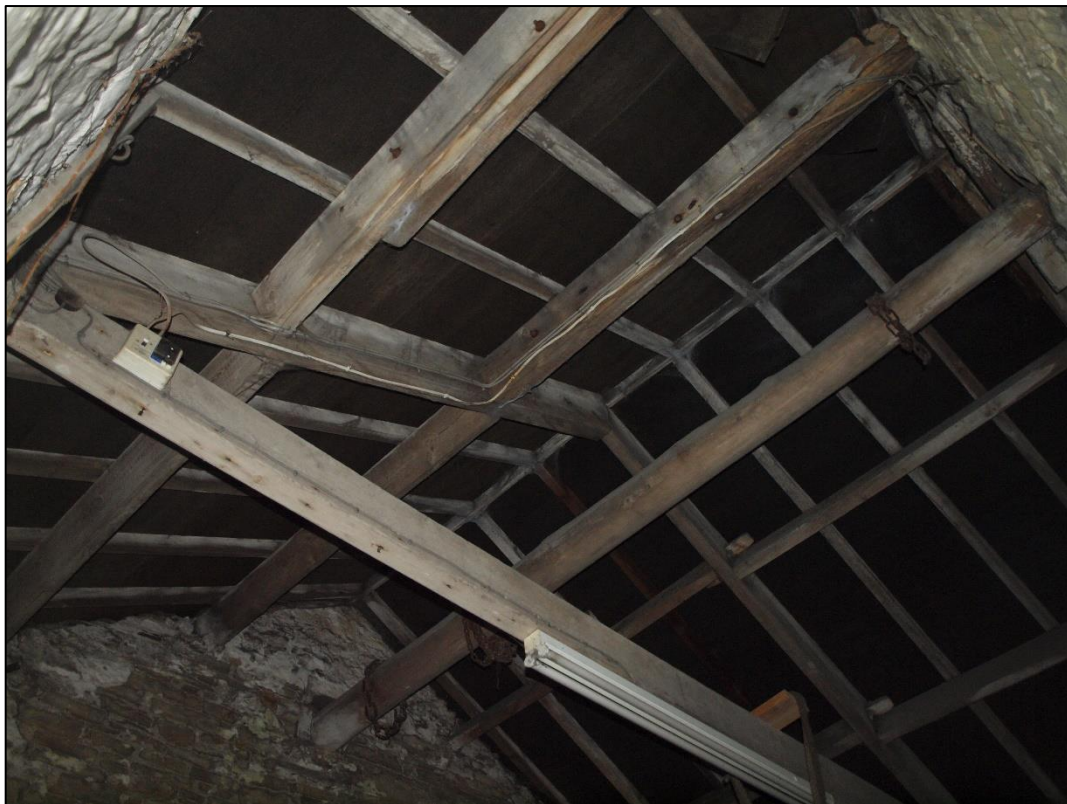
Plate 32: Details of roof structure looking northwest

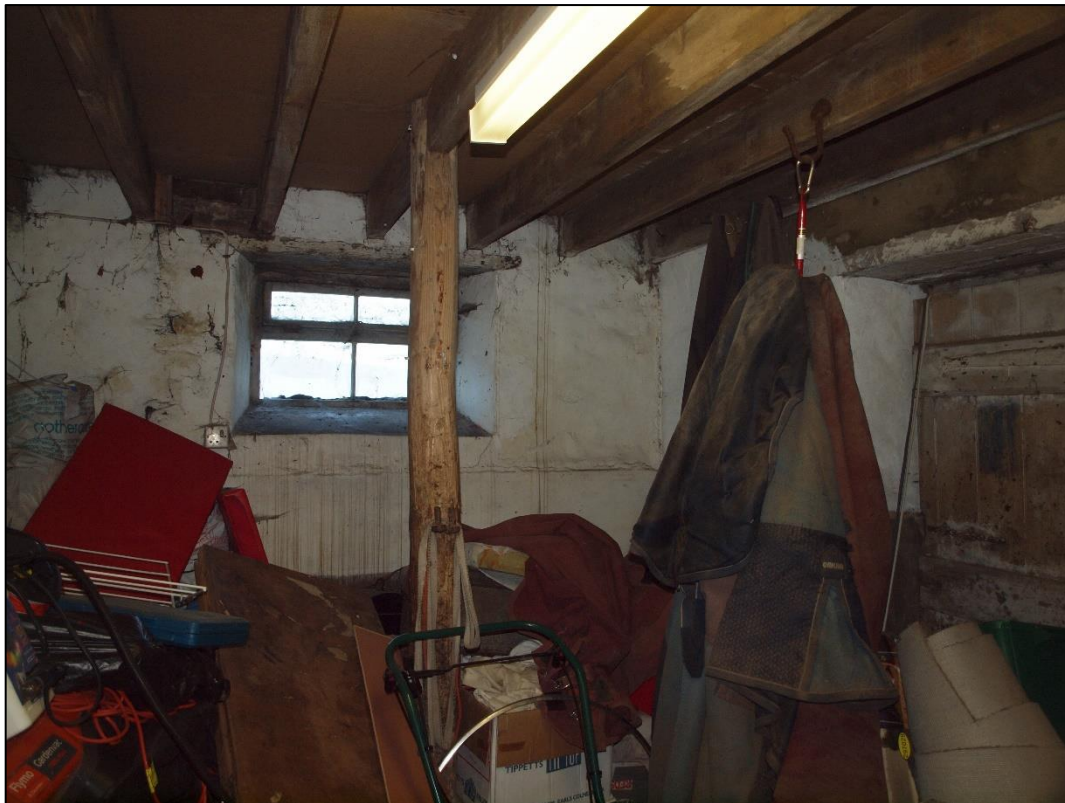
Plate 33: Room to bay 3 looking northeast

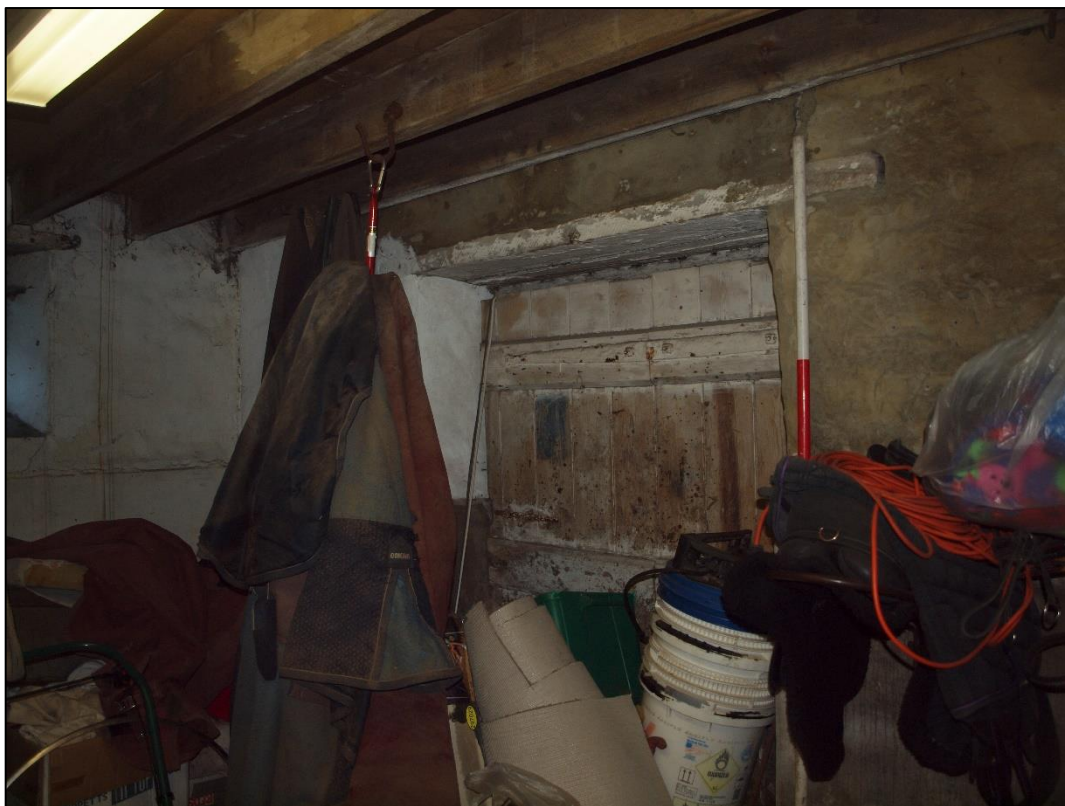
Plate 34: Room to bay 3 showing doorway in east wall looking northeast

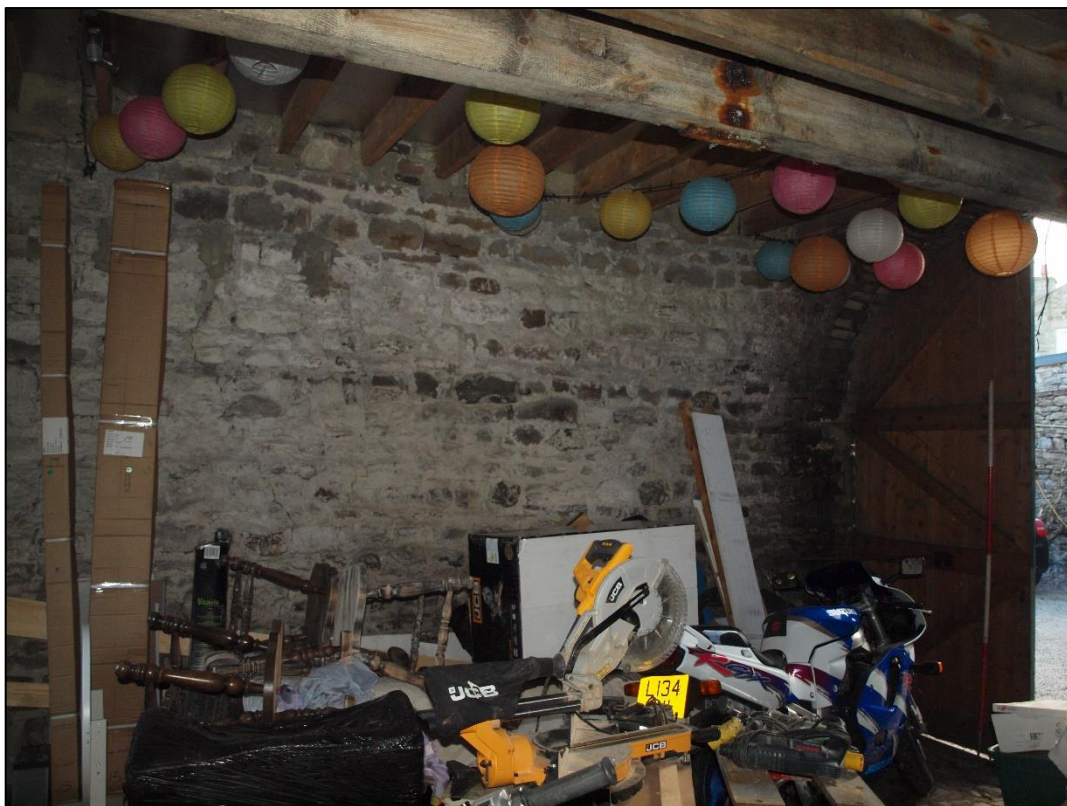
Plate 38: General shot showing whitewashed walls looking southeast

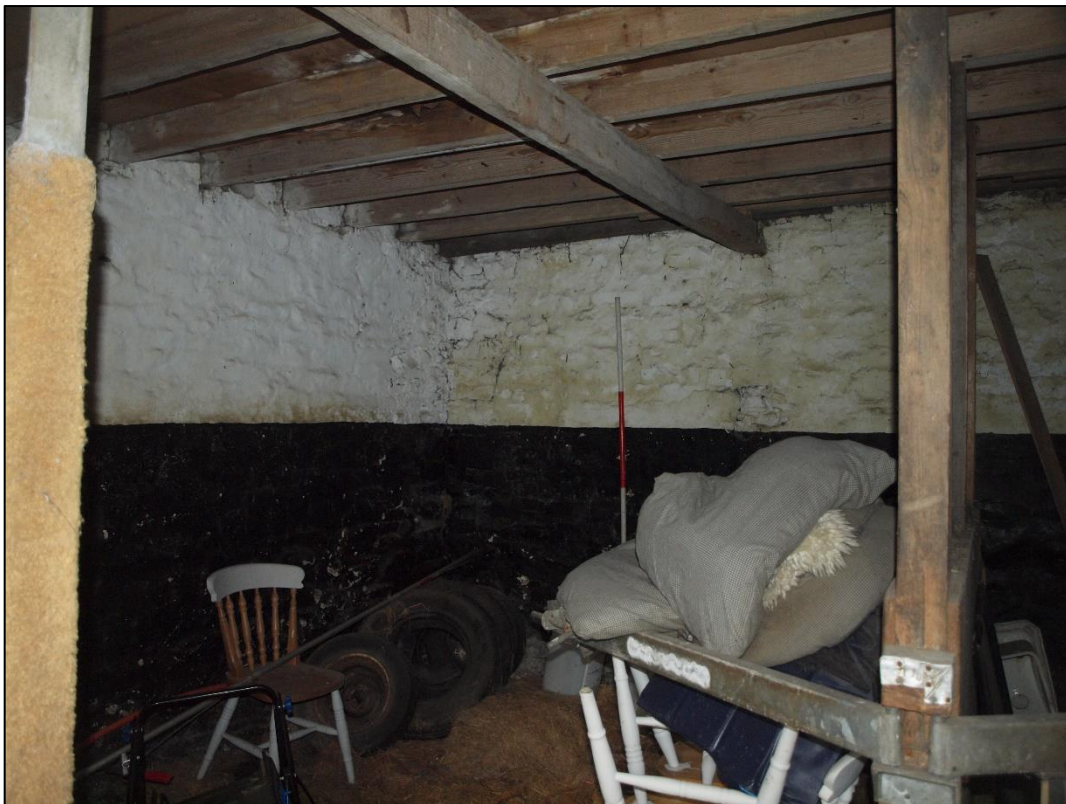
- 6.7 The doorway to bay 7 leads into the centre of a three bay room (plates 40 – 44). A pair of low concrete block walls flank the door and opposite the doorway, close to the centre of the room, is a timber post supporting a modern timber partition running to the north wall. The floor is flagged to the south side, with the northern side cobbled. A pair of machine cut timber beams span the room north – south and support the joists of the floor above. The walls are again whitewashed stone. The doorway to bay 10 leads into a two bay room (plates 45 - 47) with whitewashed stone walls. The floor is concrete along the eastern side, with a step up to cobbles on the west. The ceiling is the modern timber joists of the floor above. A small window lies in the north wall, opposite the door. At the far eastern side of the barn is the single story extension (plates 48 & 49). This is a single room with half rendered stone walls with whitewash above. The floor is flagged to the east with concrete, now removed, to the west. The ceiling is timber boards, hiding the rafters above.

Plate 40: Eastern end of room in bays 6 – 8 looking northwest

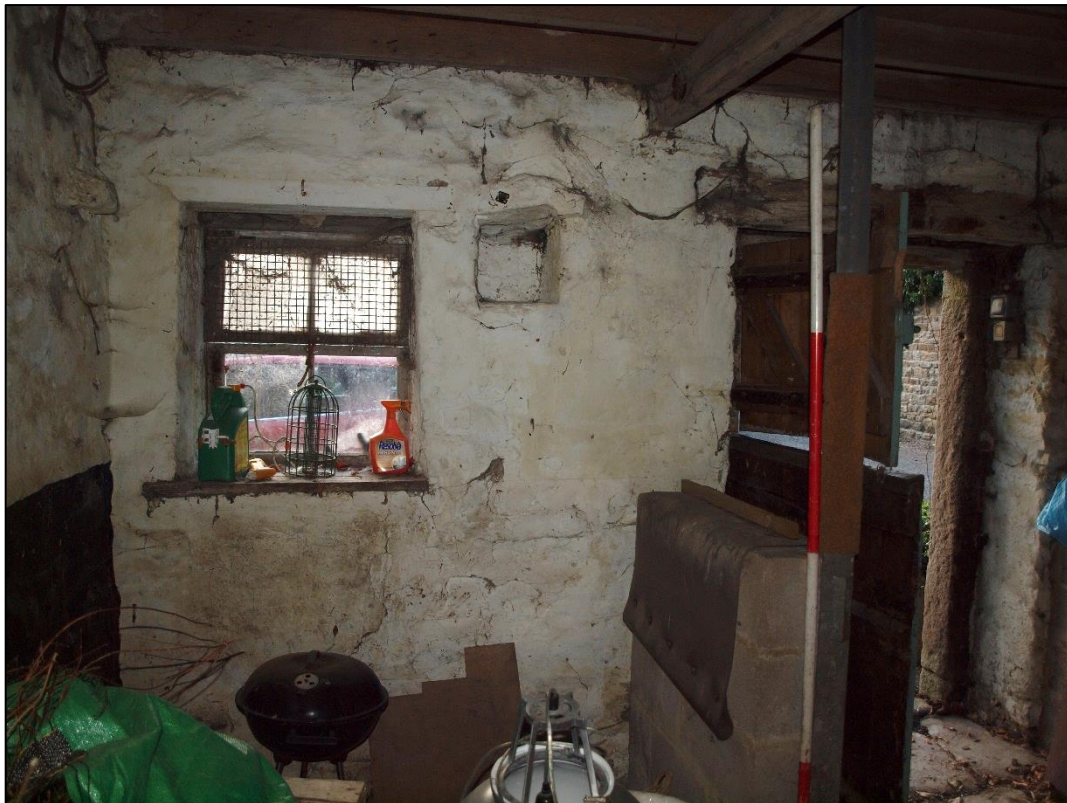
Plate 43: Southern wall showing window and doorway

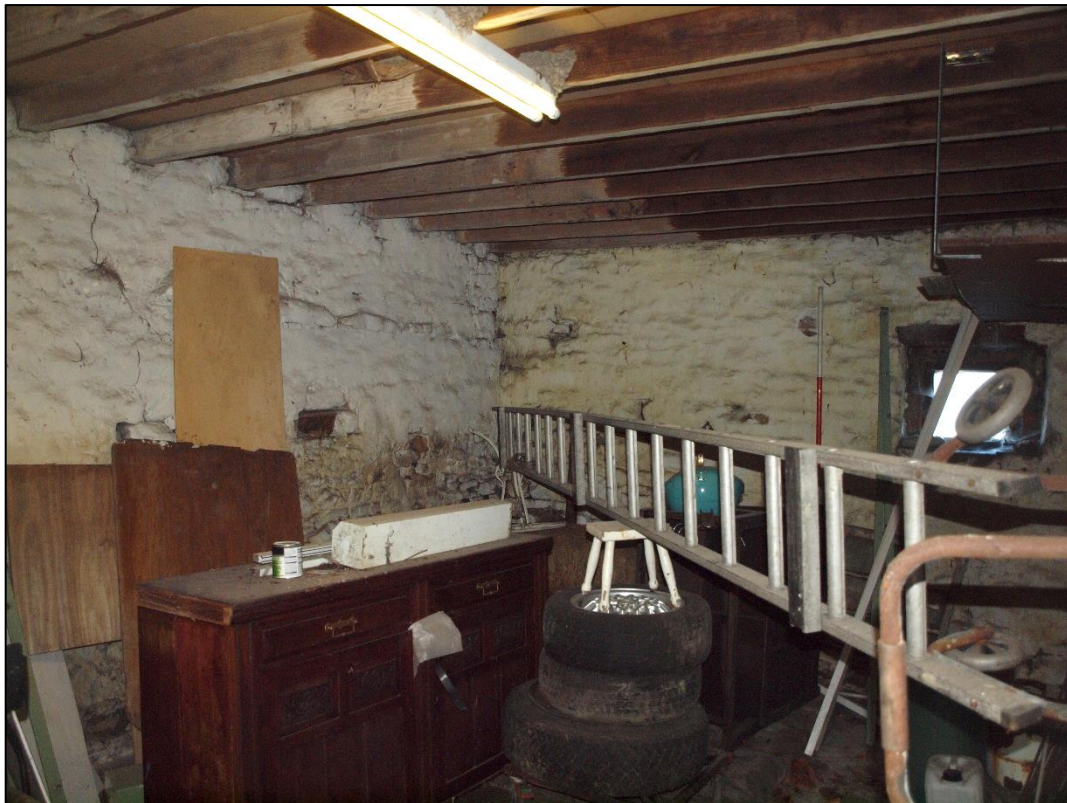
Plate 45: Room in bays 9 & 10 looking northwest

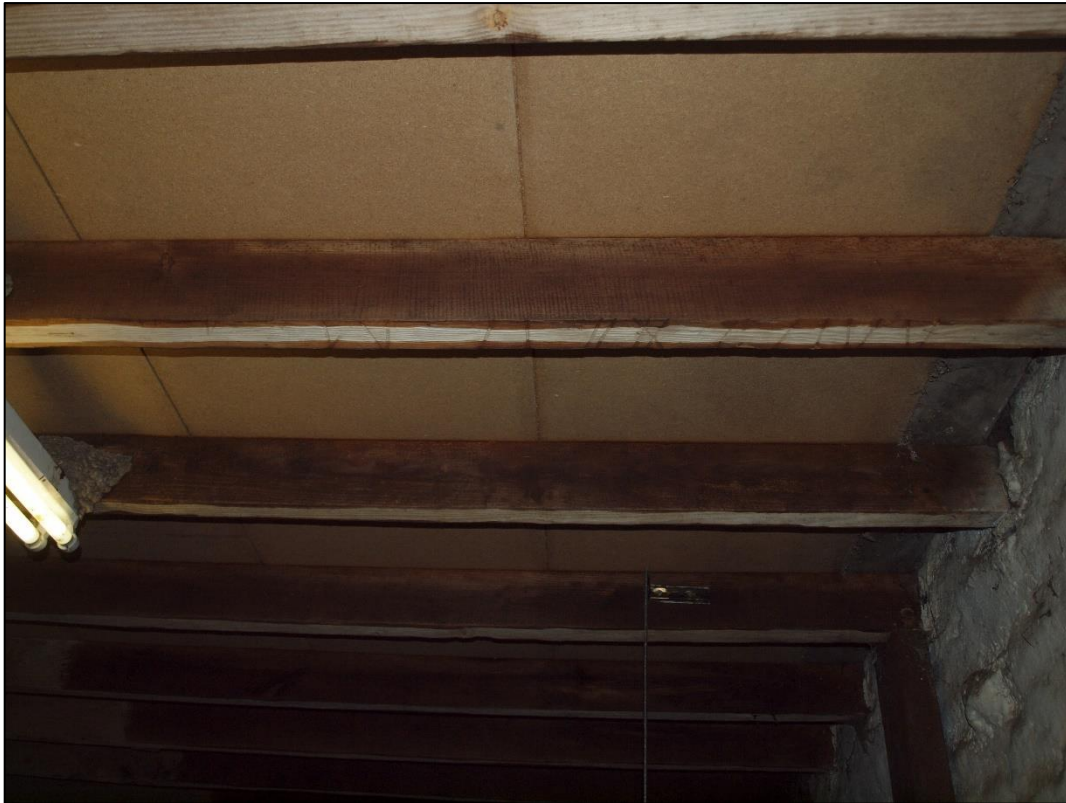
Plate 47: Modern ceiling looking south

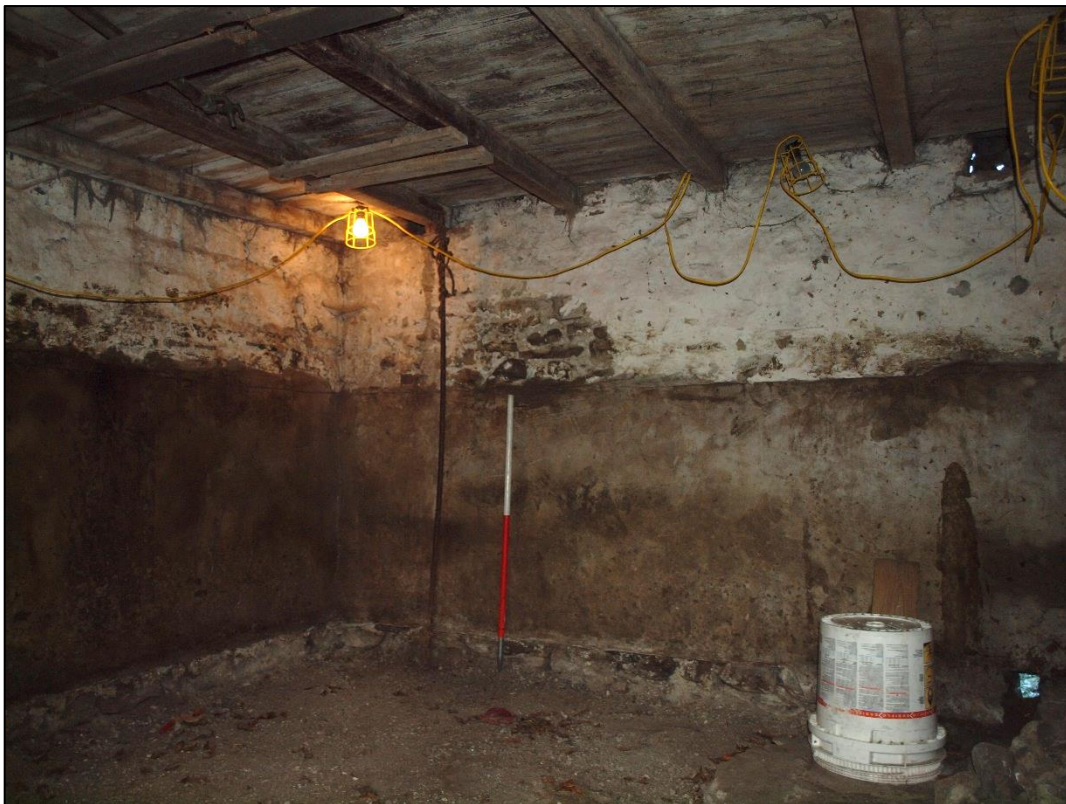
Plate 48: Interior of eastern gable extension looking northwest

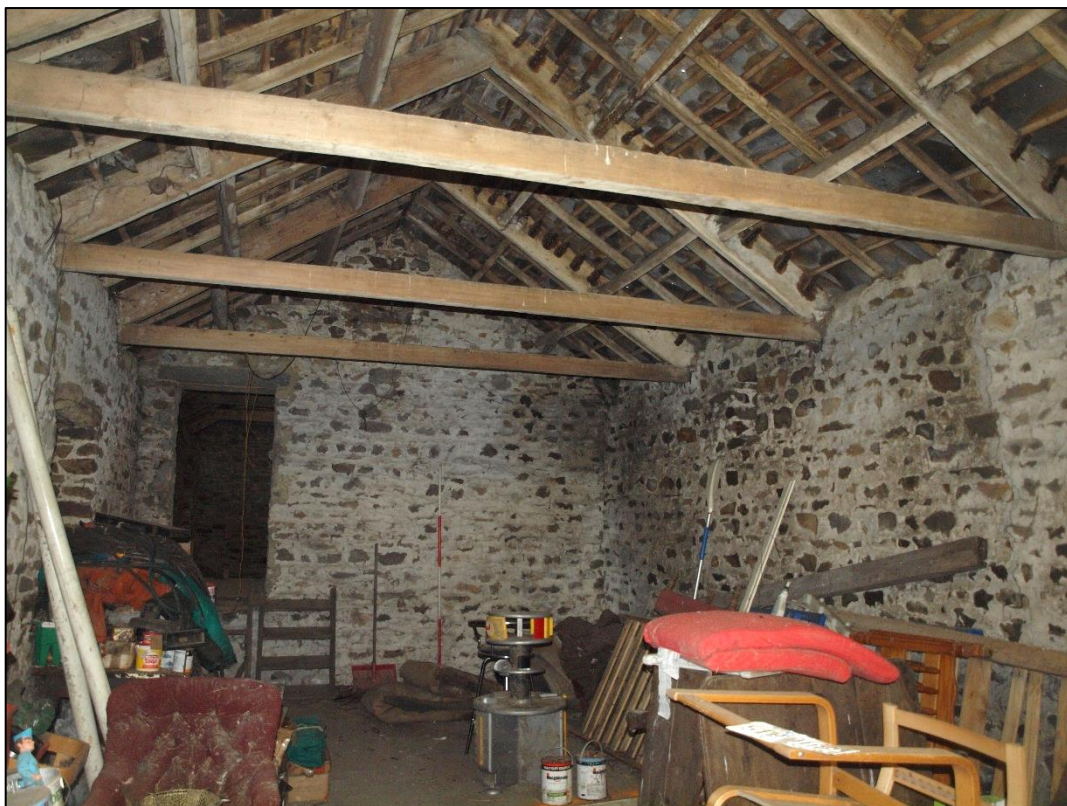
- 6.8 The first floor is accessed via the stone steps and doorway to bay 10. This leads into an open space of 5 bays (plates 50 – 58), with four A-frame trusses of modern timber supporting the roof. The purlins and rafters are also modern machine cut timber. The stone walls are whitewashed and the floor is covered with ply boards. A pair of ventilation slots lie in the north wall, with a pitching

Plate 50: East end of first floor looking west

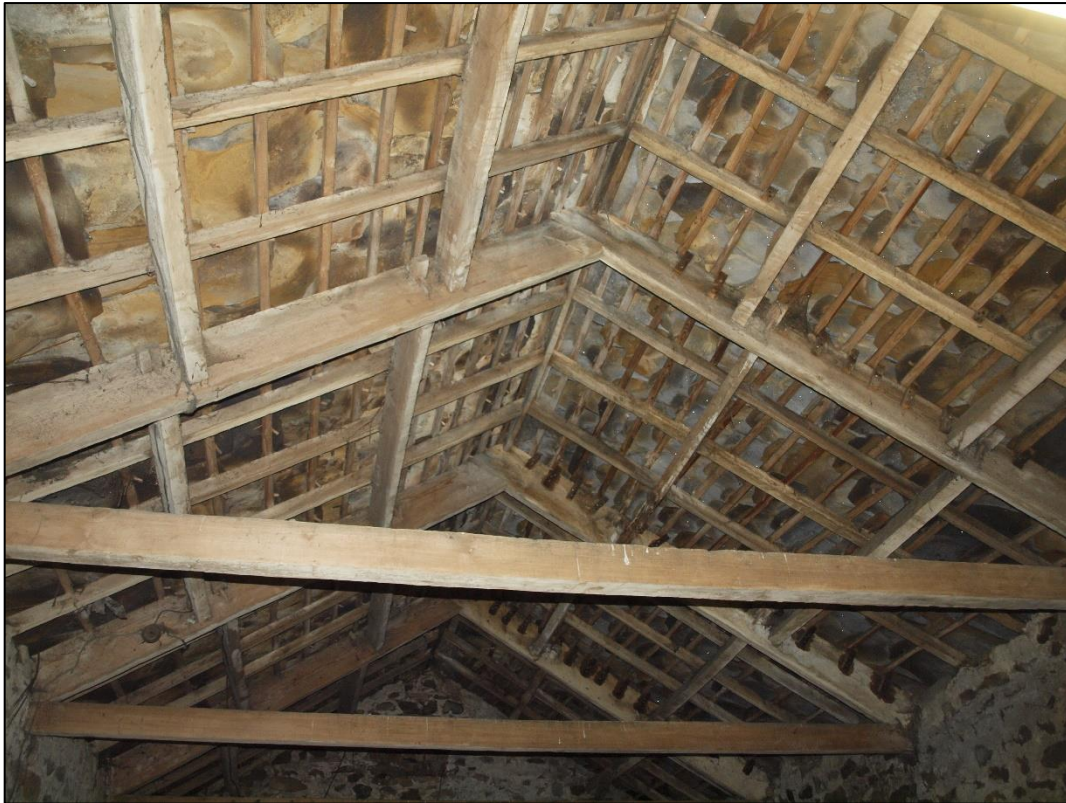
Plate 51: Truss detail looking west

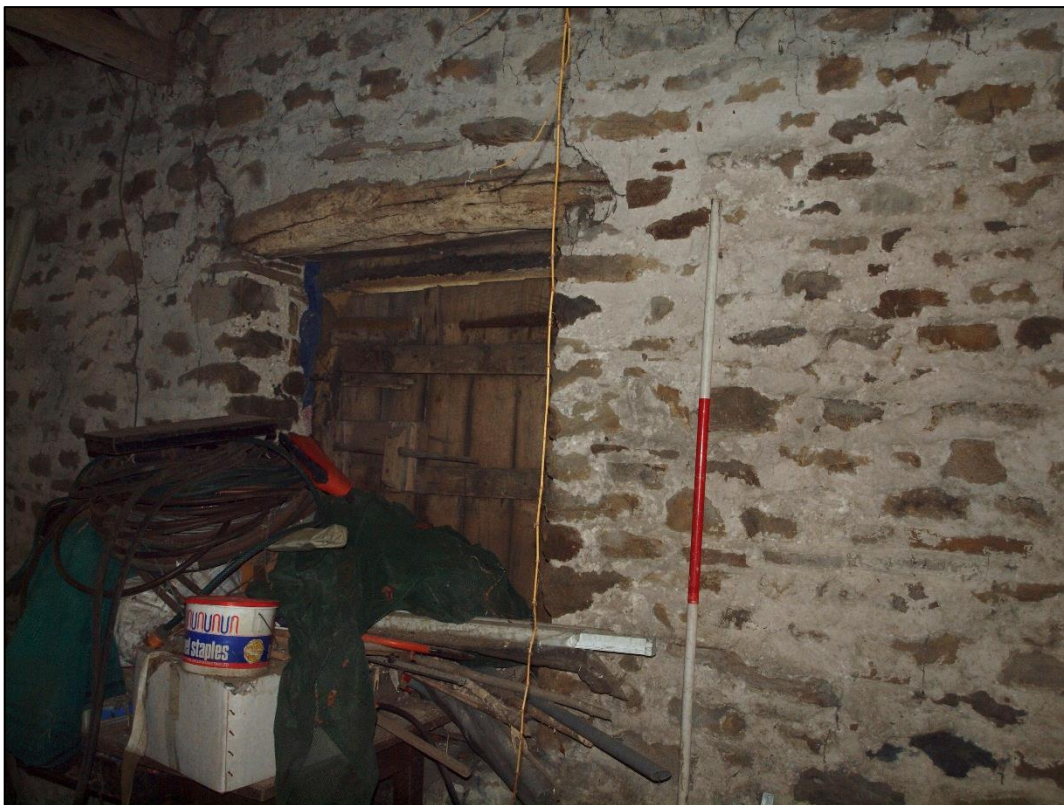
Plate 54: Pitching eye to south elevation looking south

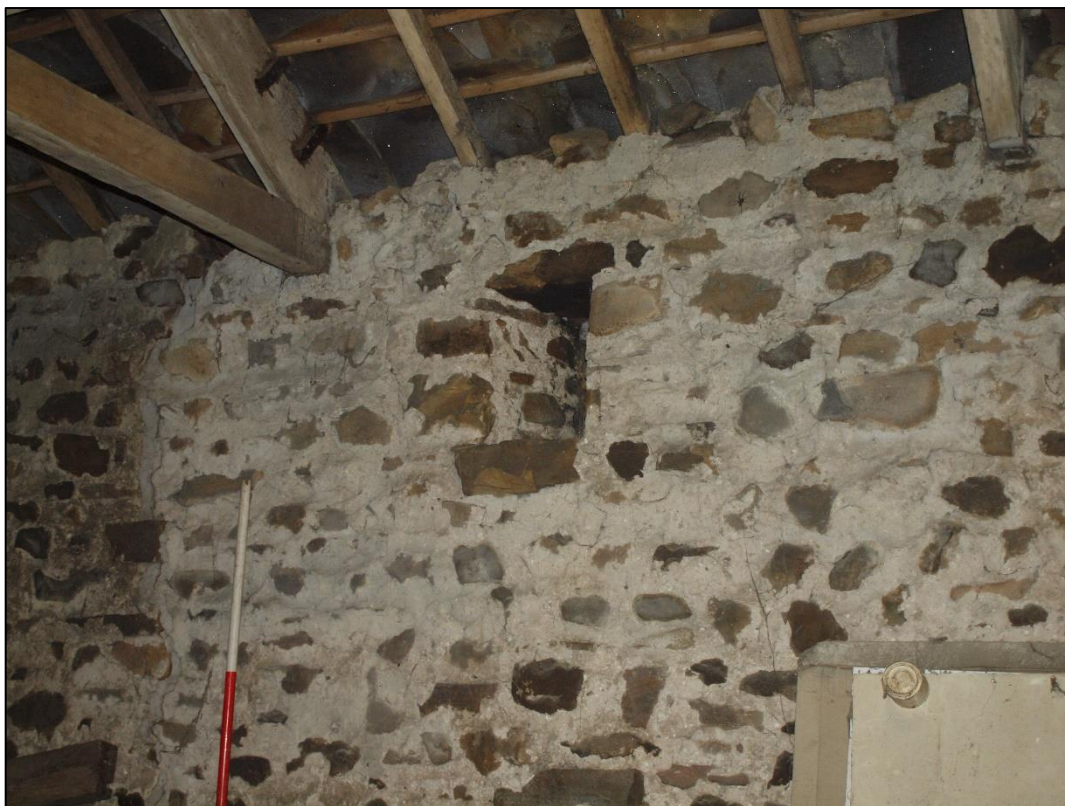
Plate 56: Ventilation slot in north wall looking northwest
