Ling Villa Barn, Mickleton
Historic Building Survey

January 2023

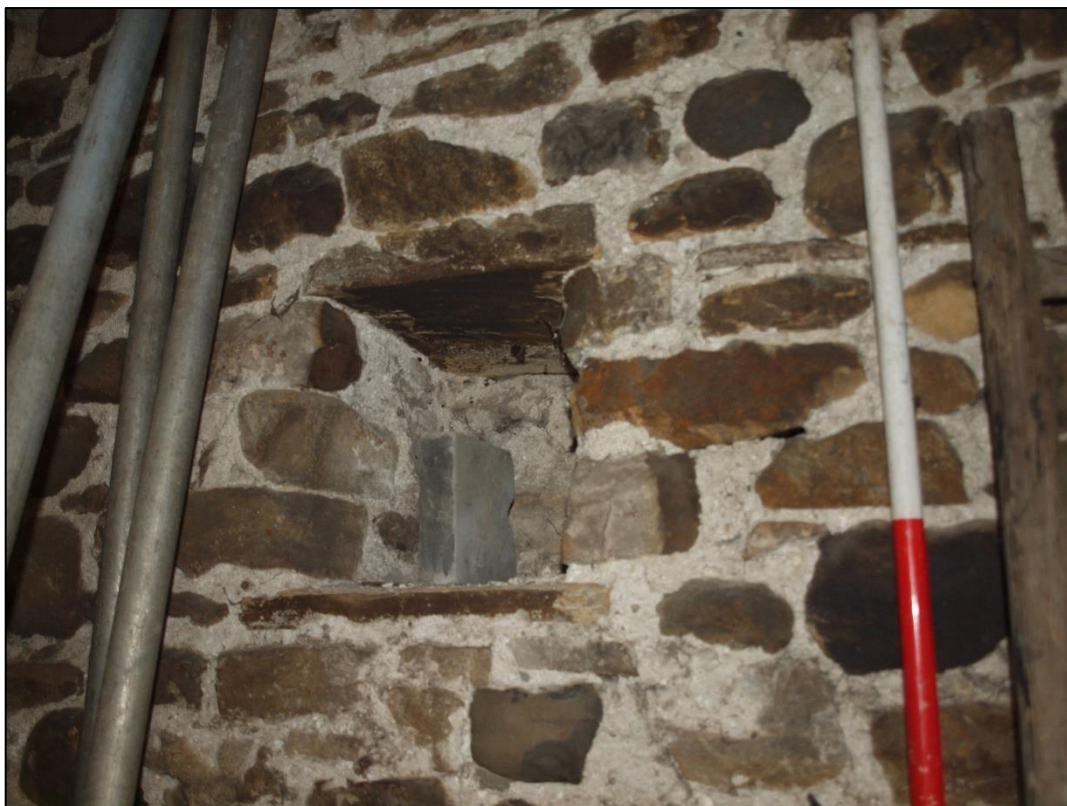
Plate 58: Niche in east wall looking east

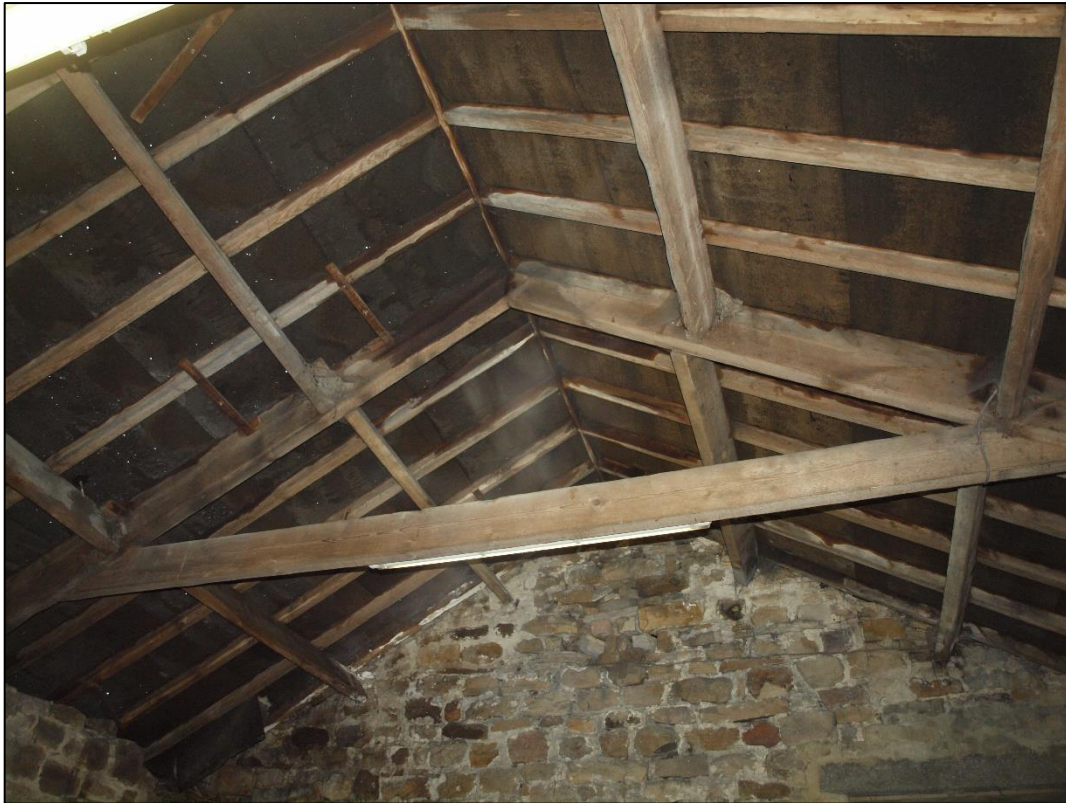
Plate 61: Detail of roof structure looking east

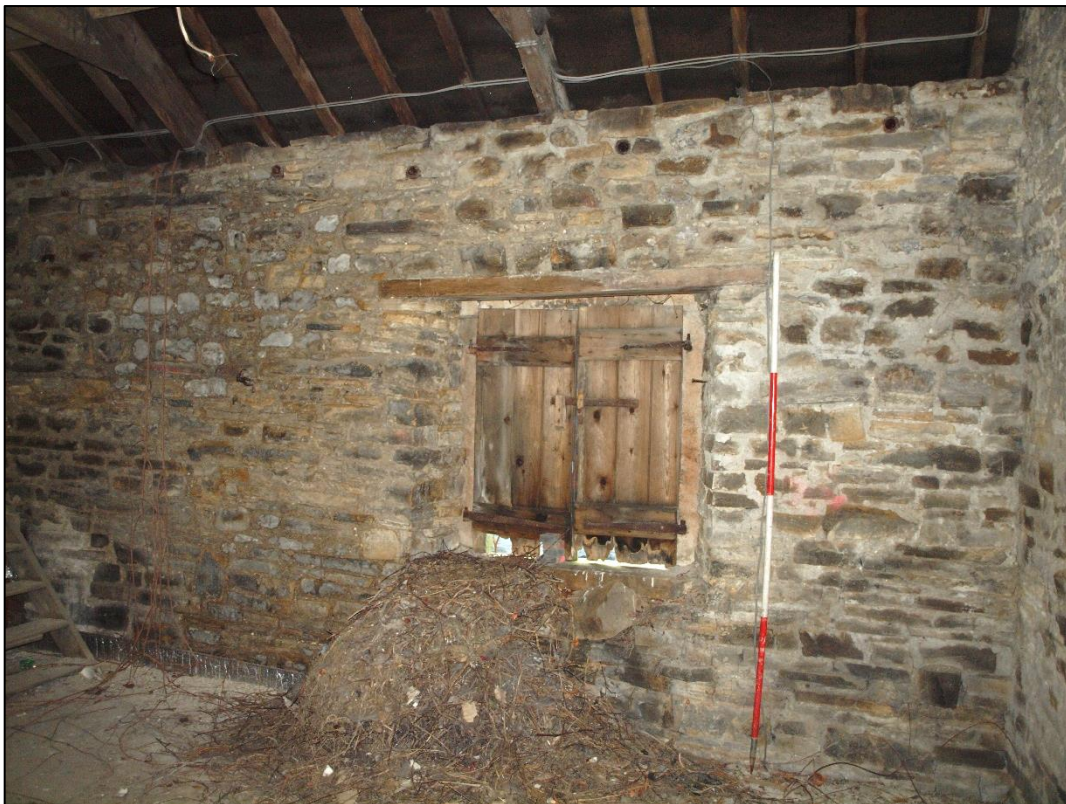
Plate 62: Pitching eye to south elevation looking south
