Land at the Former Luckwell Club and Scout Hut Site, Luckwell Road, Bedminster, Bristol

Report on Archaeological Watching Brief

City of Bristol Planning Application Ref. 15/01453/F

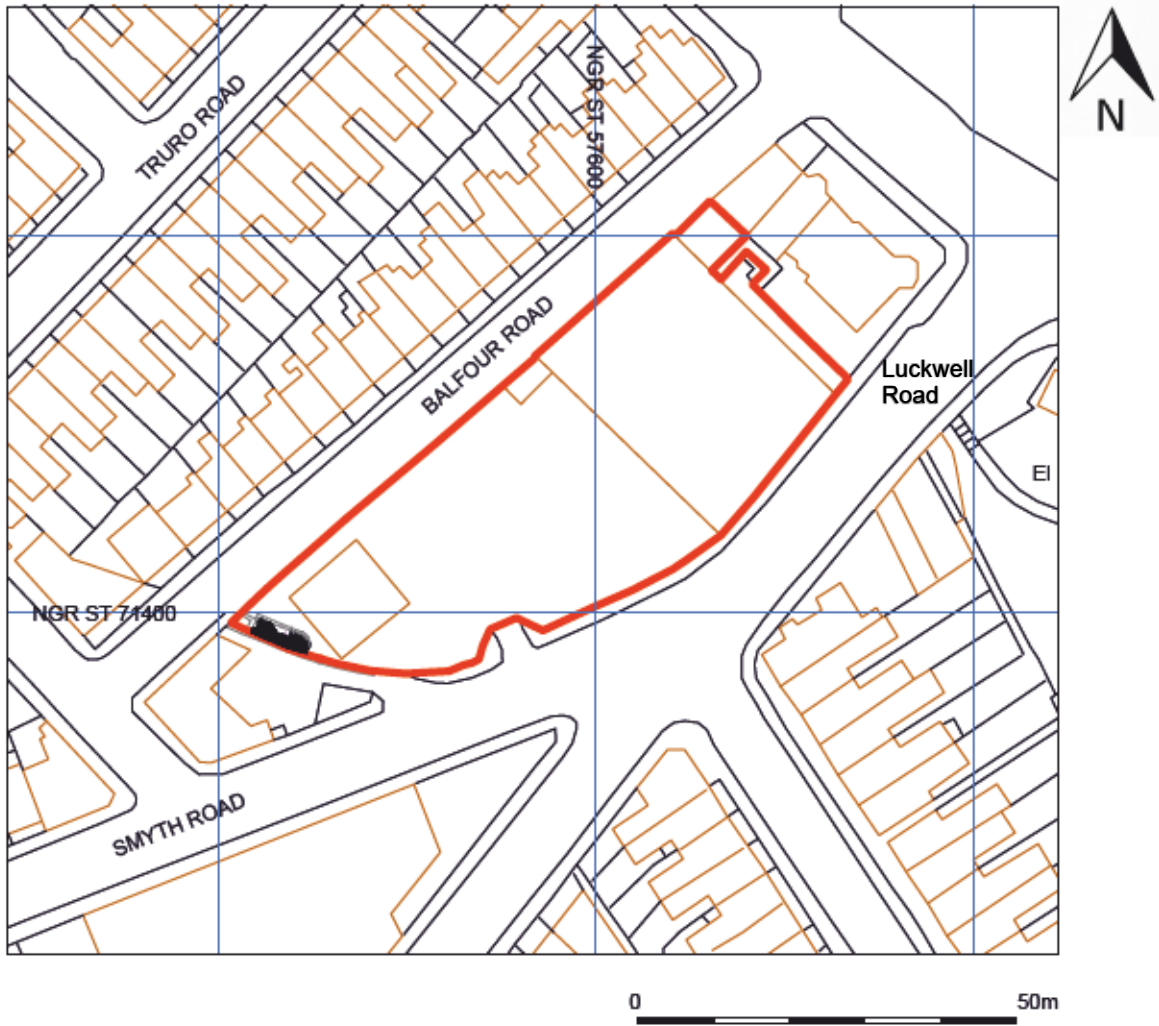
Figure 3

lean-to against the outside (north-eastern side) of wall (102). The 1:500 map, indeed, very much confirms the plan of these structures as recovered by the archaeology, leaving aside small differences easily accounted for by the vagaries of survey between the late 19th and early 21st centuries (**Figure 3**). These structures seem clearly to have been in place by the mid-19th century since as already noted, they are shown on the Bedminster tithe map of that time (**Cover**). The larger building was probably a functional, multipurpose storeroom/outhouse/shed, perhaps with provision for access for and storage of a small wheeled vehicle, maybe a small two-wheeled animal cart, as attested, in particular, by the width and design of the doorway from the street at the south-eastern end of the building. Indeed, it is also a possibility that the larger building may have been used even if only occasionally as stabling. What is particularly interesting about the general arrangement of the two putative access gaps into the larger space, is that they were made through the main boundary wall, which formed effectively the southern side of the building, and led out directly onto the street surface south of the boundary wall; the street level at the time that the access ways were in use being over 1m lower than it is today, and it seems clear that these entrances would by definition have to be blocked when the street level on the southern side of the main boundary wall was raised. As already noted, there did not seem to be any access to the larger building from the northern side, although it is possible that this is due to severe truncation of wall (102) on that side. It may partially reinforce the suggestion that the larger building was used for storing wheeled vehicles, for whom direct access out onto the street would be a logical requirement. There may, though, also be an element of social segregation here, because such an arrangement would mean that the occupants of the large house immediately to the north would not be disturbed by the constant comings and goings of gardeners, tradesmen and others of the 'lower' social orders, although this is speculation.

The Site - General Plan in Relation to First Edition OS
