**Anne Hathaway's Cottage  
and Mary Arden's Farm**

**ARCHAEOLOGICAL  
WATCHING BRIEF**

PN 16-15

12/2016

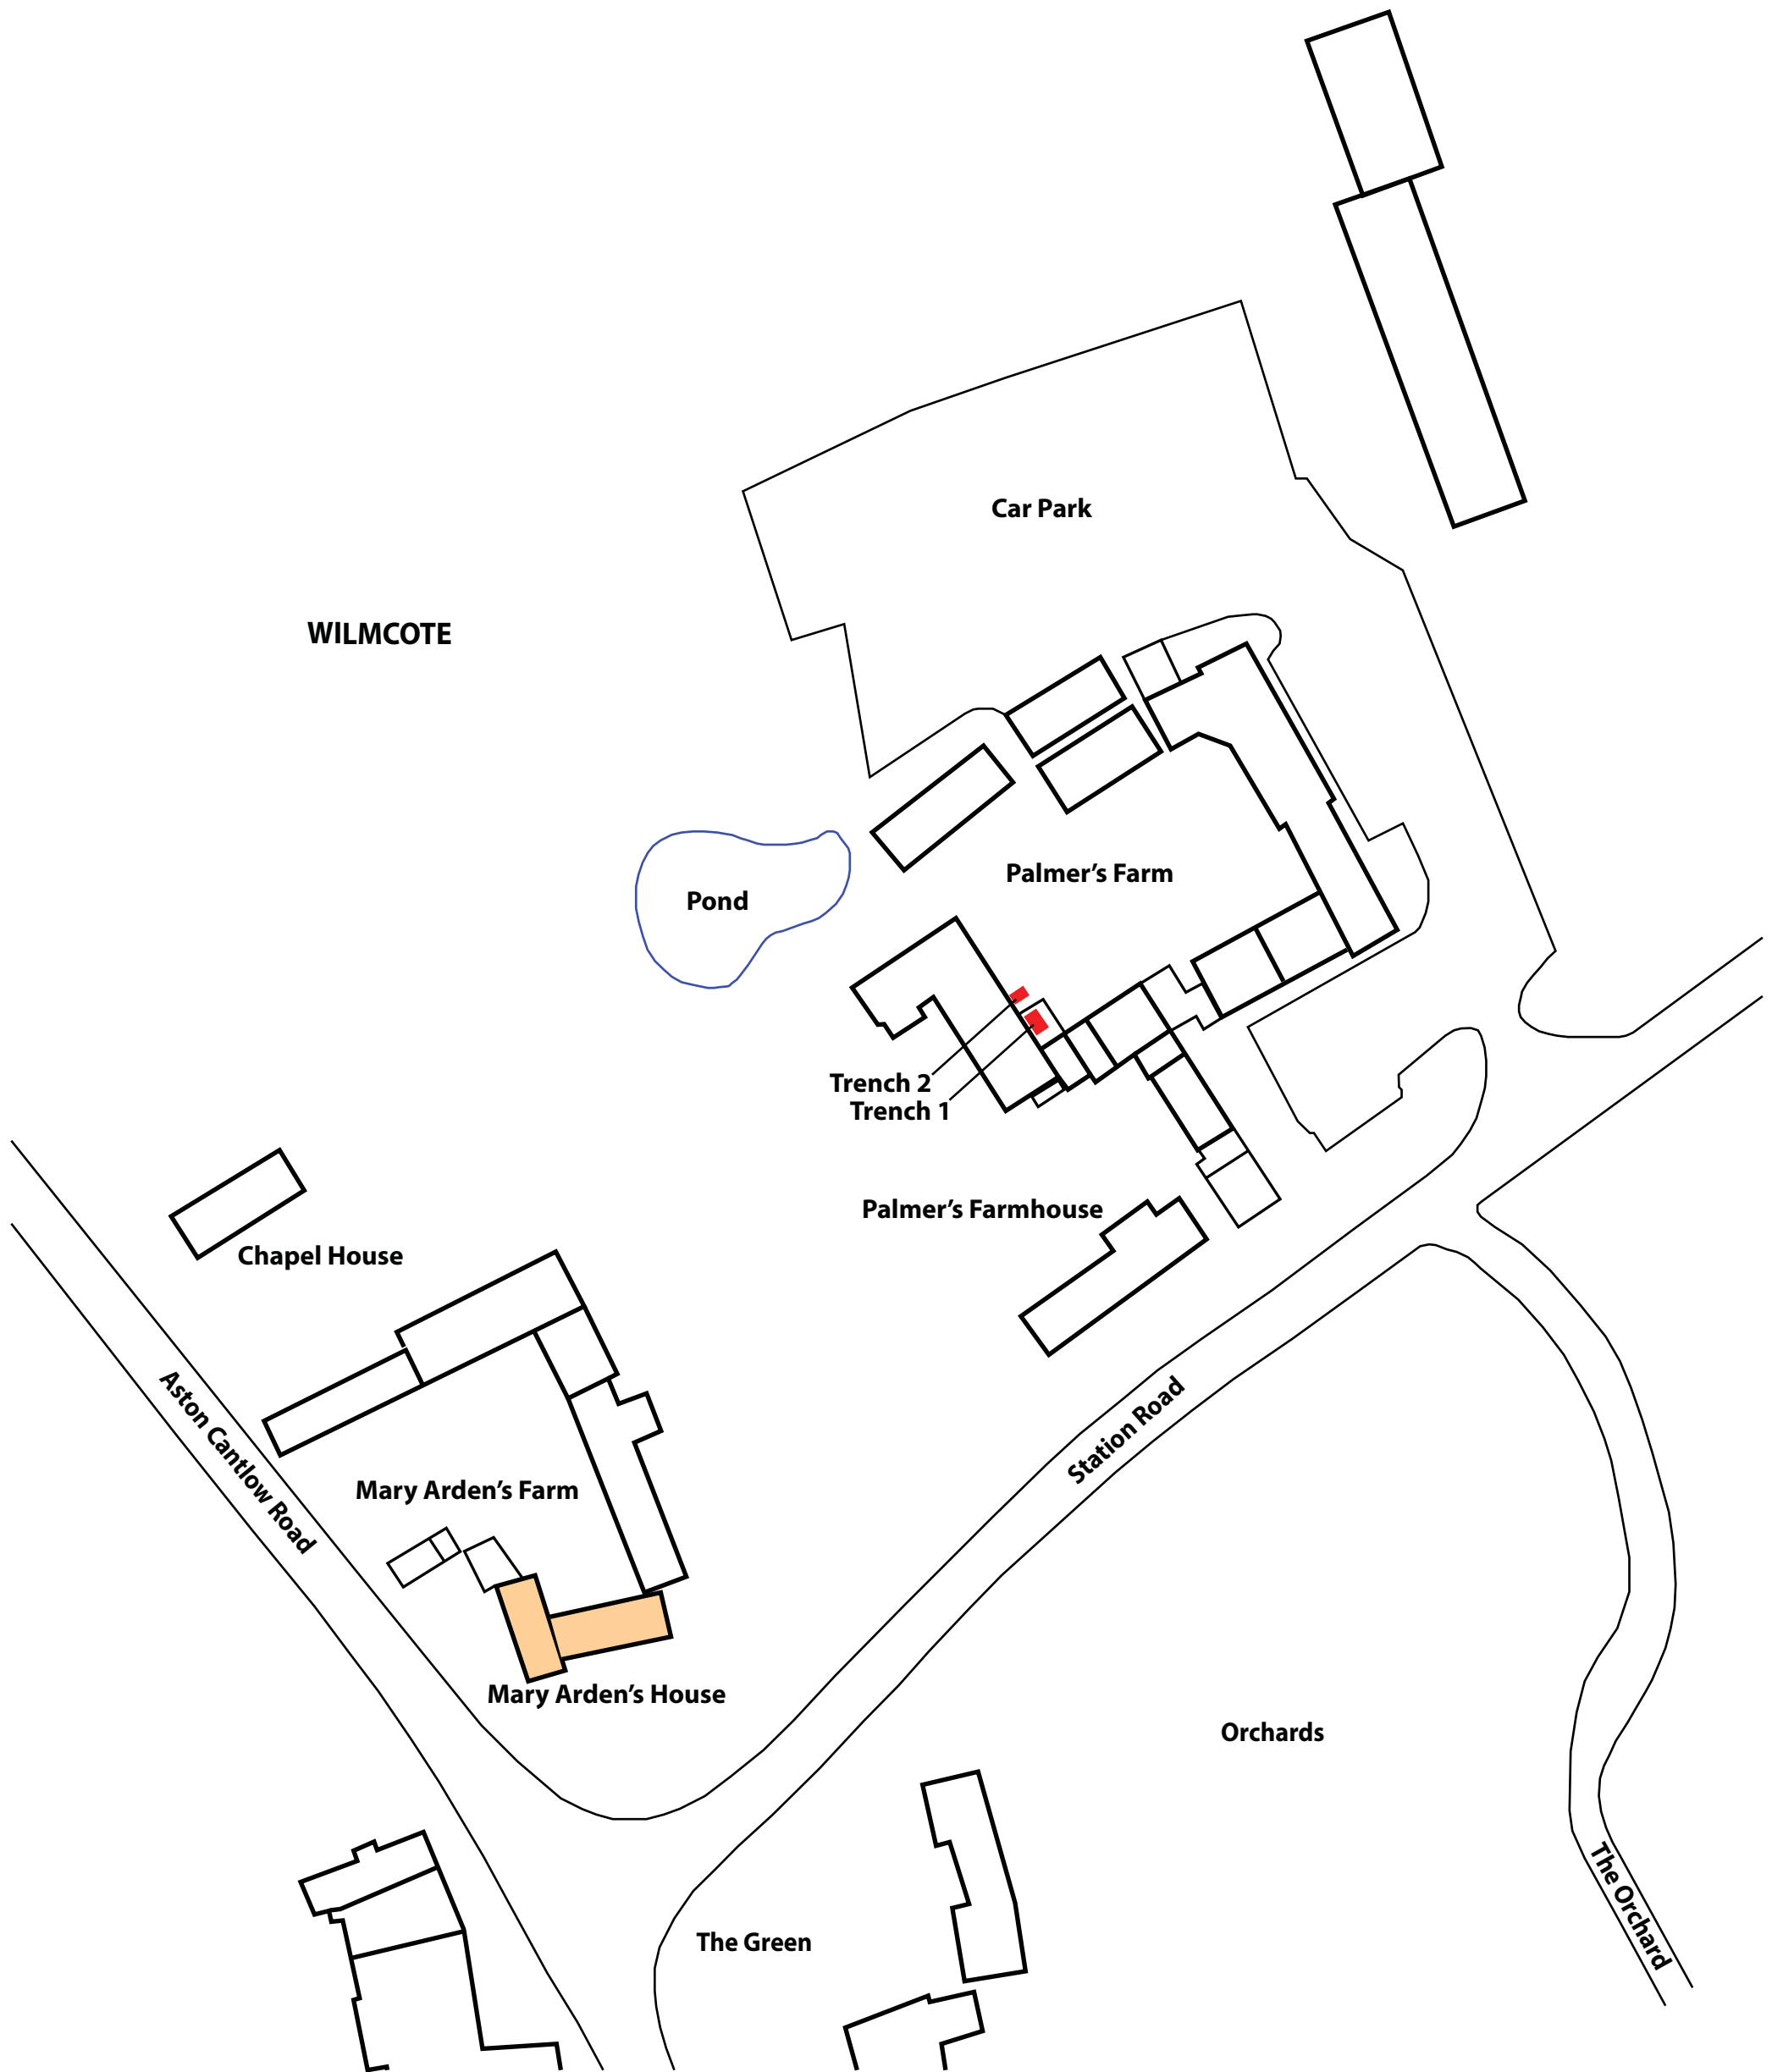
Figure 2 - Mary Arden's Farm Trench Location Plan

- 6.2.1. Two small exploratory test pits (Test Pits 1 and 2) were excavated at Mary Arden's Farm (Palmer's Farm) for the purpose of identifying the cause of the subsidence present in the toilet block wall attached to the barn. The test pits were excavated at a close proximity to one another. They were located within the main courtyard of the farm buildings and within the toilet block in the courtyard at Palmer's Farm against the eastern elevation of the main barn. Both
