***Barns at Langton Caudle, Stonton  
Wyville, Leicestershire***

*Report on Historic Building Recording*

*Acorn Archaeology Report Number 38.0*

*July 2019*

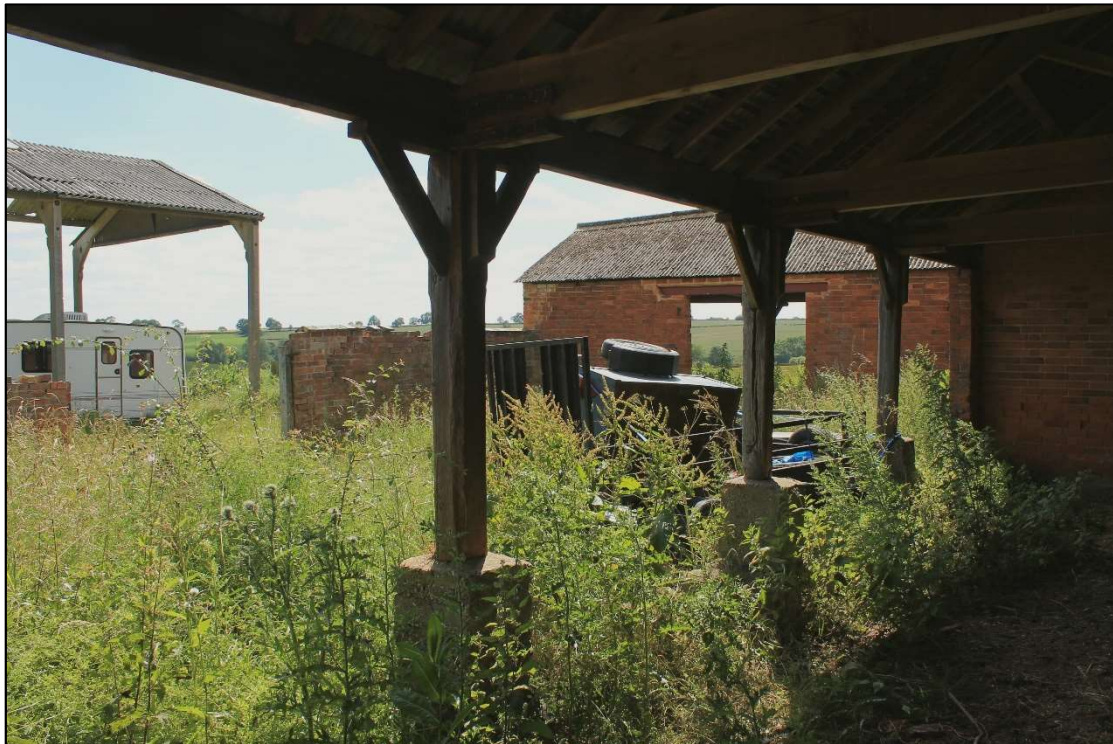
The open south elevation of Room 2 had a spliced timber wall plate supported on brickwork plinths at either end and three wooden posts with angled struts (Plate 6). Each wooden post was set on a red brick plinth with shaped blue bricks and the plinths had been the subject of later concrete repairs (Plate 7 & Plate 8).

*Plate 7 View from interior of cattle shelter, Room 2, showing posts of south wall, looking southwest*

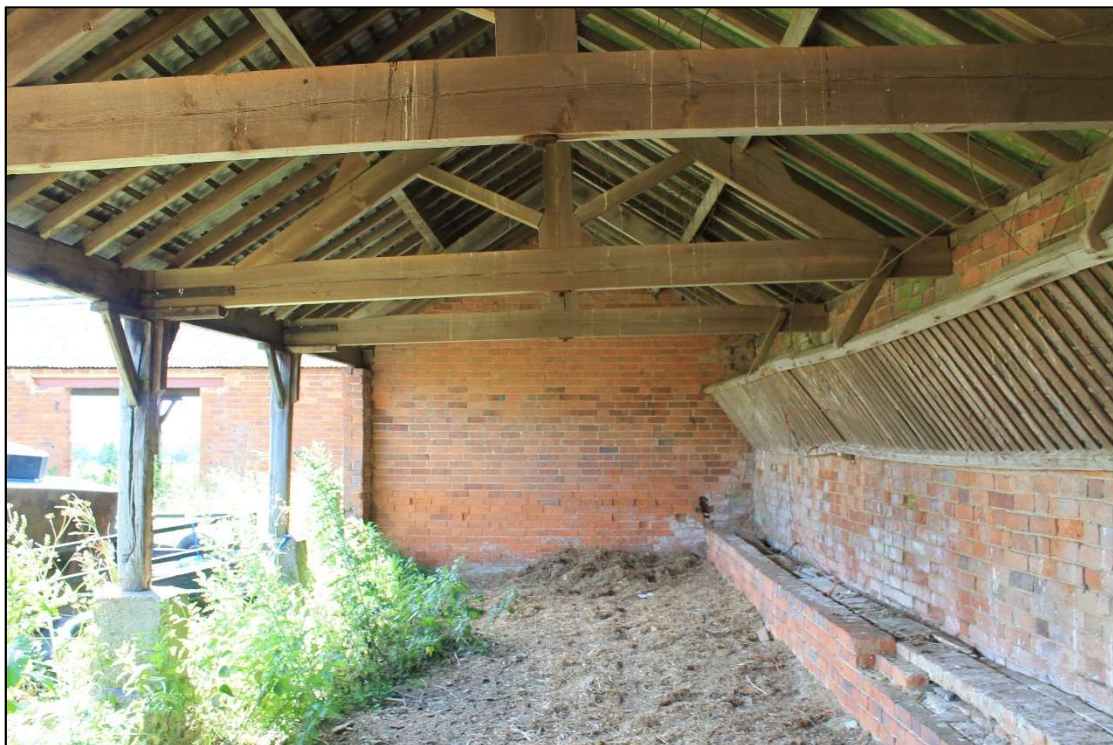
*Plate 8 Interior of cattle shelter, Room 2, looking west*

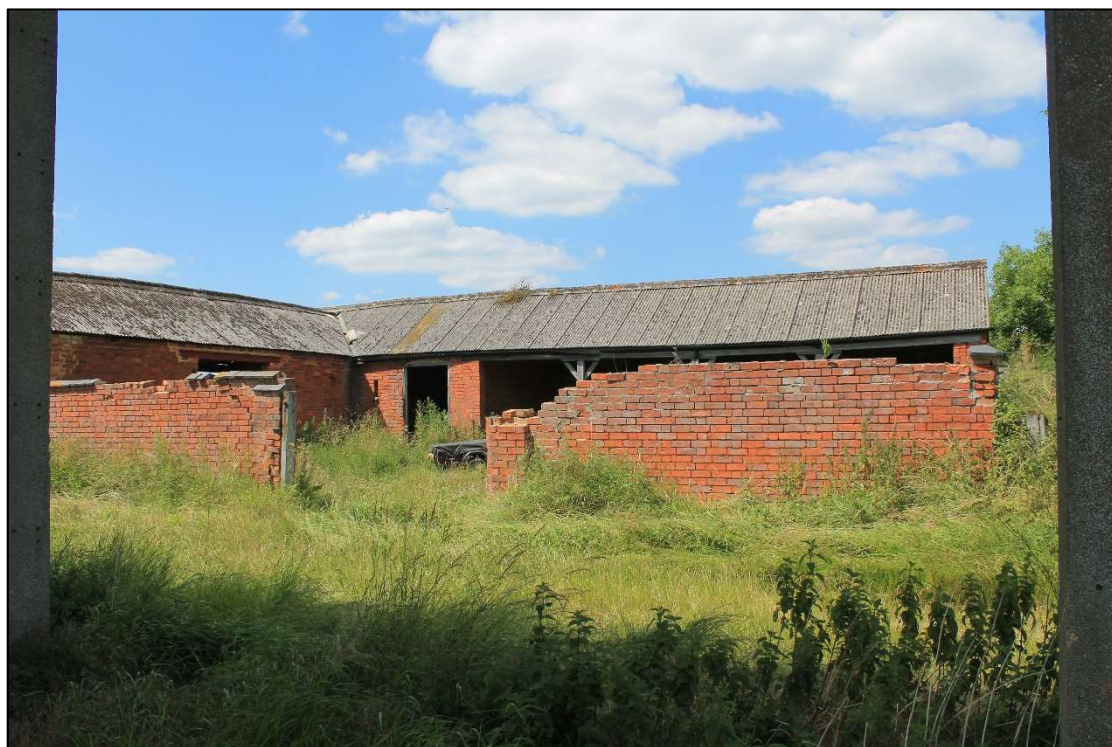
*Plate 12 View from Dutch barn towards brick-walled cattle yard (Area 6)*

The brickwork of the south and east walls matched the Flemish garden wall bond recorded elsewhere. In places blue ceramic coping survived on top of the southern wall (Plate 12 & Plate 13). The top of the south wall had a noticeable lean to the south in places, and, as such, had been subject to 20<sup>th</sup> century repairs. A single surviving

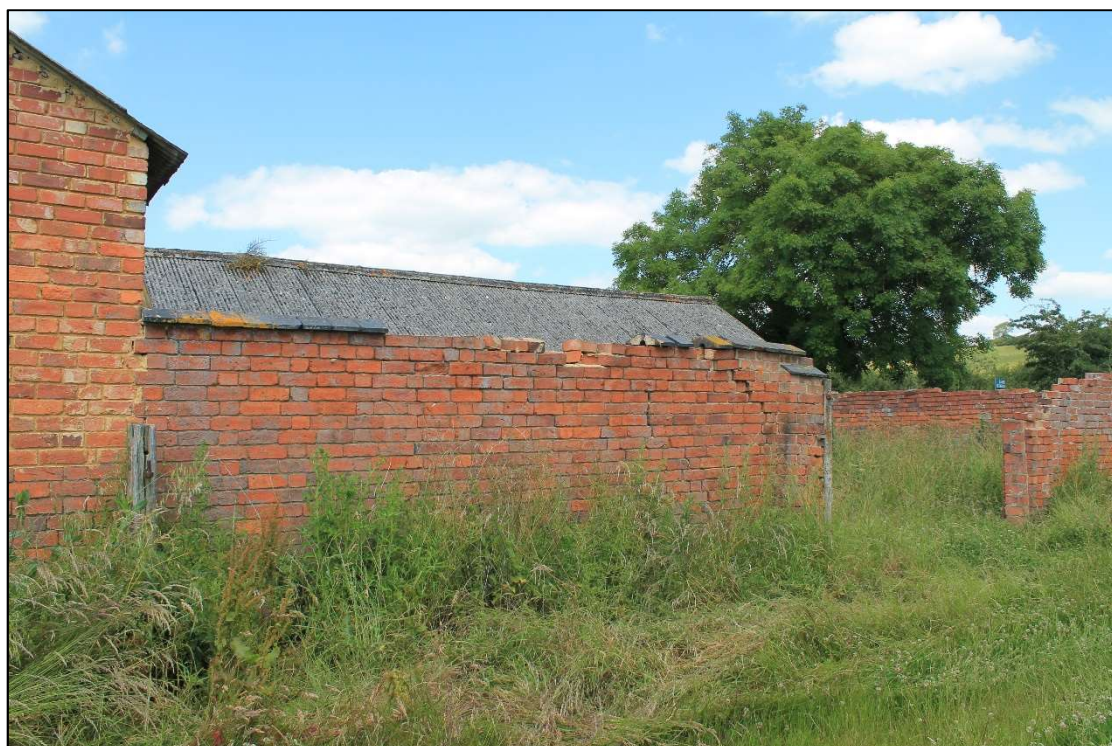
*Plate 13 Brick wall and gateway at south of cattle yard (Area 6), looking northeast*

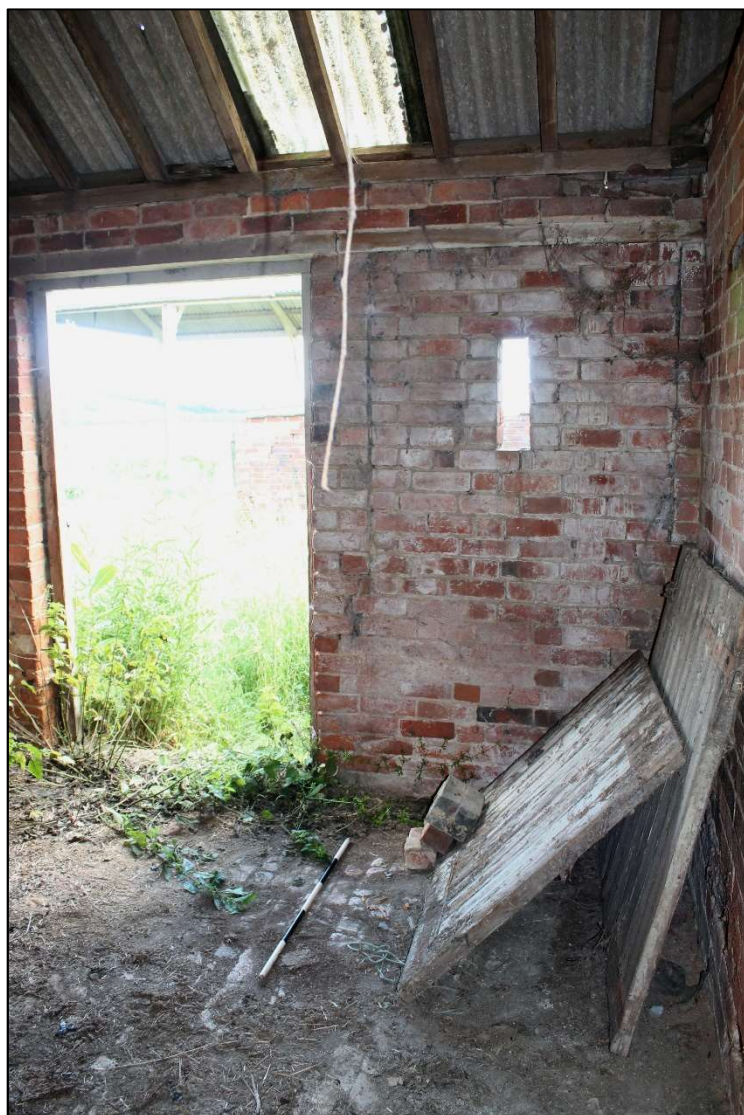
*Plate 17 Interior of Room 3, showing brick floor, blocked window and inserted breather slit, looking south, Scale 1m*

At some time after its initial construction the window of Room 3 had been blocked with brick and replaced with a single breather slit. This suggests that the room was used for fodder storage later in its life and would have been in a convenient position to serve this purpose, being adjacent to the shelter shed. The date of this alteration is uncertain, but the brickwork suggests a possible late 19<sup>th</sup> century to early 20<sup>th</sup> century date.

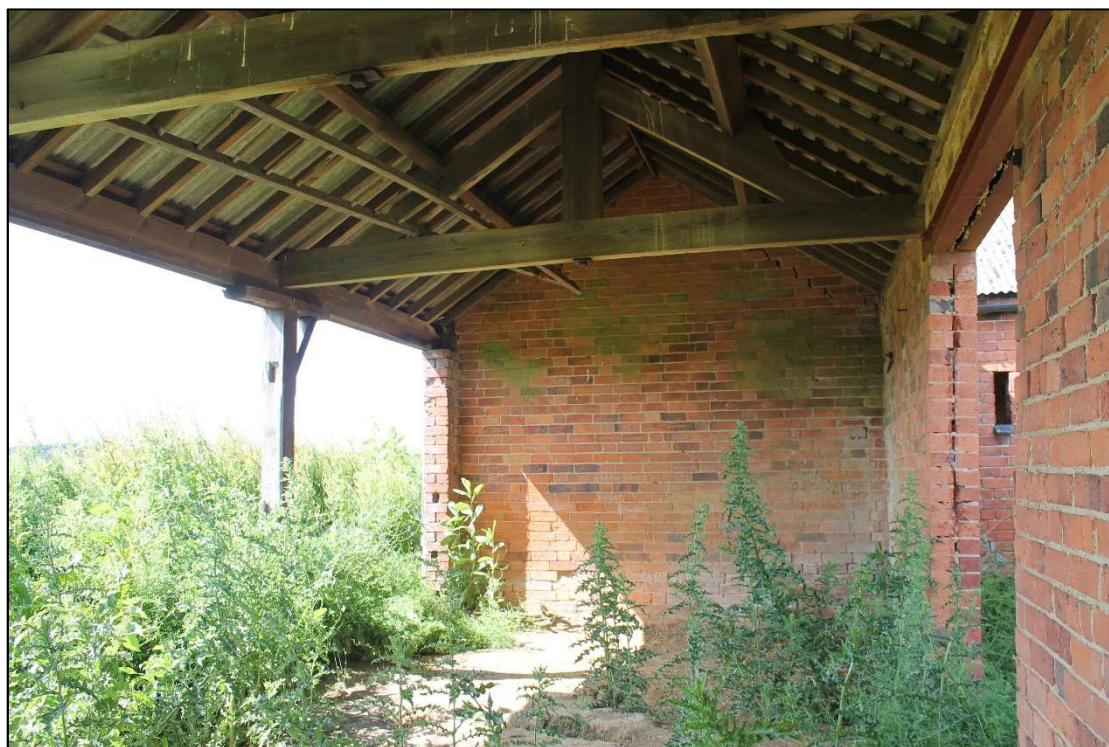
A further substantial opening had been inserted into the otherwise plain east wall of Room 5. This was cut roughly into the brickwork and a modern steel lintel inserted (Plate 11, Plate 25 & Plate 26). It is unknown whether there may have originally been a smaller opening in this position.

*Plate 25 Interior of Room 5, looking north*

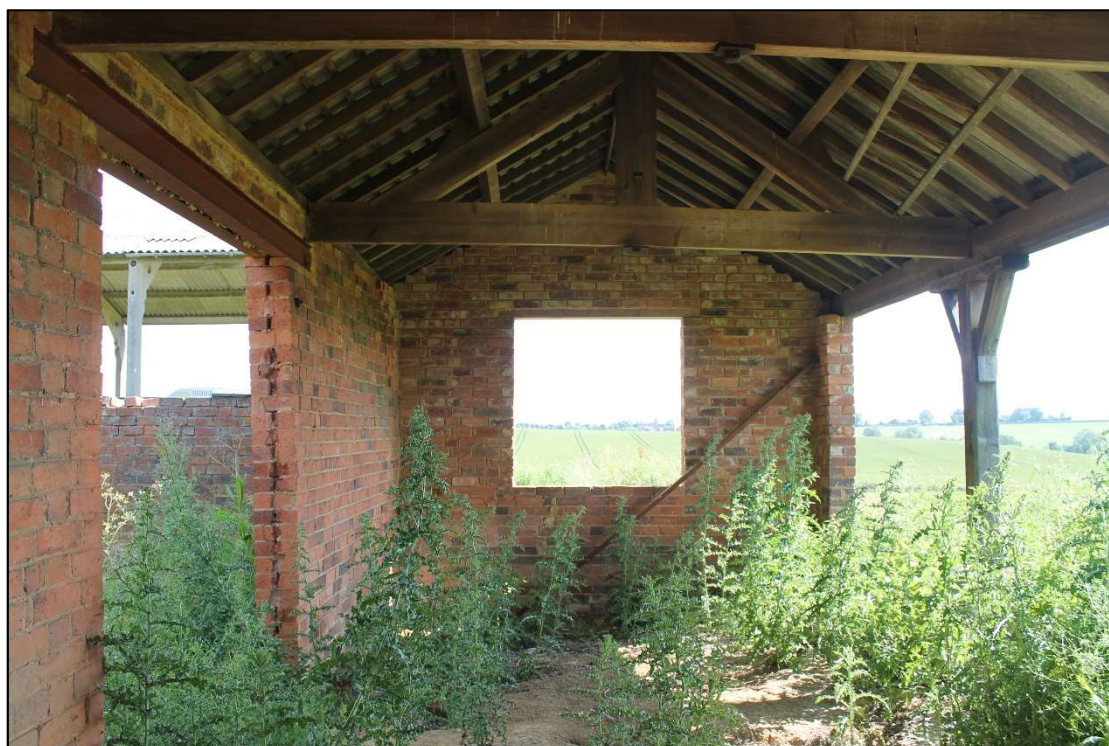
*Plate 26 Interior of Room 5, looking south*
