## Outbuilding at Tregardock Farm Cottage, Delabole PL33 9ED

Heritage Impact Assessment: SH Ref TGAR1017  
23/10/2017

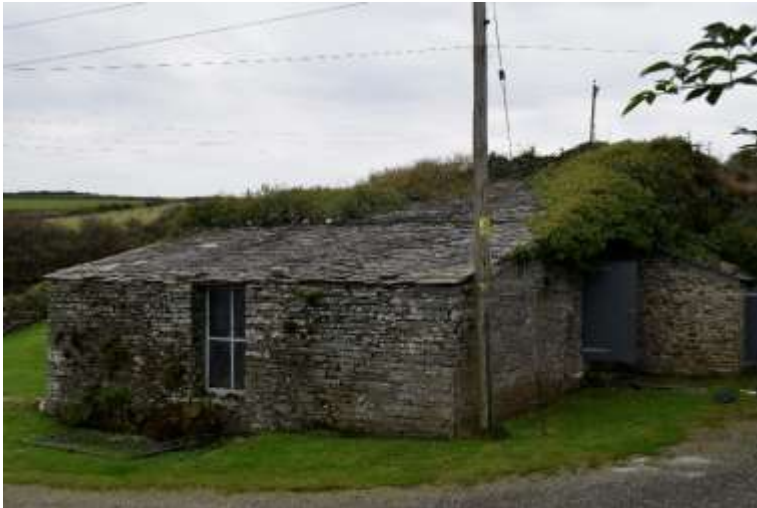
- 4.6 Site survey has shown that these buildings (figure 10) are of at least two principal phases. The south-eastern range (fig 11) is of un-coursed rubble construction, against which abut the southern annex (built from similar but coursed material – probably reused) and the north-western range which is of 'imported' slate from the Delabole formation (a much finer grained grey slate) which has been machine cut with a circular saw (fig 12) – dating it to the early to mid-twentieth century when high speed and carbide steels became available. The first OS map on which this range is depicted at the reliable 1:2500 scale dates to 1972.

Figure 10: The buildings proposed for conversion (TGAR1017\_25)

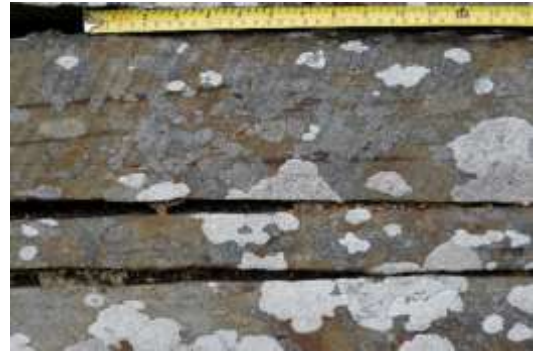
Fig 12: Detail of the circular saw cut Delabole material used for the 20<sup>th</sup> century work (TGAR1017\_0019)

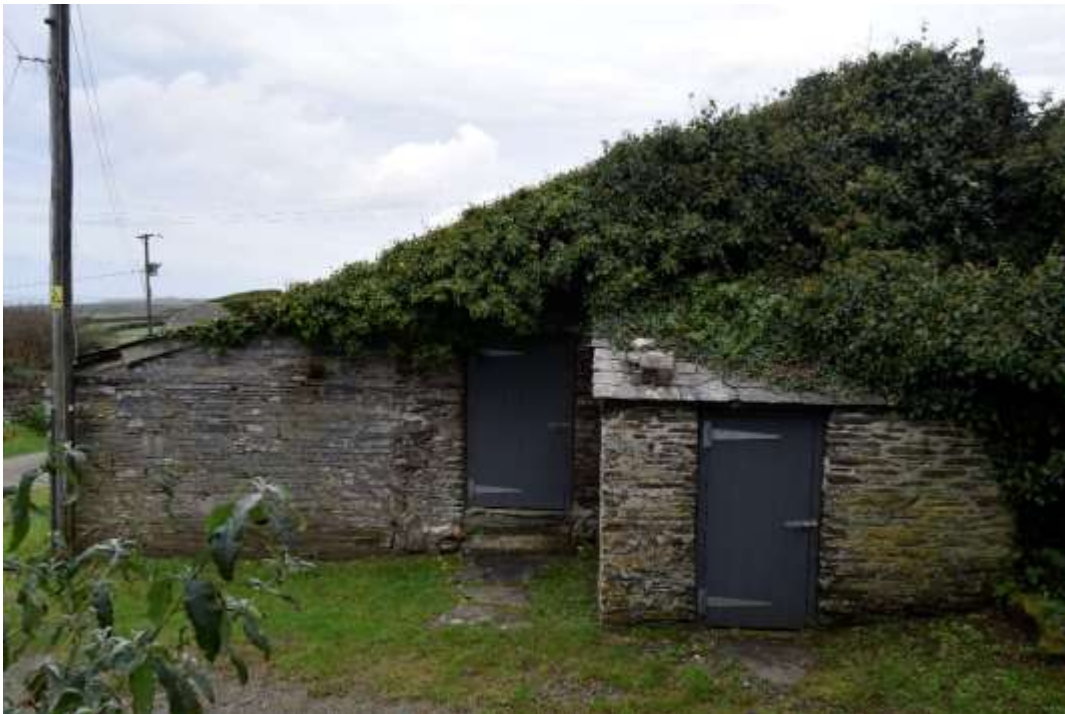
Figure 11: Southern elevation: 20C garage range is to left. (TGAR1017\_0012)

maps. These robust (0.8m-1m thick) walls are of un-coursed slate (see fig 11, 16,17, 18). These are generally well pointed with a lime mortar with slate inclusions, but in an area on the interior of the south-western wall some original matrix survives (fig16) and is of a more earthy character and may even be 'ram' – the local name for decayed granite clay subsoils, traditionally used for wall bonding. The southern doorway cut into this wall has been altered. Internally the timber lintel above it continues approx. 3.5m into the adjacent walling indicating the presence of a wider earlier opening (presumably supported by a central pier).

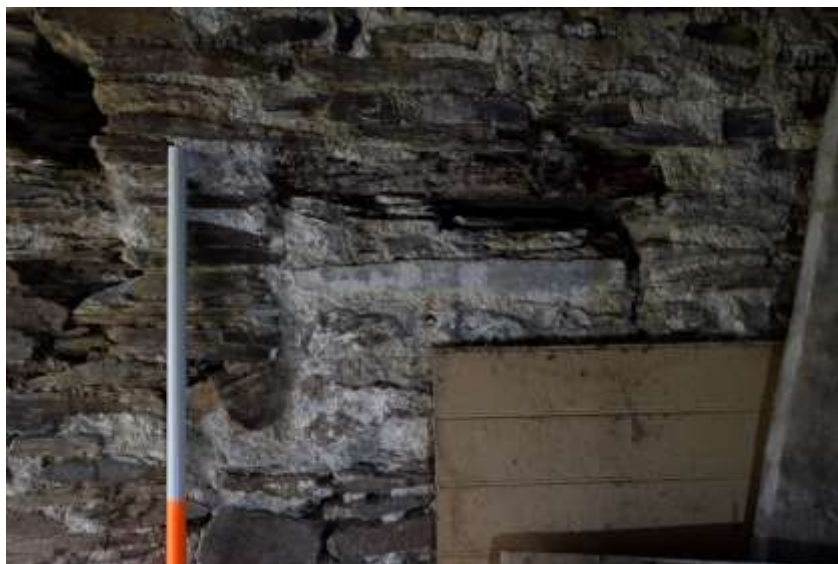
4.14 Within the long wall to the north west of the range, which is founded on large boulders, a common vernacular technique in Cornwall, is evidence of a blocked, internally splayed window opening under a wooden lintel (fig 17 and 18). This is about 0.8m in height, 0.4m wide externally and 0.65m wide internally and would have provided some low illumination of the southern end of this building. At the southern end of the north-western face of this wall there is a small void at floor level, which may have been provided to drain the interior of this space.

*Figure 18: The wider opening of the same window (indicating its internal splay) from within the stable (TGAR1017\_31)*

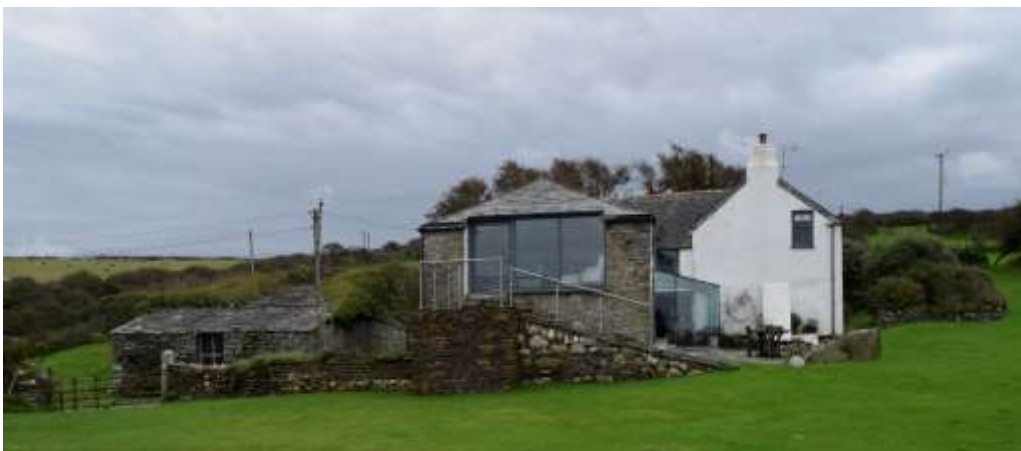
5.11 Despite the loss of the historic legibility of the farmyard, the current buildings nevertheless sit well aesthetically and architecturally within the local landscape at middle distance (fig 23) being of appropriate and locally distinctive materials and form.

Figure 23: The current buildings sit well within the landscape and make a positive contribution to the setting of the listed assets.

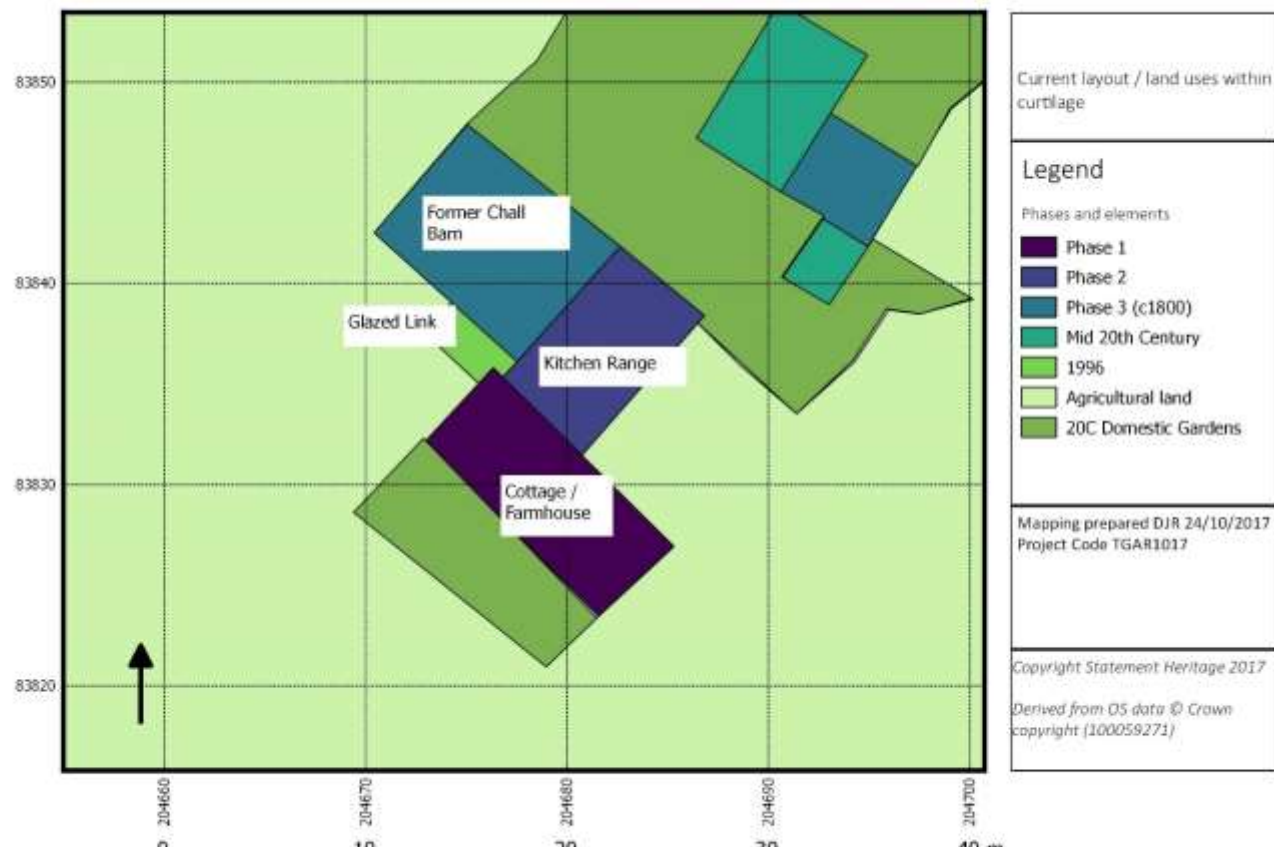
01 Figure 2: Phasing of the main buildings on site – based on map regression and site survey

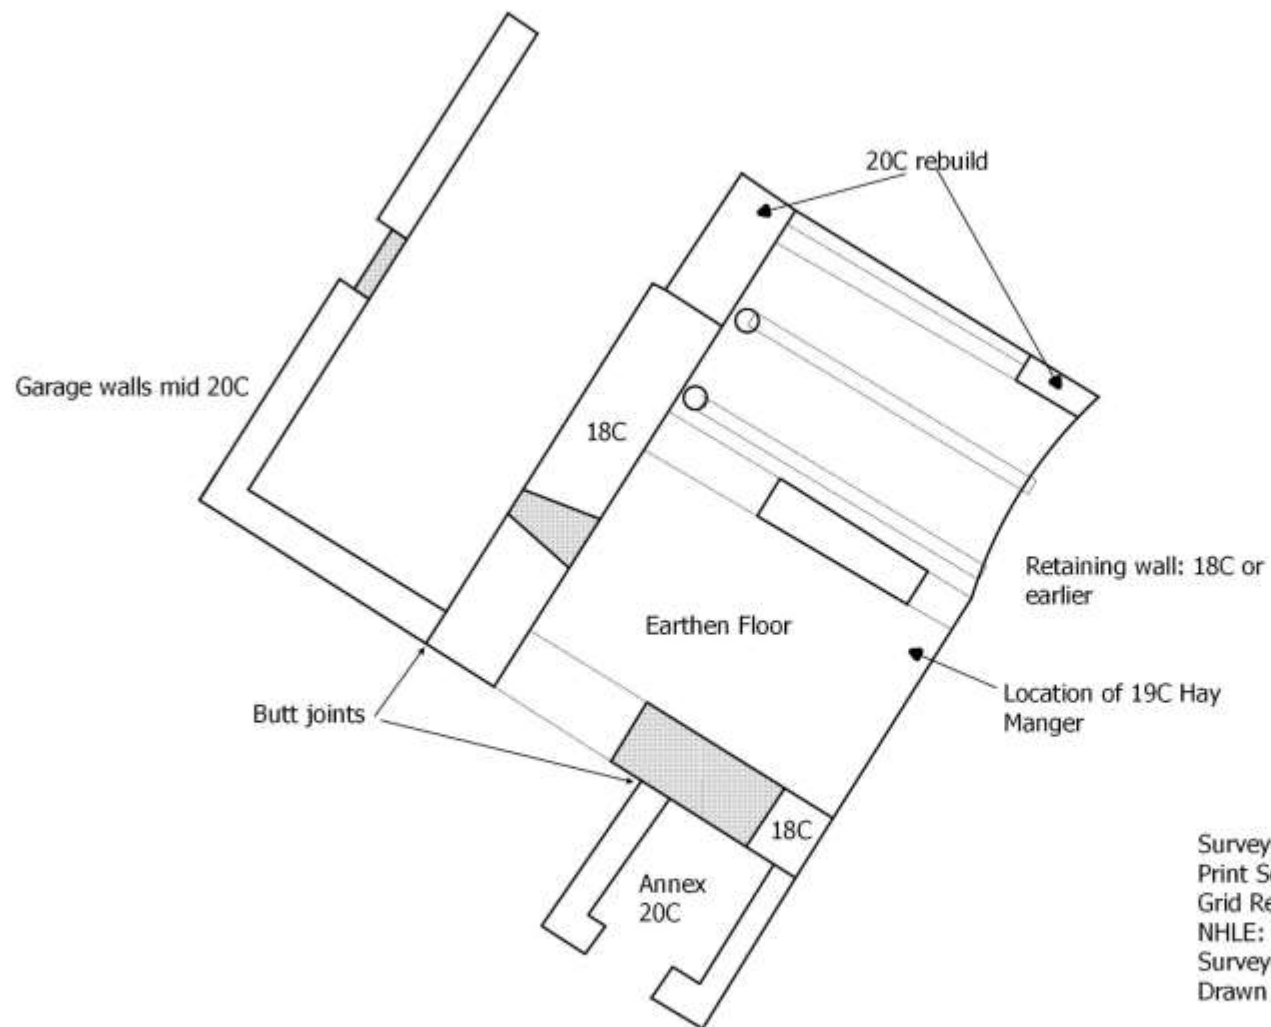
- 4.1 The buildings proposed for conversion lie to the immediate north of Tregardock Cottage.
- 4.2 These are shown on fig 8. In plan the building has three principle components, namely two adjacent north-east to south-west rectangular ranges under a common monopitch rag slate roof, with a squat and squarish lean to against the southern wall of the eastern unit.
- 4.3 The eastern unit contains the oldest fabric and is shown on the Tithe and OS plans of 1882 and 1907 (below)

Figure 8: Survey of buildings proposed for conversion

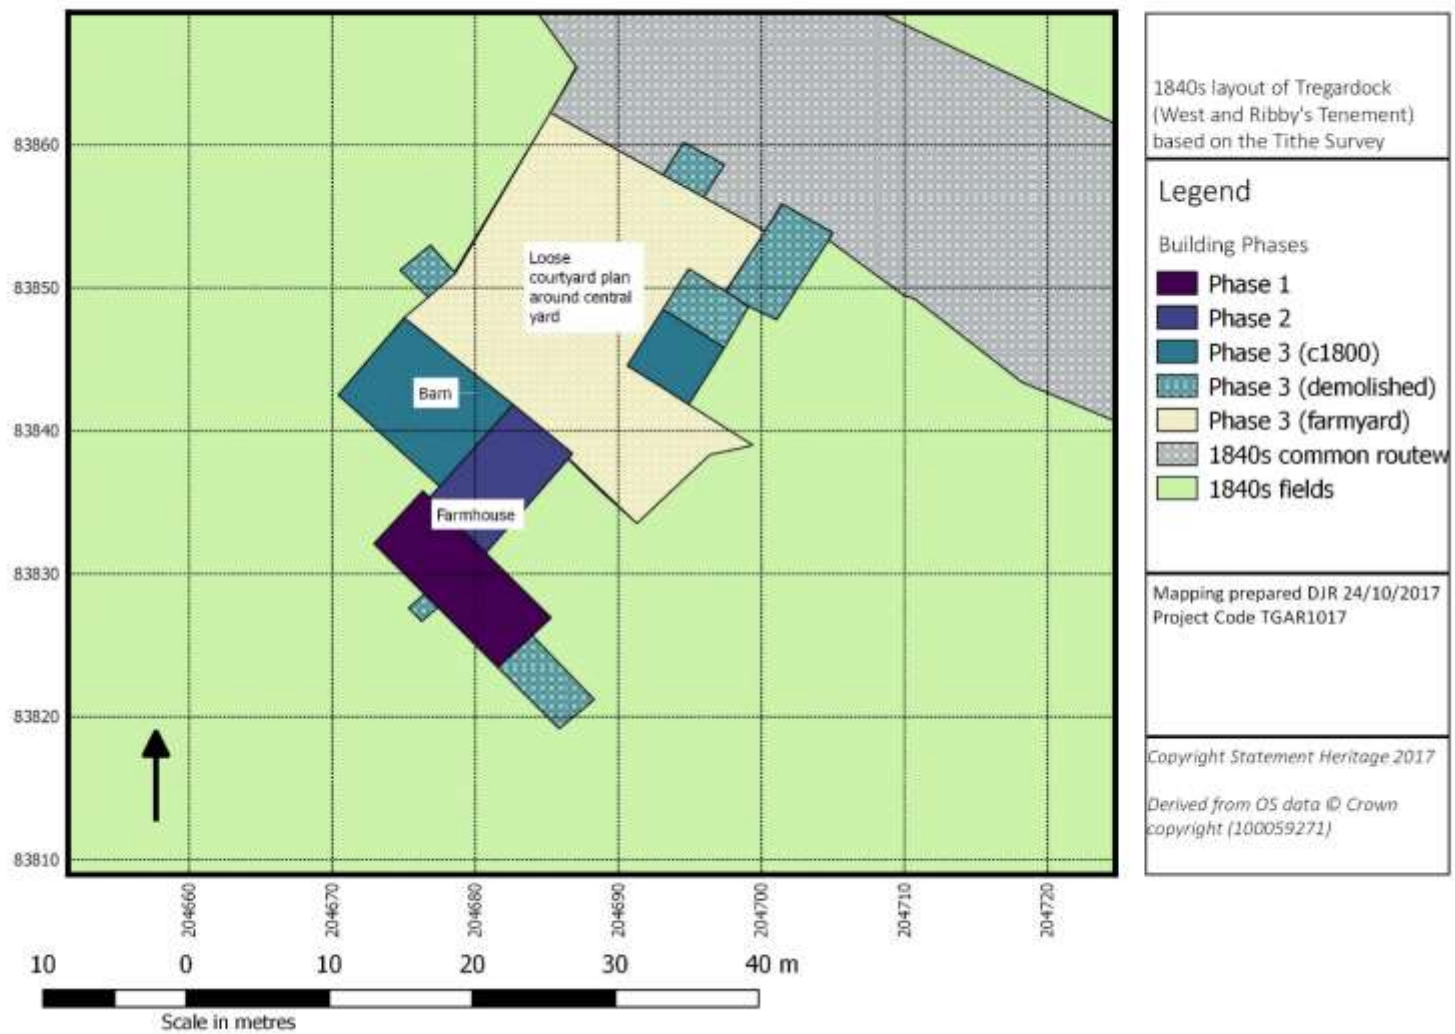
- 4.5 Following the approach outlined in the draft Cornwall Farmsteads Assessment Framework (CC/HE 2017) the development and characterisation of the farmstead's plan form is shown in Figure 9a (at rear) and discussed further in section 5b) *Significance of the setting*.

Figure 9a: Reconstructed interpretative plan of the farmstead at the time of the Tithe Survey

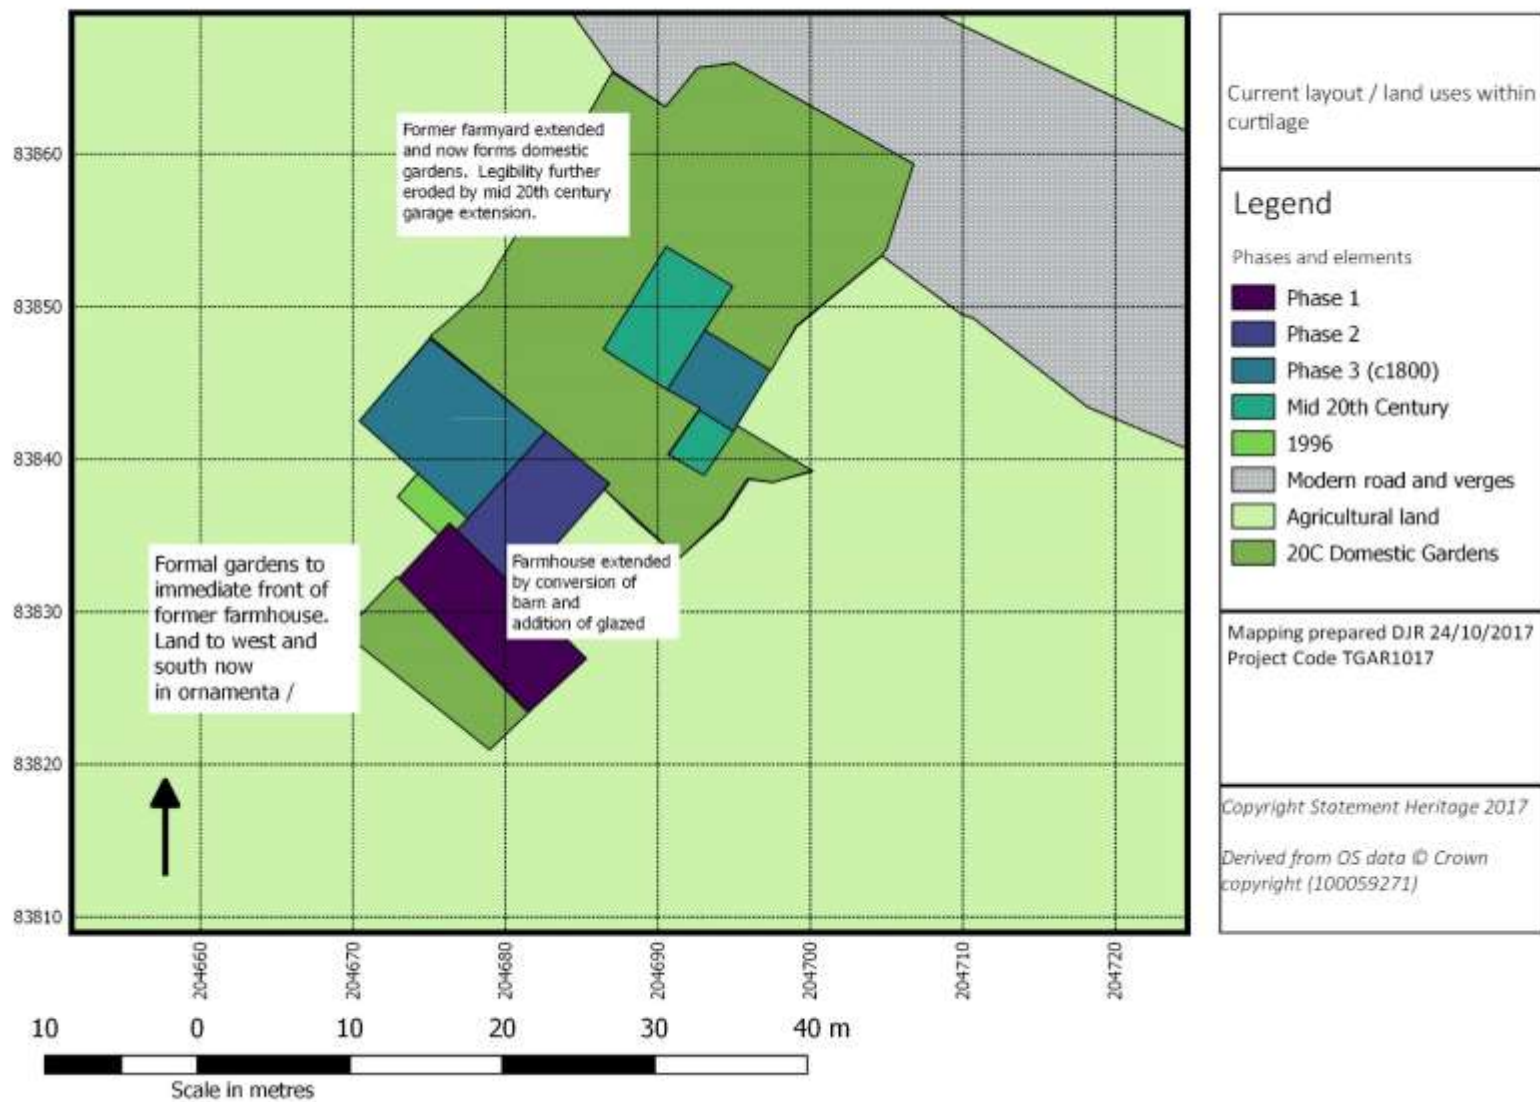
5.10 This area now reads as a domestic curtilage and driveway, rather than as an agricultural yard. In line with ‘Stage 1’ of the Assessment Framework these changes are summarized in figures 9 and 22 (at rear)

Figure 22: Historic characterisation of the site today (2017). Compare with figure 9 above to see the changes associated with the loss of legibility of the historic farmyard.
