# Statement Heritage

## 5 Tehidy Terrace, Falmouth, TR11 2SZ

Heritage Impact Assessment: SH Ref **TEHT1117HIA**

12/02/2018

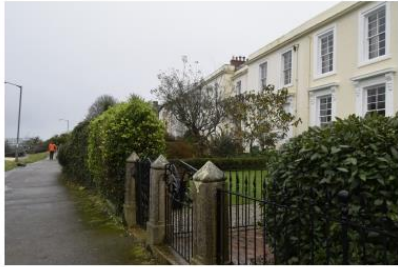
TEHT1117\_0001.JPG

*Tehidy Terrace [TEHT\_0001] is situated to the immediate south west of 'North Parade', at OS Grid Ref SW8022333784. The site lies on land sloping up steeply away from the Penryn River estuary as it flows into and becomes Falmouth Harbour, commanding views across the water to Flushing [TEHT\_0065].*

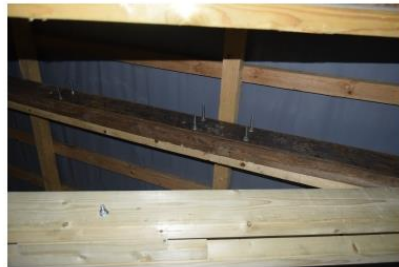
TEHT1117\_0147.JPG

0143	Mouldings from BR3 to landing
0145	Bathroom window
0147	Steel plate repair to principal rafter in SR
0151	Blocked window SR FF
0152	Bowing in hallway ceiling
0154	Repairs to joist by cole hole (coal cellar)
0156-160	Cellar joists
161-163	Details corbels
