Statement Heritage

8 Bank Street, St Columb Major, TR9 6AU

Heritage Impact Assessment: SH Ref BASC0418 Report v2
12/04/2018

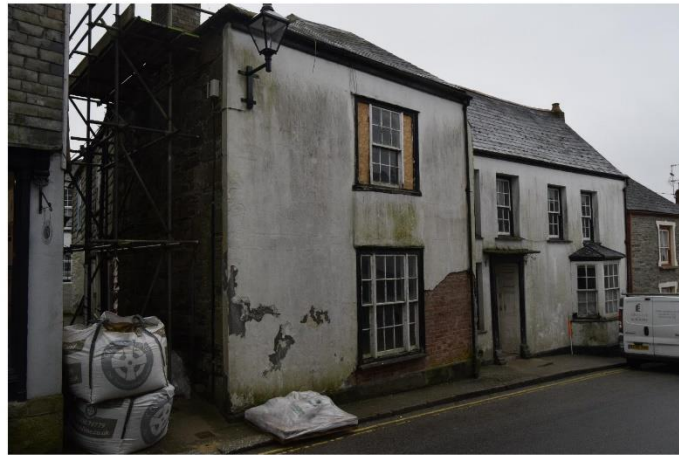
ii) 'Building 2' SE elevation

- 6.8 The client has expressed a wish to remove the render of the front elevation (see figure 2) of building 2 at ground floor level.
- 6.9 This would expose the underlying brick which local oral tradition (client pers.comm.) suggests has been previously exposed within living memory. In our view, and subject to an appropriate method statement from a lime plaster specialist, either removal or restoration would be appropriate. An incised 'stucco effect' is now not clearly visible on this section of the building, and so little would be gained from the restoration of the incised pattern on this section in isolation. Should restoration be considered we would advise that advice is sought from a suitably experienced craft professional in advance of restoration of this section only in plain render, taking care to use breathable materials. Similarly the paint / limewash finish to the rest of the front elevation would benefit from renewal in a breathable finish such as a mineral paint.

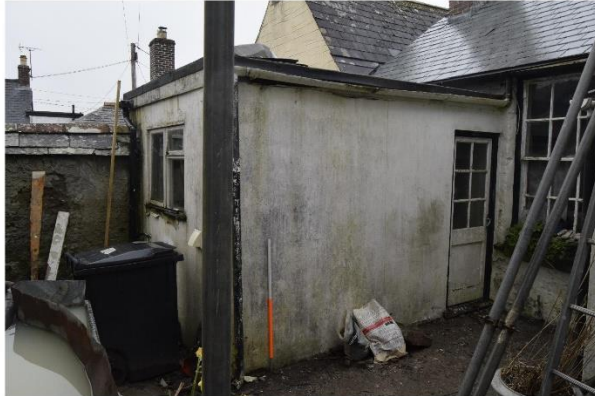
iii) Cob Wall: Cut by Rear Kitchen

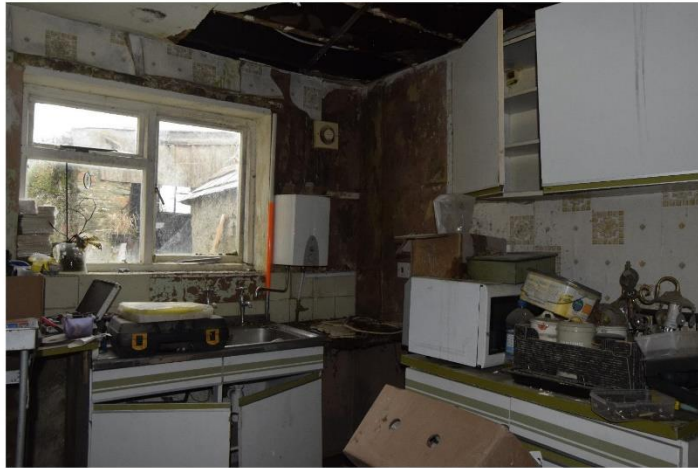
ii) Rear Kitchen: Interior facing SE.
Note Early C 20 4 panel door and
modern glazed exterior door

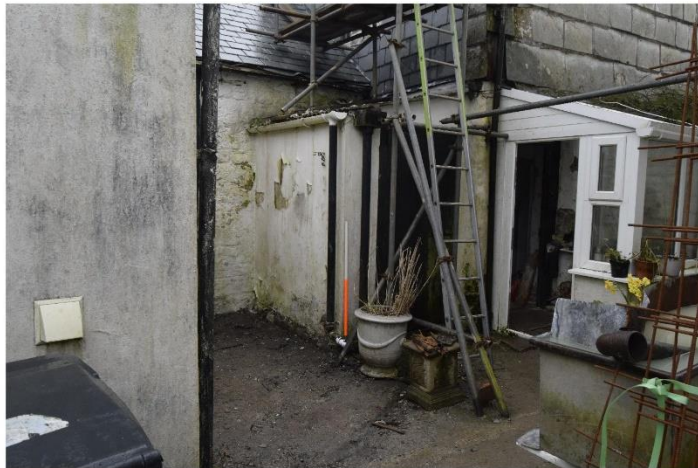
Figure 4
8 Bank Street
St Columb Major
Rear Kitchen and Rear Shed
Extension

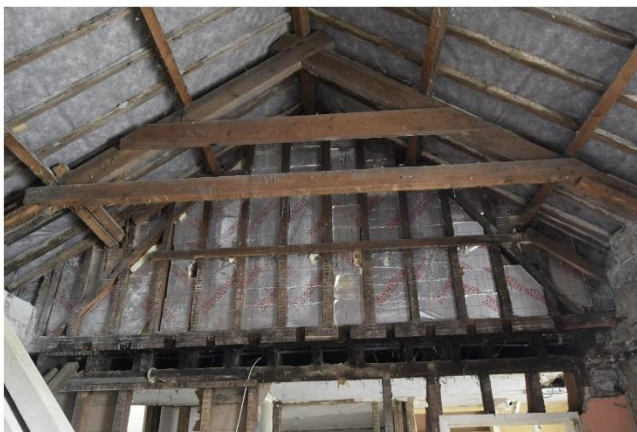
iii) Building 4 Roof looking SW

- 6.14 Stripping out works in this area have revealed a large hearth and chimneystack to its northern end of late 18th or early 19th century date (figures 5i and 5ii), a probable 19th century roof (figures 5ii and 5iii) and a blocked window in the east wall of this building and evidencing that the areas between buildings 1 and 4 was originally open.

- 6.15 The roof structure principals are three trusses of lapped and nailed sawn timber each with two original raised collars. Evidence in the masonry walls supporting these trusses indicates filled joist pockets indicating an earlier roof has been replaced. This roof structure is of only modest significance and has evidence of repairs to the ends of two principal members and two common rafters on the western slope. Structural advice should be sought on the capacity of the common rafters to accommodate rooflights, which would in our view cause **negligible impact as long as low profile conservation rooflights are used.**

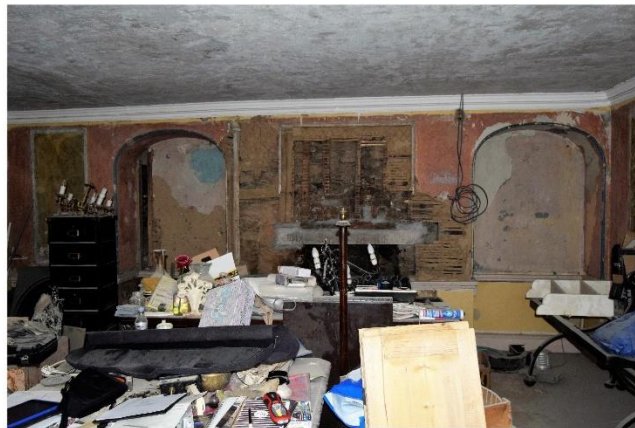
iii) Below: Recess to the right (of shot) of 19C bay window may be set in the opposing (front) door of original cross passage.

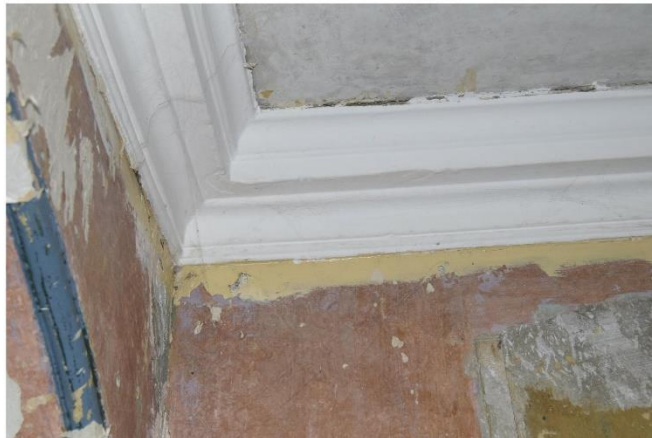
iii) Moulding Details

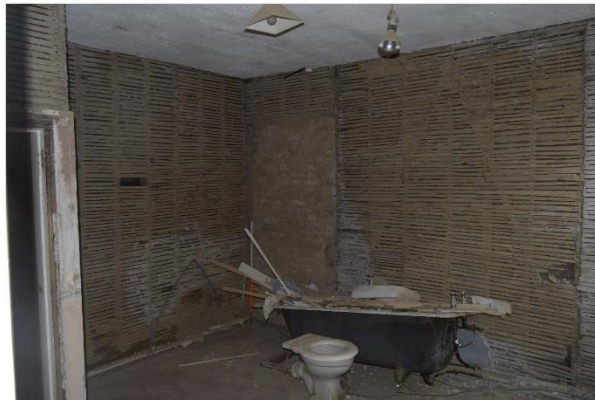
i) Building 3, Bathroom 1, showing plaster laths. Looking E

- 6.35 The ceilings of both rooms, and of the landing, are formed of 20th century hardboard at the end of its design life. It is advised that **replacement of these ceilings with plasterboard would constitute a neutral impact**.

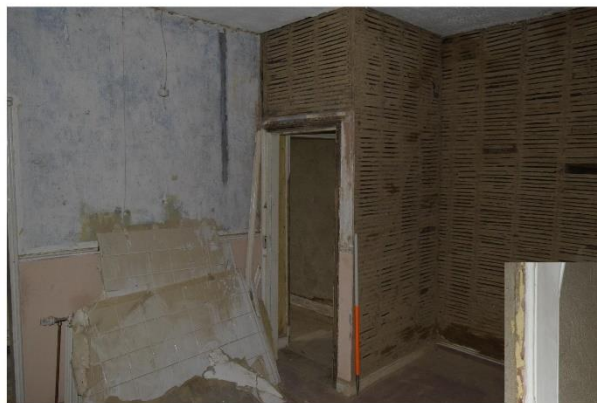
ii) Building 3, Bathroom 1. Looking North towards door proposed to be blocked

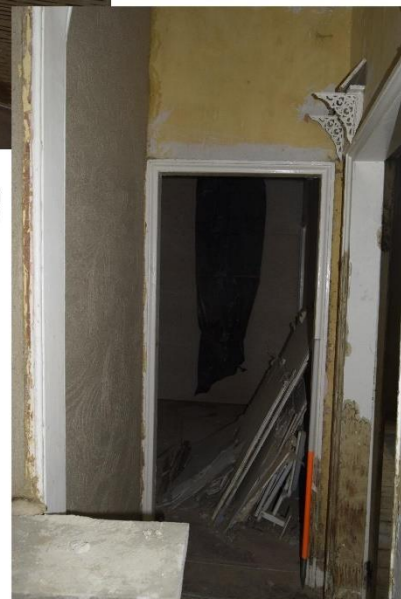
iii) Building 3, Bathroom 1. Looking from landing towards door proposed to be blocked / closed.

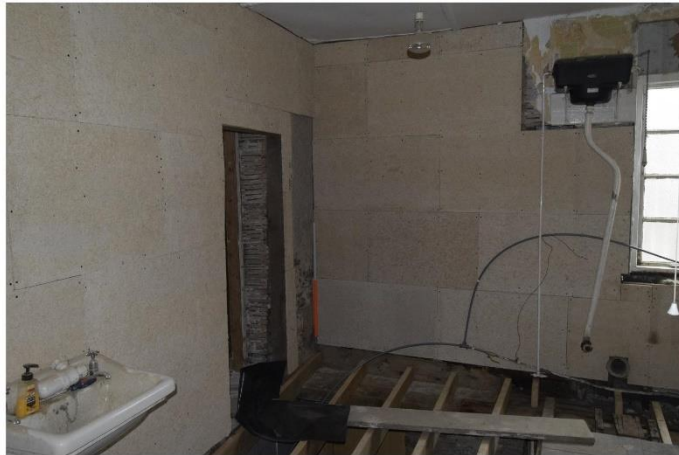
i) Building 3, Bathroom 2, Facing S

- 6.36 New plumbing works must be designed to maximise the use of existing service runs. The LPA are likely to request a plan of these works.
- 6.37 Externally the waste water goods related to the existing bathrooms comprise two cast iron spoil pipes and a narrower very corroded iron waste water pipe and cast iron hopper of 19th century date which is in better condition. Waste water currently enters the hopper via a tangle of lead pipework. The works provide an opportunity to rationalise the pipework entering the hopper, and replace downpipes in cast iron or aluminium. PVC is unlikely to be accepted by the LPA. The cast iron hopper should be retained and reused if possible.

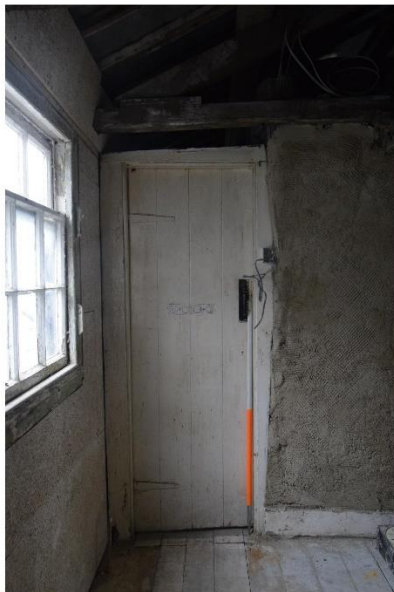
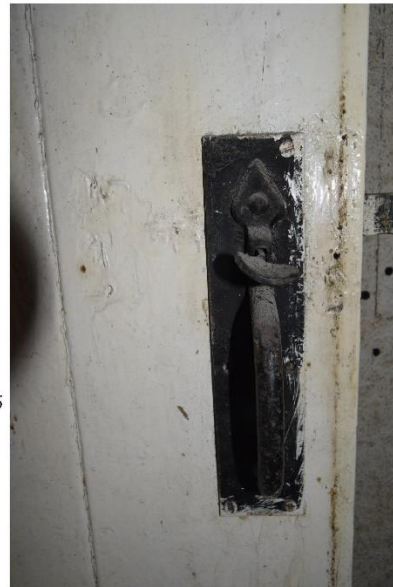
i) Building 1: (left) First floor corridor, access door to attic stairs.
ii) (right) this simple plank door can be dated by its hinges and 'norfolk latch' to the later nineteenth century (see Gloucestershire example dated to 1885 in Hall 2005,57).

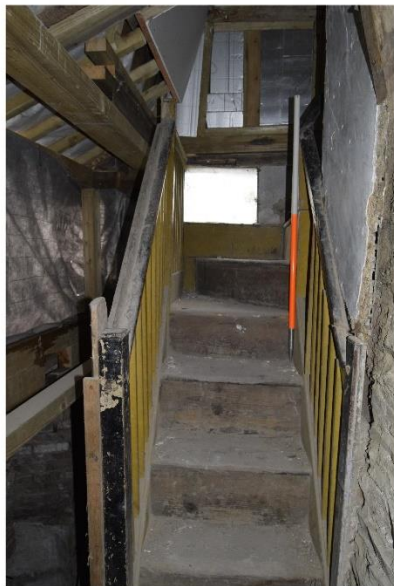
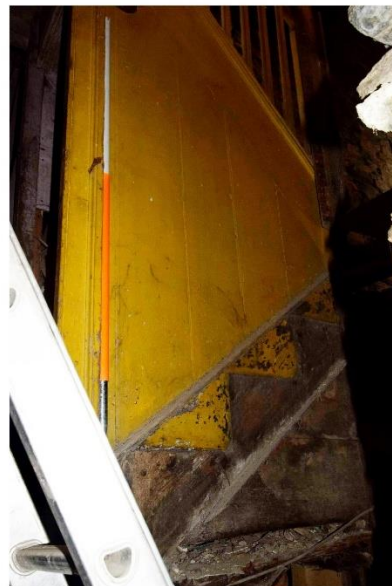
Beyond the door lies a narrow corridor within a rear lean to extension to Building 1 which houses a currently abandoned dog leg service stair case of later 19th century style which runs in two flights.
iii) left: a straight flight with winder from first floor to attic storey
iv) right: a straight flight from the rear of Building 4 to the first floor.

- 6.40 Restoration of this staircase should be informed by the evidence of the surviving first – attic flight (fig 12ii) and the surviving string which can be seen from the building 4 doorway (fig12iv). The restoration of the use of the attic storey and of the original plan-form of Phase 3 using archaeological evidence would constitute enhancement of the architectural and historic values of the building.

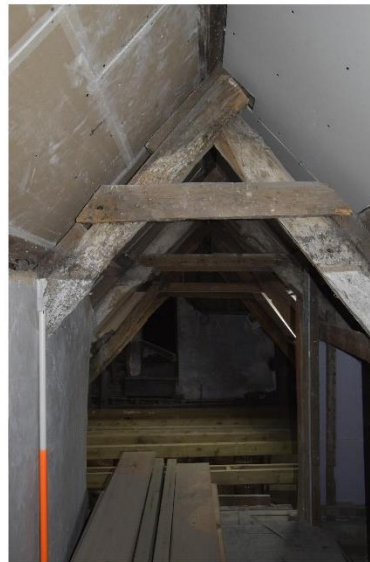
ii) Building 1: (left) Detail of apex of second truss from north showing wooden fouble pegged jointing technique
