Post Investigation of East Service Wing
'The Wells' Addendum to Building
Recording of Salvation House Ranelagh
Road Malvern Link WSM69253

Grid Reference OS National Grid Reference: SO 79066 48034

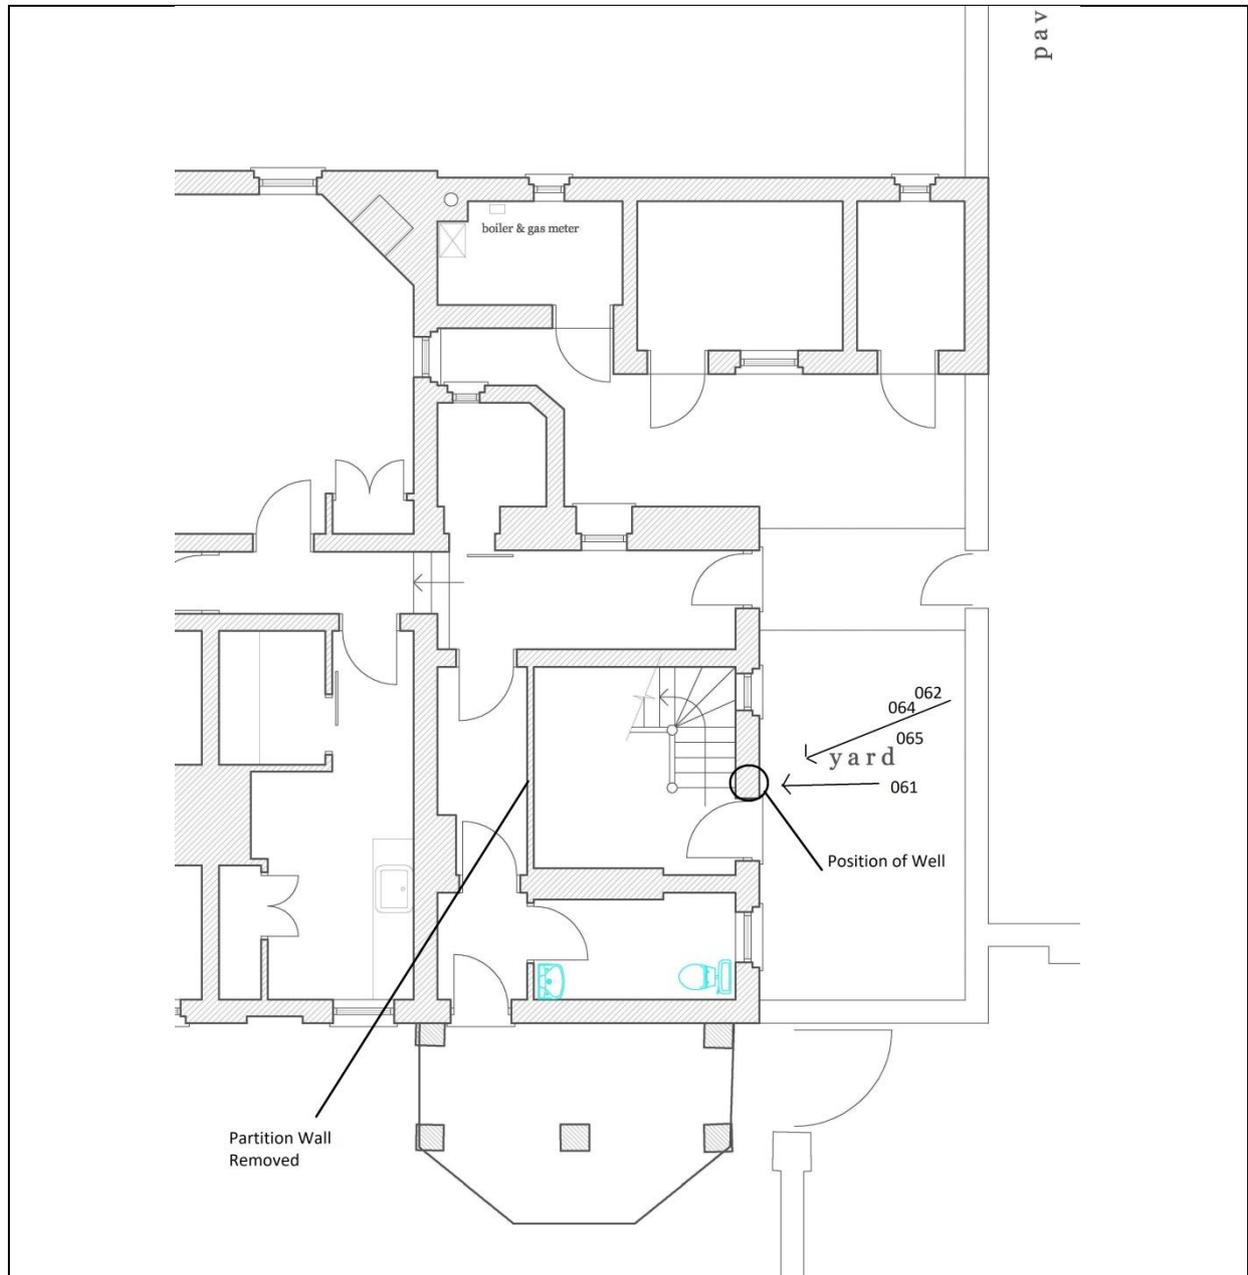
3. Interior Ground Floor Position of Photos Plan Outside Well

This plan is based on Nick Carrolls Architects Plan Drawing No 1530/03a of date Dec 2015 Planning App 16/00148 NB for illustrative purposes only, DO NOT SCALE from this drawing. Annotated by RDA. Direction is from the camera position and photographer.

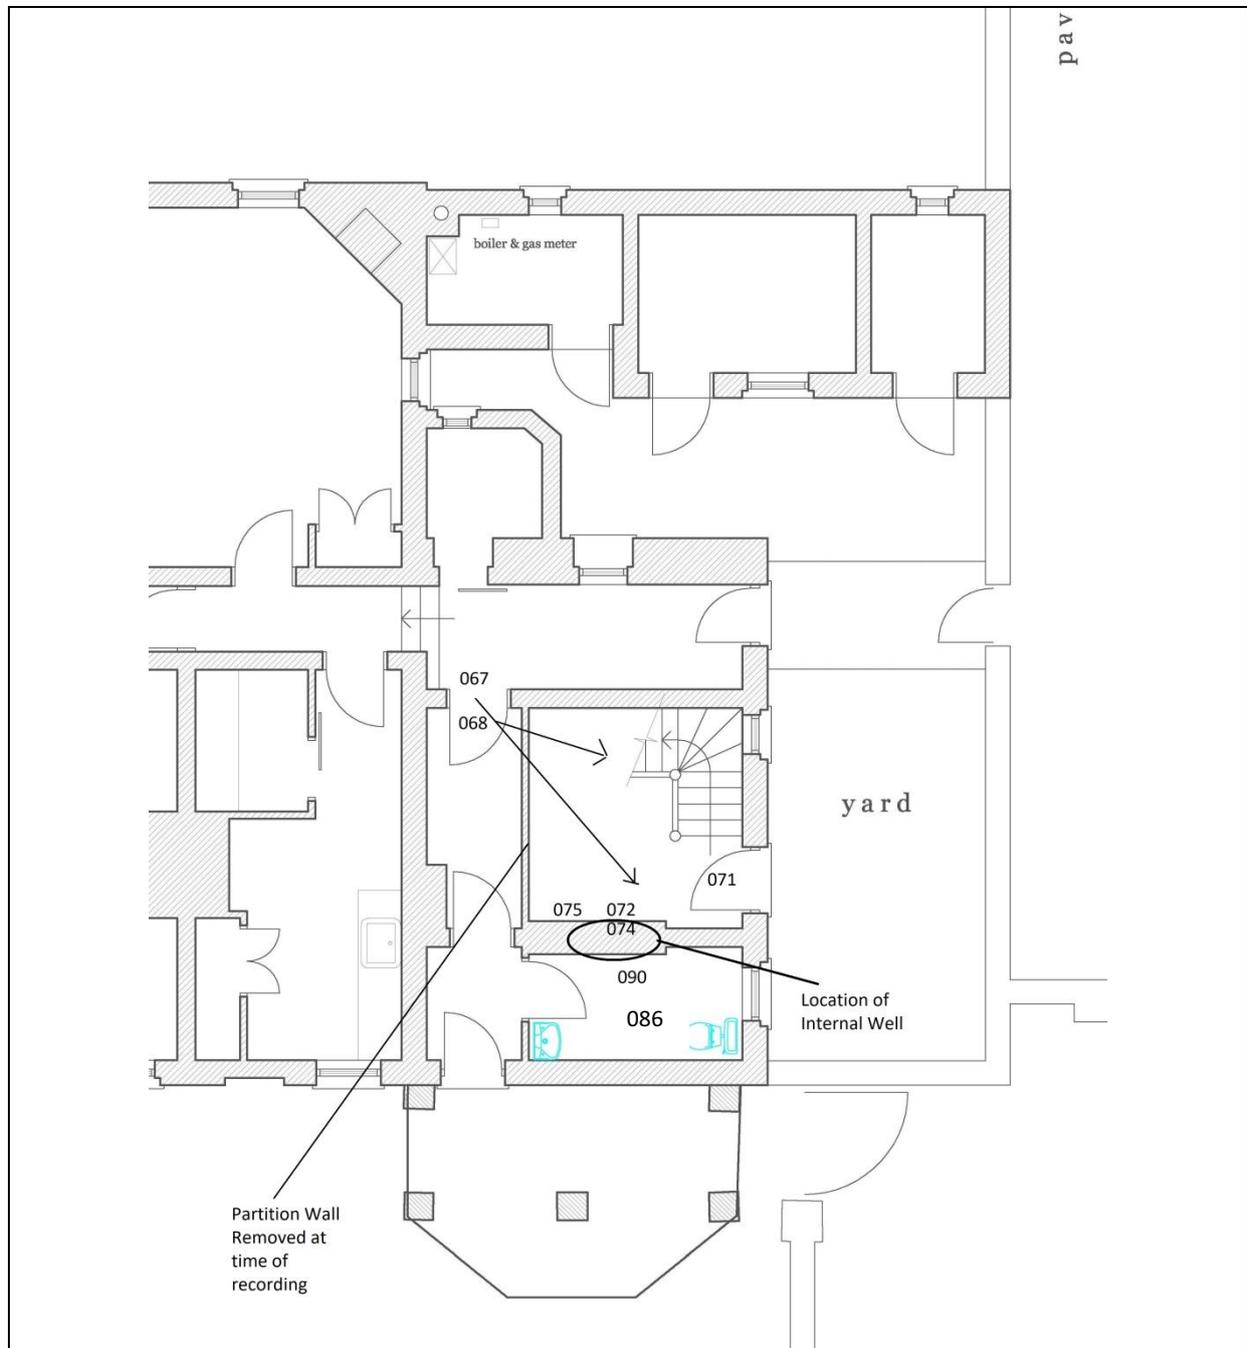
4. Interior Ground Floor Position of Photos Plan Inside Well

This plan is based on Nick Carrolls Architects Plan Drawing No 1530/03a of date Dec 2015 Planning App 16/00148 NB for illustrative purposes only, DO NOT SCALE from this drawing. Annotated by RDA. Direction is from the camera position and photographer.

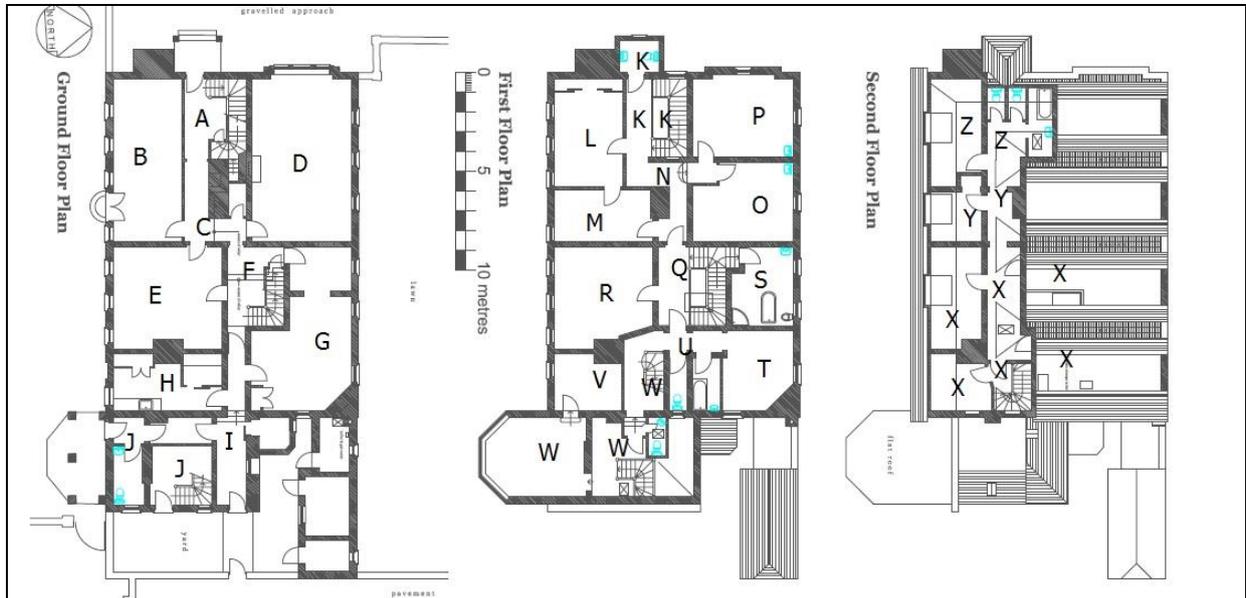
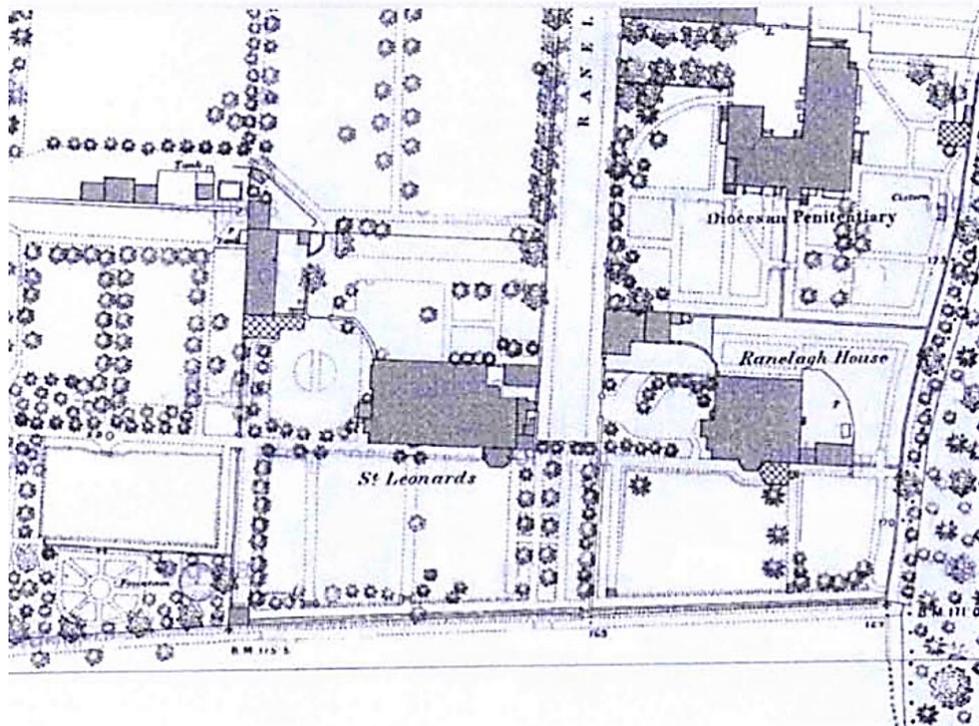
1886 Town Plan St Leonards, Ranelagh House and the Diocesan Penitentiary

Room Plan from Dec 2017 Building Recording Report based on Nick Carrolls Architects Plan Drawing No 1530/03a of date Dec 2015 Planning App 16/00148 NB for illustrative purposes only, DO NOT SCALE from this drawing. Annotated by RDA. AND 1886 Town Plan Malvern of St Leonards House.
