Heritage Assessment 2 Manor Farm  
Cottages Atch Lench Worcestershire  
WR11 4SW

### 1 and 2 Manor Farm Cottages Atch Lench Worcestershire WR11 4SW

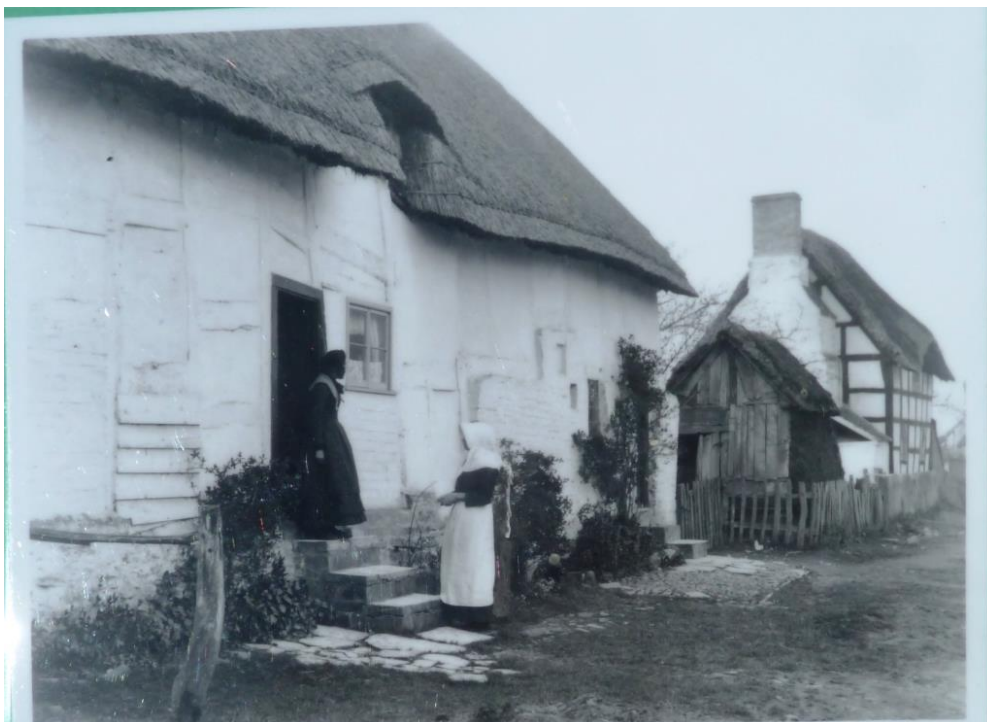
**Analysis :** This photograph shows both cottages habitable with x2 roadside entrances. The timber frame is limewashed , the thatch roof has a small dormer to No1 ; the stone wall of the chimney stack is visible protruding like it does today in No2 . No 2 has a ground floor casement window but no upper floor window; the small square fires window\* is visible. The other recess square is the end of the bressumer beam. There is a small thatched building[hovel] in the plot adjacent

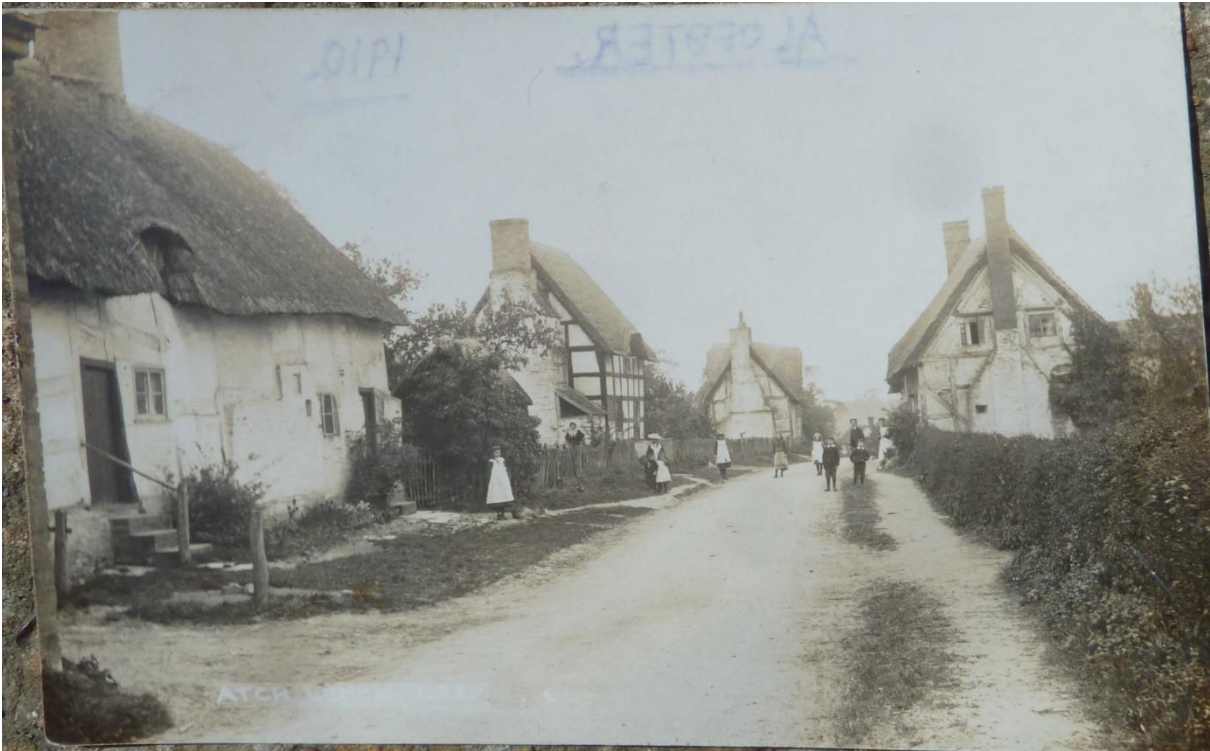
**Analysis:** This postcard late C19 shows both cottages habitable with x2 roadside entrances. The timber frame is limewashed, the thatch roof has a small dormer to No1; the stone wall of the chimney stack is visible protruding like it does today in No2. No 2 has a ground floor casement window but no upper floor window; the small square fire window is visible. End of the bressumer beam also visible. There is a small thatched building[hovel] in the plot adjacent

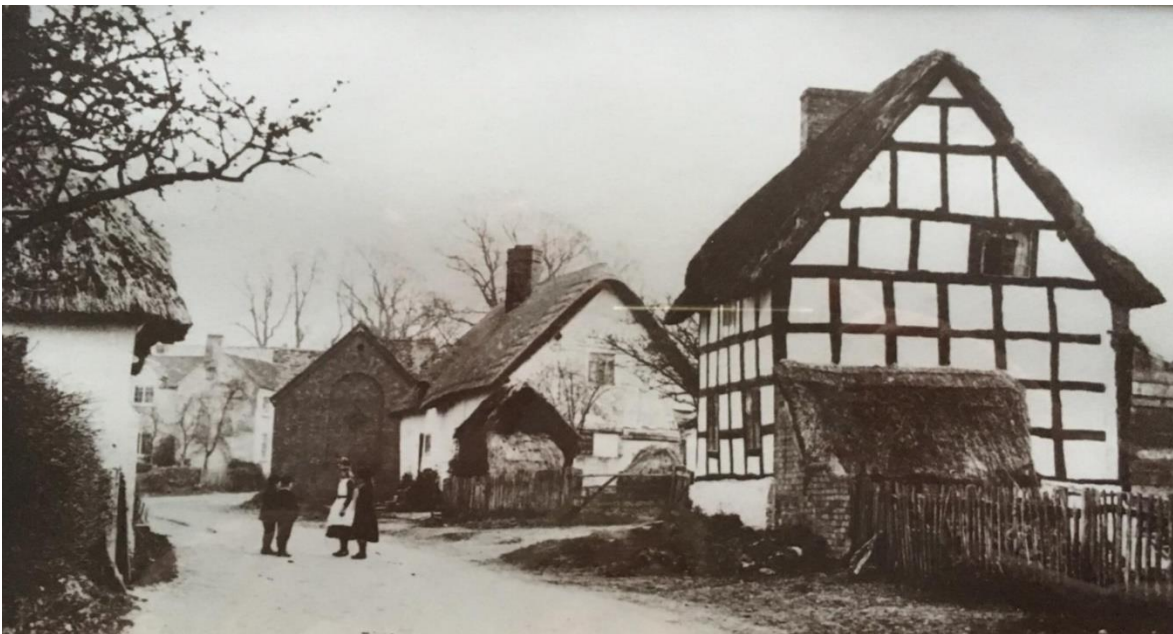
**Analysis:** West view of cruck end of No 2 with upper window. Small hovel building in foreground. Cottages are limewashed unlike The Sett in the foreground. Brick barn seen beside No1.

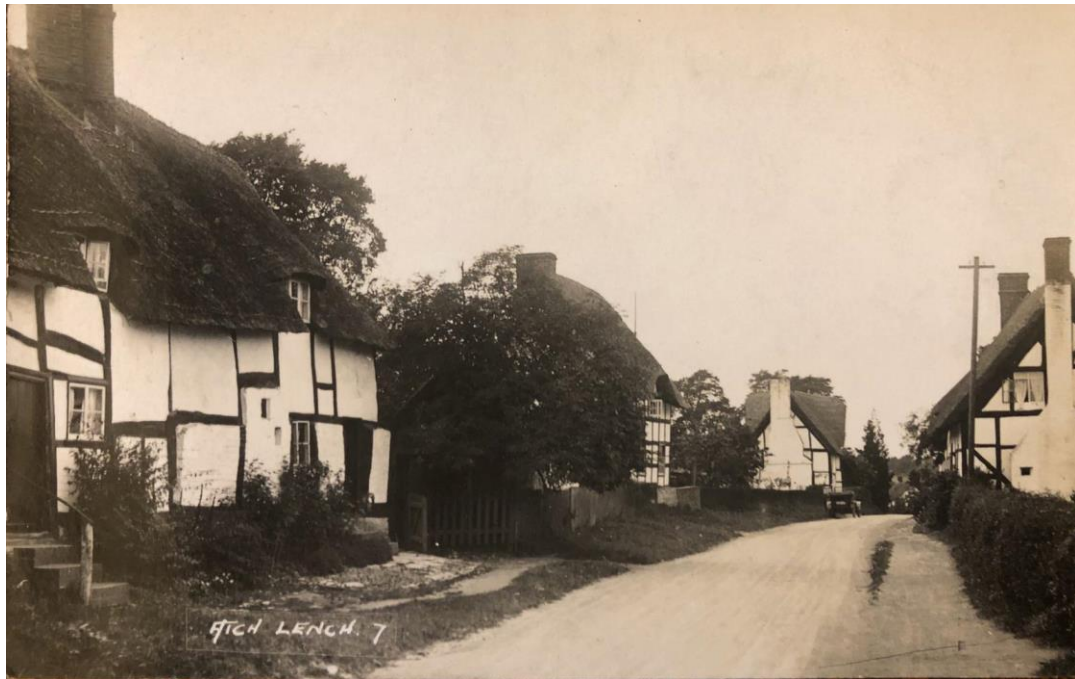
Circa 1910-1920 Postcard [Approx dating due to the type of car parked in the distance].

**Analysis :** Manor Farm Cottages now have two dormers in the thatch roof. Black painted timbers. Painted stone work from chimney stack still protruding. The small square fire window is visible. End of the bressumer beam also visible.

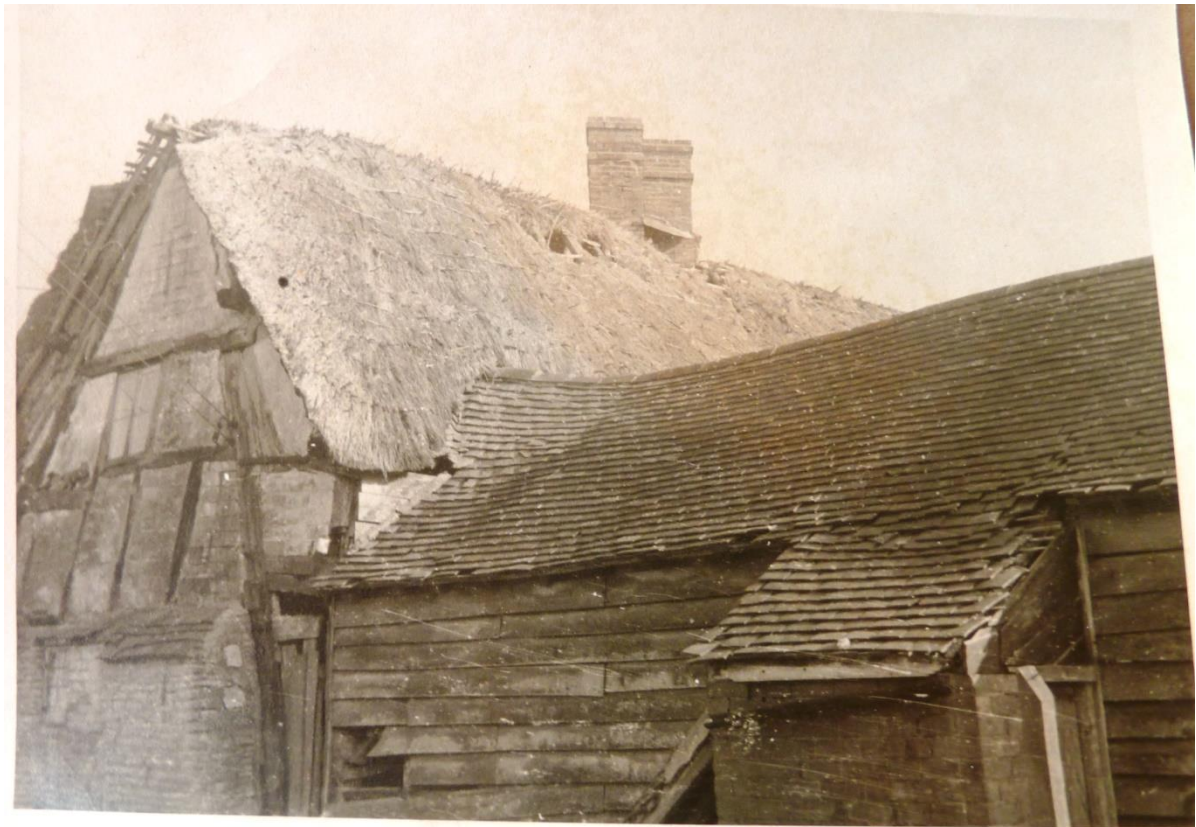
**Analysis:** West View with Cruck and Timber Framing. Window to upper floor. Protruding \*garderobe with capped roof to ground floor or possible reduced chimney stack? [since demolished] Barn with tiled roof attached and weather boarded to rear of No 2 cottage [Demolished in circa 1967]

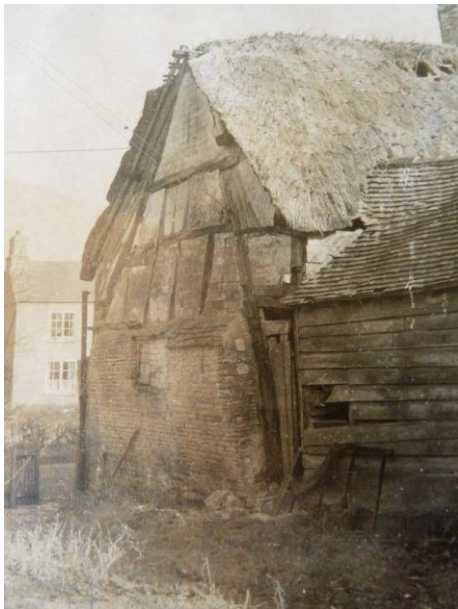
**Analysis:** West View with Cruck and timber framing Window to upper floor and lower, in stone walling

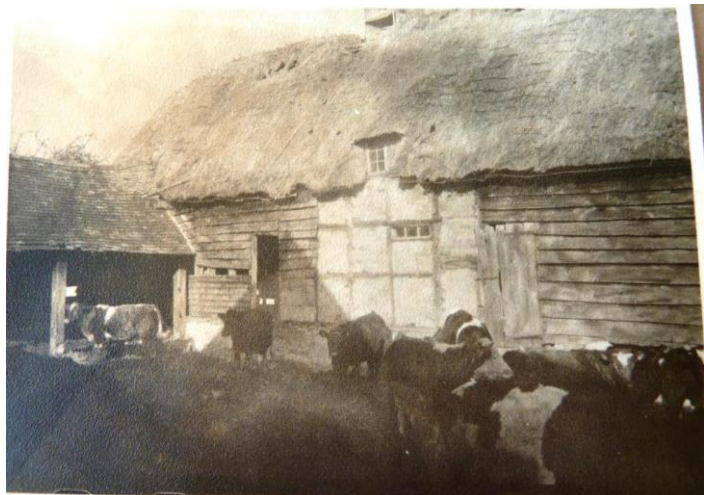
**Analysis:** To rear of the Cottages used as farmyard with cows. Barn attached is shelter shed. Only the middle of the cottages appear habitable with small dormer and 3 light window

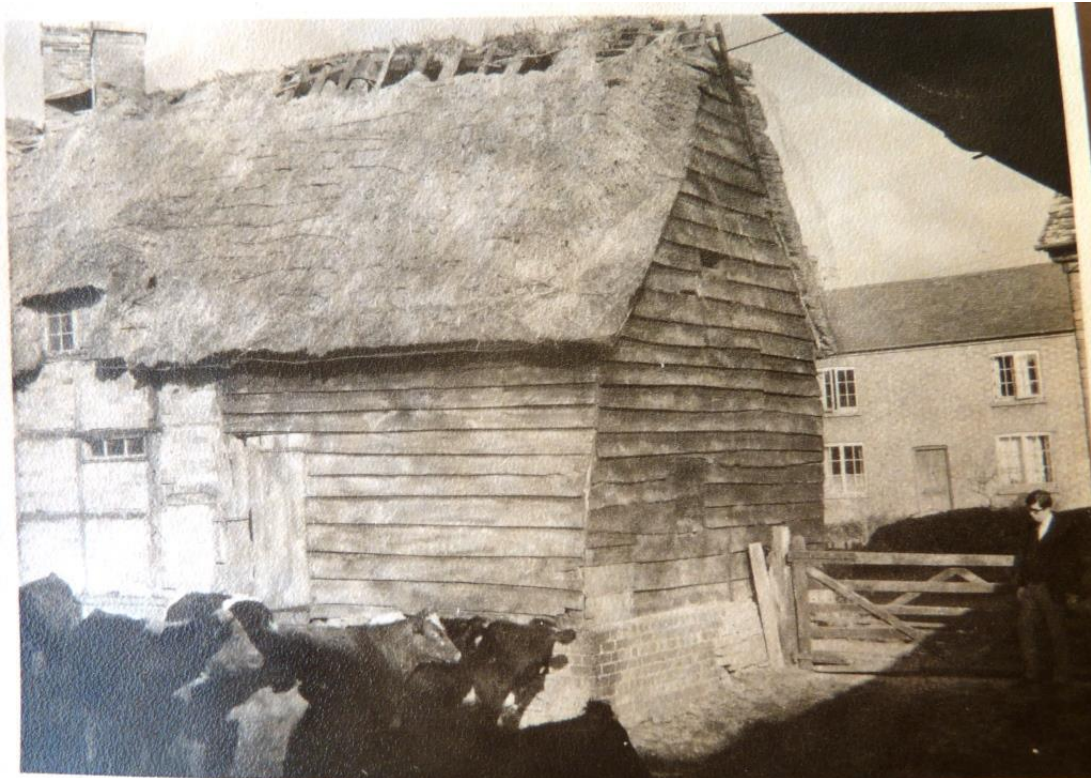
**Analysis:** To rear of the Cottages used as farmyard with cows. Only the middle of the cottages appear barely habitable with small dormer and 3 light window. No 1 rear and side is weather boarded on a brick plinth wall.

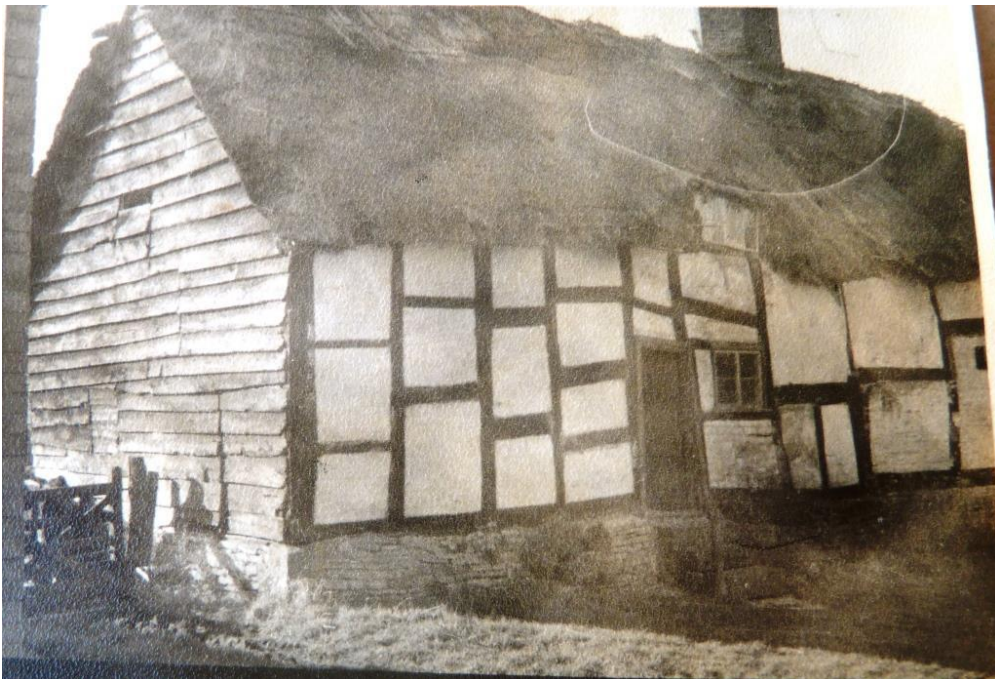
**Analysis:** East end view of No 1 exposed timber framing; lias stone plinth

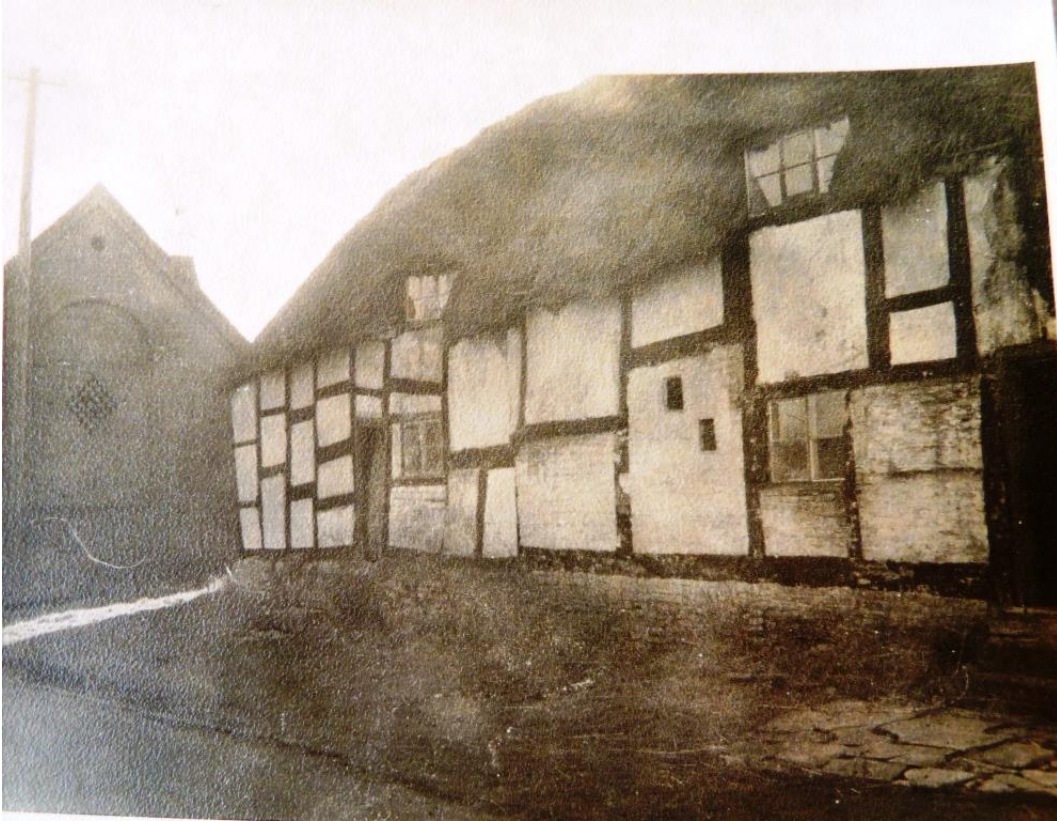
**Analysis:** View towards brick barn. Ground floor stone walling in panels and chimney stack with small fire window and end of bressumer beam visible.

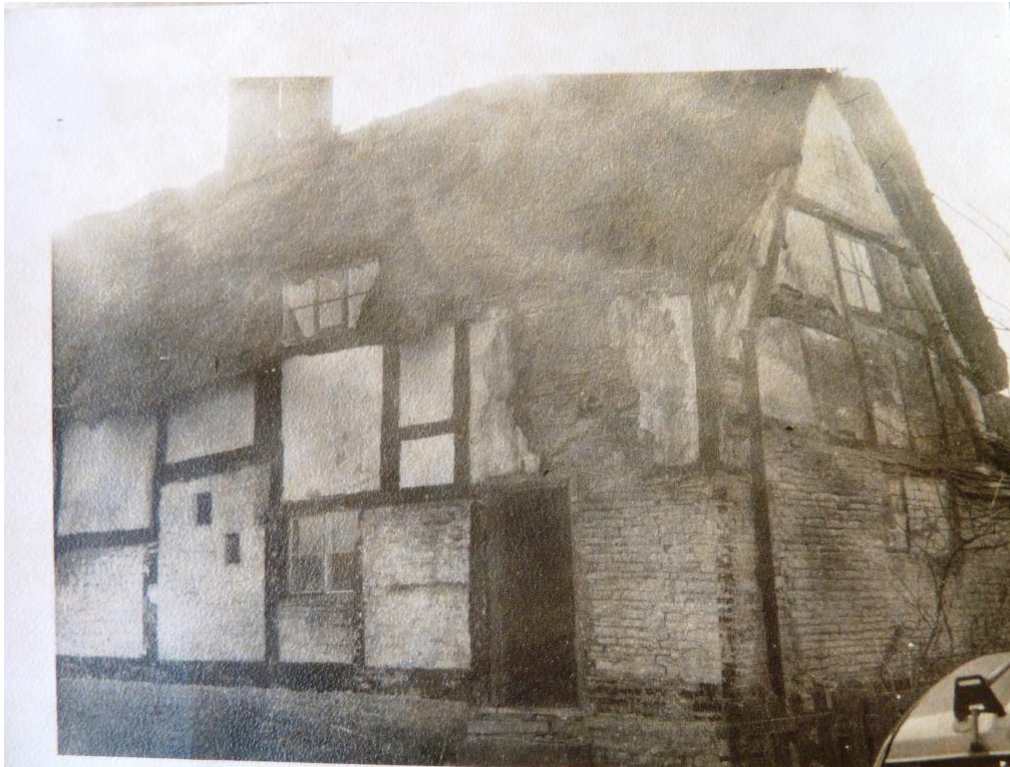
**Analysis:** View of No 2 with West end Cruck clearly with stone walling. Wattle & Daub panel above front entrance. Stone panels and wall of chimney stack to lower floor; x1 window ground floor, x1 dormer in thatch.

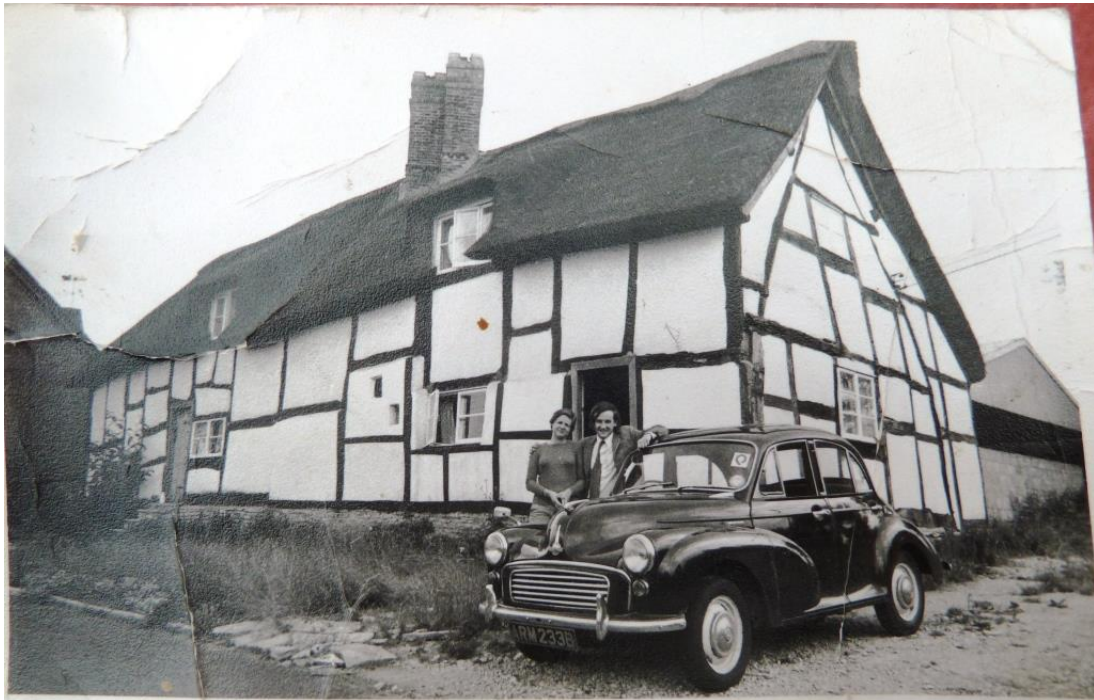
**Analysis:** Ground floor and side west painted black and white. New Barn in distance to rear.

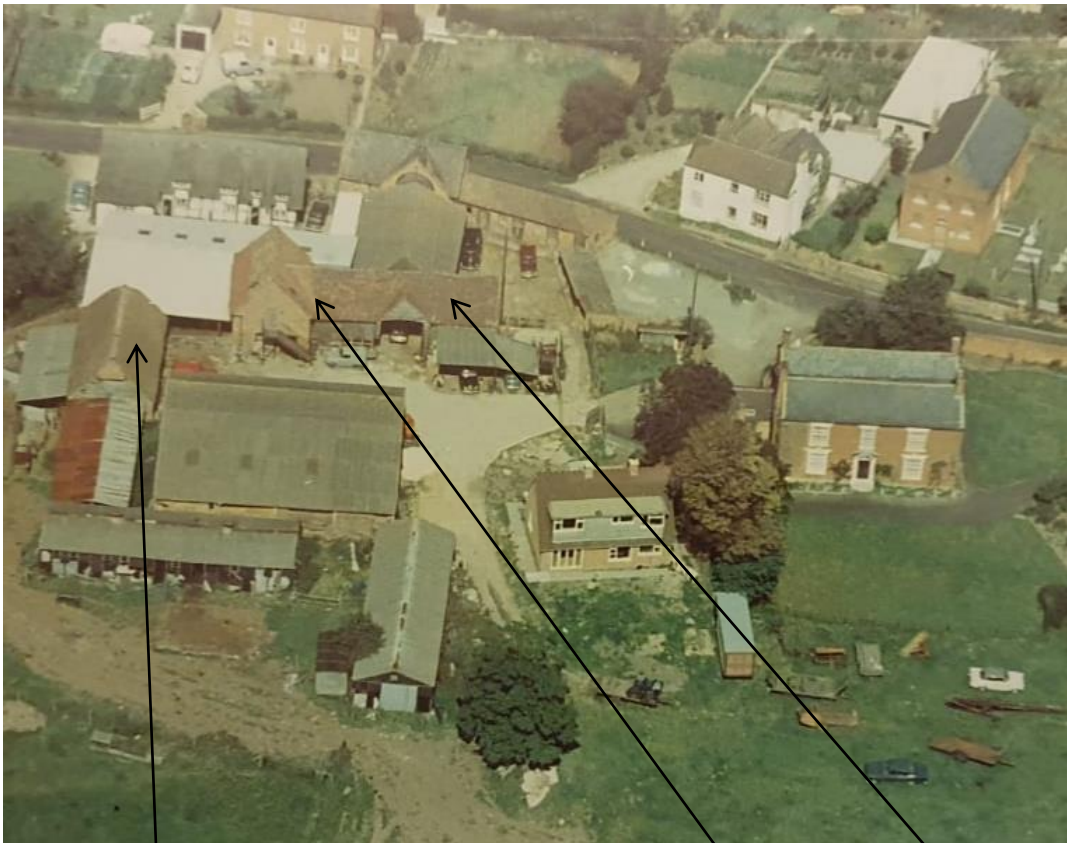
**Analysis:** Manor Farm Cottages recent renovations complete. Bungalow built 1970 in farm yard. Manor House to the right New barns behind the cottages. C18 Granary with threshing barn still intact. C18 Cow/shelter shed to end of yard

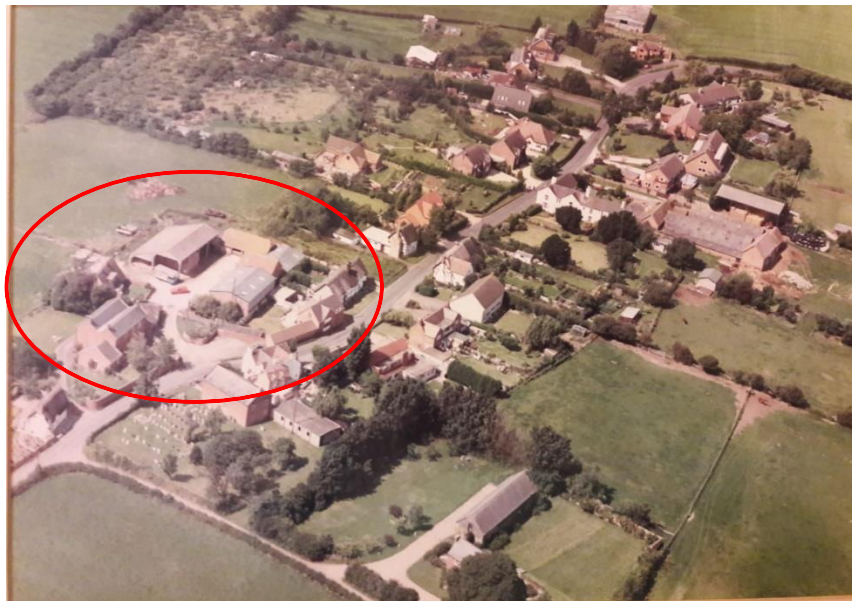
**Analysis:** Manor Farm and Cottages circled red Analysis: Threshing Barn now demolished. Granary and Cow House still remain

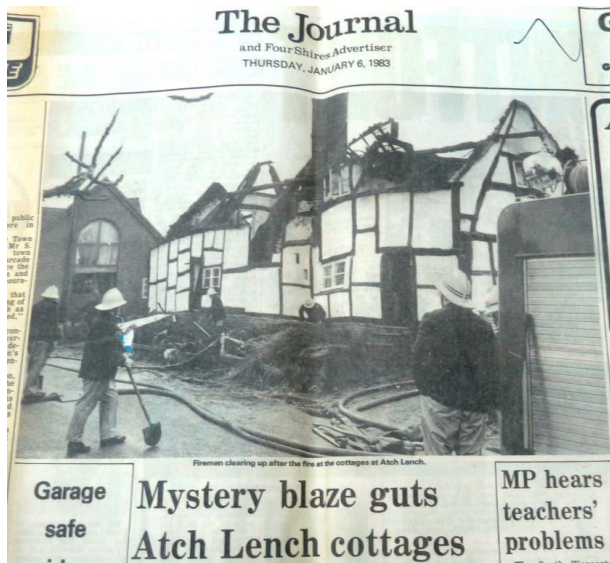
1983 Fire Damage

“Two black and white cottages believed to be among the oldest in Worcestershire were gutted in a mystery New Years Day fire. The fire broke out at 1.30a.m. in a store shed behind the 500 year old Manor Farm cottages standing beside the main village at Atch Lench. It quickly spread to the thatched roofs and it took four fire crews several hours to bring it under control. The alarm was raised by Mrs Margaret Welch who was living in one of the cottages ....the other cottage was tenanted by Mr and Mrs Smith who were visiting friends in Bristol.” The Journal Jan 6<sup>th</sup> 1983

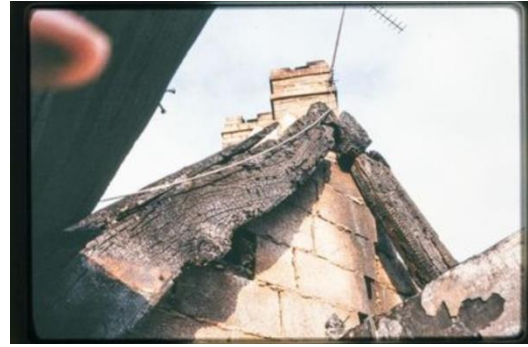
Ref Omnia Manor Farm Cottages Atch Lench 1983  
Image Archaeology Data Service

**Analysis:** Cruck blades No1 charred. Modern blockwork from 1967 renovations visible

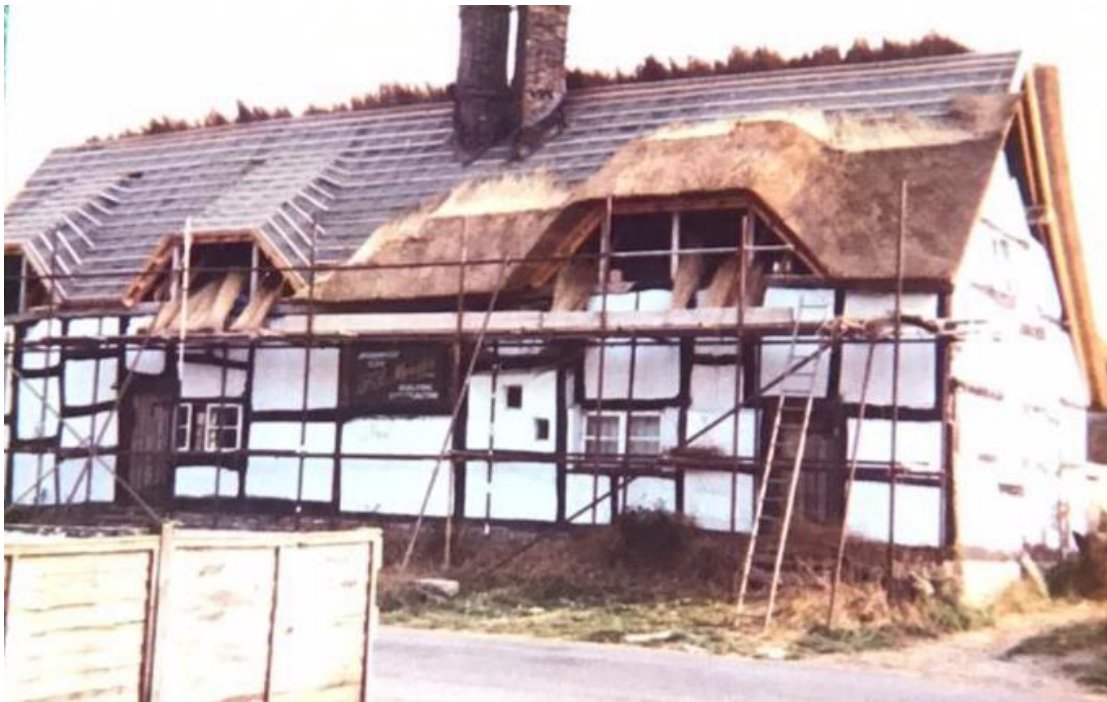
#### 1984 Repair and restoration in progress

**Analysis:** re thatching the roof but changing the dormers to front elevations

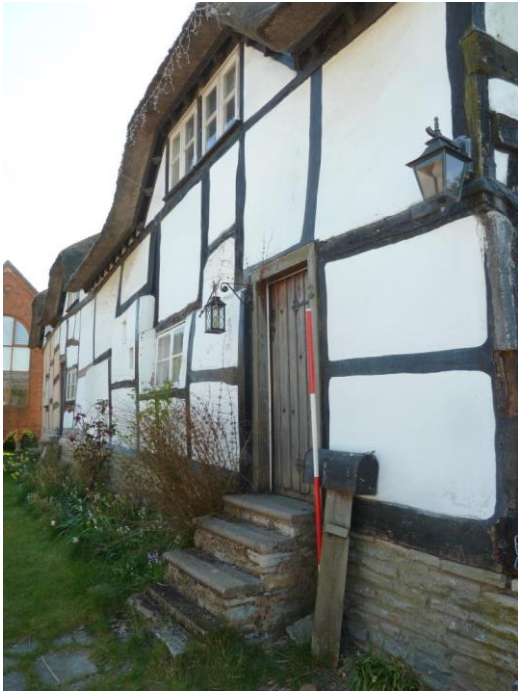
[Photo A] liars stone and concrete steps to front door

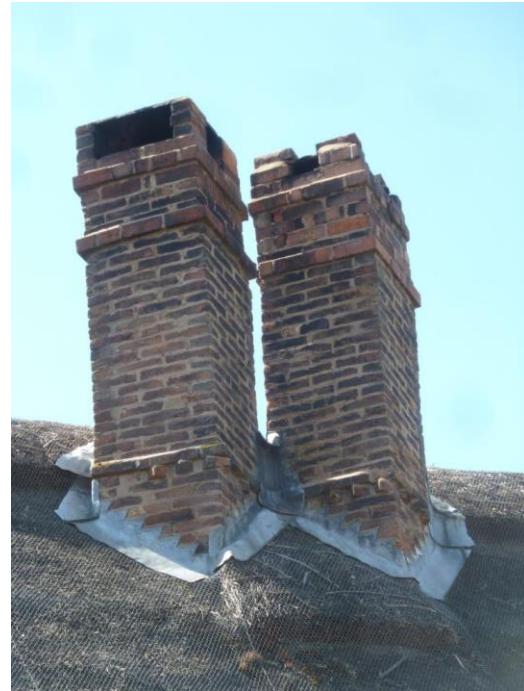
[Photo B] two diamond shaped brick chimneys

South elevation. (Rear). **(Photo A )** South roof is thatched with heavy ridge; two diamond shaped brick chimneys; the top 6 courses have been replaced and both chimneys have two sets of corbels separated by three and four courses; lower courses of brick thin smaller bricks suggest an earlier date(2 inches high by depth 4 inches length 9 inches )brick cogging at roof level; both chimney stacks have slate on top of simple openings. Eyebrow dormer's at 2nd floor Level. Three dormer's installed in 1967 and reconfigured in shape in 1984;There is a continuous outshut roof to left that runs over small kitchen extension; dormer with 2 light casement window in dormer to right all replaced in 1980s . Dormers changed in 1980s; replaced due to fire timber wall plate runs beneath dormers at eaves. At ground floor level the cottage has a timber stable style; door single light to top and cat flap to bottom; 2 light timber casement window to right side; frame is sitting on stone lias plinth which was rendered in 1967; x2 concrete steps to garden area. Wall frame made up of square panels; photograph of renovations in 1967 show all being equal and regular spacings for infill that were cement rendered. Kitchen outshut of 1967 extension cement rendered block or brick; airbrick; Triple casement window each with X3 lights has timber lintel above; posts visible on either front corners, are sitting on rendered brick plinth.

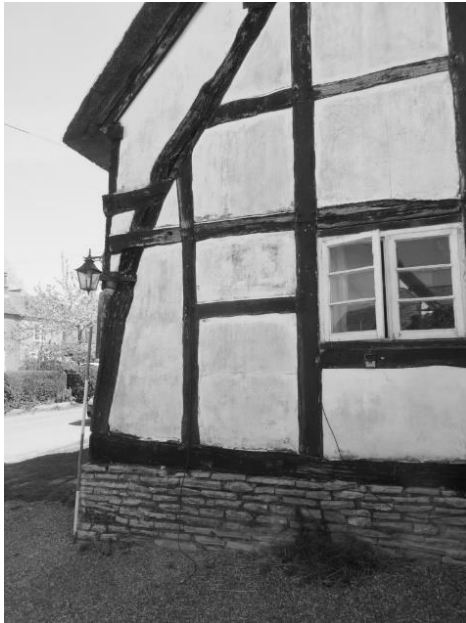
**[Photo A]** End gable elevation and the cruck blades

At the end gable elevation the cruck blades **[Photo A/B]** with collar and framing are visible; collar appears to be half lap joint to cruck blades with ends running beyond blade; spurs to wall plate to front and rear. **[Photo C]** Infill between blades of timber framing of square panels; infill woodwool slabs cement rendered 1967/1984 to sill beam **[Photo B]**, casement window inserted in panel to ground floor **[Photo B]**; photographic evidence suggest that panels have been adapted in 1967/1984 and originally had a casement window to 2<sup>nd</sup> floor and the panels ran to top of GF stone wall although may have run behind wall; right hand cruck blade visible running to sill left now is scarf jointed; timber framing now to ground floor walls; photographic evidence pre 1960s show this was stone walling. Note: *enclosing walls of cruck buildings could have been of any material, earlier cruck frame buildings have wall of earth or turf; Later timber frame walls were used and these have been known replaced by stone or brick which could conceal the timber frame wall and only be cladding to a set of cruck trusses.* No yoke or saddle at apex. **[Photo B]** Cruck is open at eaves, but photographic evidence suggest there was a saddle and short king post as is evident today at the internal truss. Cruck blades are now sitting on sill beam on a DPC; below is a stone lias plinth. **[Photo D]** Outshut of 1967 to rear continues framing and panels with spur and wall plate tying into cruck blade, sitting on sill plate with DPC with cement rendered breeze block plinth **[Photo E]**

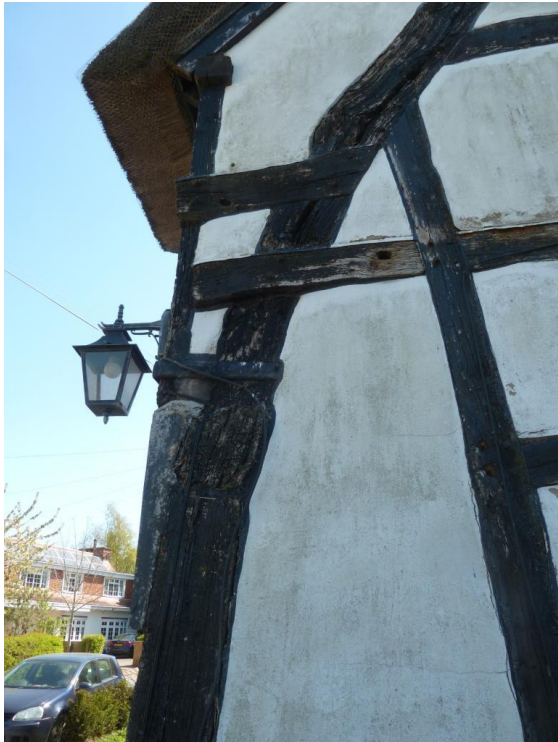
[Photo C] spurs to wall plate to front and rear.

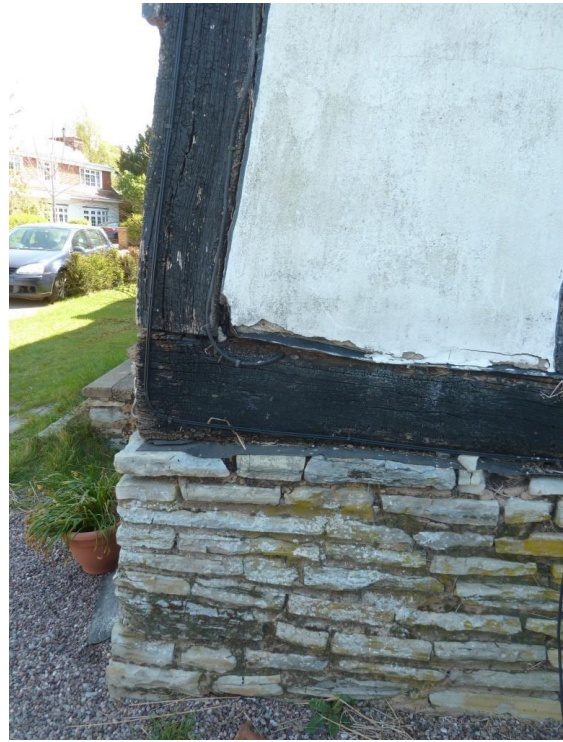
[Photo D] sill beam on a DPC/ stone lias plinth

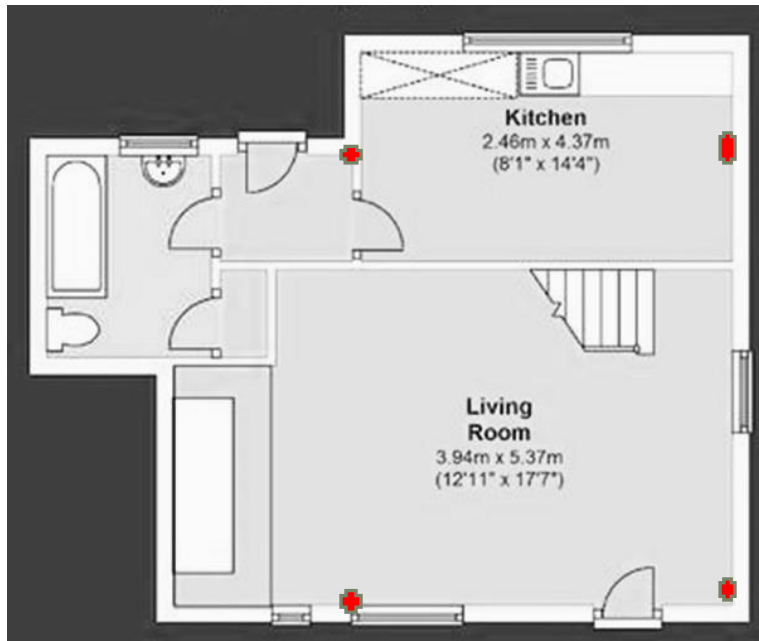
**Annotated Floor Plan, Rooms Labelled for reference; do not scale off this drawing**

Interior: ground floor room is original 1st Bay; [between Cruck 5 and 4] as described in survey drawing 1983 in Appendices [See red squares] Flooring Cement screed.

There is a bathroom off a rear lobby and a kitchen outshut built in 1967 and restored after fire in 1984 to rear elevation. The living room is to front and is entered via the front door via steps from the road.

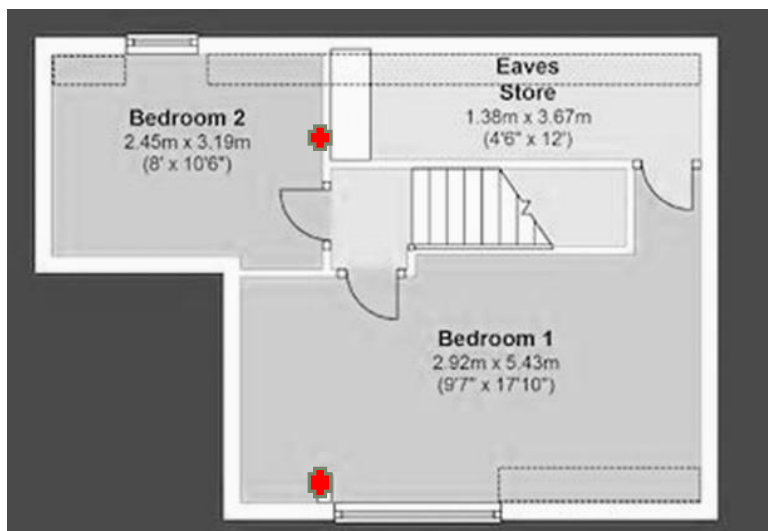
Annotated Floor Plan, Rooms Labelled for reference; do not scale off this drawing

Approached via C20 open tread timber staircase. Small landing with C20 doors to two bedrooms. Bedroom 1 has door to Eaves store. RED squares indicate Cruck Blades

**First Floor Written descriptions:** Stair leading to 1st floor; C20 timber stairs; single flight sitting on partition brick wall of back of kitchen; landing has floor of mixed pine boards wide [10 inch] ; stud wall with wallpapered panels infill [could be lath & plaster] to rear of random posts painted black, nailed. **(Photo A)** x2 oak purlins renewed after 1983 fire**[Photo B]** ; from landing C20 door leads to bedroom 2 within Bay 3 and 4 which has a timber C20 casement to rear and continuation of replacement 1980s purlin at ceiling; sitting upon upper cruck blade with collar tie,**(Photo C & F)** all painted black running to floor level. Sidewall to fire space is breeze block and party wall is also block. **Front room bedroom 1** has painted glazed lights over stairwell **[Photo A]** , set in painted black timber frame, plasterboard ceiling and eaves; **[Photo D]** main bedroom 1 cruck blade visible with collar**(Photo F & G)**; Front wall with timber framing exposed **[Photo E]** C20 door to storage space under eaves above kitchen below **[Photo H]** All upper floor of pine boarding in poor condition.

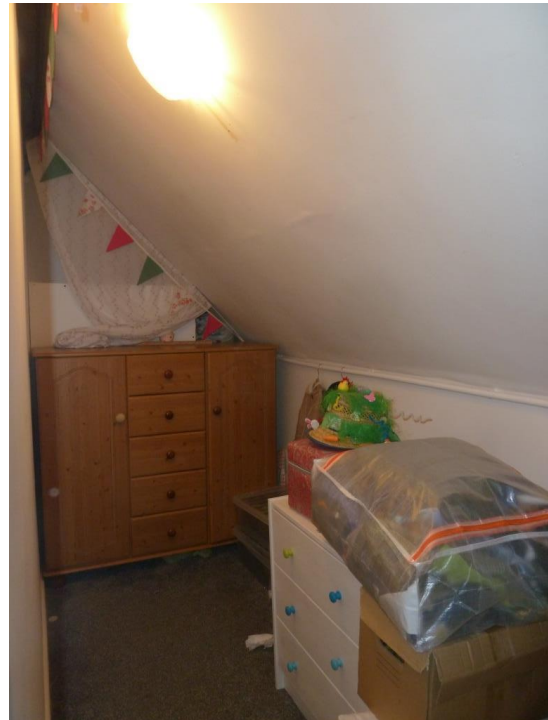
Photo H Eaves Storage

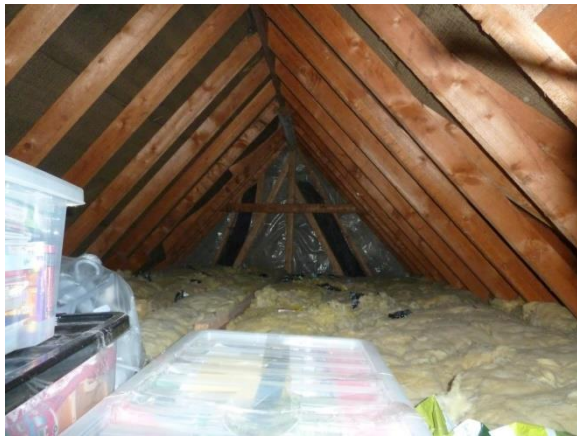
Photo A

**Written description:** The majority of roof timbers/rafters including purlins were replaced after the 1983 fire; roof lined with bitumen felt under thatch roof. Chimney end loft area **(Photo A)** Party wall to number 1 of is block work **[Photo B]**; top of internal cruck apex, saddle and short king post cruck apex; left in situ after fire; heavily charred **(Photo C)** is a significant feature; end gable also has internal face of cruck blades visible **(Photo A)** although apex missing, no yoke or saddle at apex; cruck open at eaves. This may have been saddle and short king post as is the case at internal truss no 4. Gable end is covered in plastic sheeting and timbers as fire repair. **(Photo A)**

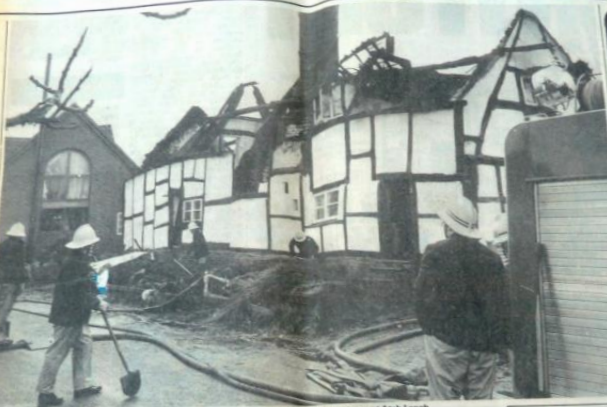
Firemen clearing up after the fire at the cottages at Atch Lench.
