Standing Building Recording 3 Link Lodge, Pickersleigh Road, Malvern Link WR14 2RP WSM20391

# WORCESTERSHIRE HISTORIC ENVIRONMENT EVENT NUMBER WSM78248

**JULY 2022**

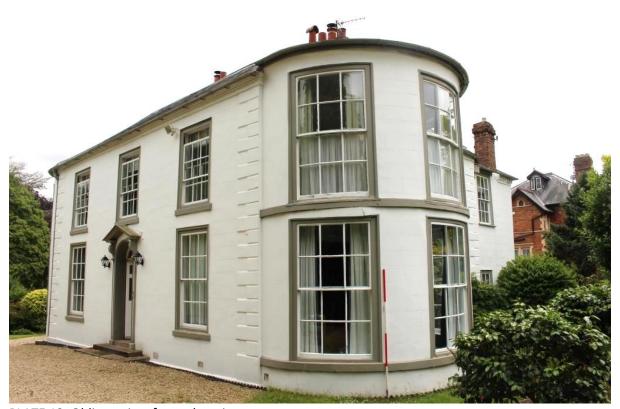
PLATE 12. Oblique view front elevation

Principal larger elevation [PLATE 10. PLATE 11] painted ashlar effect stucco render with slate hipped roof with central valley; brick chimney stacks adjoining brick clay tiled building that has been faced with ashlar effect stucco render and has one hipped roof covered in slates facing Pickersleigh Road. The principal larger side has a two storey Bay to the north [PLATE 12] with six full height 6/6 curved sliding sash windows; further two 6/6 sliding sash windows to GF and FF. A brick wing with clay tiled roof; brick chimney stack to front elevation; slightly set back faced with ashlar effect stucco render; FF 6/6 sliding sash windows; GF 3/3 sash window to Utility Room; room set partly underground with external solid stone walling faced with ashlar effect stucco render to match the principal building. Boundary has character criss cross pattern fence panels in a Regency style between 19th century brick pillars and low brick walling with hedges.

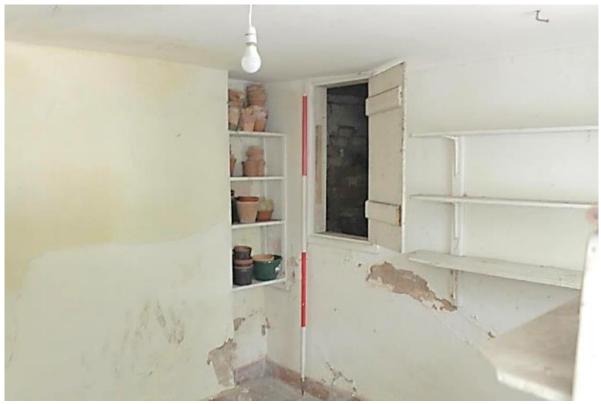
PLATE 13. Outbuilding

One of Two single storey painted brick outbuildings over clay tiled gabled roofs; formerly part of stable yard; one building [PLATE 8] attached to the main building incorporating a chimney stack; external C19 timber plank entrance door[Plate 16]; 2/2 pane C19 casement window with original latch.[Plate 16]; tiled floor; dividing wall with a timber door/hatch [Plate 17] where modern water tanks have probably replaced older water tanks [still evident and visible] that would have been housed here[Reference RDA Heritage Assessment 1933 Auction description p20]

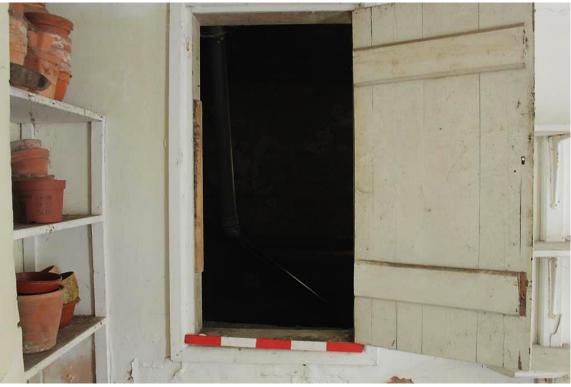
PLATE 17. Outbuilding hatch into water tank

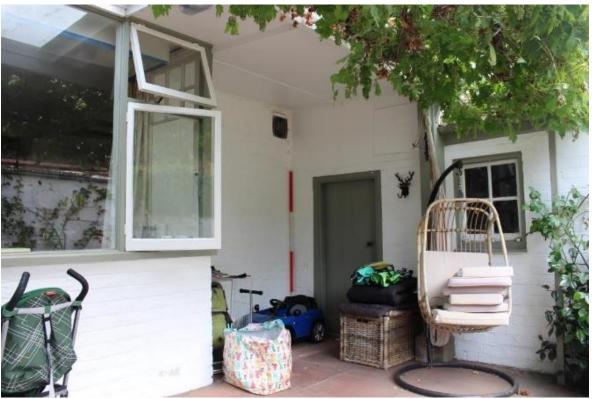
PLATE 21. Lean-to looking toward outbuilding

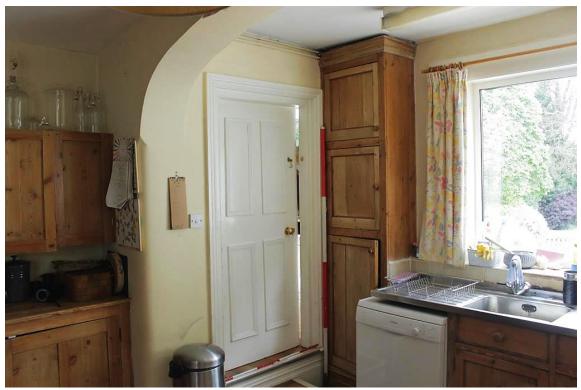
This room has undergone the most changes. It appears to have been opened up [PLATE 28]. Entrance door from corridor; x 4 panelled raised and fielded mid C19 door; heavy architrave maybe late C19 or reproduction. [PLATE 31]. Door to lobby and pantry also x4 panelled mid/late C19 door with bolection type mouldings. [PLATE 32]. Fireplace undergone alterations and its recess is not deep. [PLATE 31]. Floor; timber pine boards; C19 recess stripped fitted pine cupboard. [PLATE 31]. To the east is the inserted Upvc window [PLATE 29] and to the south the C20 Porch with C20 timber casement bay window and outside Lean-to. [PLATE 30]

PLATE 32. Pantry door

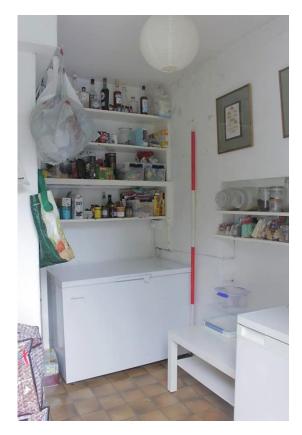
PLATE 33. Pantry

Entered by an exterior C20 8 pane glazed door[PLATE 34]; approached by four semi-circular brick steps [PLATE 4]The door opening appears to have been narrowed as the door lintel is wider than the current door opening. Pantry on a higher level than the Kitchen Dining Room and is approached by steps from the Kitchen.
