**Historic Building Survey Report  
of  
The Stable Block,  
The Old Mill House, Donington on Bain, Lincolnshire**

This historic building survey has been prepared by Keystone Archaeology  
for Mr R. Osmond  
The Old Mill House, Welsdale Road, Donington on Bain,  
Louth, Lincolnshire. LN11 9QZ

Nat. Grid Ref: TF 23332 83438  
Accession Code: LCNCC : 2016.177  
Planning Reference: N/042/02464/15  
Site Code: OMHS16

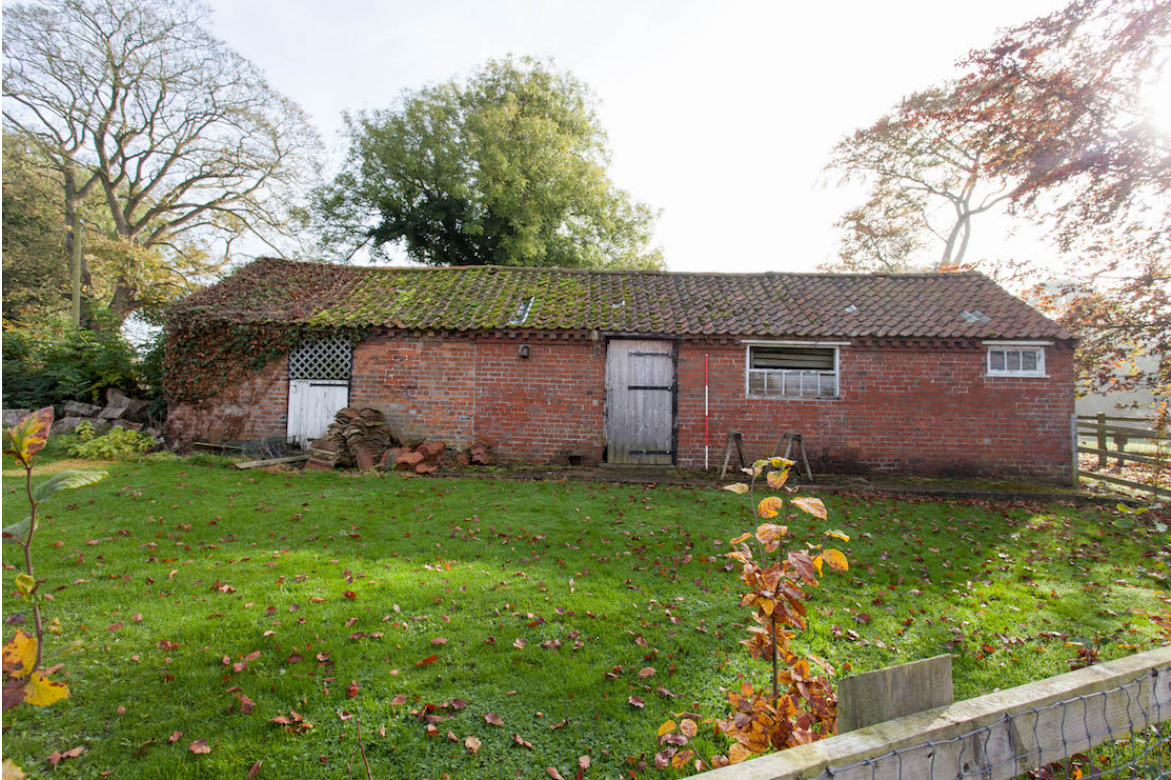
Plate 4 (shot 8) – North western elevation, looking south east. This shows slope of ground NE to SW.

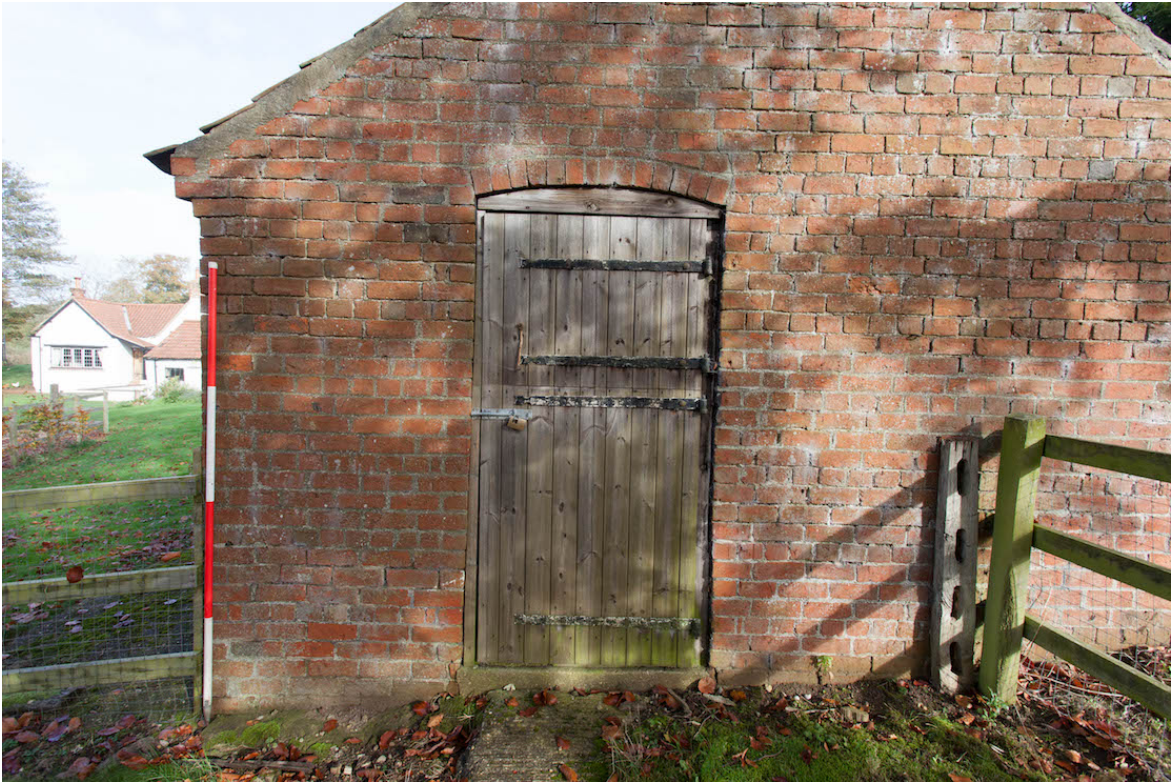
- 6.9 The south western end gable is of brick construction. It has a doorway in the western most side featuring a single brick segmental arch, wooden internal lintel and a modern stable type wooden door.  
Built in to the eastern side of the end gable is a post box beneath which can be found and ordnance survey benchmark carved into the brickwork. The height of this benchmark is 0.6m AGL and 69.6986m (229.3ft) ODN.

Plate 6 (shot 12) – South western elevation, looking north east.

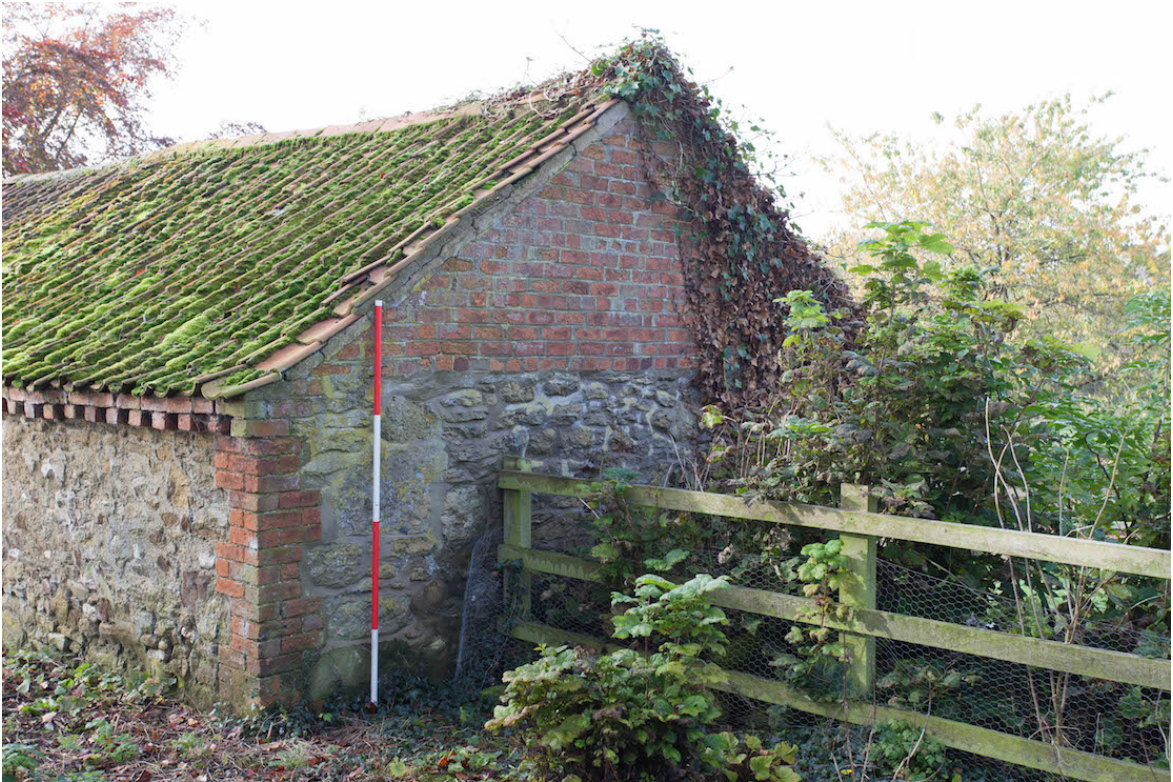
- 6.7 This north eastern elevation also shows two distinct phases of construction – northern third to southern two thirds. There is also evidence of rebuilding / repairs. The upper most section of the southern end of the building has bricks within a rebuild section next to the brick corbelling under the eaves. There is also evidence that the top 40cm of the eastern elevation at the northern end has been rebuilt as the stonework is now in two rough but distinct courses whereas the rest of this elevation is uncoursed.

Plate 15 (shot 25) – North eastern elevation looking west south west.

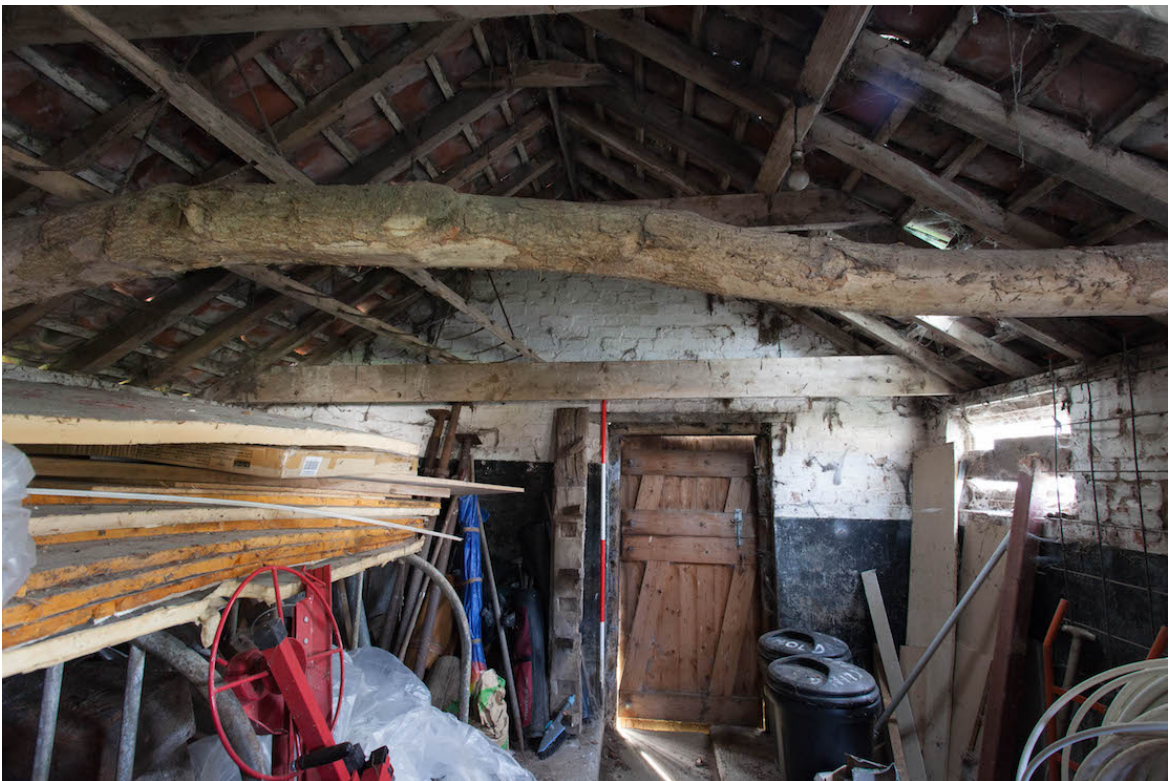
- 6.14 The floors in both sections of the building have been covered in a deep layer of concrete with a rusticated cross hatched surface for grip and a central gully present to facilitate the wash out / drainage of animal waste. At the point where the gullies reach the wall, a small hole has been knocked through with the removal of two bricks to form an exit for the waste. These small holes - one in each section of the building - have been reinforced with a thin slate lintel; likely a reused roof tile.

Plate 18 (shot 31) – Interior of southern section, looking south west.

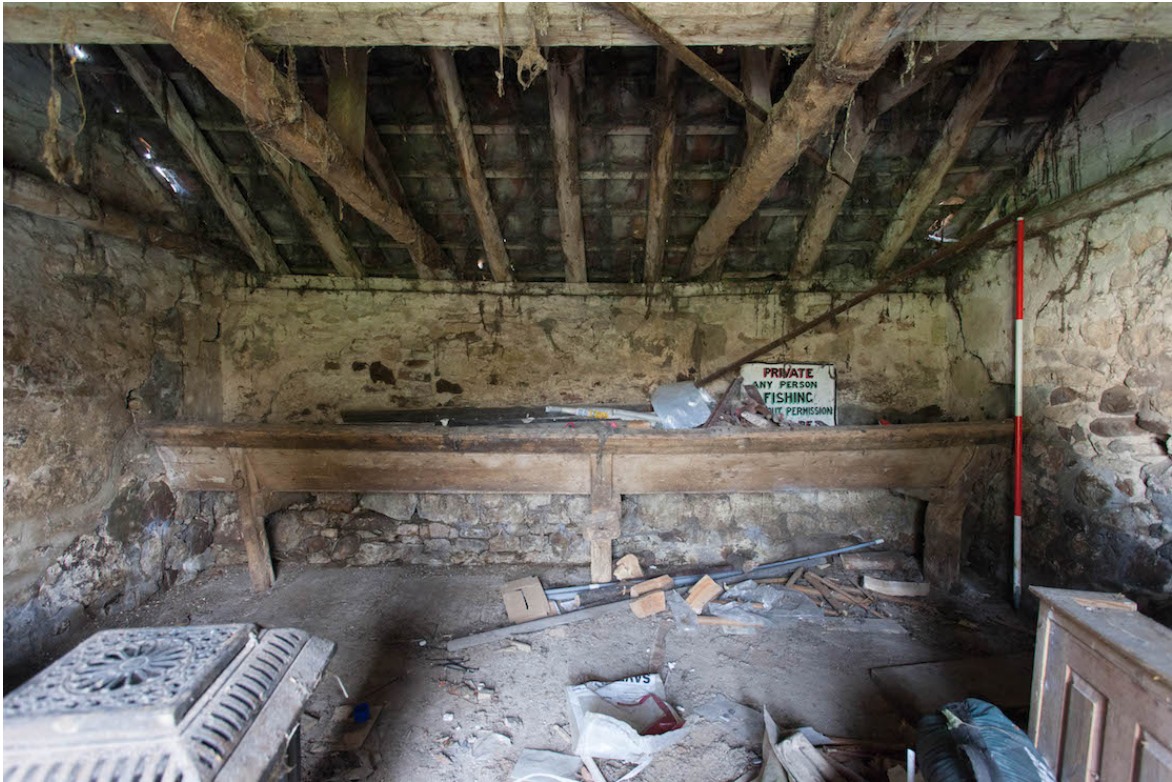
Plate 27 (shot 41) – Interior of northern section showing feed trough, looking south east.

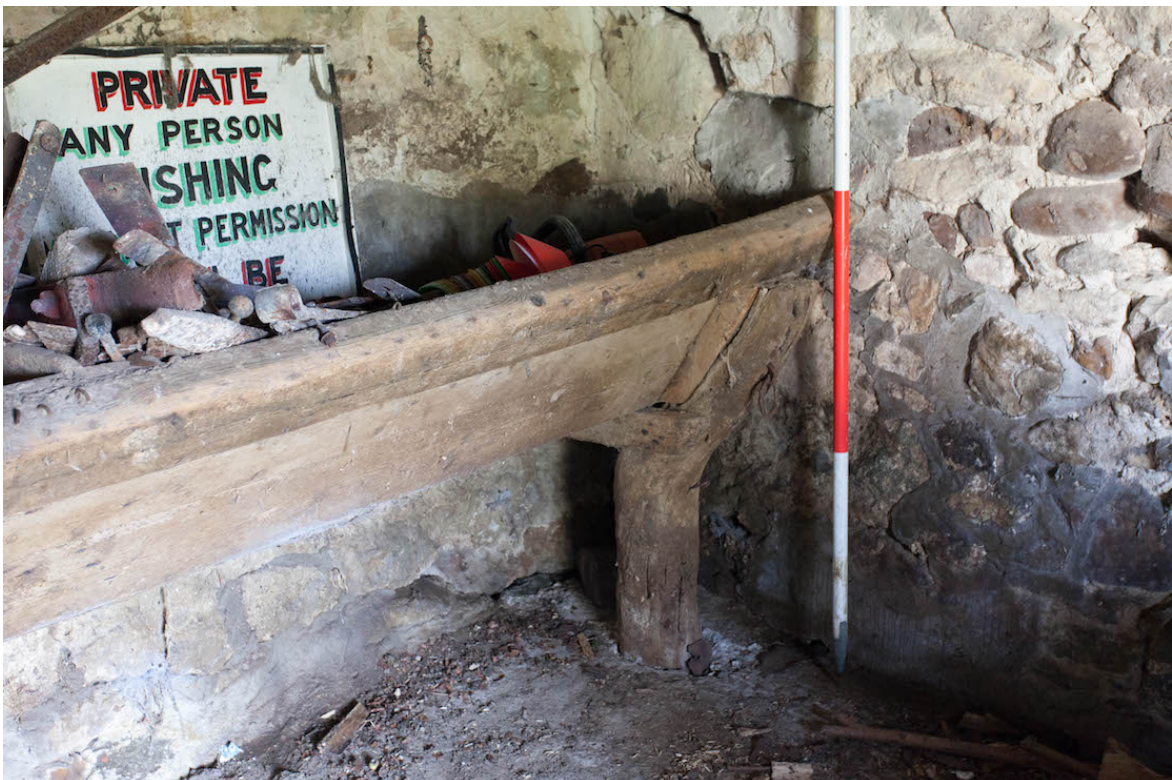
Plate 28 (shot 43) – Feed trough detail with iron rings in northern section, looking south.
