SUTTON BARN, BROOK LANE, ENDON

LEVEL 3 SURVEY

Prepared on behalf of MR and MRS D PENNINGTON

21ST SEPTEMBER 2016

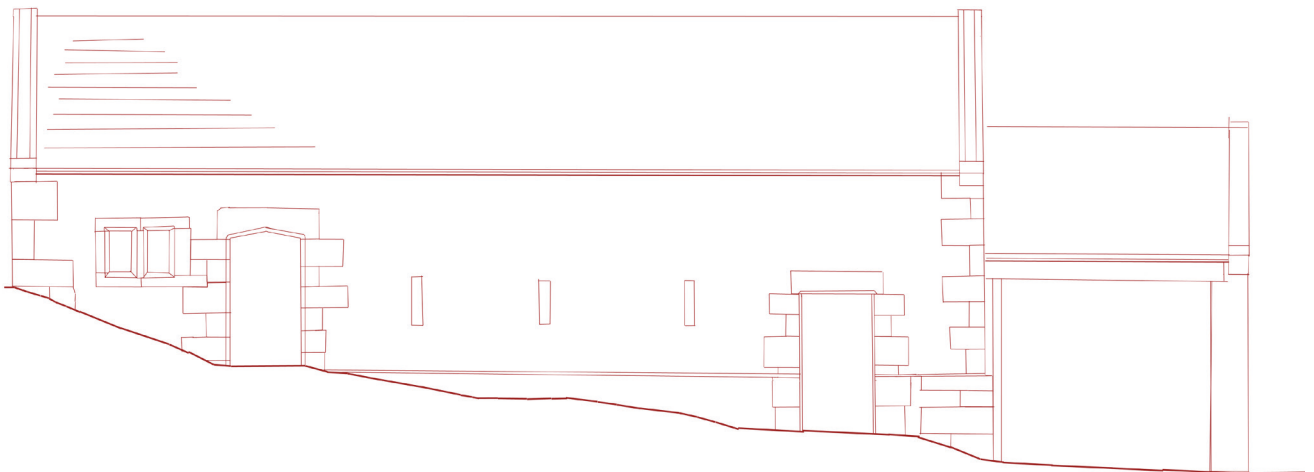
Plate 2 - Reconstruction drawing showing the probable appearance of the 17th century combination barn and stable, with the later 18th century cart bay, prior to 19th century remodelling

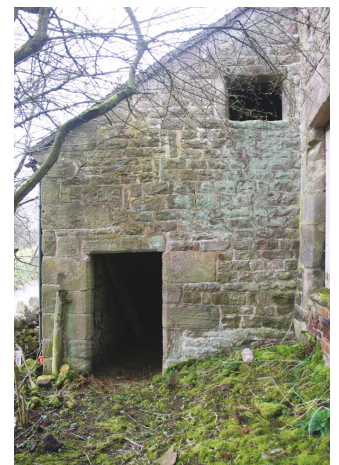
Oak posts (former joists) set aside. The sockets for the joists can still be seen in the masonry

In this case, some of the hay and straw was stored on a raised timber platform above the cows and was simply dropped down through the floor to the cattle below. There is plenty of evidence for this arrangement. The sockets for the large oak timber joists survive in the lower, eastern wall and a number of the oak joists have been simply set aside when the building fell out of use and the internal framework collapsed, or was removed.

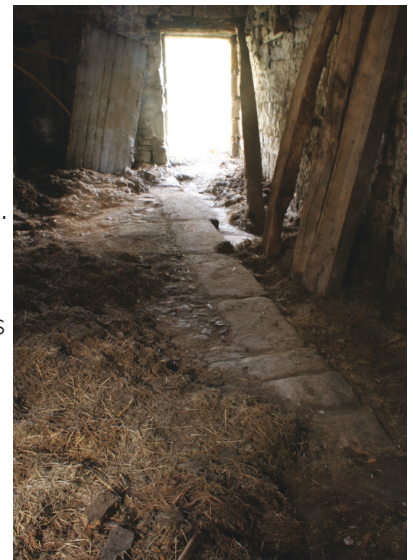
Fragment of oak rack with sockets for staves is part bedded in the lower wall

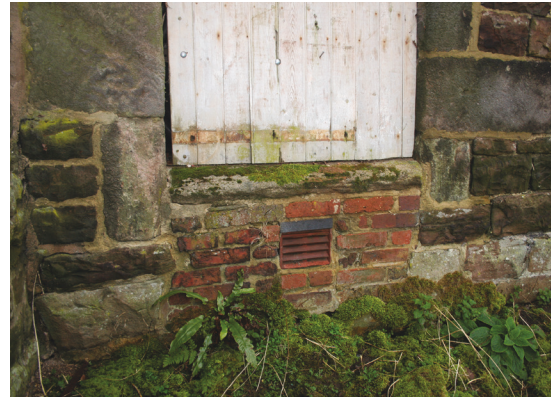
the sloping ground and both may have once had steps, although only the steps to the western side survive; the original opening to the eastern side has been altered with brick infill, of no interest (pictured right). There are niches ("keeping holes") to either side of the winnowing doors where lamps could be placed to light the area during winter months or dark days.

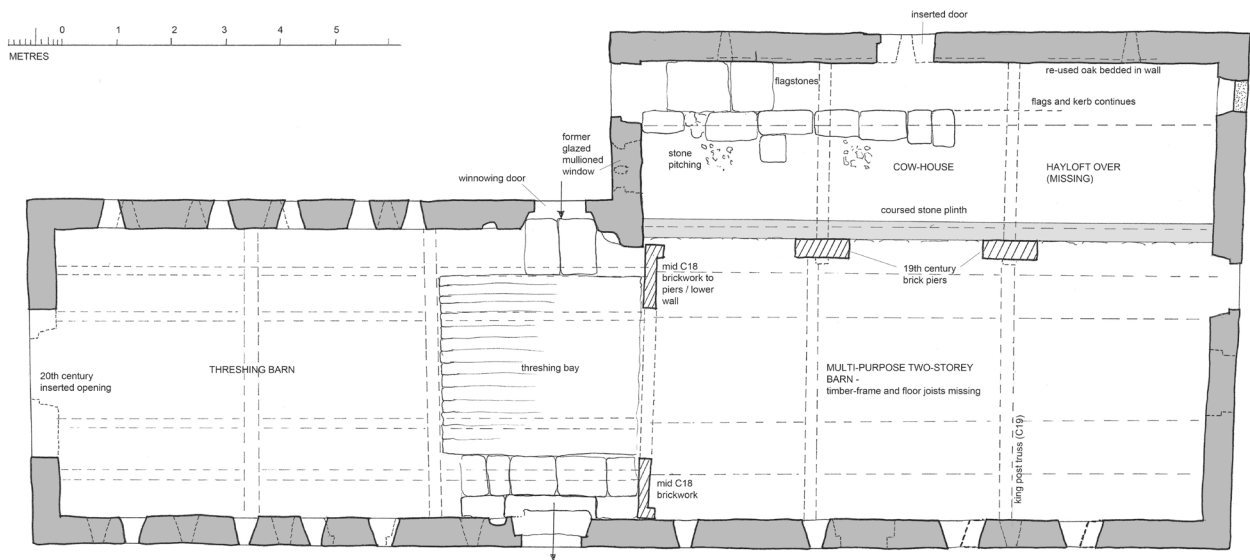
Plate 3 - Bank Barn - measured survey drawing overlaid with notes. Main phase is illustrated in dark grey tone. Inserted brickwork is hatched.

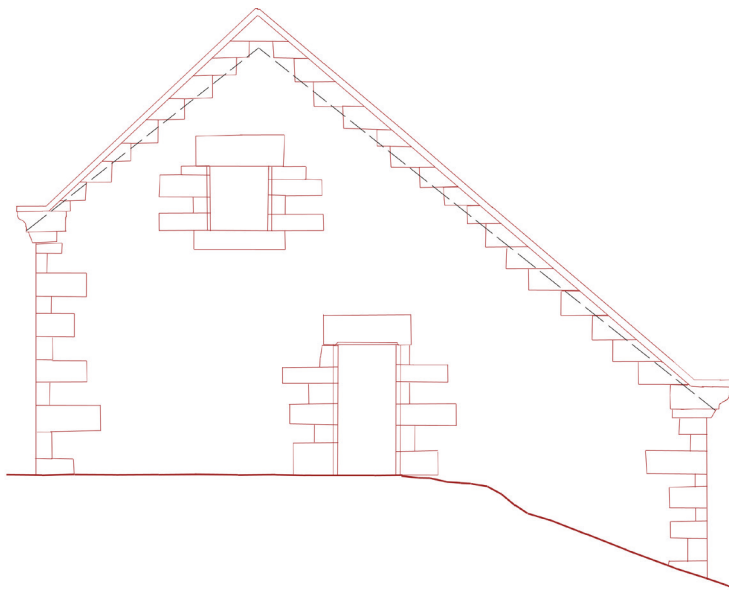
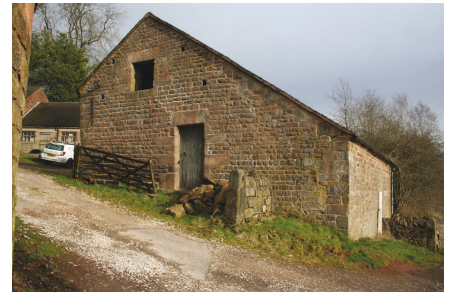
Bank Barn - reconstruction drawing of the south elevation showing the original form of the roof with stone copings and the current pitch and alignment (dotted)
