PRIORY CRESCENT SOUTHEND-ON-SEA

Condition Survey

06 November 2009

Site condition report following the dismantling of Camp Bling

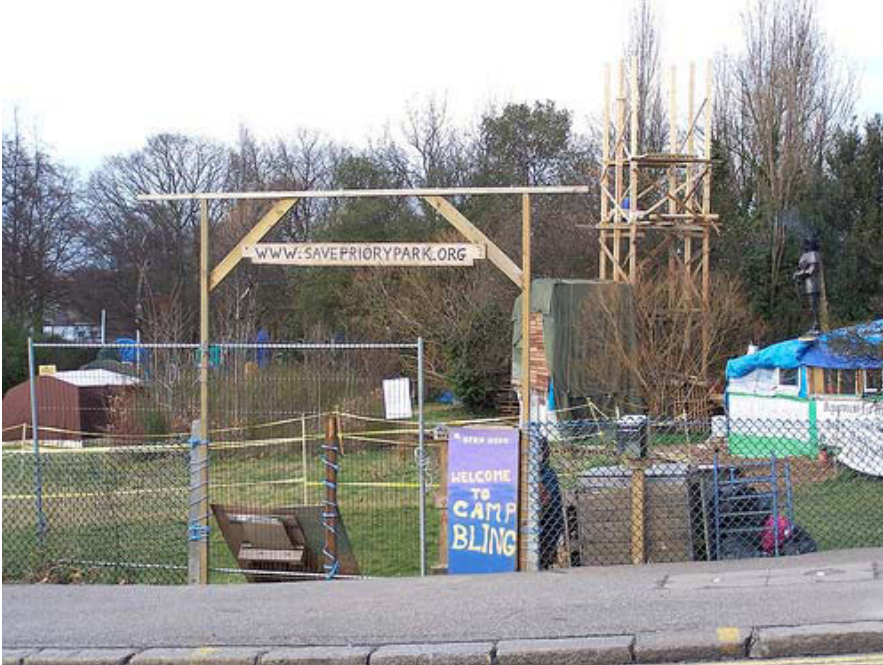
Fig 1 Condition survey plan of site showing areas of 'Camp Bling' surface disturbance in relation to the 2003 evaluation trenches

A total of ten areas which met with the above criteria were defined and these targets located using a combination of handheld Global Positioning System (GPS) and EDM total station (see Fig 1 and cover) likely to reflect the positions of the more robust structures and buildings of Camp Bling (see Fig 2 and Fig 3).

Fig 2 Entrance to Camp Bling looking N/E towards the visitor centre and wind turbine tower

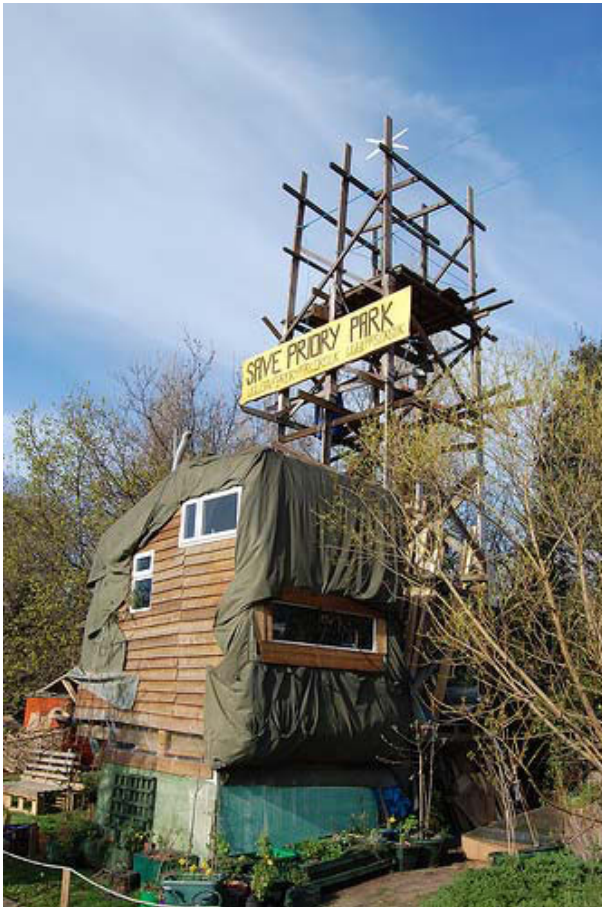
Fig 3 The wind turbine tower and adjoining Camp Bling house (looking N/E)

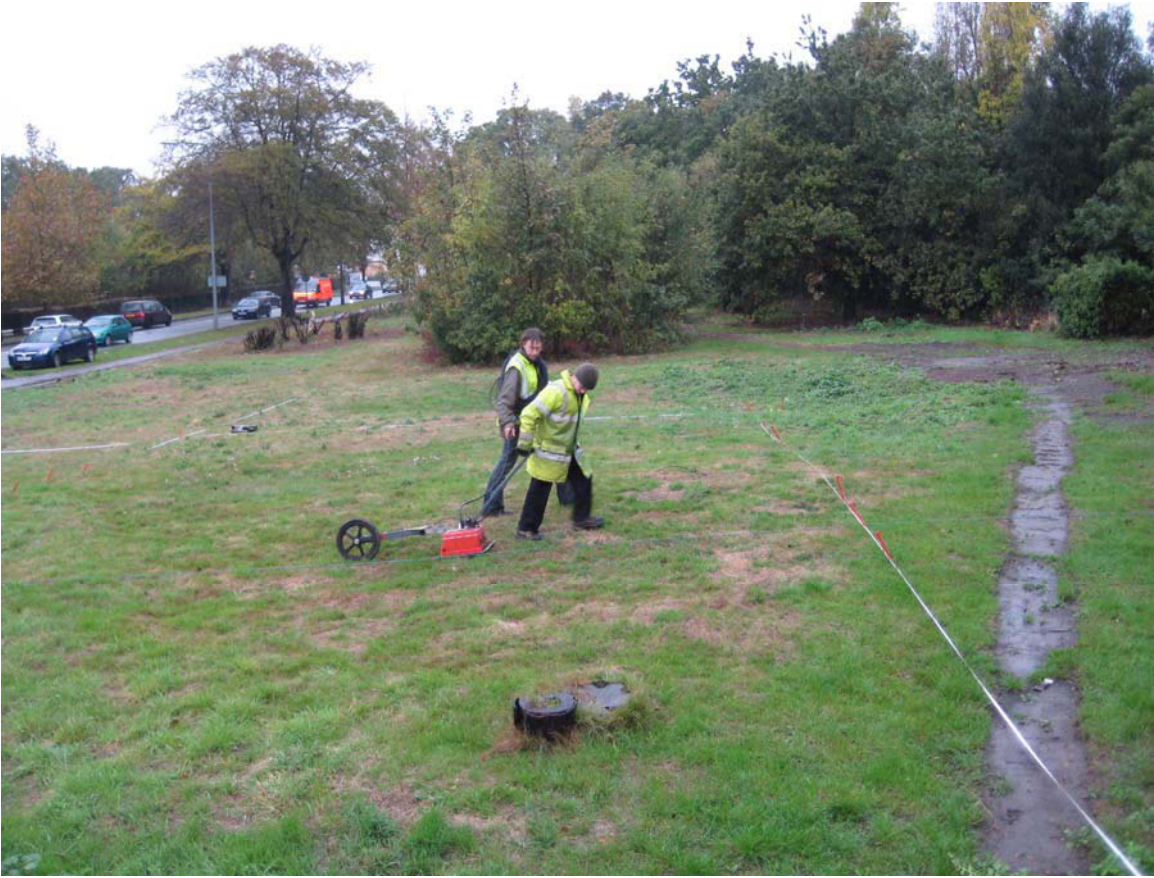
The site condition survey was undertaken on 21st October 2009 and was concurrent with the programme of geophysical work, with a GPR survey being underway at the time of the visit (Fig 8 and Fig 9). The principal aims of the survey were to define and accurately locate areas of:

Fig 8 Ground penetrating radar (GPR) survey in progress due south of the position of backfilled evaluation Trench 1 at the S end of the site (looking N)

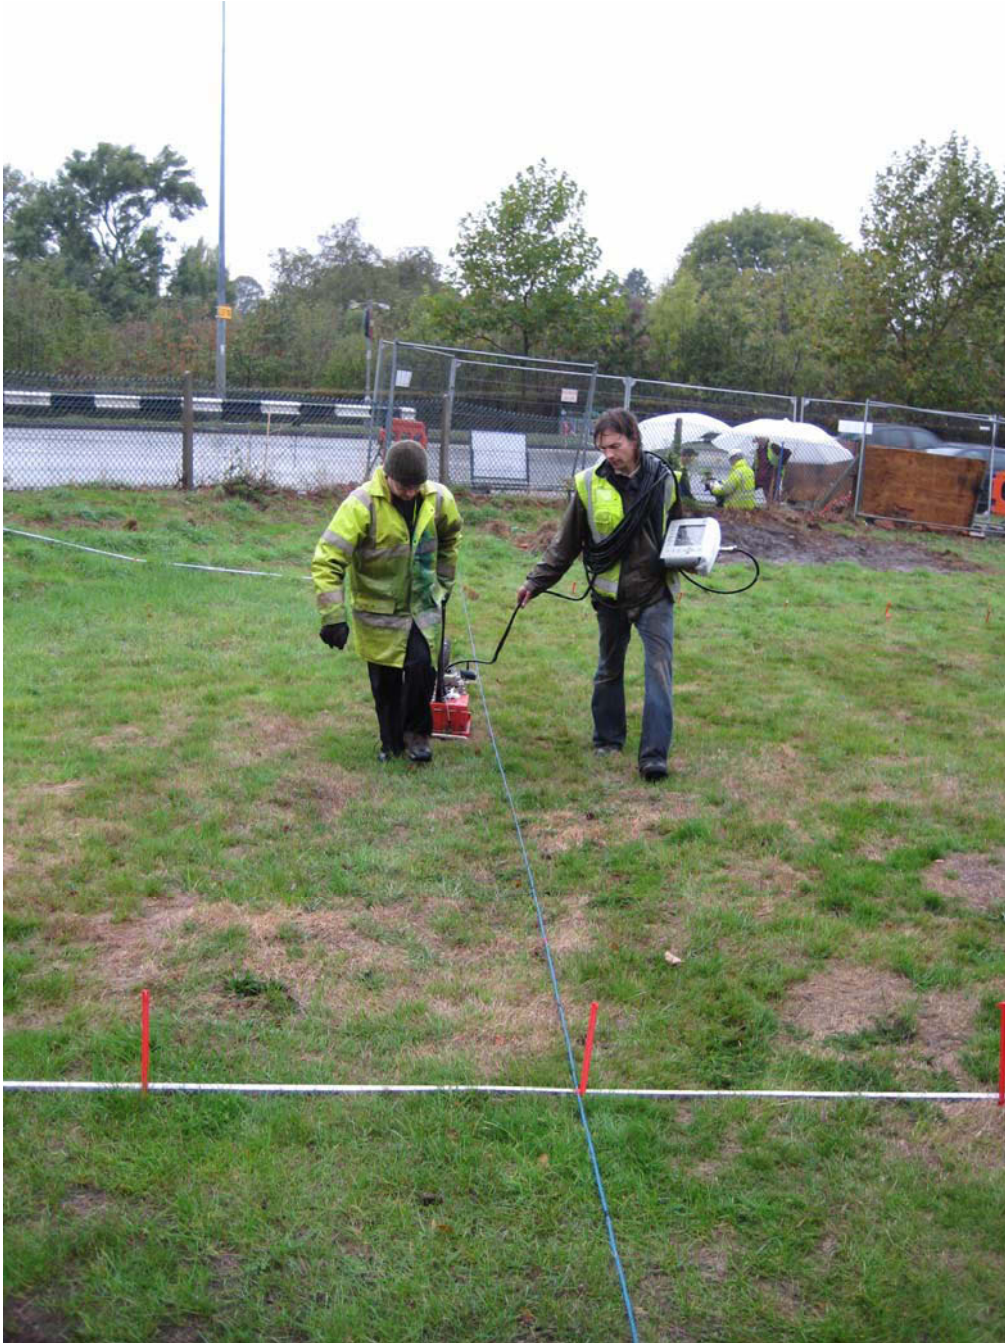
Fig 9 GPR survey in progress at the south end of the site (looking W towards Priory Crescent)
