The Orchard 3rd Auxiliary Military Hospital, Dartford

Archaeological Survey

Report Date: July 2018

Report Number: 001

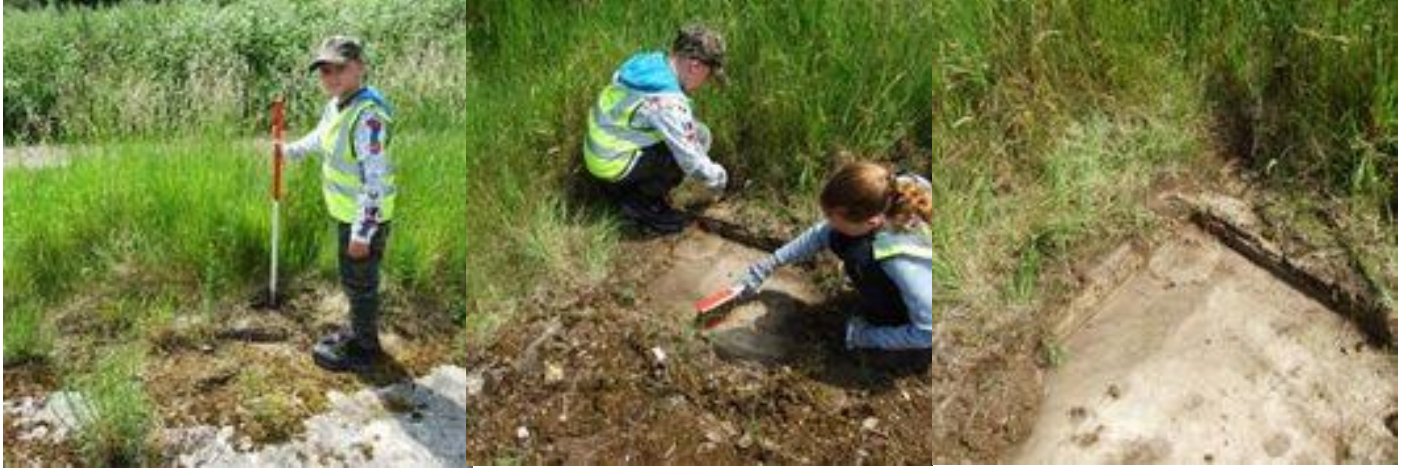
3.5.1 This building appears on the existing maps of the site and is marked as a workshop, though it may also have doubled as a store building. The presence of mirror glass and nails would help corroborate its existence as a workshop.

In the picture on the left, I am measuring the length of the base of building D (labelled as a workshop on the map). In the middle picture, I am helping to find the edge of the building. The picture on the right shows what it looked like once we had finished.

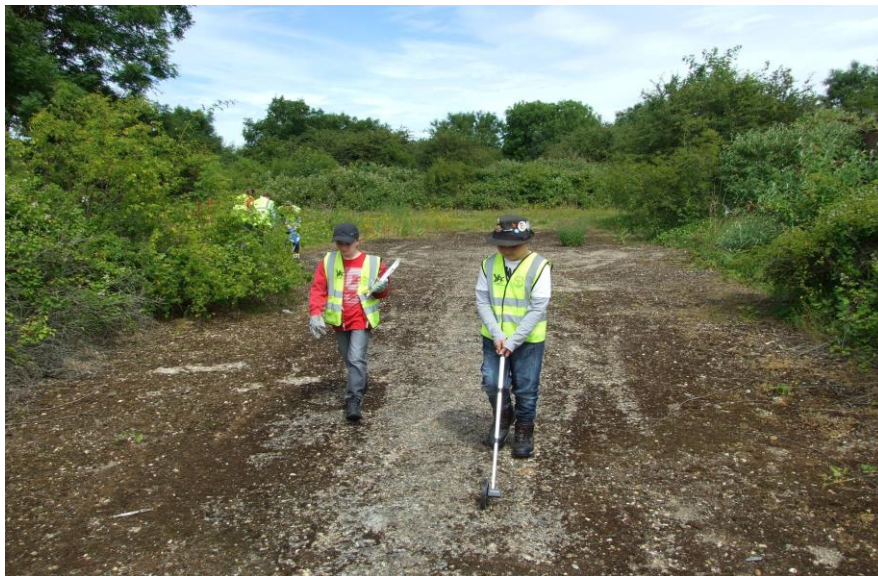
In this picture, I was measuring (in metres) the distance of a ward block base.

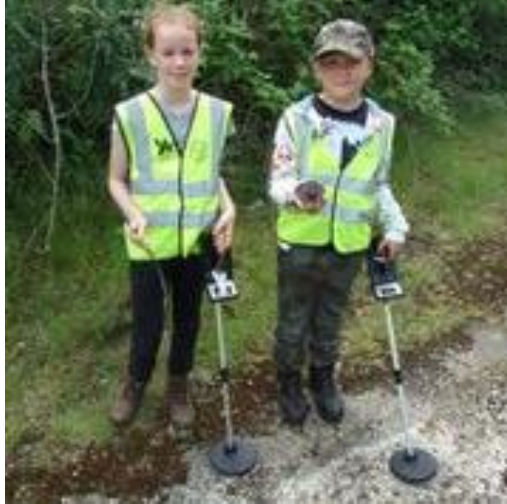
In this picture we are looking for traces of metal with metal detectors. We found the frame of a window and part of the wheel from a tram.
