VI Aydon Castle Kitchen and its Roof

David Sherlock

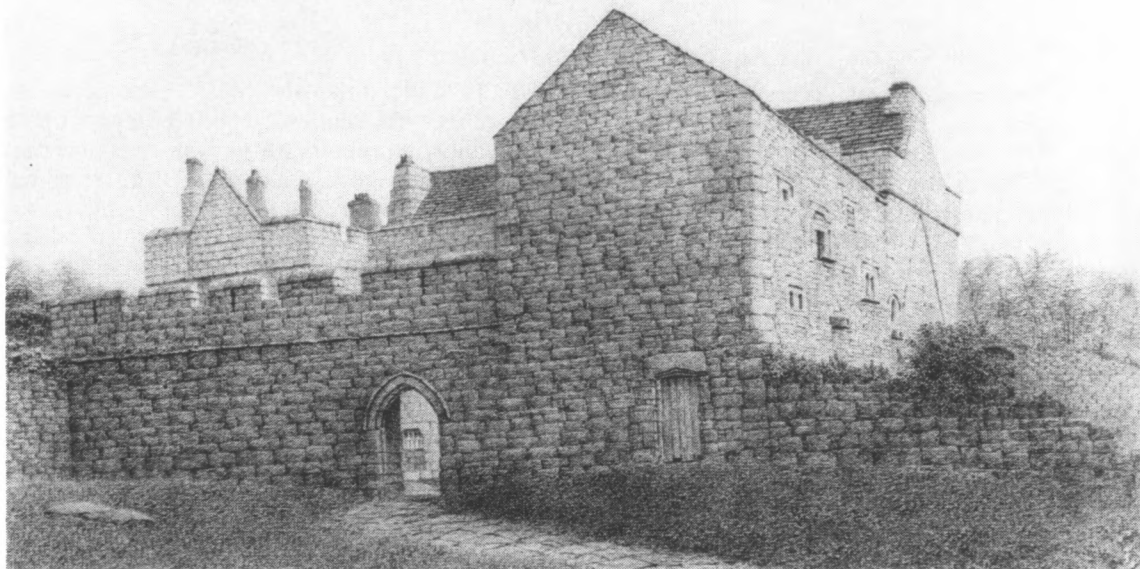
Fig. 2 View of the kitchen range from the north-west in about 1915. © Henry Oliver.

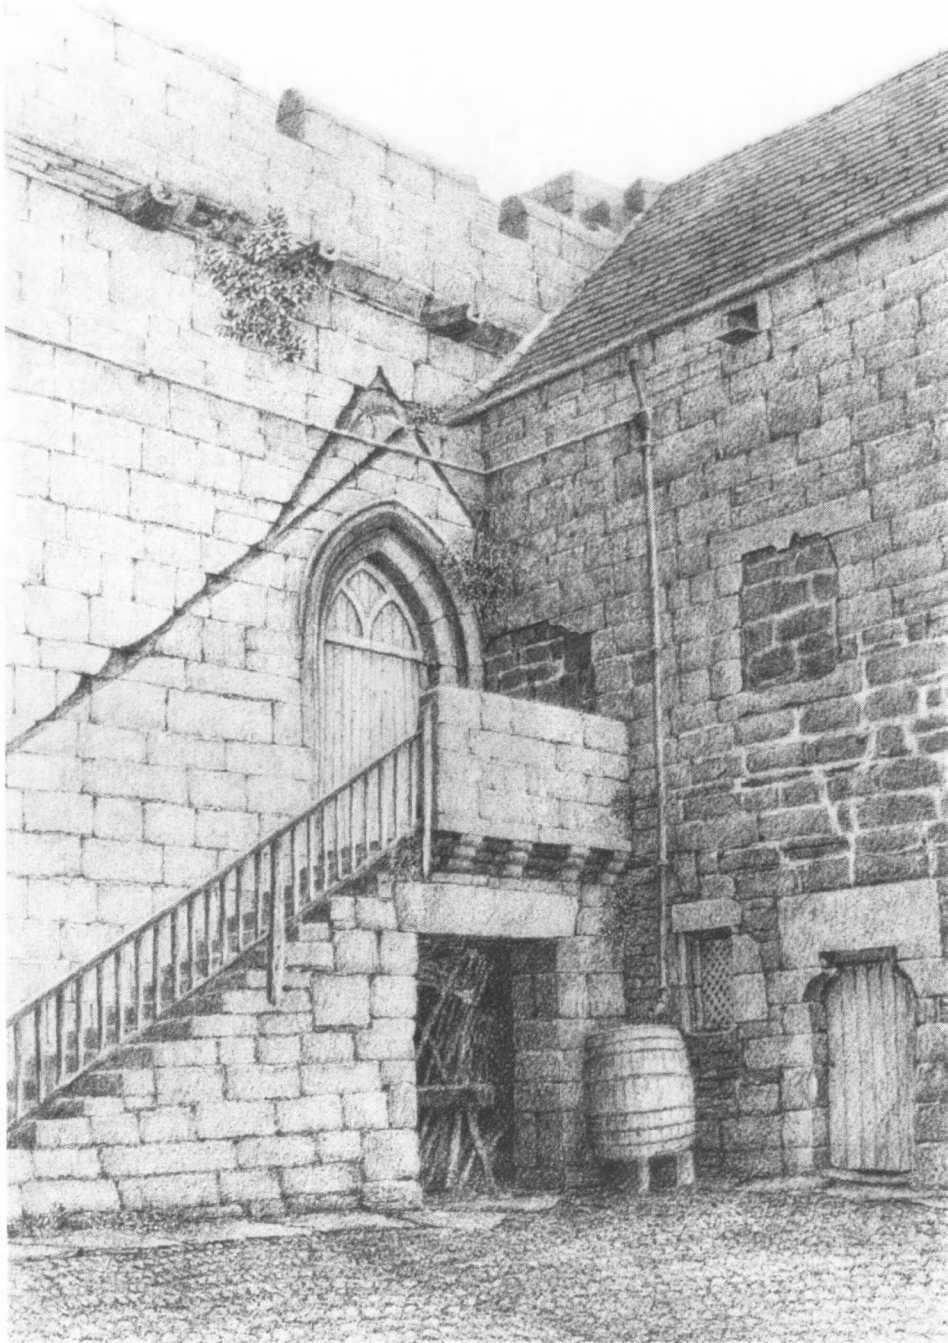
Fig. 3 South-west corner of inner courtyard at junction of kitchen and hall ranges, showing blocked first-floor door and window with pigeon landing stage above. About 1915. © Henry Oliver.

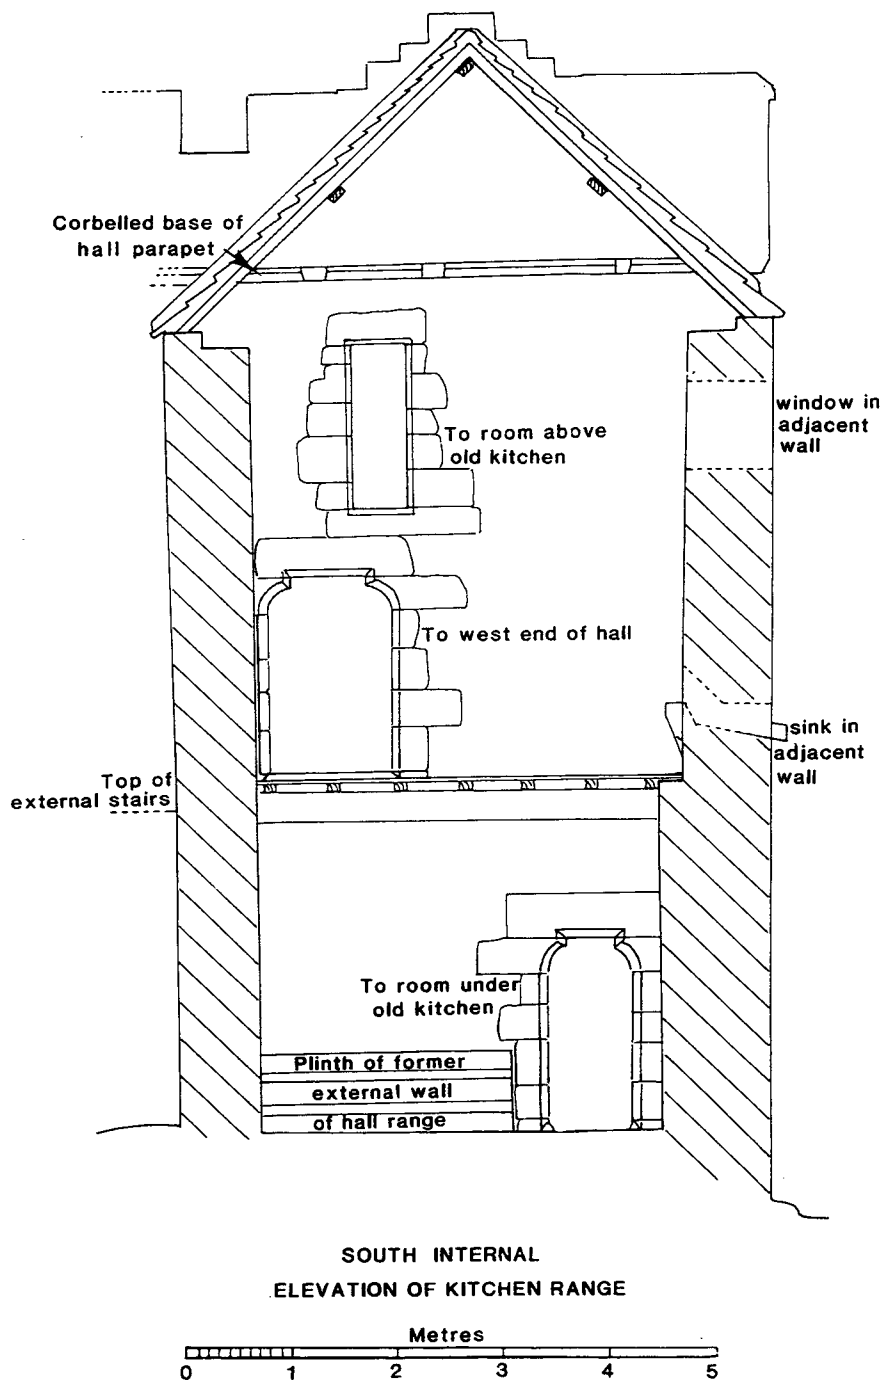
This kitchen range was added onto the service end of the hall range very soon after 1305. The chamfered plinth of the hall and the corbelled base of the hall parapet can be seen in the south internal elevation of the kitchen range (fig. 4). The new kitchen range was built

Fig. 4 Internal elevation of south end of kitchen range.

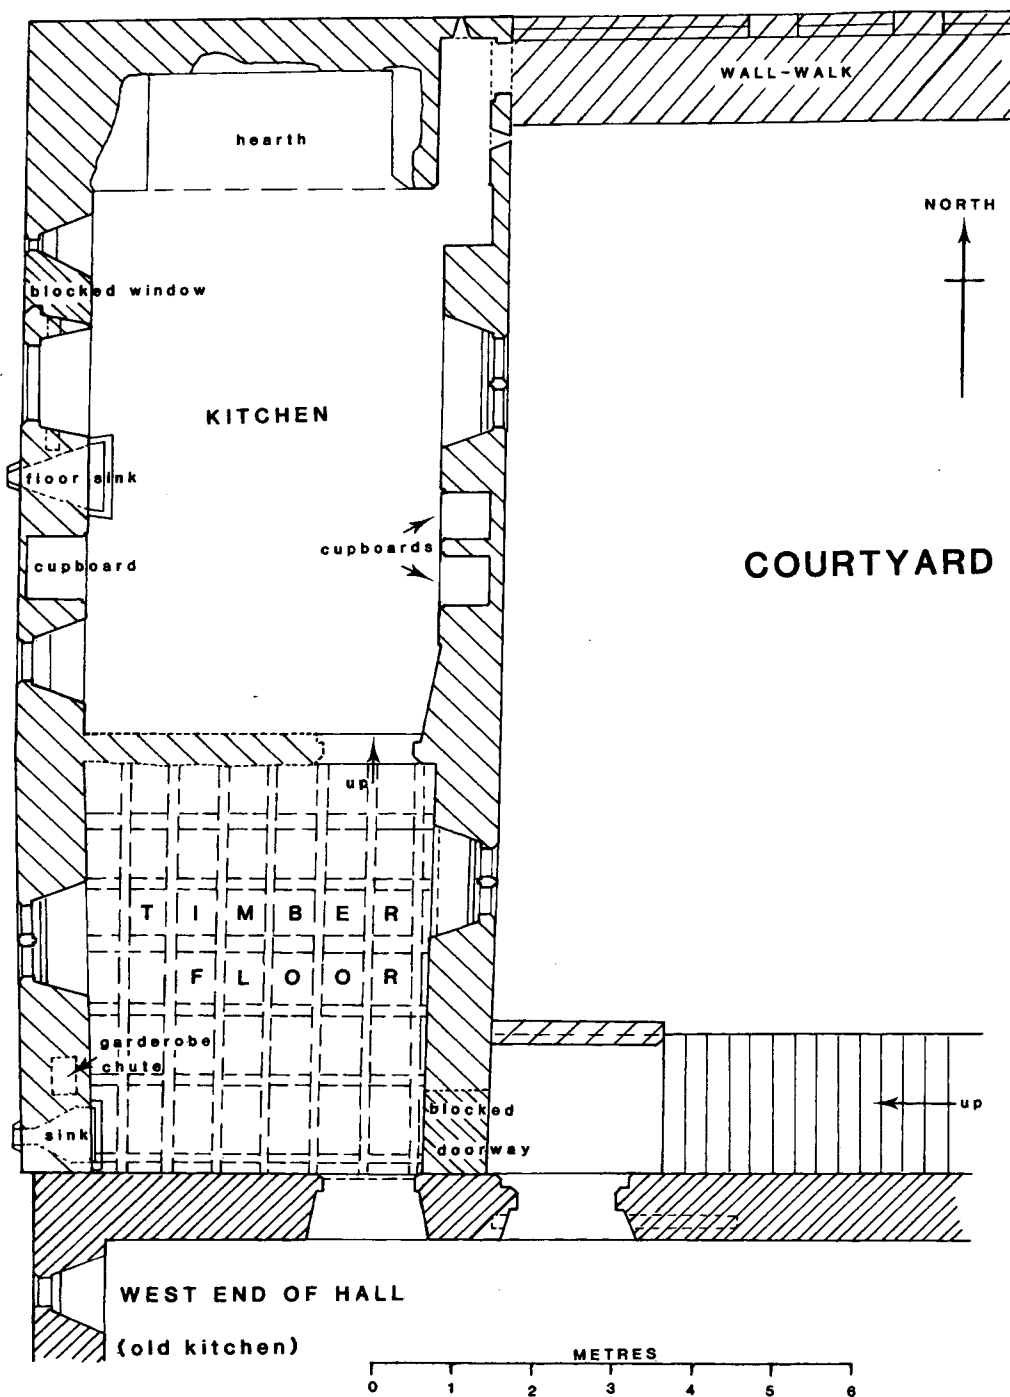
Fig. 5 Plan of first-floor of kitchen range.

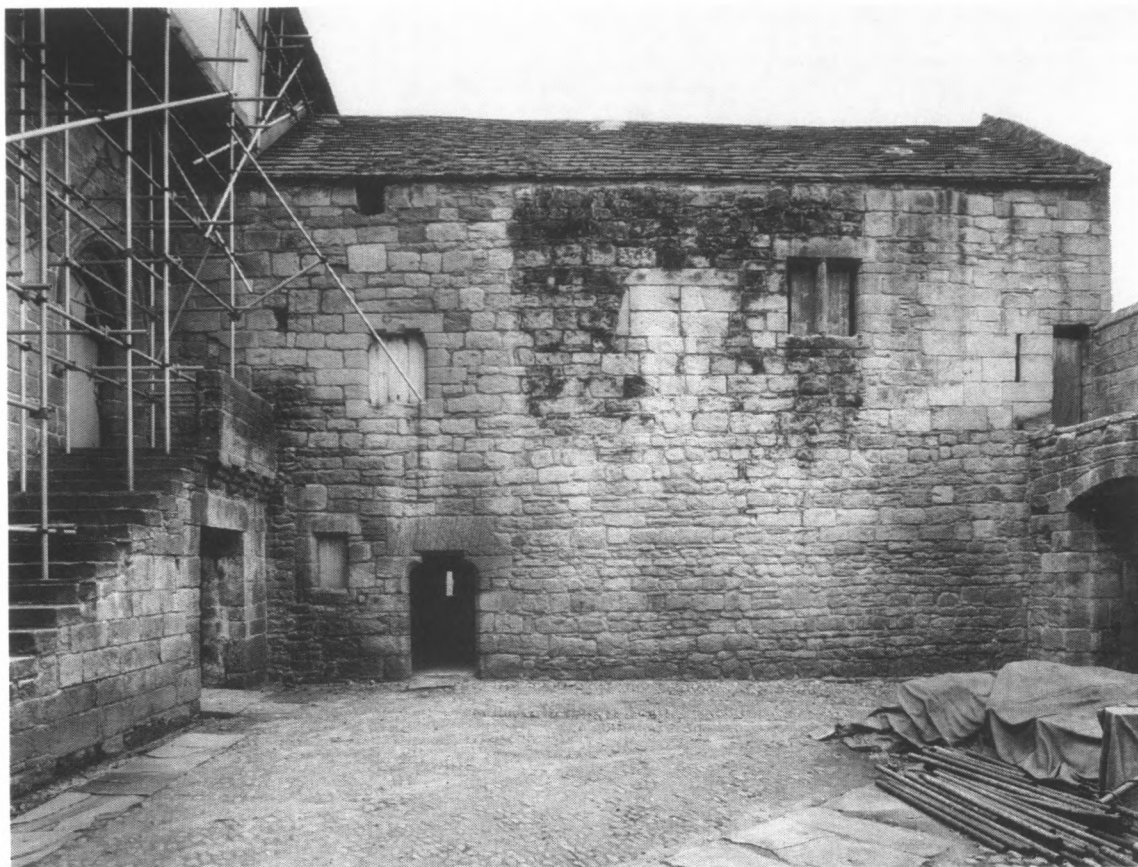
Fig. 8 East elevation of kitchen range during conservation work in 1967.

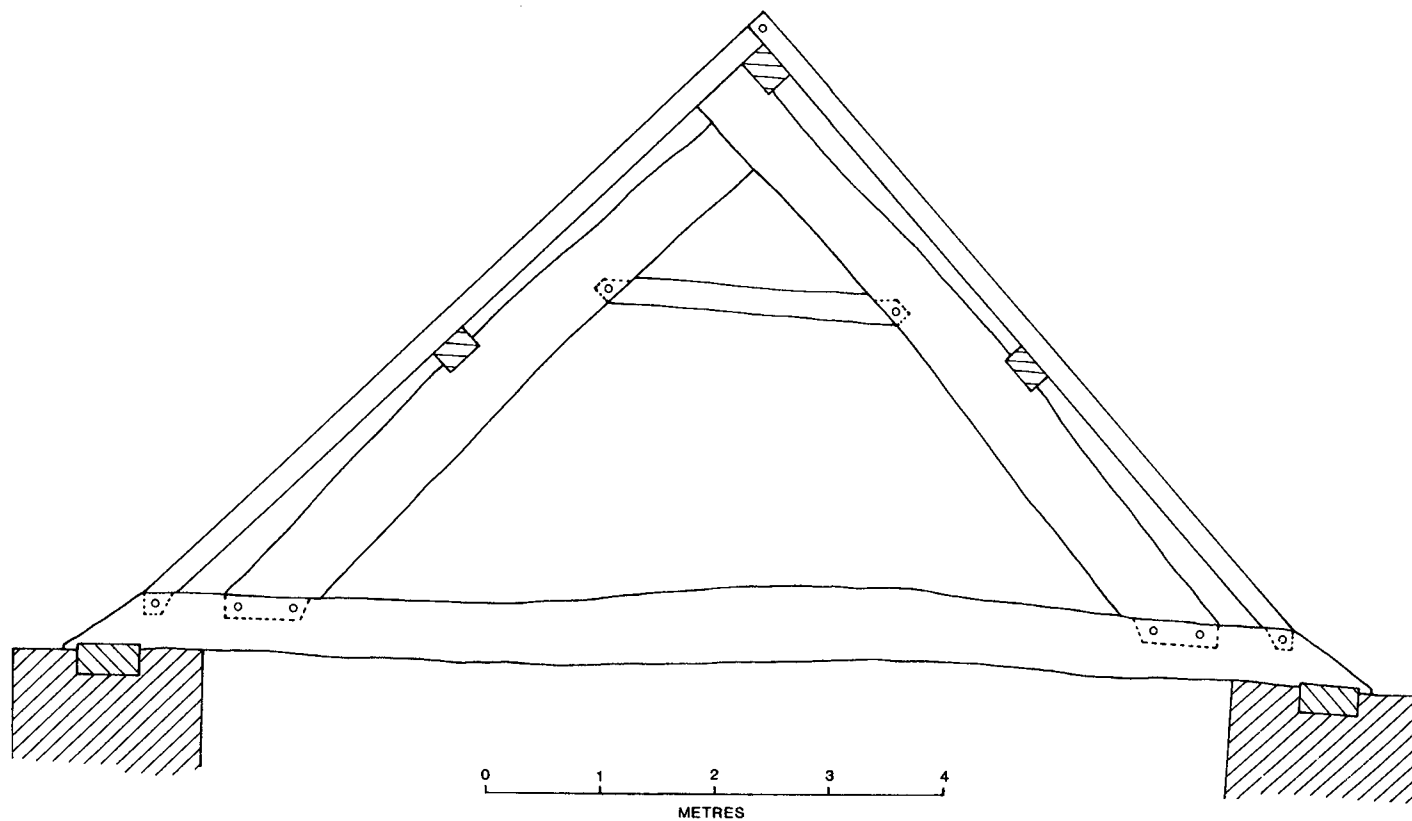
Fig. 11 Roof truss C as originally built. Truss B is similar, but trusses A, D and E have no collar.

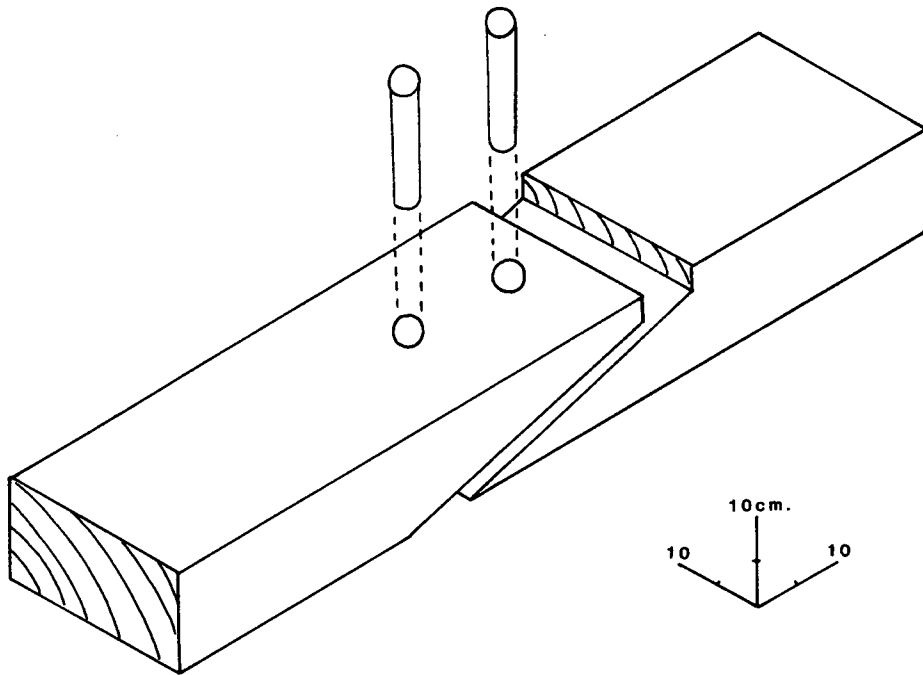
The plates along each wall were in two sections with scarfs as indicated on the drawings (figs 6 and 7). The detail of the scarfs could not be examined because the wall plates are bedded in masonry flush with the top of the plates and they were not lifted; but they were held with two pegs and are assumed to have been similar to the design of the scarf in the purlins as shown in Fig. 12. The ridge piece has one scarf but as this timber is of deal not oak it is

Fig. 12 Scarf joint in roof purlin.

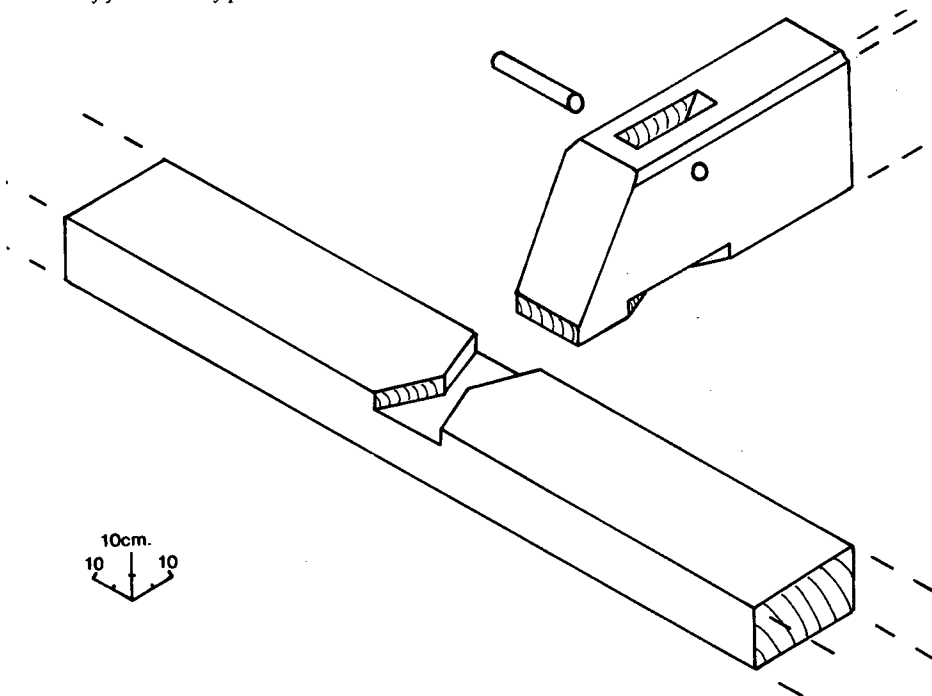
slightly curved and have been made by sawing or splitting large timbers longitudinally, while the end grains of the beams show that some timbers were of sufficient girth to make more than one. Tie beams A and B certainly came from one trunk. The angle of the apex of the trusses is approximately 85–90 degrees. There are pairs of carpenter's marks in the form of roughly incised crosses near the joints in the trusses, with the exception of the north face of the western truss where two pairs of inch-long I's have been chiselled. Between the tie beams and the wall plate a dovetail joint (figs 13 and 14) prevented the former from sliding out-

Fig. 13 Dovetail joint between roof tie beam and wall plate.
