# The Black Barn at Tow House, Bardon Mill, Northumberland: a heather-thatched barn and its context

*Robin Dower and Peter Ryder*

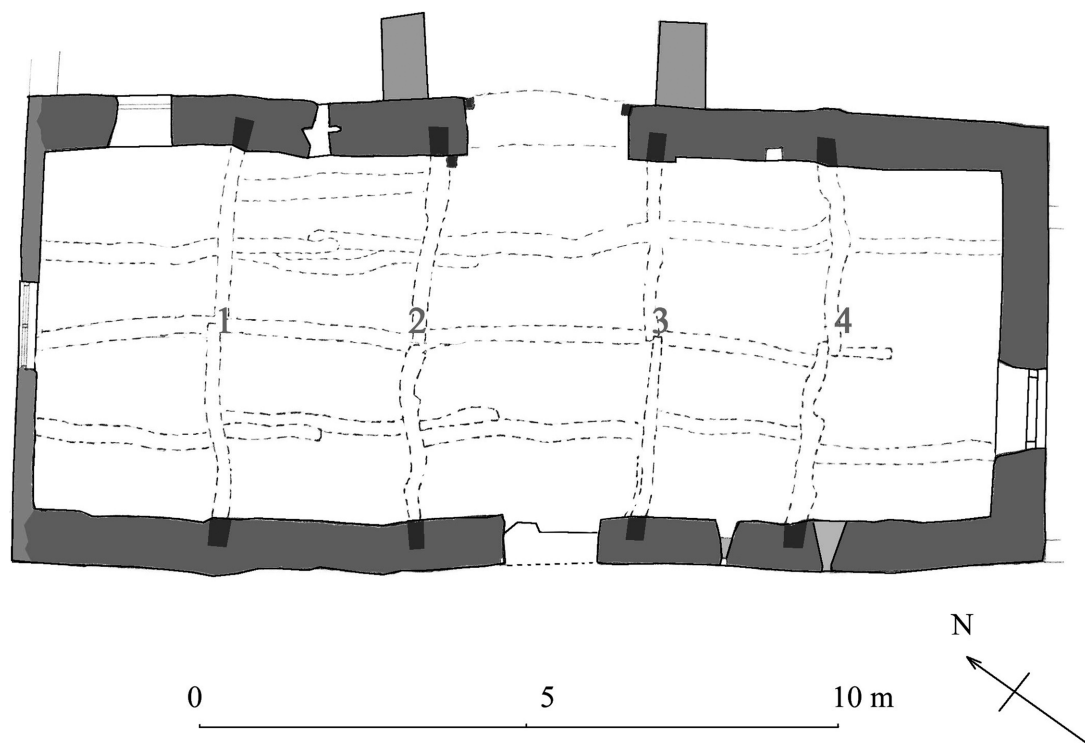
Fig. 2 Plan of Black Barn based on survey by Greenhatch Group 2011.

The Black Barn is a rectangular structure *c.* 12.0 by 5.4 m externally, with walls of roughly-coursed and roughly-shaped sandstone rubble 0.5–0.6 m thick, except for the north-west end which is of brick, and much thinner (fig. 2). The north-east elevation (towards the road) has a central pair of boarded doors (renewed) flanked by short wing walls only *c.* 1.0 m high; to the right of this opening is an area of irregular rubble, with a slit vent that has a projecting block as its sill, and then, close to the end of the wall, a square window with a timber lintel. The south-east gable end has a rough boulder plinth and a single window, with a timber lintel, set left-of-centre. The steep gable (typical of a heather-thatched building) has a number of projecting through stones, but lacks any real coping, although the outer face is carried up above the inner face of the wall to form a stepped profile. The north-west gable is all of brick, in English Garden Wall Bond; the orange brick is of earlier 20th-century character, and may have come from one of the local small brickworks. There is a window set centrally, under a timber lintel; the ends of the purlins and ridge are exposed in the wall; above this, the apex of the gable was missing. The south-west (rear) elevation has a central single-leaf door with a timber lintel, and to the right a pair of slit vents and evidence of another, now blocked, to the left (fig. 3).

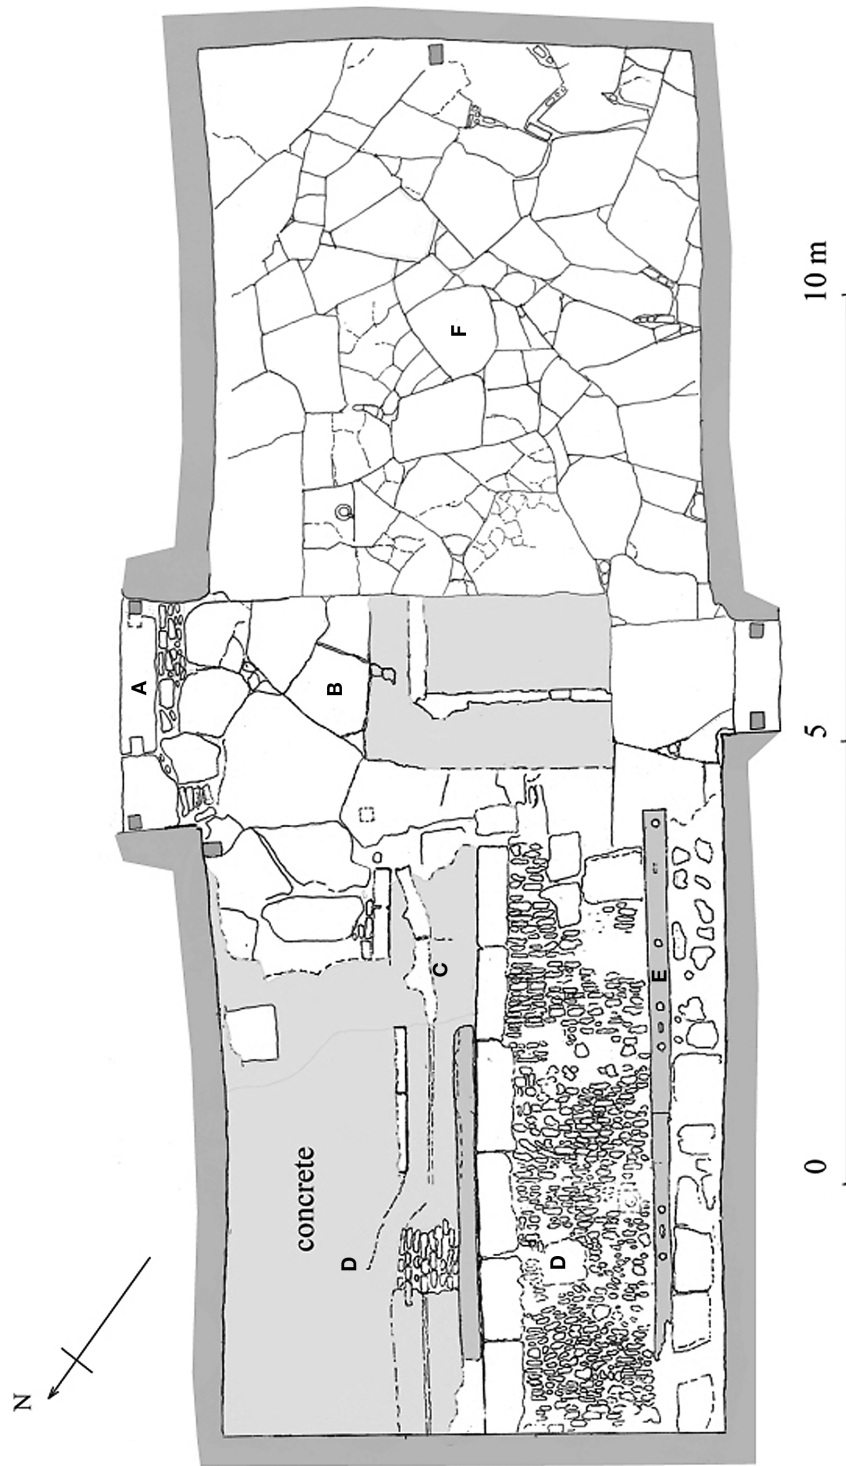
Fig. 4 Plan of floor, surveyed by Peter Ryder December 2013.

The barn floor is in three parts; the central threshing bay, the byre floor to the north-west and a paved area to the south-east. Before the 2012/13 works it was partly covered by stored materials; after the works it was cleared and recorded but no work was carried out (fig. 4).

The threshold stone of the main entrance to the barn contains sockets for timber jambs, defining what was originally a smaller opening around 1.0m wide (similar to that in the south-west wall); at some later date the opening has been almost doubled in width to the north-west. The threshing bay is 1.8m wide and defined by virtually continuous straight joints in the flooring slabs. Inside the main threshold is an area of pavement made up of large irregular flagstones carefully fitted together, with small gaps between them infilled with either cobbles or small stones. Adjacent is a concreted area 2.0m by 1.4m, its long side on the line of the south-eastern edge of the bay, with two lines of cut stones *c.* 120mm wide showing through the concrete forming the north and east sides of a rectangle 1.5 by 0.75m internally, the south-eastern and south-western sides being contiguous with those of the concreted area. South-west again is another area of large slabs within the threshold of the smaller door.

Close to the north-west edge of the threshing bay and 1.28m inside the north-west jamb of the main entrance is a shallow socket *c.* 0.1m square cut into a flagstone, roughly aligned with the south-east side of a central drain 0.45m wide that runs down the byre floor. The drain is lined in concrete with a central groove that ends in a short length of ceramic pipe; it seems to be laid on top of earlier cobbling and *c.* 1.2m from the north-west end its concrete floor has broken away to expose a patch of cobbles, *c.* 0.50m square. On either side of the drain is a line of elongated blocks raised *c.* 50mm above its floor, running parallel with the structure. Inside and set against the blocks to the south-west side is a timber, decayed for 0.60m at its

north-western end but then extending for 2.70 m. Behind the blocks and at the same level as their tops is an area of cobbles, and then another timber 130 mm across, decayed at its north-west end for 0.90 m but then intact for 4.0 m. This timber contains a series of circular holes for staves with small rectangular sockets between, and presumably formed the base of a feeding rack. Between it and the south-west wall is a passage/gap only c. 0.35 m wide, roughly paved with small slabs. At its south-west end the cobbled strip is bordered by a series of slabs c. 100 mm thick, which appear to rest on top of the flagstones of the threshing bay.

To the north-east of the drain is an area that has been concreted over, with occasional large slabs showing through. To the south-east of the threshing bay the floor is quite different, a level pavement made up of large (up to c. 1.0 m across) polygonal flagstones (a number now cracked into smaller pieces), which have been fitted together in a very careful and painstaking manner, leaving only very occasional small spaces infilled with smaller stones.

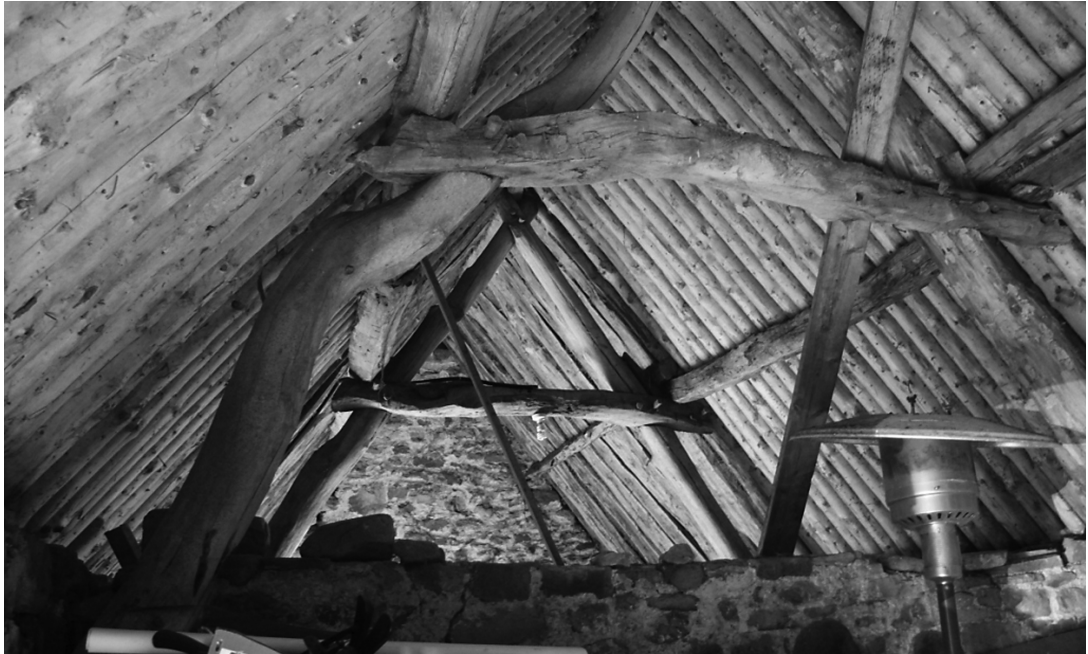
Fig. 15 High Meadow Barn — interior. The rafters renewed in round-pole in the 1990s and re-thatched.

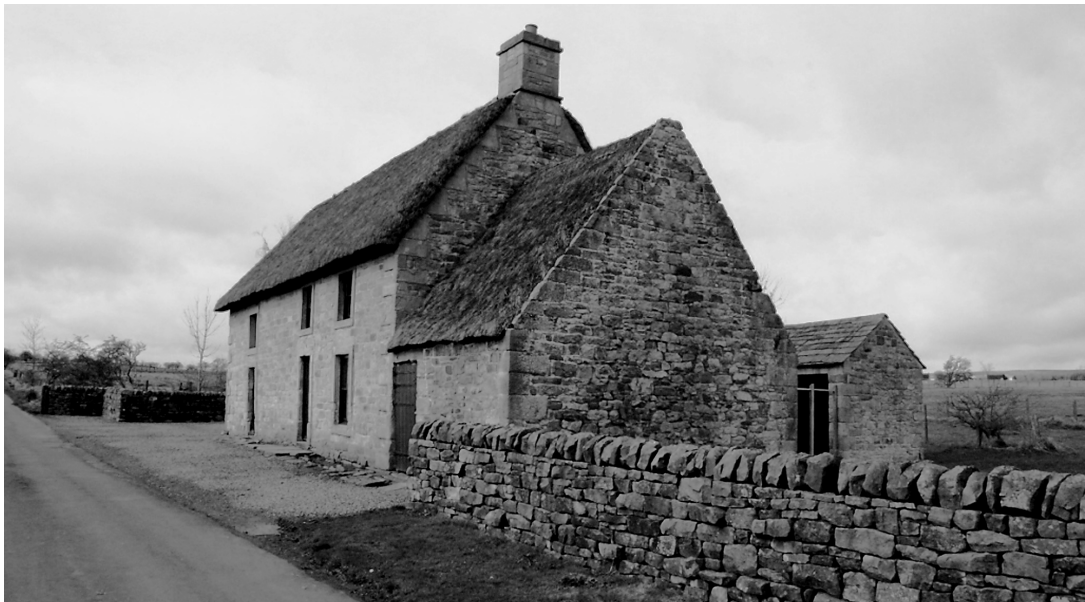
Fig. 16 Causeway House, Vindolanda — re-thatched 1989.

It is worth going back to the repairs carried out in 1990. The then owners, Mr and Mrs Hayward, had contacted John Warner, a Master Thatcher from Brandon near Coventry, who was working on the heather thatch at Causeway House near Vindolanda a few miles north of

A. If the existing coat of heather is in good enough condition, patch where necessary with new heather and fix new eaves. Thatch a new ridge using heather and turf fixed with hazel spars and liggers. Cover entire roof with  $\frac{3}{4}$ " square mesh UV protected plastic netting.

B. If the condition is so bad: strip off all existing heather and to a sound timber roof and stone gables/eaves thatch a new coat of heather fixed with hand-forged iron hooks and iron sways. Thatch a new heather and turf ridge fixed with hazel spars and liggers. Cover the entire roof with UV protected netting as A.

Once the sheeting was removed Warner realised that the existing thatch was in good enough condition to repair (Option A). This was an important decision, for while the work done in 1990 came to a lamentable state of decay in too short a time, through weathering and lack of maintenance, the significance of this rare surviving and sufficiently intact example of historic heather thatch pre-dating the repairs of 1990 has grown.
