**HISTORIC BUILDING RECORDING:
THE OLD MALTINGS
BEDFORD ROAD
MILTON ERNEST
BEDFORDSHIRE MK44 1RJ**

NGR: TL 01959 55942

on behalf of Reach Living

Ref: BHS/0092/MEM/2

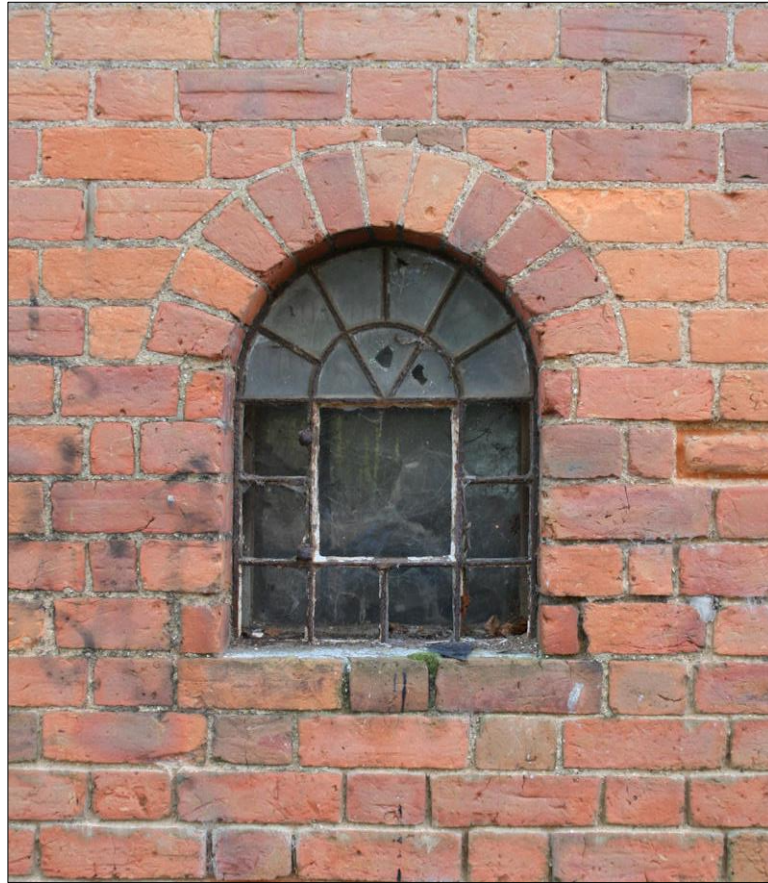
Plate 4: Building 2, close-up of small arched window in north elevation

flat brick-arched lintel, with a similar door directly above. To the east of the smaller ground-floor doorway, a small window with a delicate 18-pane cast-iron frame is set in an opening with a semi-circular arched lintel and a brick sill (Plate 4). To the east of this, the apparently rebuilt section of the elevation contains a second similar window, then a doorway beneath an inserted modern concrete lintel with a second doorway beneath a flat brick-arched lintel directly above.

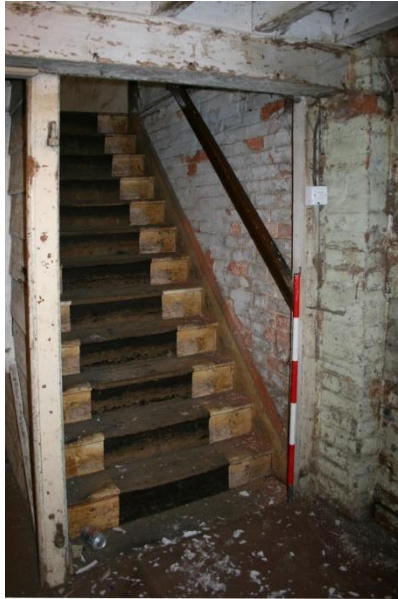
Plate 31: F1 landing, stairs to second floor

From the first-floor landing in Building 1, stairs lead to the second floor (Plate 31). This floor comprises a single space running the full length of Building 1, interrupted only by the rails surrounding the stairwell and a modern storage 'cage' inserted at the east end. Construction of the upper floor is as described for the first floor.

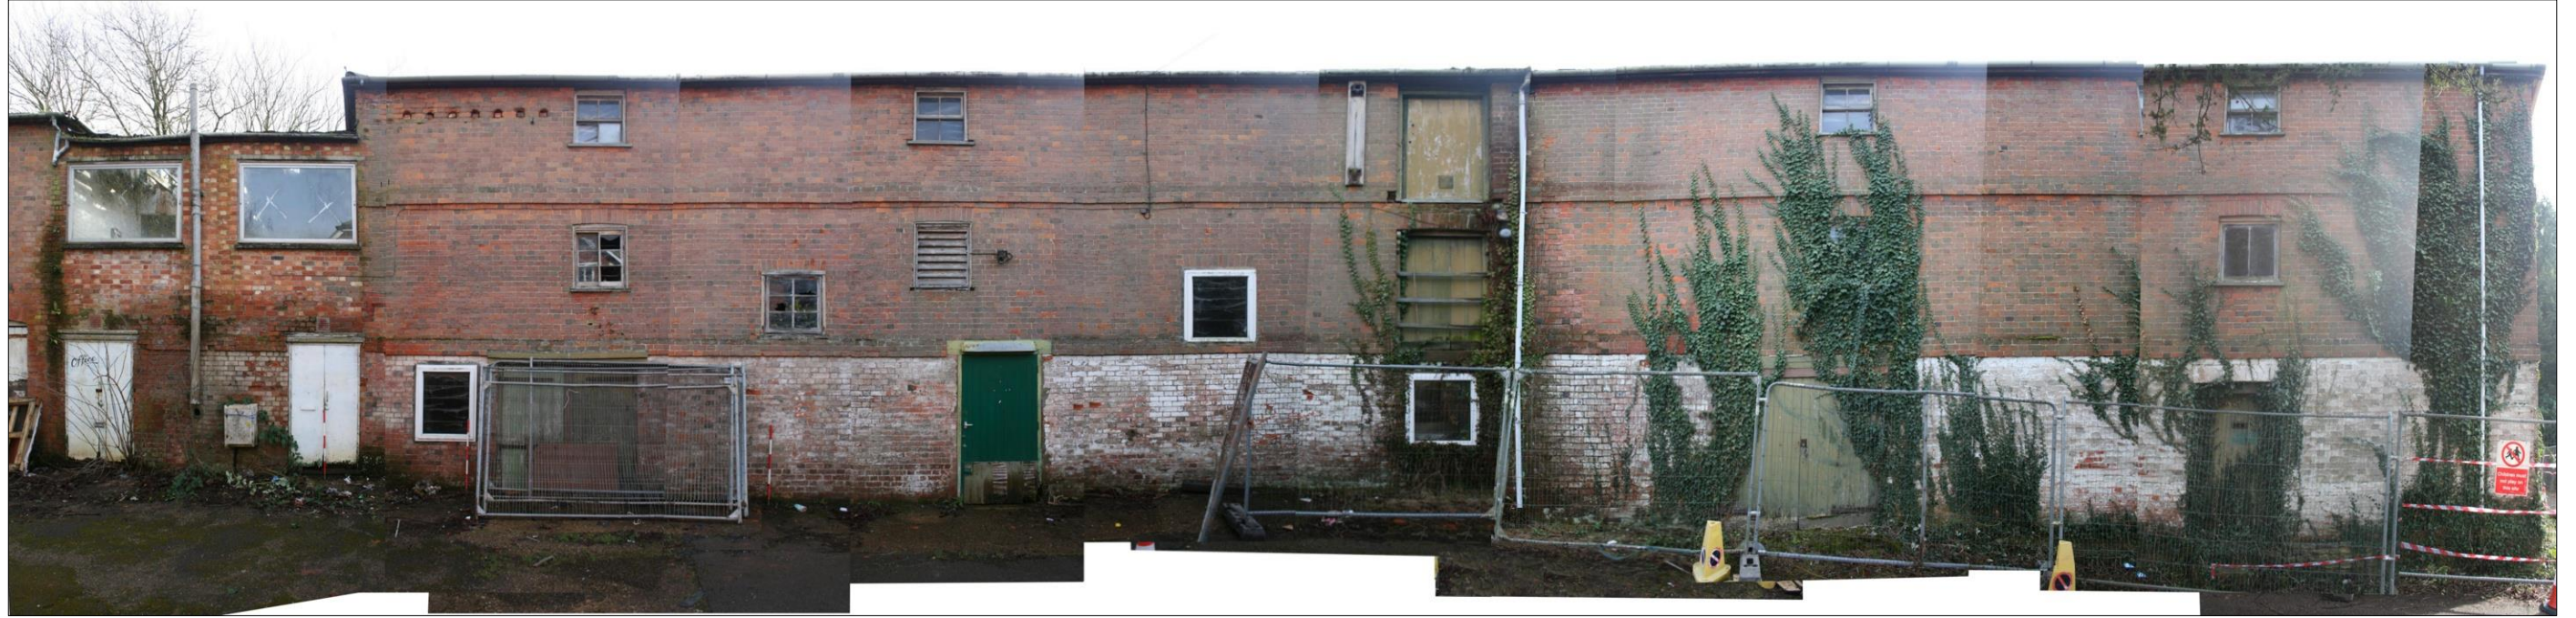
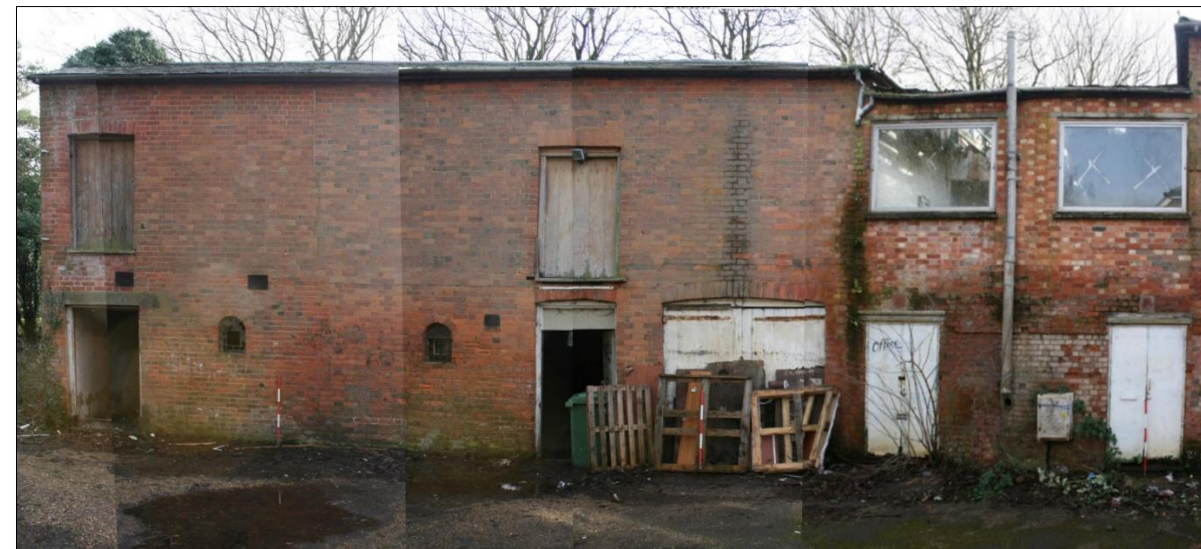
Figure 9: Composite views of the north elevation of Buildings 1 & 2 and the infill structure

Building 2: In contrast to Bldg 1, the north elevation of Bldg 2 has no string courses or other embellishments. Its most noticeable feature is a distinct change in the character of the brickwork, marked by a staggered but near-vertical line up the face of the building (Figs 9 & 13), suggesting a major rebuilding episode. To the west of this, openings comprise a wide double 'cart' door beneath a flat brick-arched lintel, adjacent to a single door set beneath a

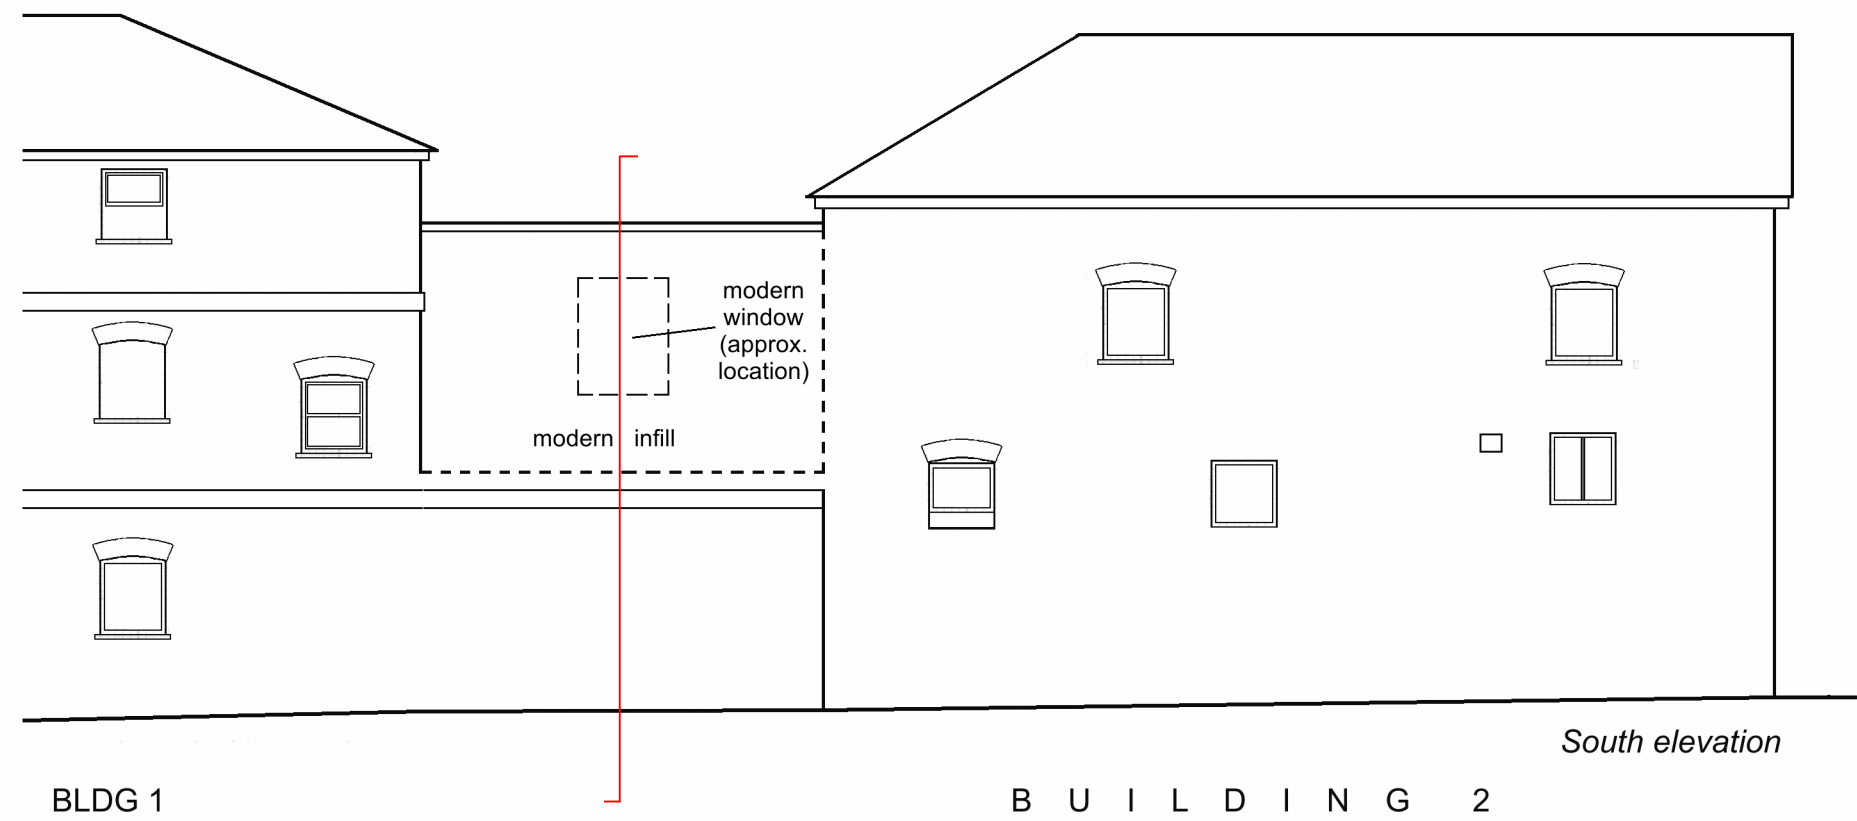
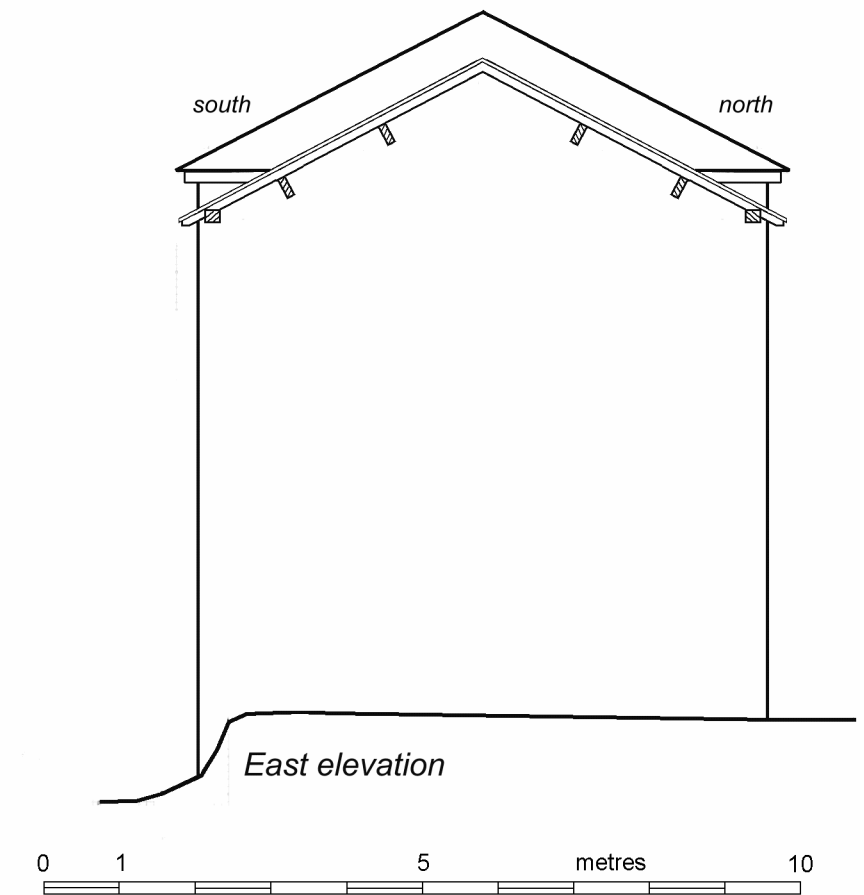
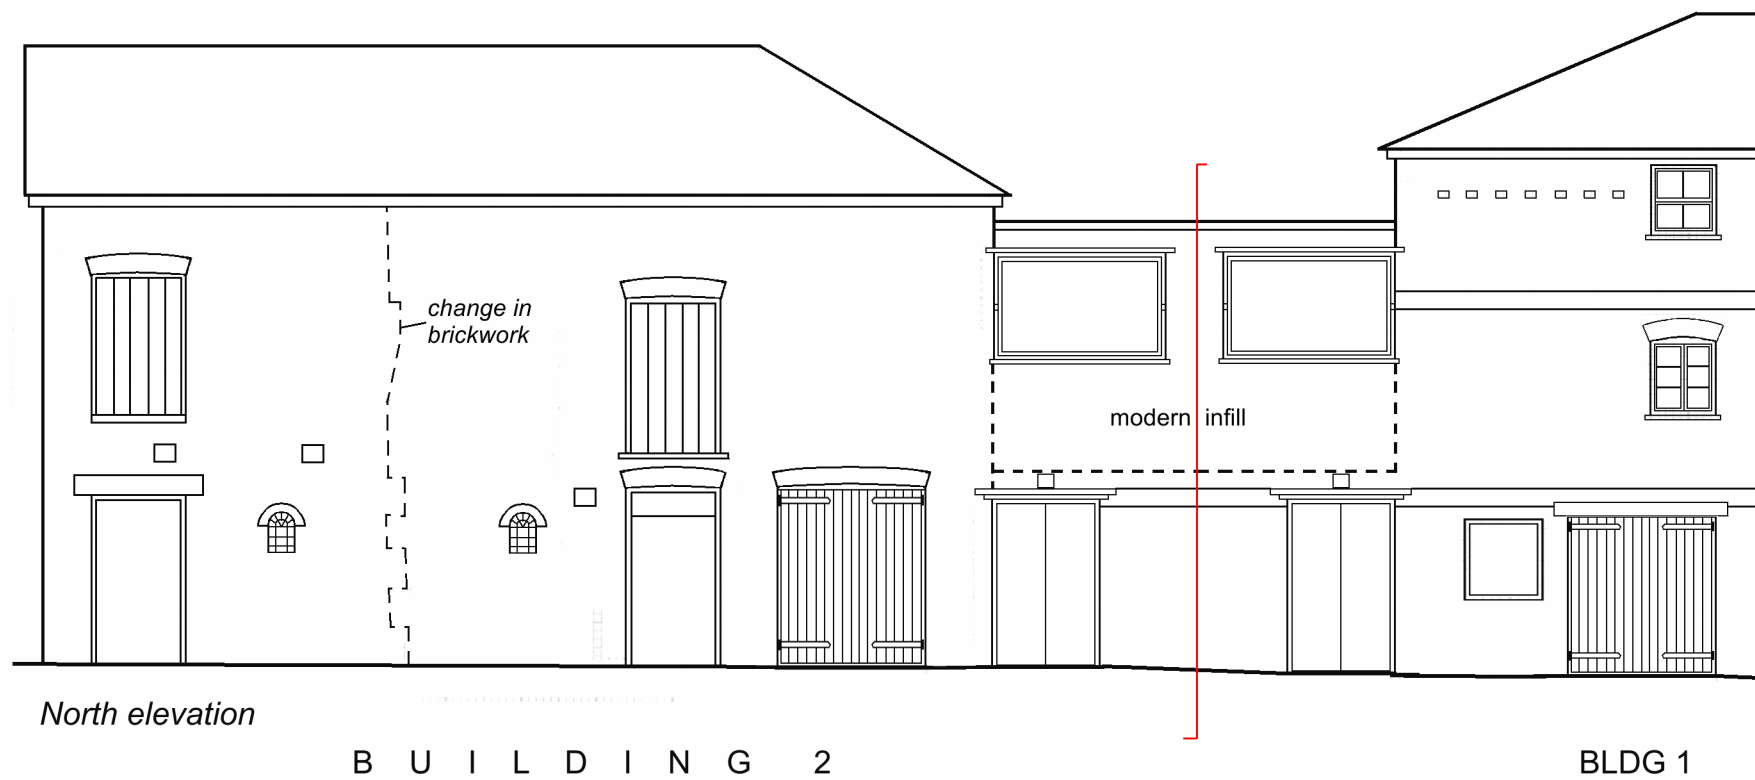
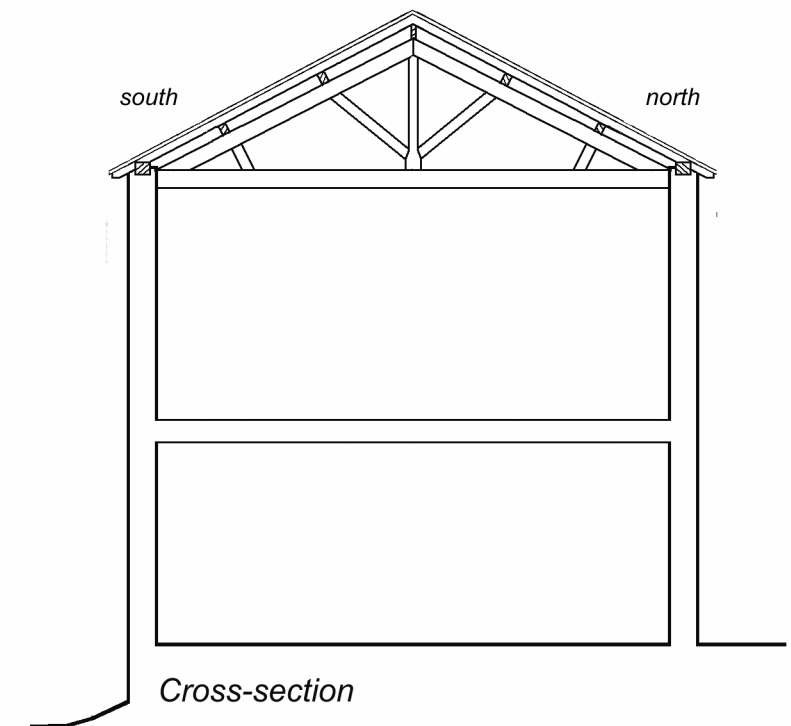
Figure 13: Building 2, elevations and cross-section (scale 1:100)

Building 2: Partly covered with ivy, this elevation was featureless, apart from exposed purlin ends. A horizontal timber, fastened to the wall c.2m above ground level, may be the surviving roof support for a possible lean-to structure at this end of the range, shown on the 1979 Ordnance Survey sheet (Fig. 7).
