# **Crake Trees**

Crosby Ravensworth, District of Eden, Cumbria

## **THE EARTHWORKS**

June 2012

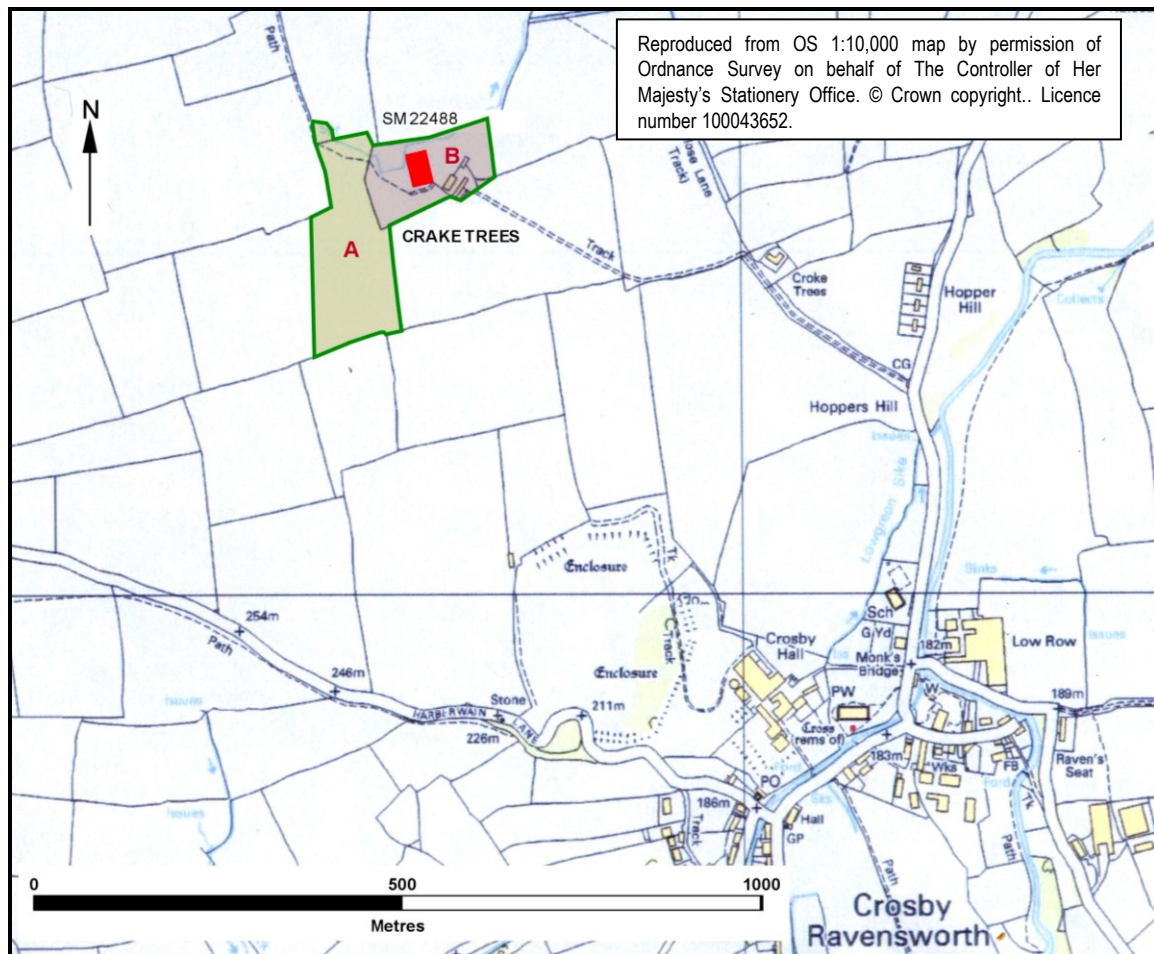
**Figure 2:** Crake Trees to the north-west of the village of Crosby Ravensworth. The extent of surviving earthworks is outlined in green and identified as A and B as per section 2.1 in this report. The red rectangle indicates the extent of the scheduled monument

- No evidence was noted during the site walkover in March 2012 for ongoing erosion or damage to earthworks in Area B which includes the scheduled area and the field beyond (see figure 2). At a number of points there is limited tumble of dry-stone walls but this is considered beyond the scope of the current survey.
- In Area A, upslope from B, there is some evidence for minor rutting by farm vehicles (none occurring across earthwork boundaries) and limited poaching by livestock. This is in the context of a working agricultural landscape and has not had a major impact on the earthworks. Catalogue photographs 20 and 21 and 25 show limited rutting along parts of T1 and T5; Photographs 28, 32 and 35 show vehicle disturbance at the gateway along south side of wall B15; 36 shows some animal poaching or tracking adjacent to the south corner of B1.

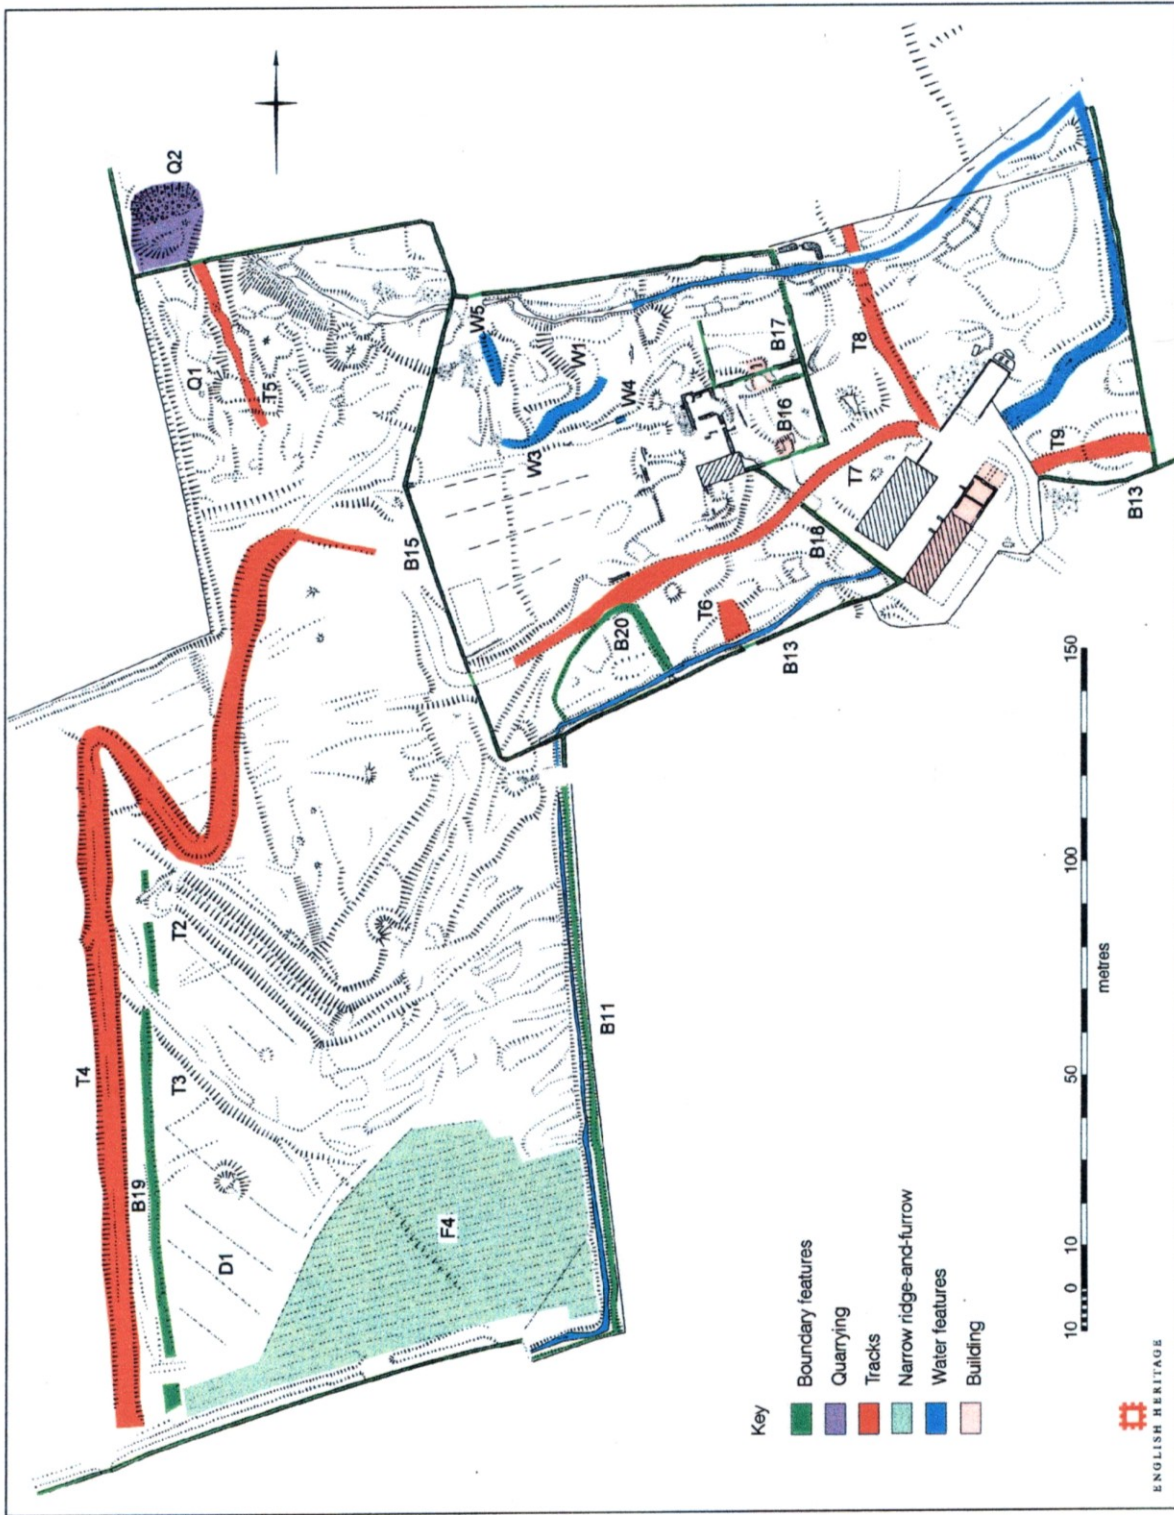
Figure 5

Figure 23. Phase diagram of late 18th and early 19th-century features

Any plant used on the site should be equipped with appropriate tyres to prevent rutting and damage to surfaces. Movement of plant (if required) and materials from the compound to the tower house should be along the track identified during the 2000 EH survey (T7, figure 23). No movement of plant should be carried out across earthworks. If any movement of plant beyond route ways is deemed necessary, a suitable strategy in consultation with the managing architect and English Heritage should be implemented to protect these areas. Movement of materials over the remains of the former yard wall B16 up to the tower house should ideally be manual only, or if not possible, carried out with appropriate protection over the exposed feature.

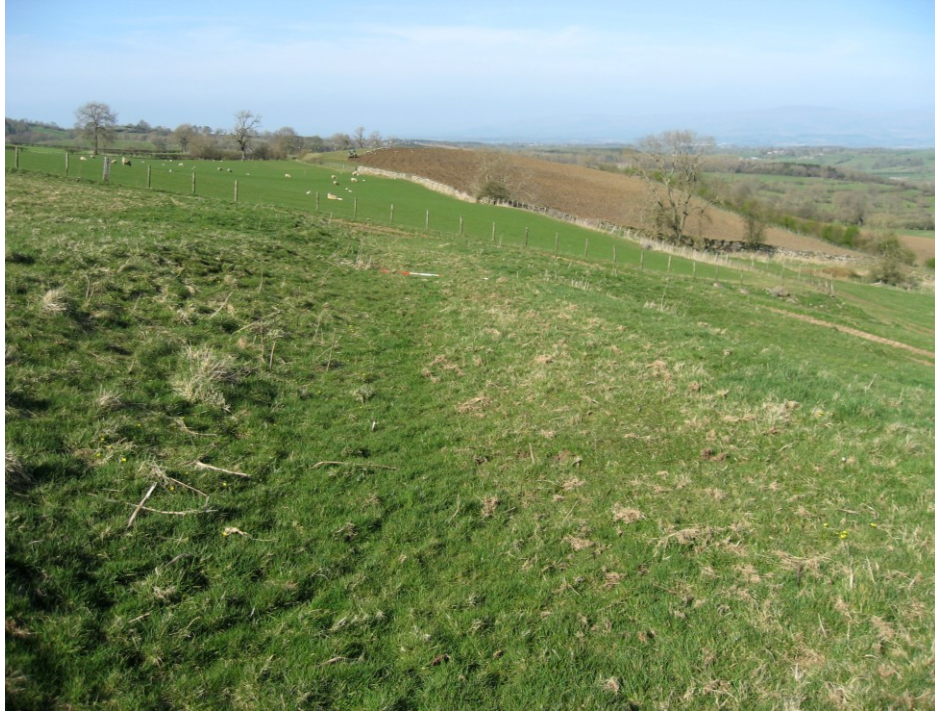
**Plate 8:** Looking north along line of trackway T4 (CT 22).
