THE VAULTED BUILDING AT CASTLE HEATON

CORNHILL-ON-TWEED, NORTHUMBERLAND

ARCHAEOLOGICAL MONITORING
DURING GROUNDWORK FOR
INSTALLATION OF BUTTRESSES

July 2015

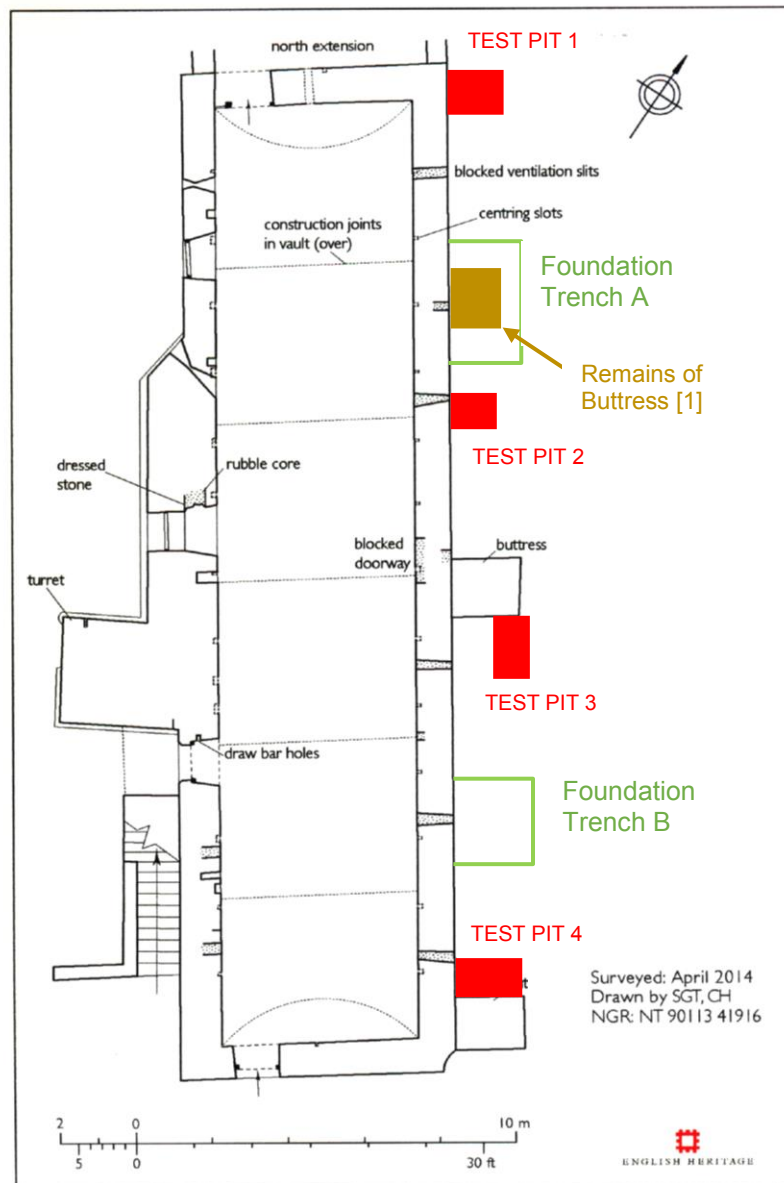
Figure 2: Location of Foundation Trenches A and B (outlined in green) for the installation of new buttresses against the unstable east wall of the building, and the remains of an earlier butress in Foundation Trench A. Previous Test Pits are in red. Plan with thanks to English Heritage (2014). Not to scale in this figure.

Excavation of the foundation by Heritage Consolidation Ltd (conservation builders for the project) revealed a stone structure immediately below the present ground surface. In order to establish the nature of this structure, the trench was extended by c0.8m to north and south. Investigation by the retained archaeologist, Alan Williams Archaeology (AWA) showed that the remains formed the first and (partial) second foundation-courses of a butress in just about the same location chosen for the new structure.
