CRAKE TREES TOWER HOUSE

CROSBY RAVENSWORTH, CUMBRIA

BUILDING RECORDING AND MONITORING

DURING CONSERVATION WORKS

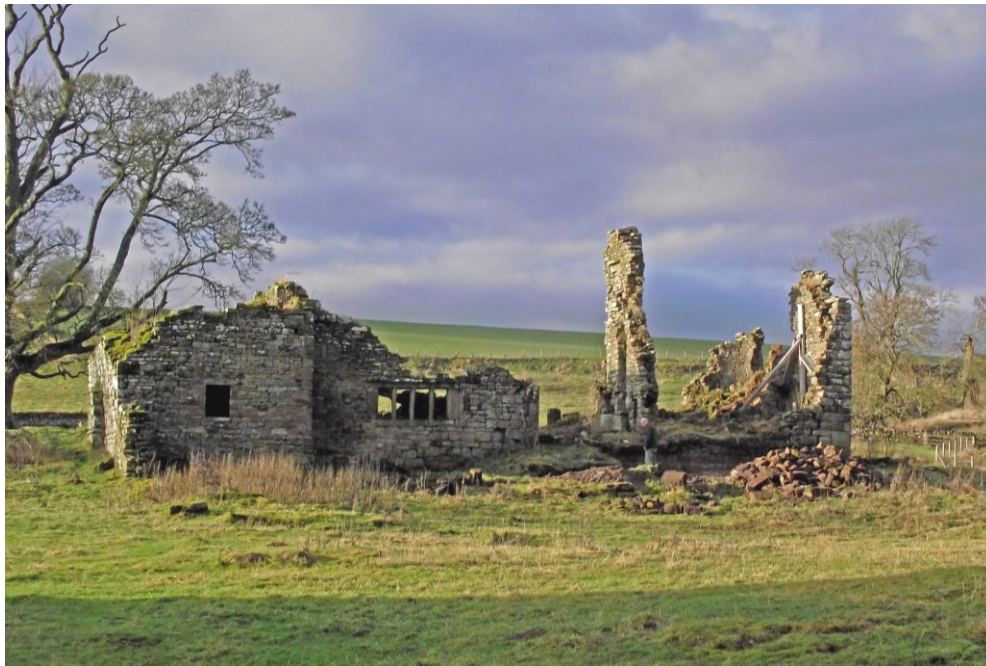
Plate 1: *Crake Trees from the east in 2013.*

The appearance of Crake Trees in 2012 prior to conservation can be seen on plate 1. Much of the northern part of the east (front) wall had tumbled leaving considerable portions of the north gable wall (K) and the central cross wall (M) standing but unsupported and in imminent danger of collapse. Preservation of these walls involved the rebuilding of the reduced east wall sufficient to provide secure cross-bracing along with some rebuilding of the cross and gable walls themselves. The rebuild drew on areas of tumbled masonry, lying either within the northern part of the building or externally in a substantial mound against the east wall, all of which had fallen in recent times as shown by the relatively complete building shown in a photograph of 1935.

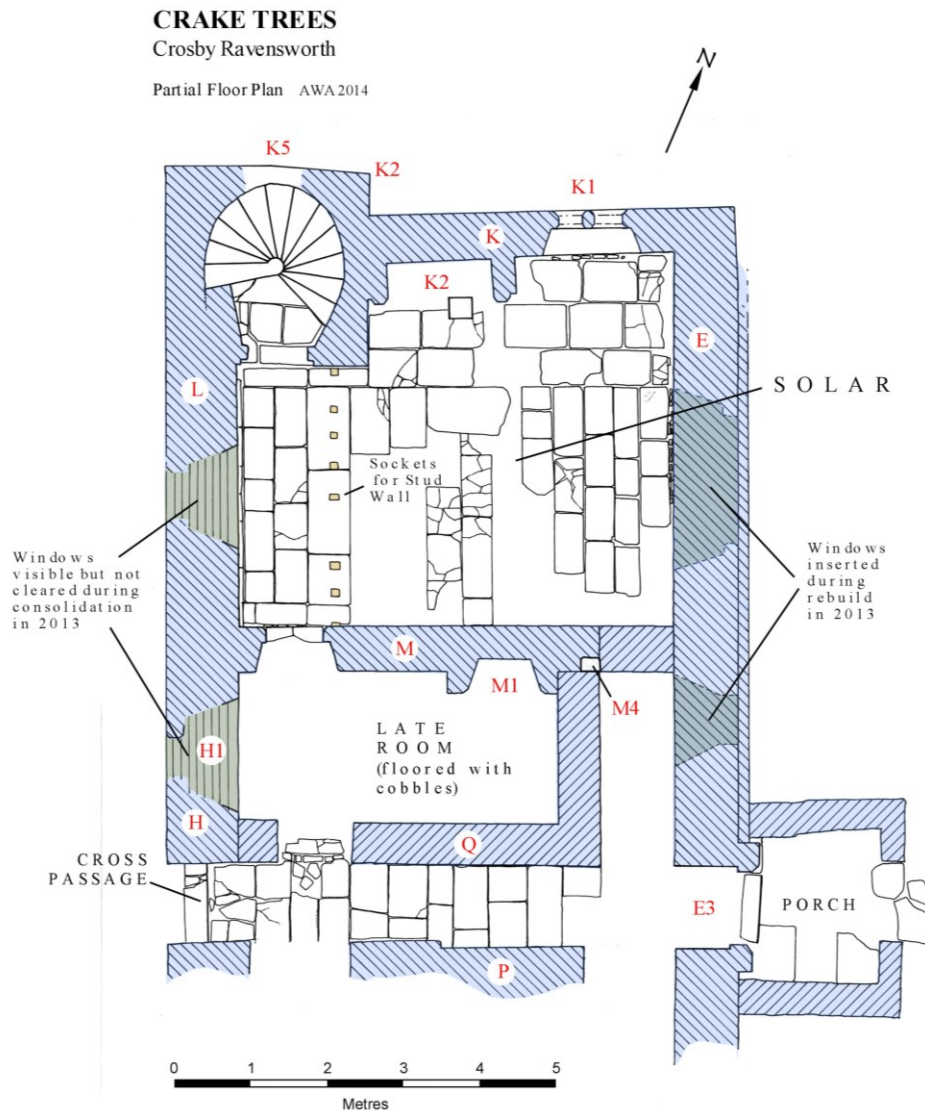
Figure 6: Ground plan of the northern part of Crake Trees (1:100 scale) showing floors revealed in 2013 and feature codes as per Ryder's structural inventory in this report. The level of horizontal section through the building varies to best represent specific features.

The floor surface exposed throughout the north room and turret is of pink sandstone slabs. These are almost all rectangular and set without mortar in a regular pattern parallel to the walls (figure 6). The largest slabs are around 1.10m long by 0.6m wide. A number of slabs had been removed prior to the clearance in 2013. The lack of any indication of new flooring material in the gaps suggests that they were removed when the building was abandoned. Given the irregular shape of the small turret, floor slabs here were irregular. A line of sockets had been cut into the slabs between the door into the central room and the door into the turret. These mark the line of a stud partition-wall forming a corridor along the west wall. A wider spacing of sockets 0.9m from the central cross-wall marks the position of a door through the stud wall which would have been about 0.8m wide. No earlier floor level was noted below the sandstone slabs, although inspection was limited.

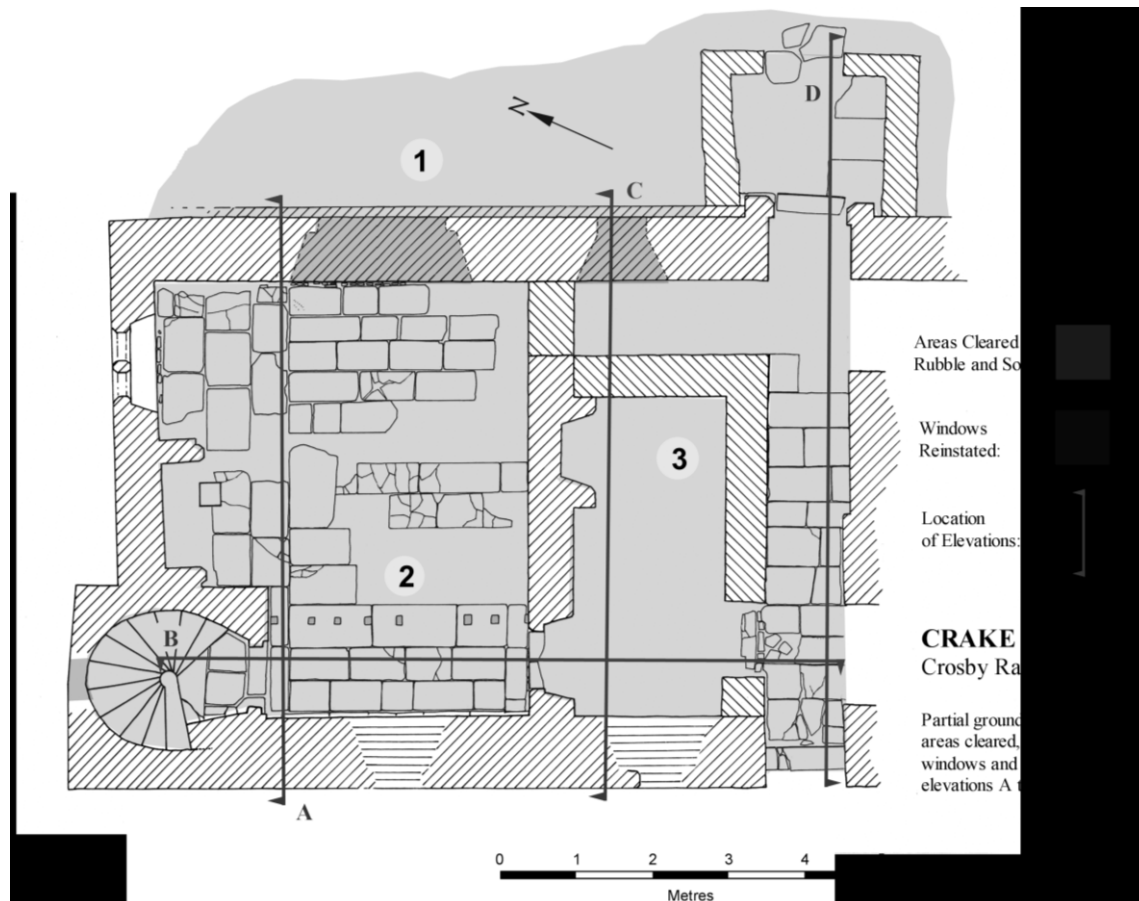
Figure 7: Ground plan of the northern part of Crake Trees showing areas cleared in 2012-3 (pale tone): east of east wall (1), within the north room (2) and in the central block and cross passage (3). Elevations (A, B, C, D) showing fabric revealed during the clearance works are marked by the lines (1:100 scale). Clearance was also carried out over the southern vaulted block.

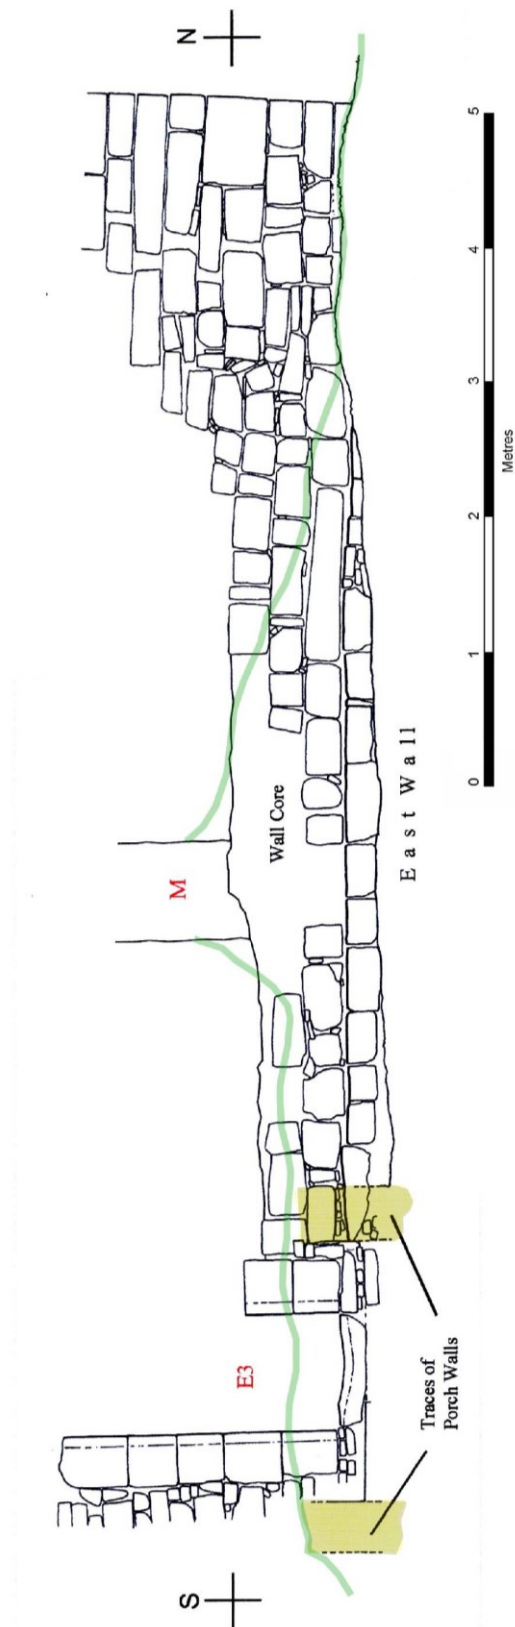
Clearance of rubble deposits along the external face of the east wall (E) by HPR began in winter 2012. This work extended along most of the northern part of the frontage including the footings of the demolished porch. Figure 12 shows the reduction in level, the green line marking the pre-2012 ground surface. As well as much rubble from the wall and core, considerable portions of the four-light window which can be seen in the 1935 photograph were recovered from the debris (plate 10). A square plinth was revealed in-situ along the wall. This will have extended along the full length of the wall but was only cleared to the level of the base of modern tumble. Rebuilding of the work carried on into spring 2012. A number

Figure 12: East facing elevation of the east wall of the manor house prior to conservation and rebuilding. The green line shows ground level prior to removal of rubble in 2012 (not to scale).

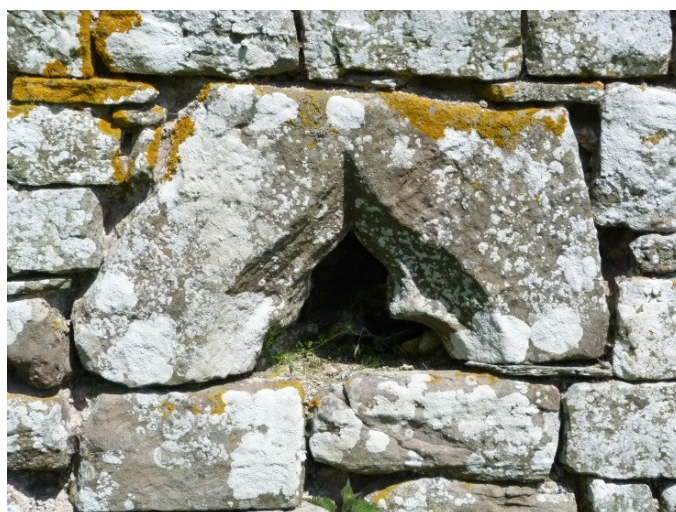
Plate 8: Trefoiled ogee arch in the south wall at Crake Trees (B3).

The shoulder-arched doorway on the north (D1) has a chamfer that runs the full length of its lintel, beyond the corbels which support it, so could be made up of re-used material. The small arched opening (B3), trefoiled and ogee-arched, in the exterior of the south wall, which the EH report confidently identifies as the piscina of a timber-framed chapel, seems far more likely to be a re-used window head, as it was previously interpreted.

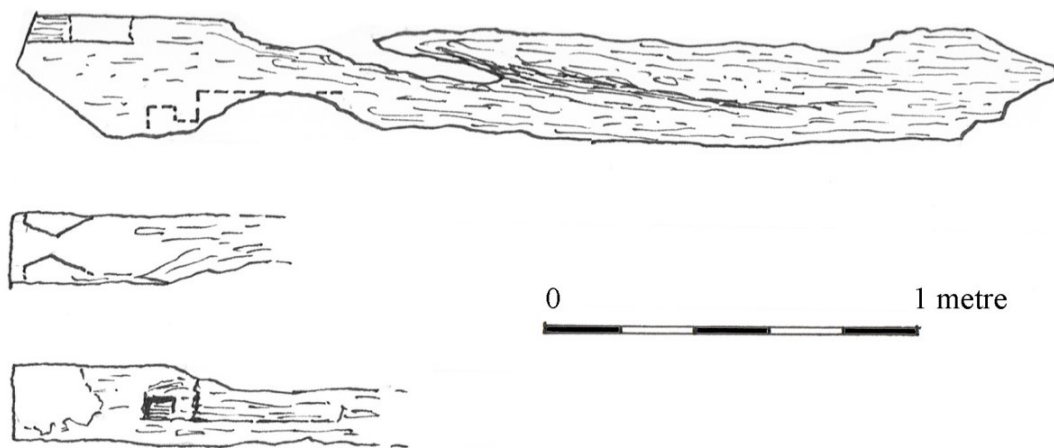
- E4 A four-light mullioned window to the south of the door, that has a hood with turned back ends (the southern terminal has gone), its lower face cut with a pair of hollow chamfers and its upper sloped. Internally the timber lintel, now dropped, has a dovetail housing at its south end and must be a re-used tie-beam.
- E5 Immediately to the north of E4 in the external face of the wall is an upright block in the wall with a vague chamfer on the north, perhaps part of an earlier window.

Figure 15: *Timber T1, re-used as the internal lintel of window E4.*

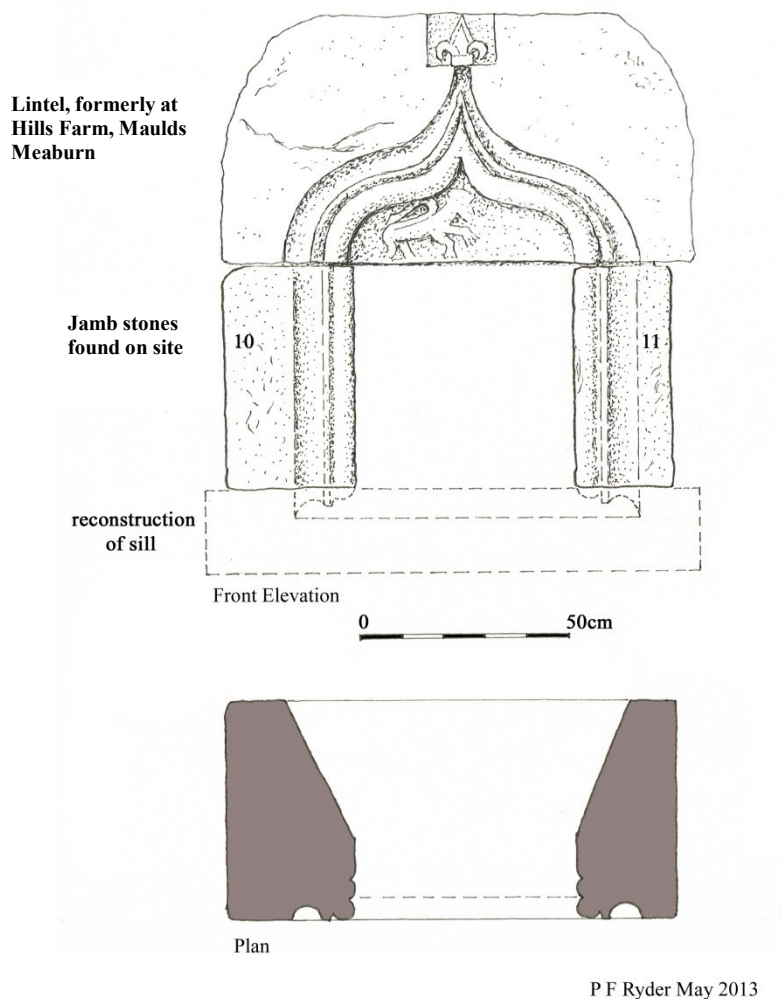
- E8 Set in the wall at ground floor level a metre or so to the north of doorway E3 is a small square-headed window with a moulded surround, carried up above the lintel as an ogee arch, framing a recessed panel with a lion carved in relief.

Figure 16: Window E8 Reconstructed.

The carved lintel, considering its ill-treatment in the mid-20th century, survived in remarkably good condition; the jambs on which it was re-set do not appear original;

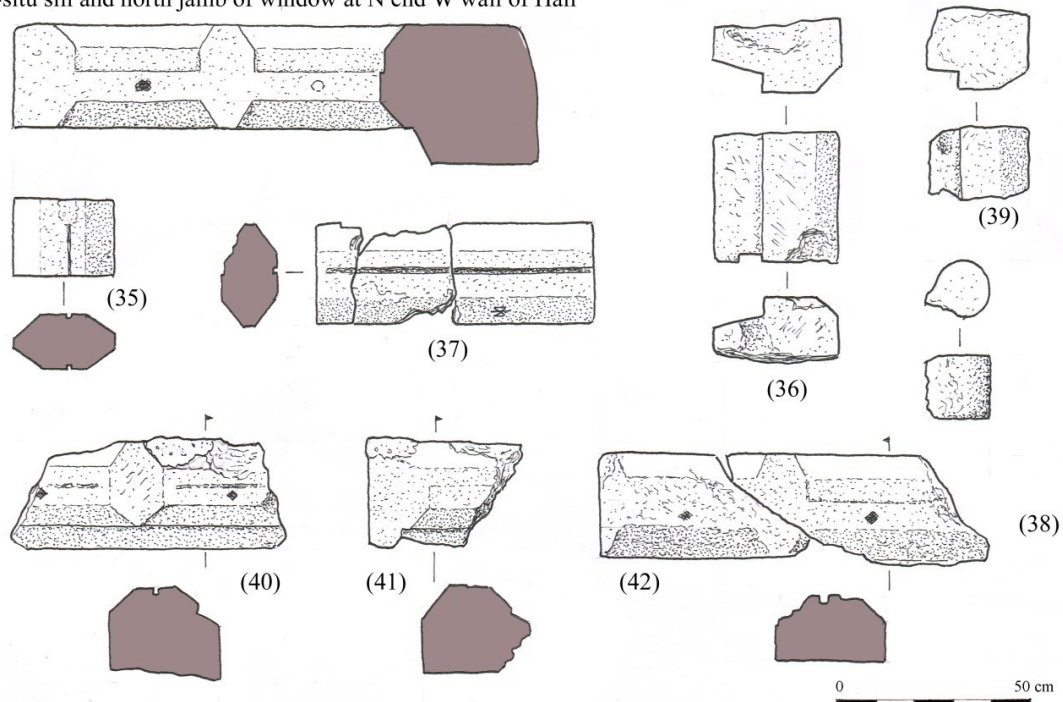
Figure 22: Stonework from Crake Trees.

In-situ sill and north jamb of window at N end W wall of Hall

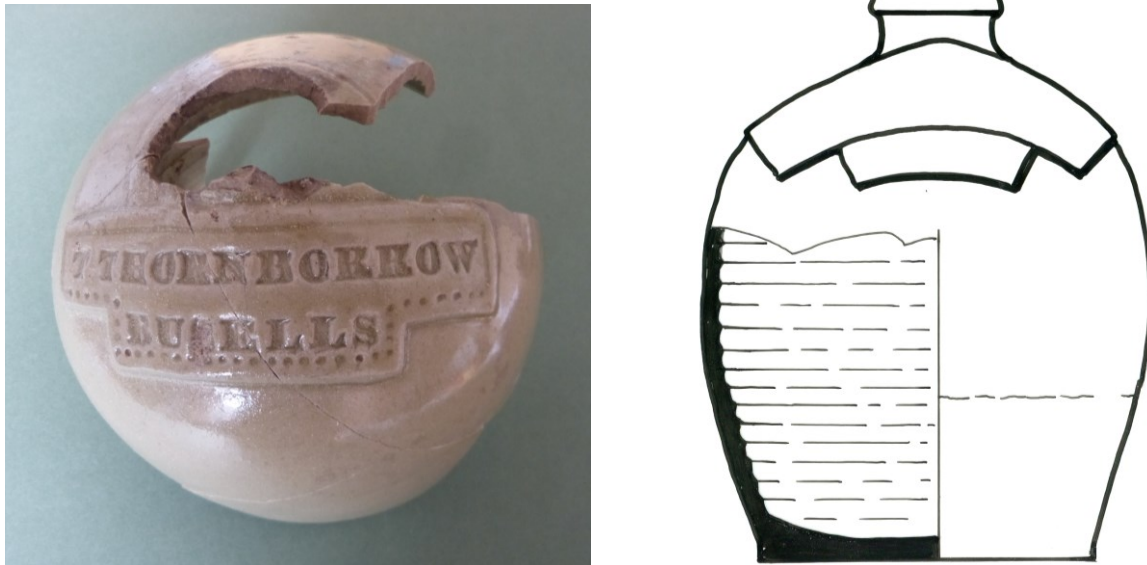
Pottery was recovered from excavated deposits of topsoil and rubble, both internal and external. This material was exclusively of 20th century and some possibly mid to late 19th century in date and all domestic wares. Fragments of a stoneware flagon with a slab-seal with the names *T Thornborrow Busells* were recovered from the northern room (plate 13). This may date to as early as the mid C19.

Plate 13: *Remains of stoneware flagon with slab seal stamped T Thornborrow Busells
Probable full profile to right is 1:3 scale*

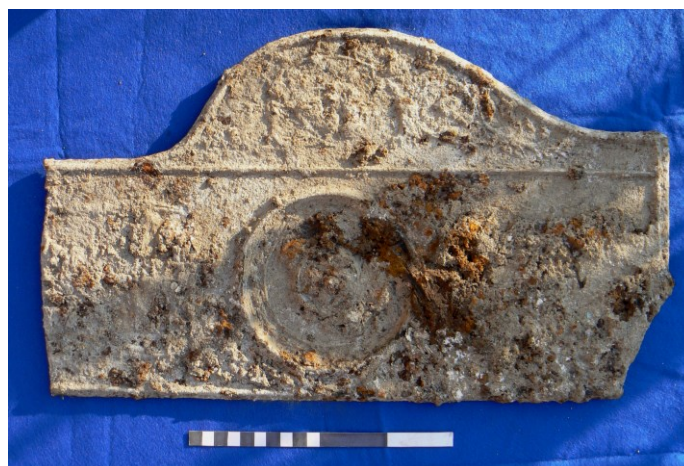
Much ironwork, dumped within the building, was recovered from topsoil and rubble deposits. All was modern. Fireplace K3 in the north wall of the north room retained some C19 ironwork within the hearth along with two decorated lengths of ornamented cast-iron screen (plate 14). A key was recovered from near the east (front) door.

Plate 14: *Cast-iron screen from fireplace K3 (scale 20cms long).*

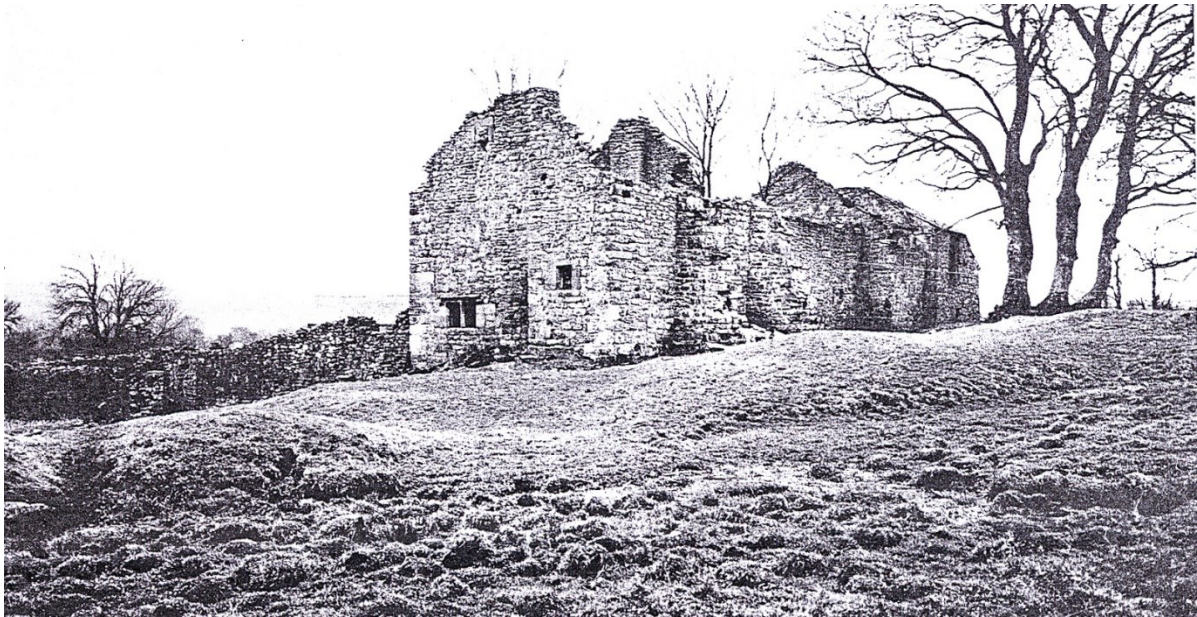
*Plate 15: Looking south-east at the north end of Crake trees RCHME photograph
(National Monuments Record)*

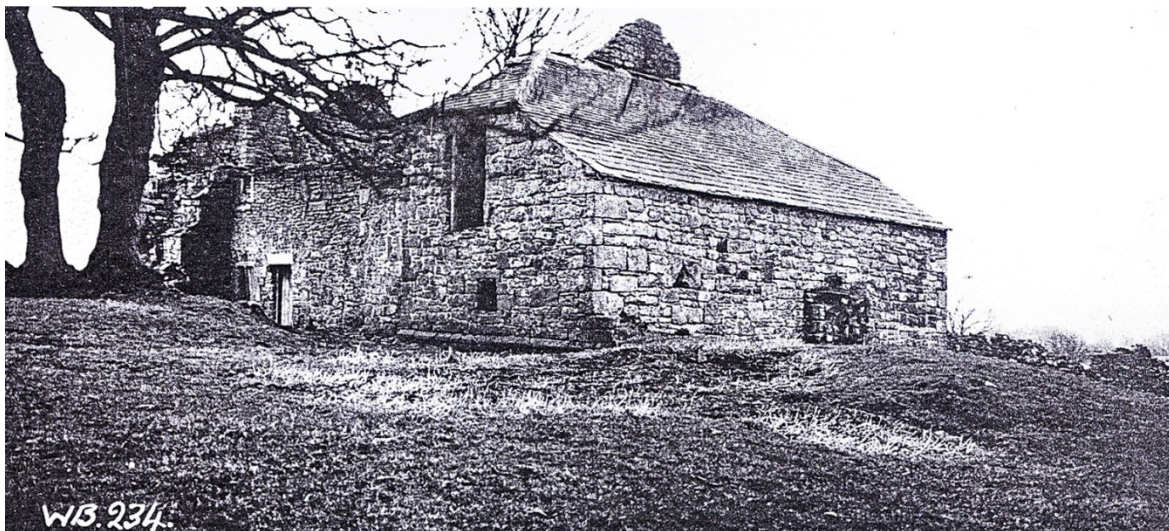
*Plate 16: Looking north-east at the south end of Crake Trees RCHME photograph
(National Monuments Record)*

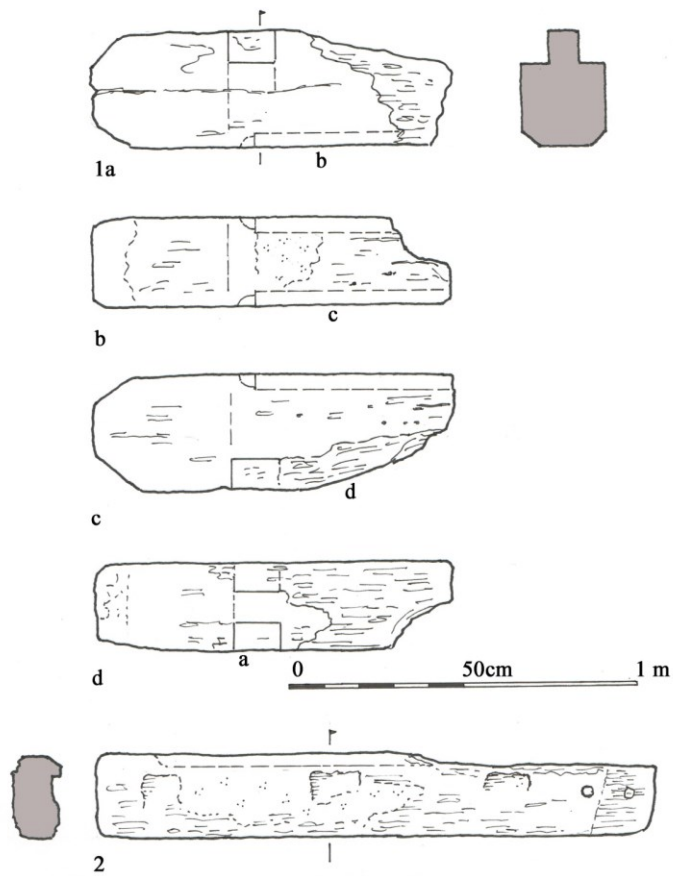
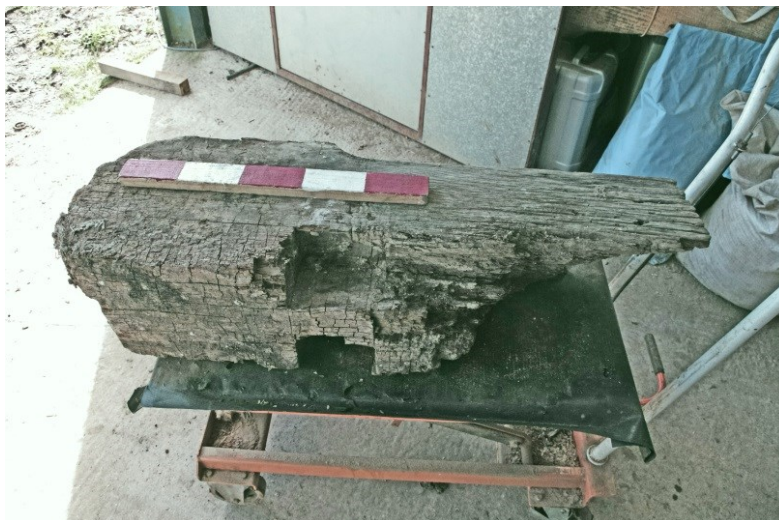
- (1) The end of a substantial first-floor beam from the Parlour; it would seem high likely that this is original to this part of the building. 330 by 20 mm in section, and surviving to a length of 1030 mm, the beam had chamfers 45mm wide on its lower angles with neat stops of a common late medieval/post-medieval form consisting of a concave triangle and a straight step (close to the form often termed a 'lambs' tongue' stop). Into its upper angles were cut housings for a pair of ceiling joists 130 by 90mm – decay meant that only one pair remained, so there was no insufficient evidence to determine joist spacing. One patch of white pigment remained on the soffit of the beam.

Plate 17: Timber 1 (from first-floor frame in Parlour block)
Scale is 0.5m long.

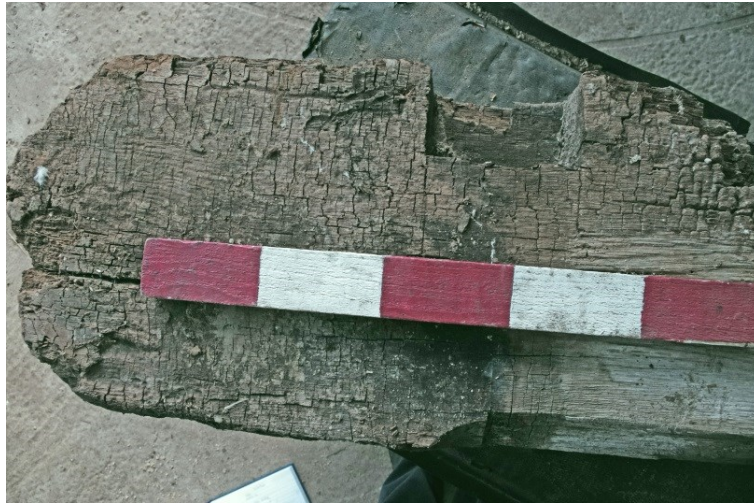
Plate 18: *Timber 1 (from first-floor frame in Parlour block)*

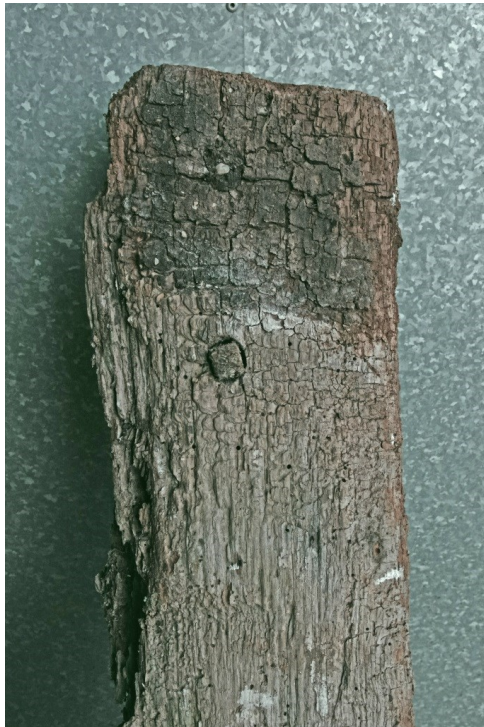
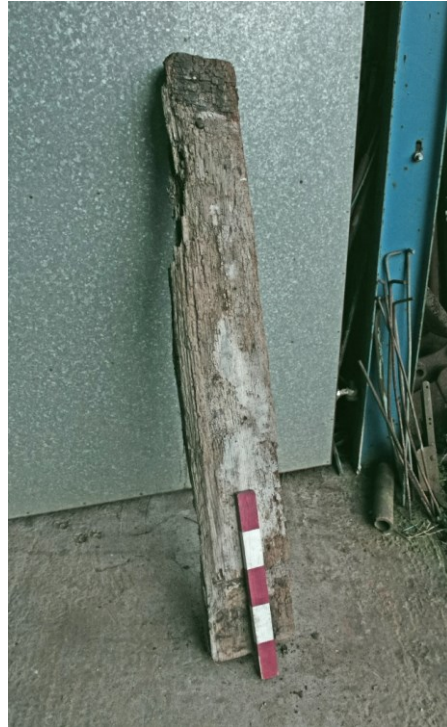
- (2) A timber 240 by 135 mm and 1600 mm long, found lying on the site of the hall in the main block of the house. One angle preserved a chamfer 35mm wide, stopped just short of one end; in the broad face adjacent to the chamfer were eroded remains of three sloping housings, such as one might find where rafters rested on a wall plate – which might suggest re-use, as one would not expect to find the external upper angle of a wall-plate with a chamfer. The same face had traces of white coloration around the 'rafter settings' and a clearly demarcated darkened area towards one end, the edge of it falling between a pair of pegholes which did not seem to relate to any mortice. The other face and three other angles of the timber were all badly decayed, so much so that it was impossible to say whether there had been any further chamfers or other structural features. Whilst the timber is probably of late medieval or early post-medieval date, its condition precludes any clear identification of its function.

Plate 19: *Timber 2 (from hall) with detail of darker end section, with pegholes.*
