**Archaeological
Building Survey:**

Woods Mill, The
Narrow Spinning
Mill, Glossop

Report No:
2015/25

Document Type: Archaeological Building Survey

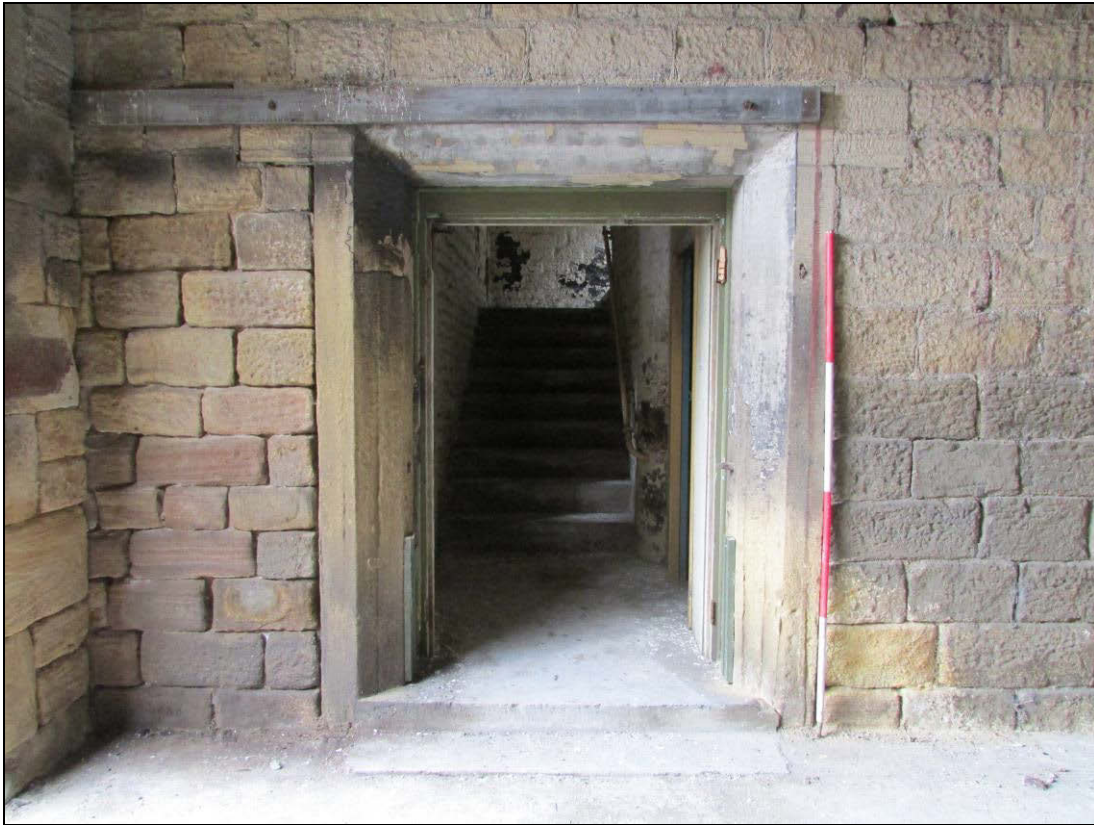
Plate 4 Original entrance into the mill, via the stair tower

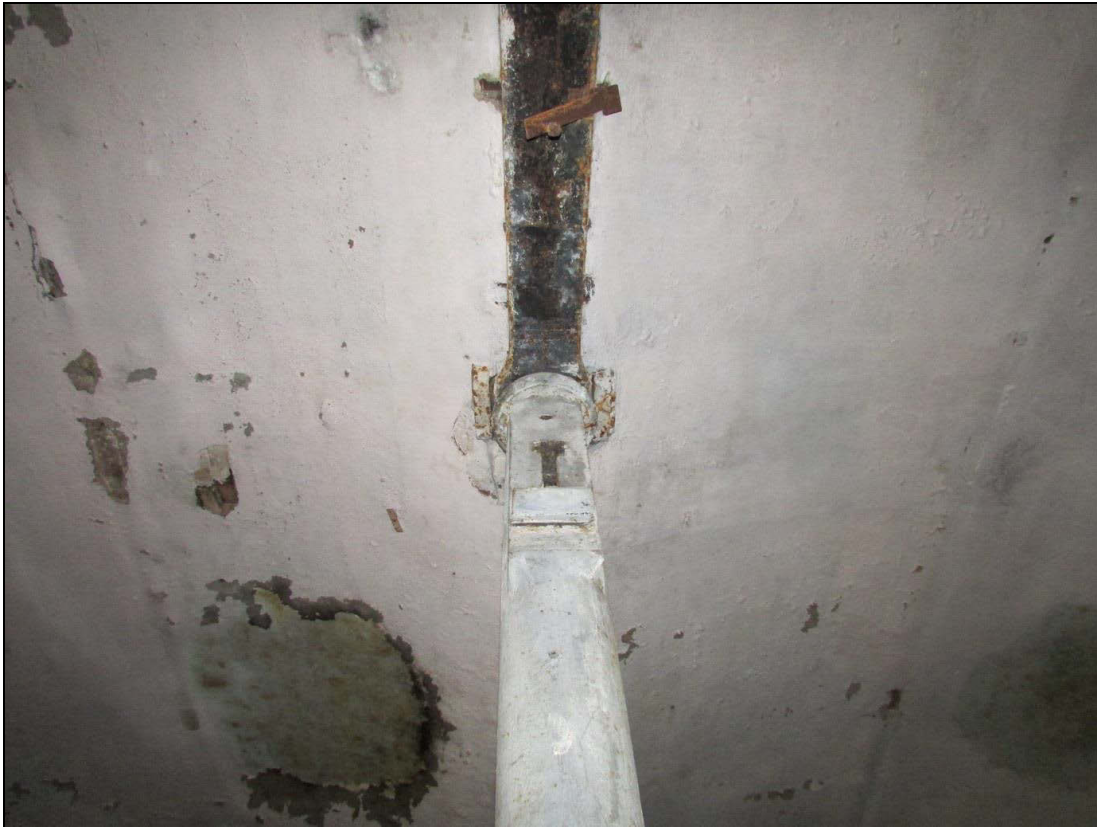
Internally, two east/west axial runs of iron columns supported single-span iron beams running north/south. This supported a fireproof ceiling, with shallow hand-made brick arches, constructed in stretcher bond, supported by what appeared to be inverted I-section iron beams. Each bay of the mill had one brick arch and the columns were located 2.75m from each other east/west and 7.65m north/south. Originally, there would have been fifteen pairs of columns with intervening beams, however on the western side, the columns have either been replaced or encased in concrete (Plate 7). The same applies to the beams, with three additional concrete beams running east/west along the western side. The ceiling has also been completely removed from this area. The surviving northern run of columns had bolting faces within them (Plate 8), probably to support the line shaft.

Plate 8 Close up of a column with a bolting face, supporting the line shaft

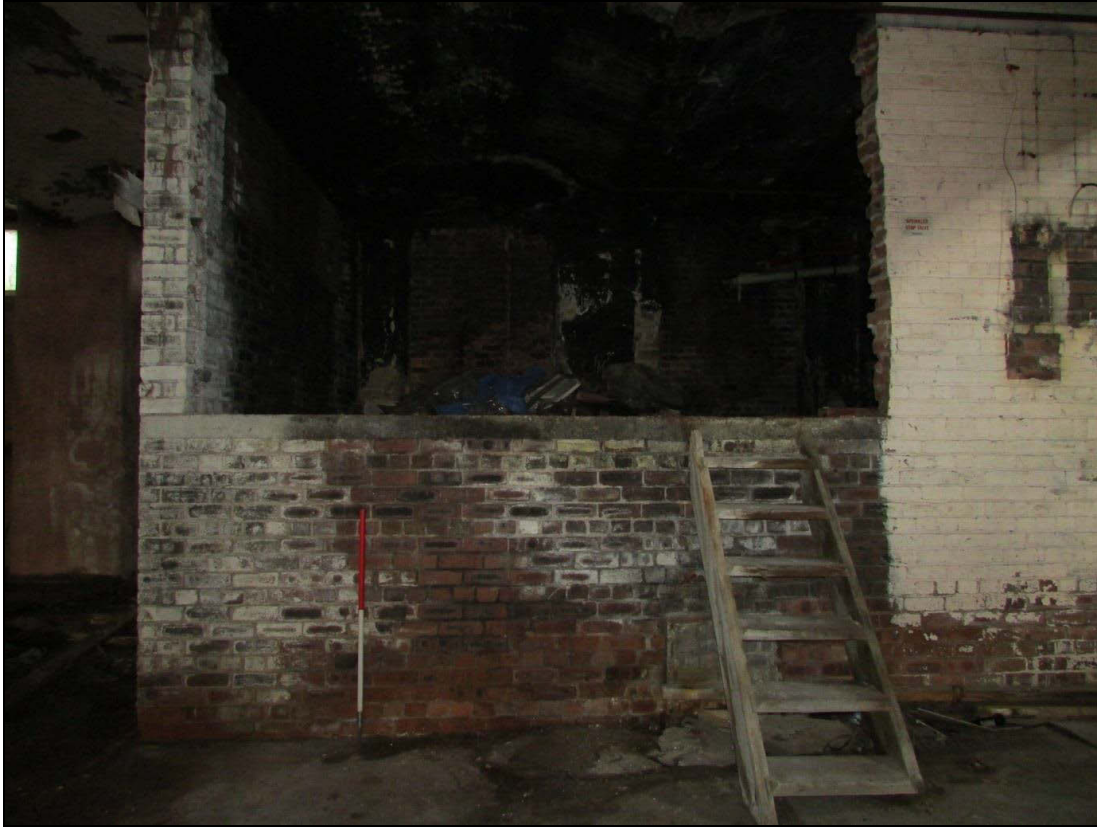
At the eastern end of the ground-floor, there are a series of sub-divisions including a possible storage area, accessed by a small wooden ladder and constructed from machine-made brick (Plate 9). Immediately east of this was a toilet block, where the window was also blocked with cinder blocks and was also constructed from machine-made bricks. To the south of the toilet block, the ceiling had also been removed from the eastern end of the ground-floor. The modified entrance in the eastern elevation was separated off using wooden partitions. A ramp leading into the building slopes down to a pair of rubber swing doors which open out onto the ground-floor. The part of this entrance which was blocked with stone on the exterior was blocked with machine-made brick on the interior. There was also a raised level with access via two wooden steps. This appears to have been partitioned at the time of the architects' survey in 2006 but was not present during the current fieldwork.

Plate 9 Later machine made brick sub-divisions in the north-east corner of the mill included this storage area and a toilet block to the east

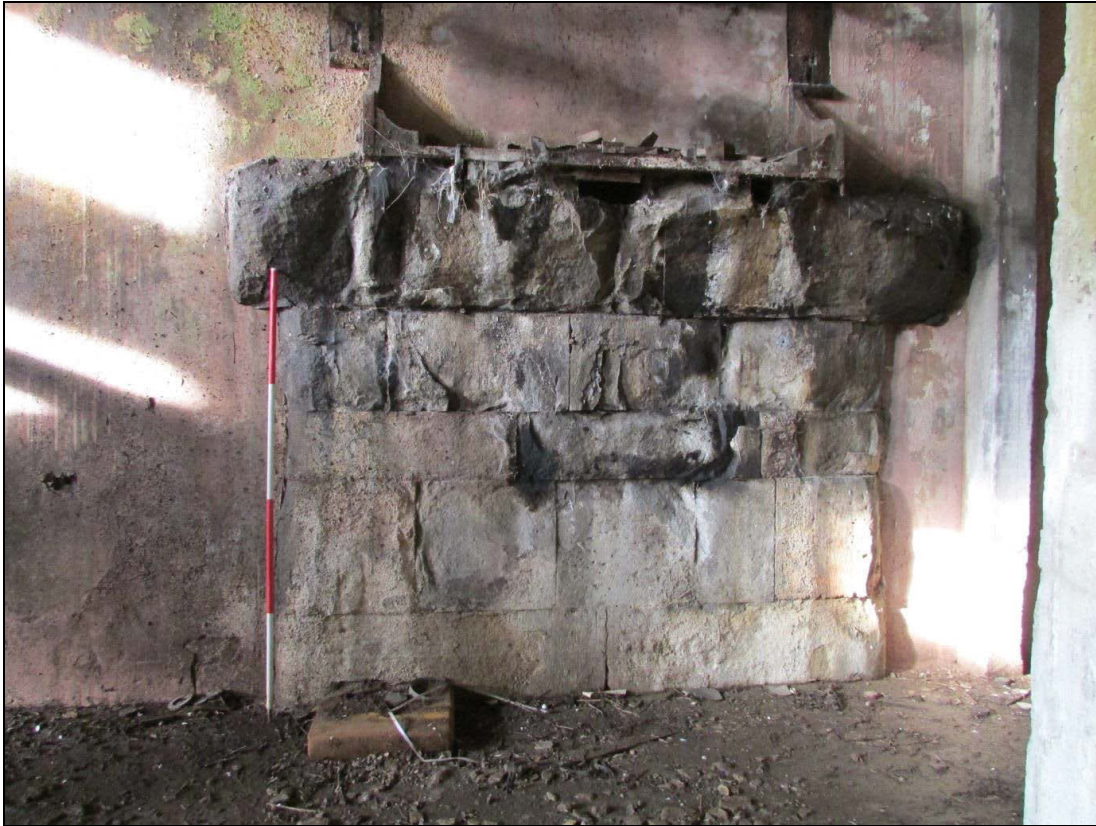
The western wall, which divided the main spinning mill from the engine house, acted as a gearing wall. It contained a number of features including a projecting pier of large rough and coursed ashlar blocks standing four courses high and supporting a large stone lintel (Plate 11). Overall this measured 2.00 x 2.50m and provided support for a footstep bearing (Plate 12). Some of the metal fittings associated with this were still visible, built into the wall although partly obscured by a later concrete beam. This beam marked where the ceiling would have been originally and ran

Plate 11 Projecting stone pier supporting footstep bearing for driveshaft

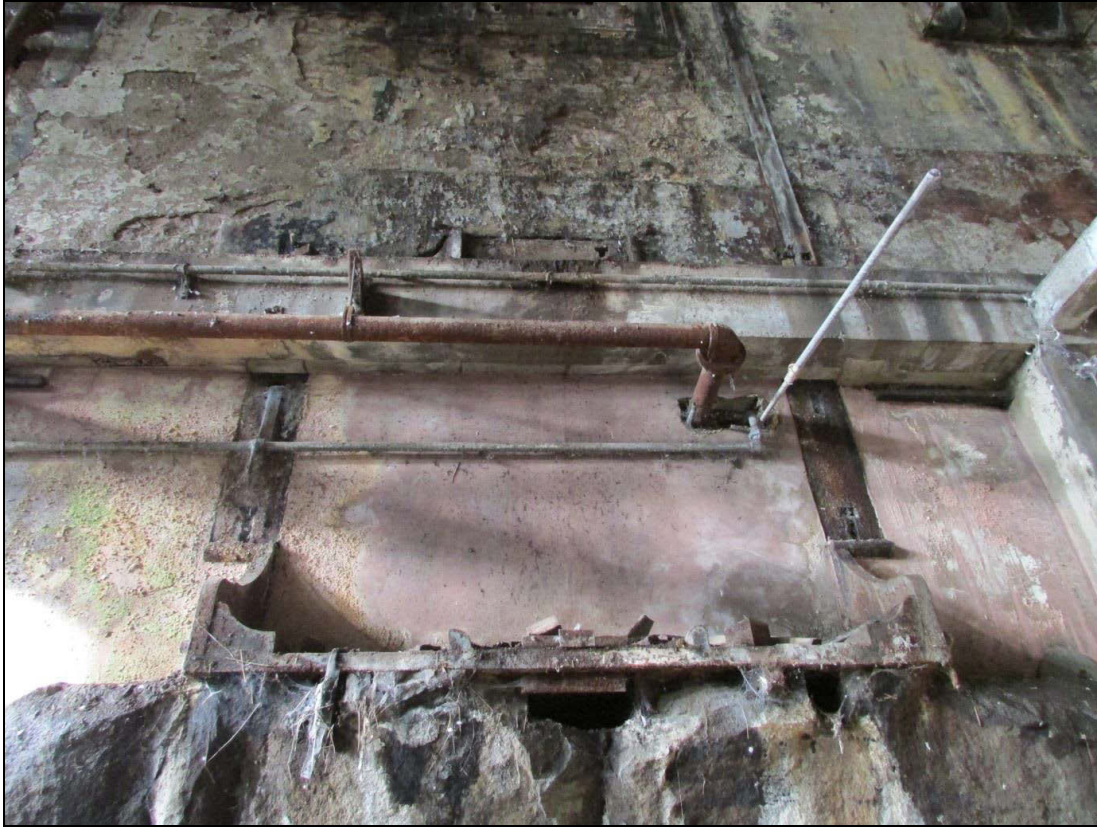
Plate 12 Close-up of the footstep bearing for the driveshaft

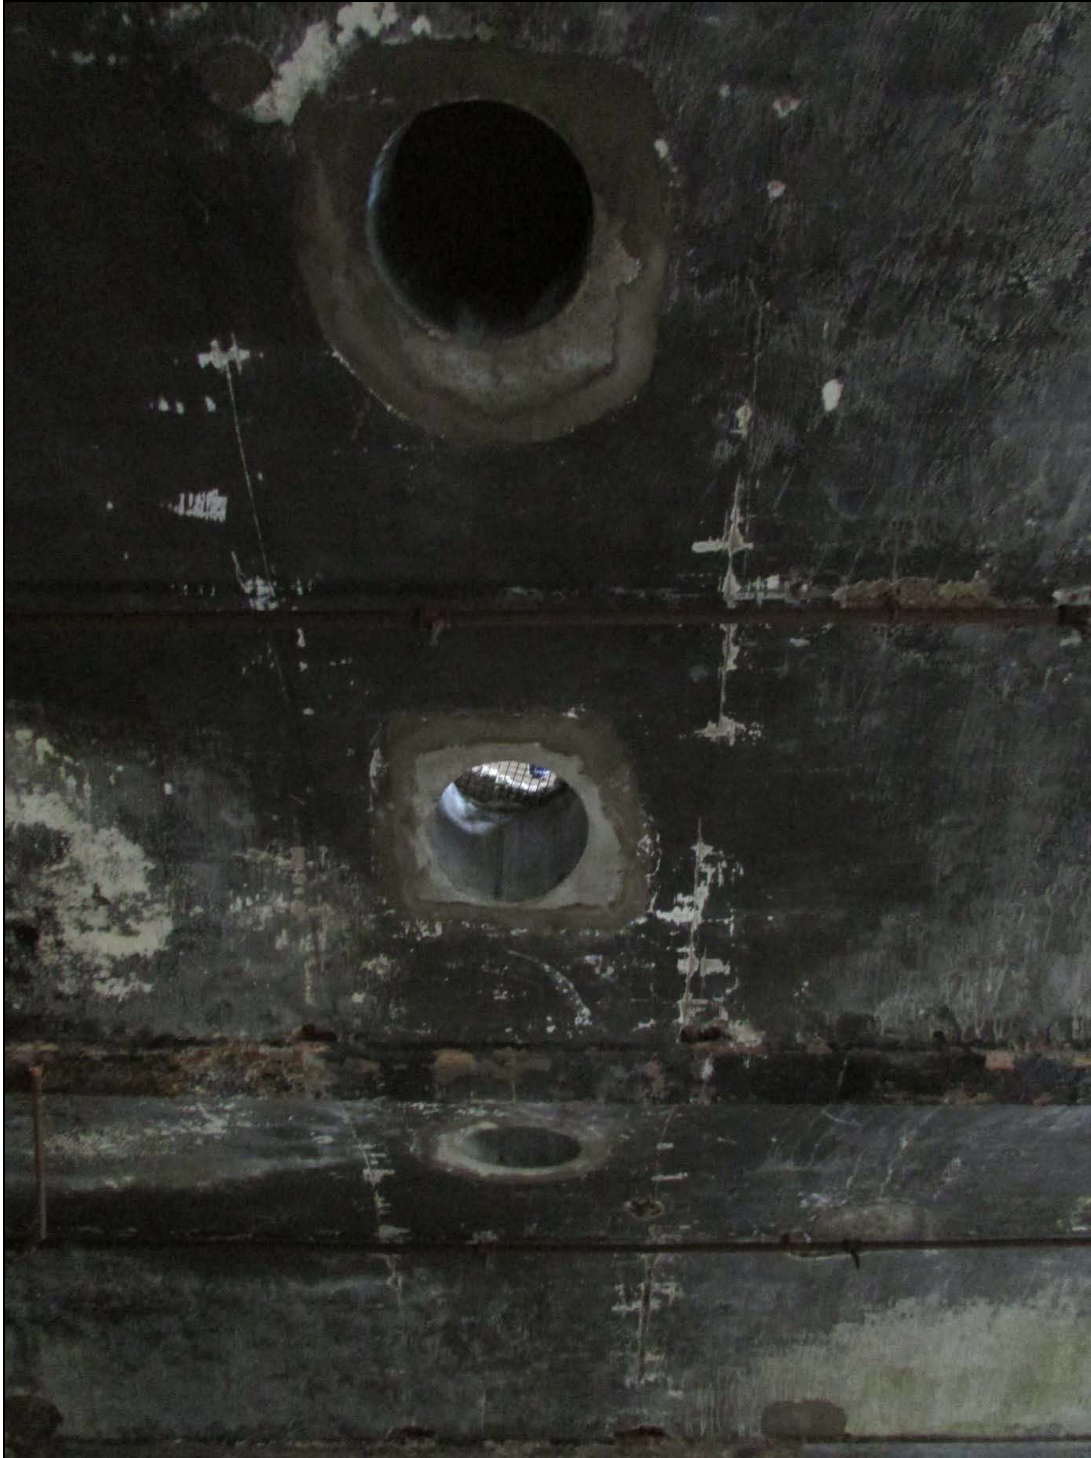
Plate 15 Small circular apertures inserted at a later date into the first-floor ceiling

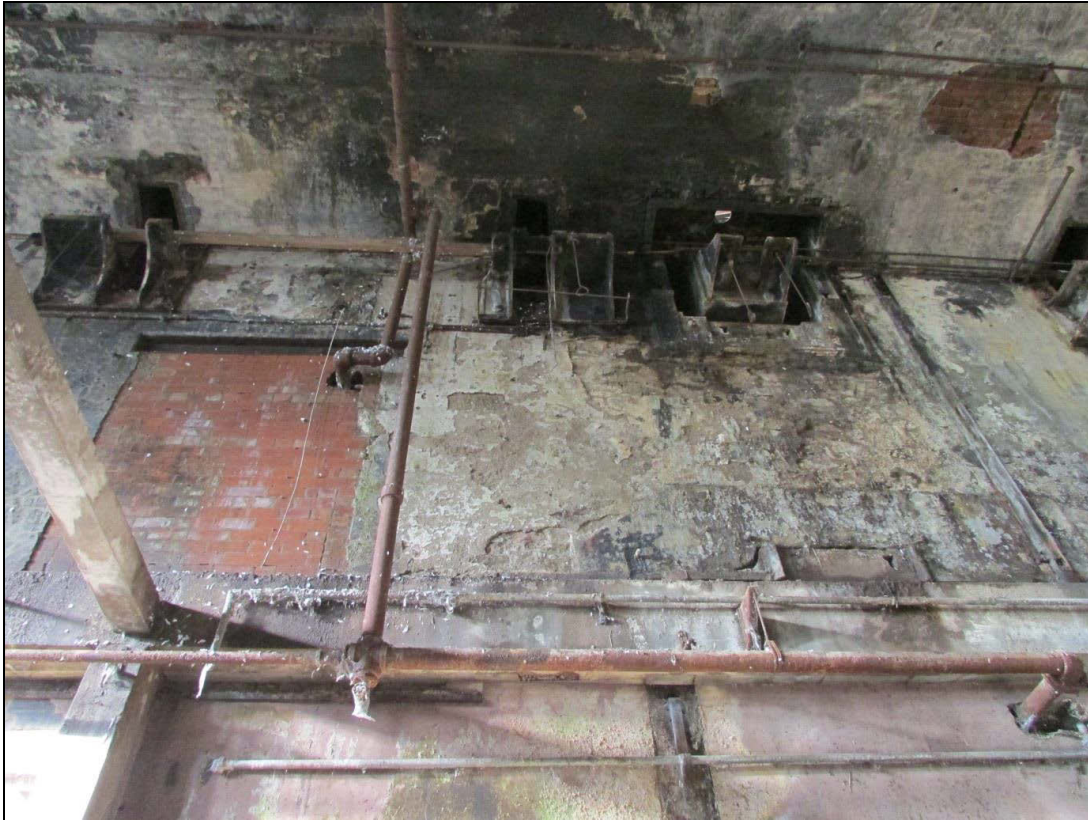
Due the removal of the floor from the western part of the mill, observations could only be made from the ground-floor. The blocked entrances are described in detail within the engine house description below. Above the footstep bearing is a supporting bracket and a small circular aperture for the driveshaft. There are another two supporting brackets for bevel gears and further shafts to the north of this and three more are located to the south (Plate 16).

Plate 16 The bracket and aperture for the driveshaft is located to the right; a blocked entrance and two more brackets are shown to the left

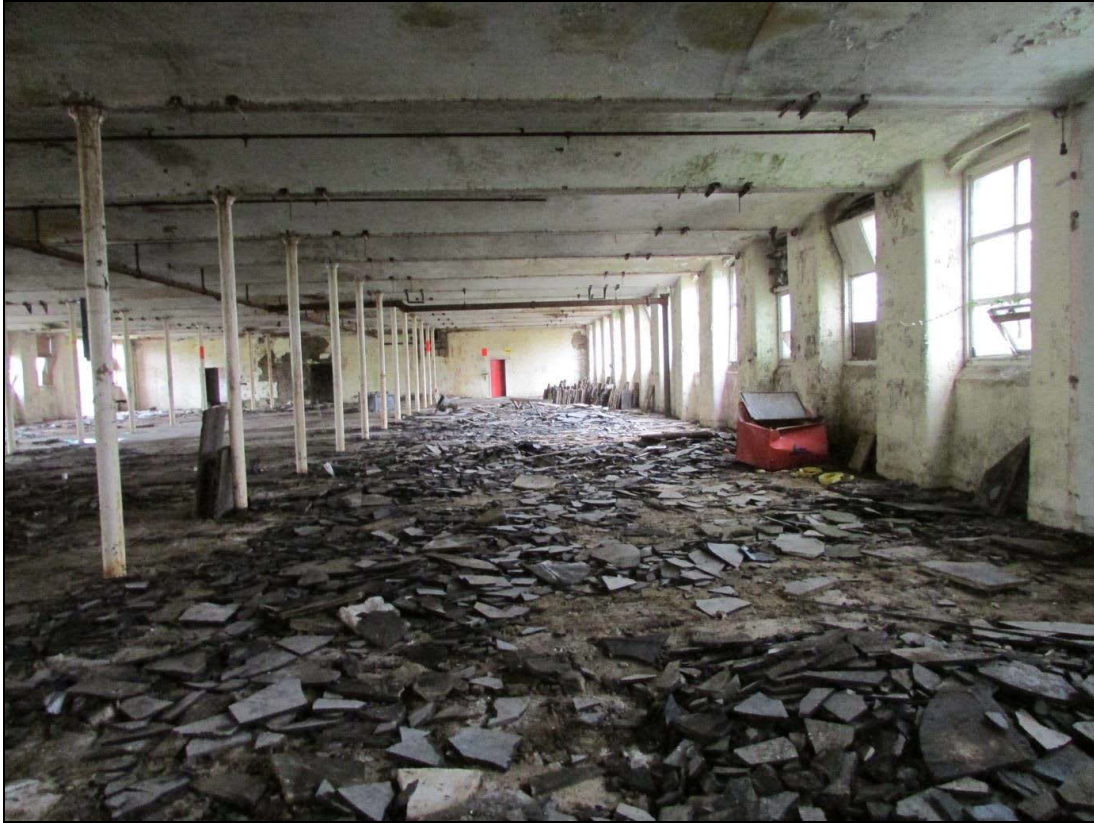
Plate 18 Visible on the beams within the ceiling are two lines of lineshaft hangers, which helped power the machinery

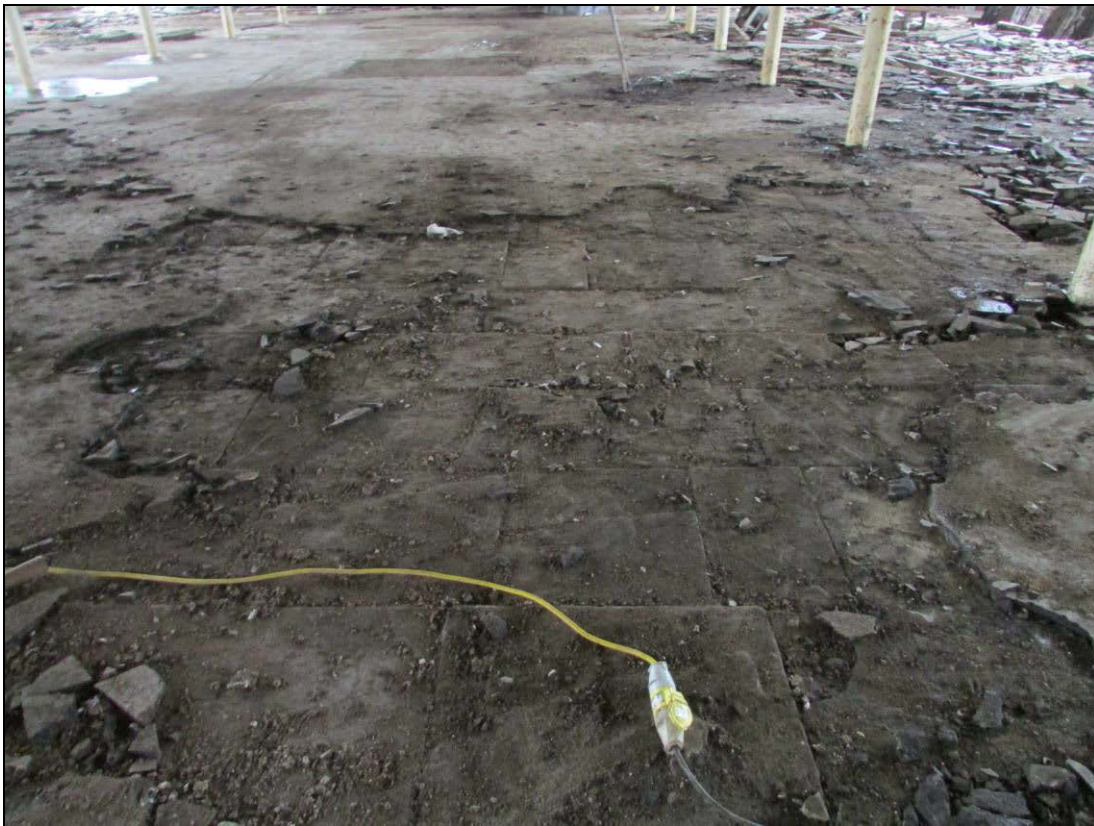
Plate 19 Original stone flagged floor sealed below concrete skim

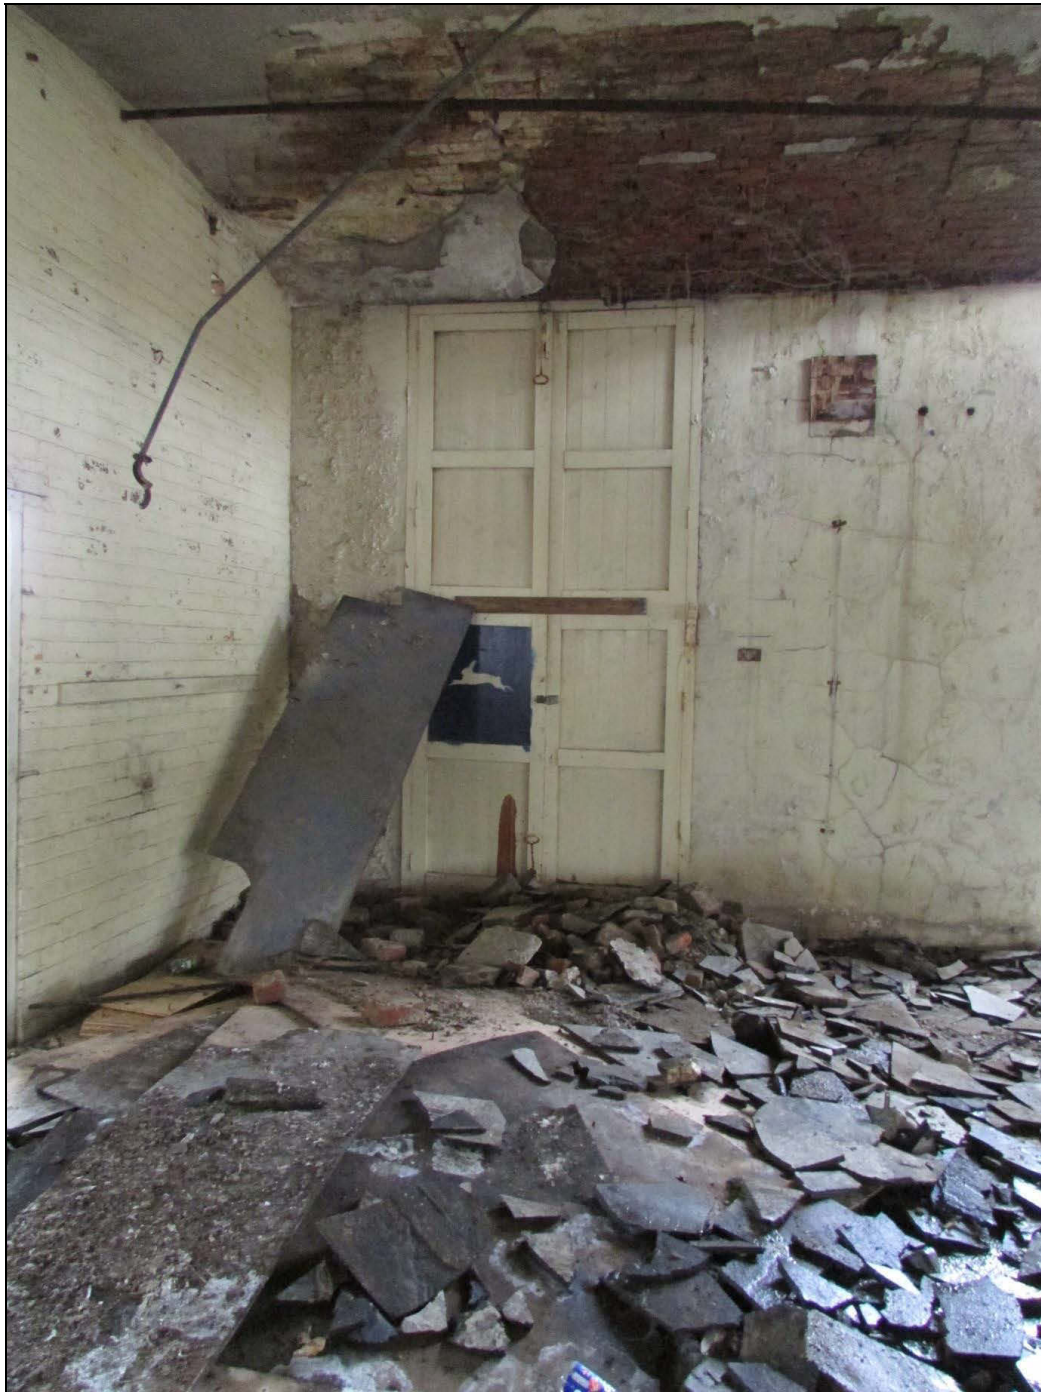
The later toilet block, as seen on other floors, was also located on this floor. A series of wooden partitions depicted on the architectural plans were not visible during the time of the survey. A wooden taking-in door was visible immediately south of the toilet block also (Plate 20). An entrance into a later extension to the privy tower led into a small room. Its function was unclear, however there was a window in the northern elevation and a recess in the southern wall with a pipe inserted near the top. Immediately south was an entrance with a dressed stone surround and led into the original privy tower, which would only have been 0.60m wide and was blocked subsequently with regularly coursed undressed stone (Plate 21).

Plate 20 Wooden taking-in door visible immediately to the south of the later toilet block

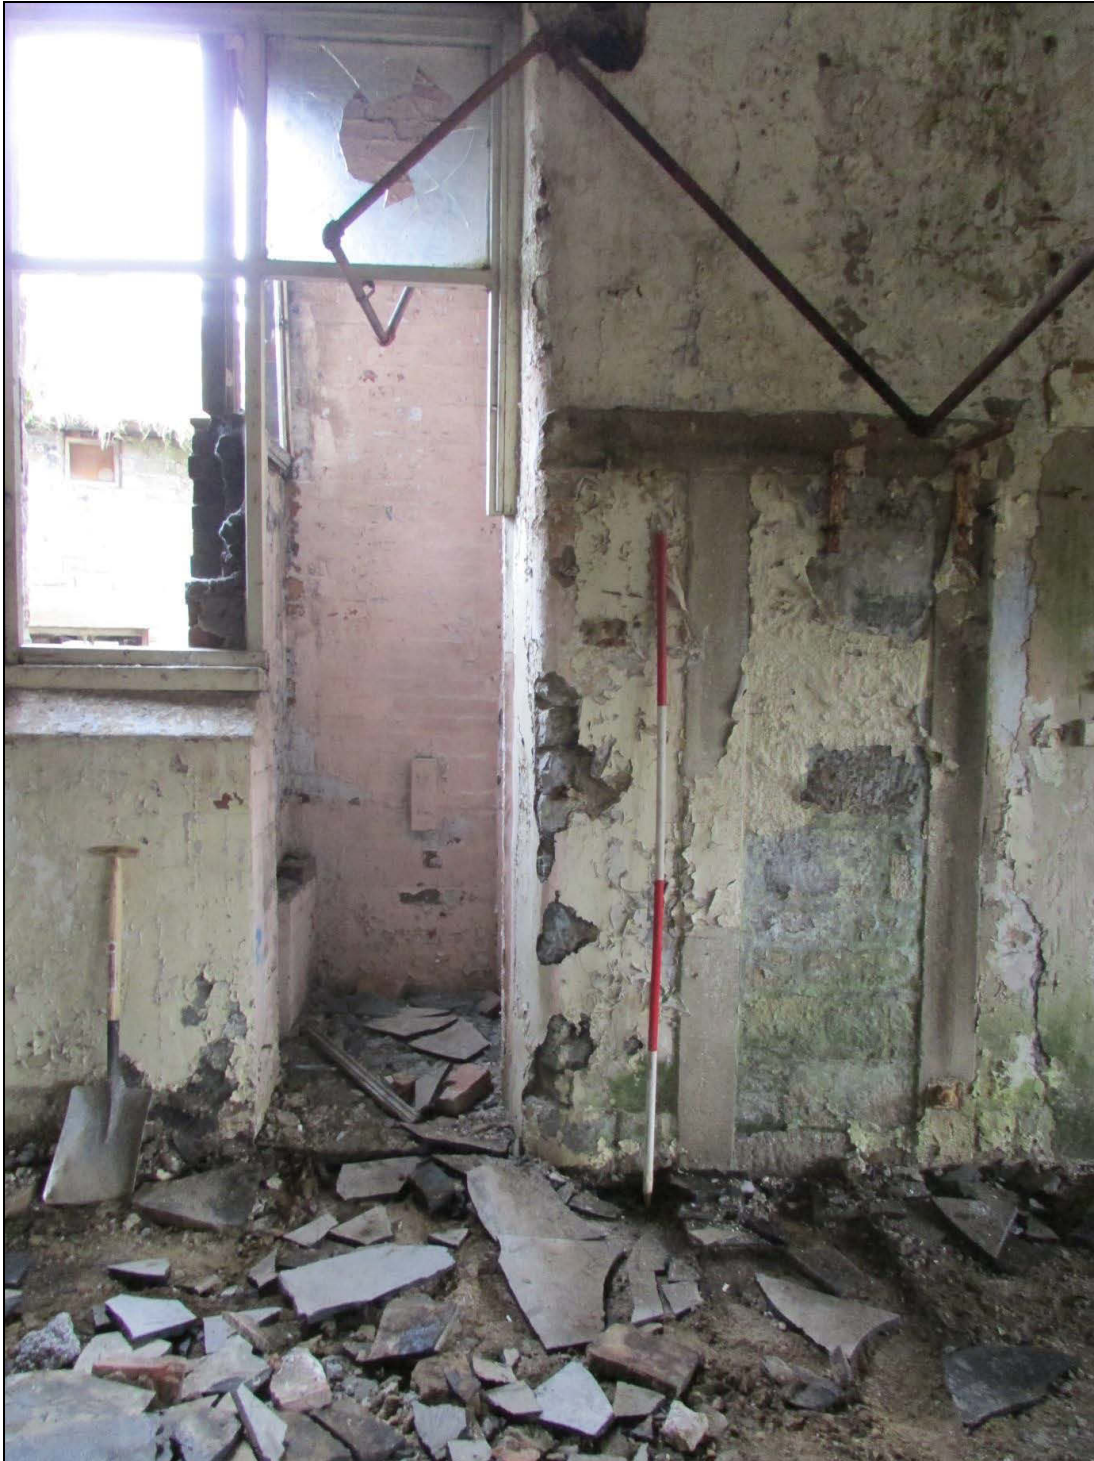
Plate 21 The entrance on the left leads into the privy tower extension and the blocked entrance led originally into the privy tower

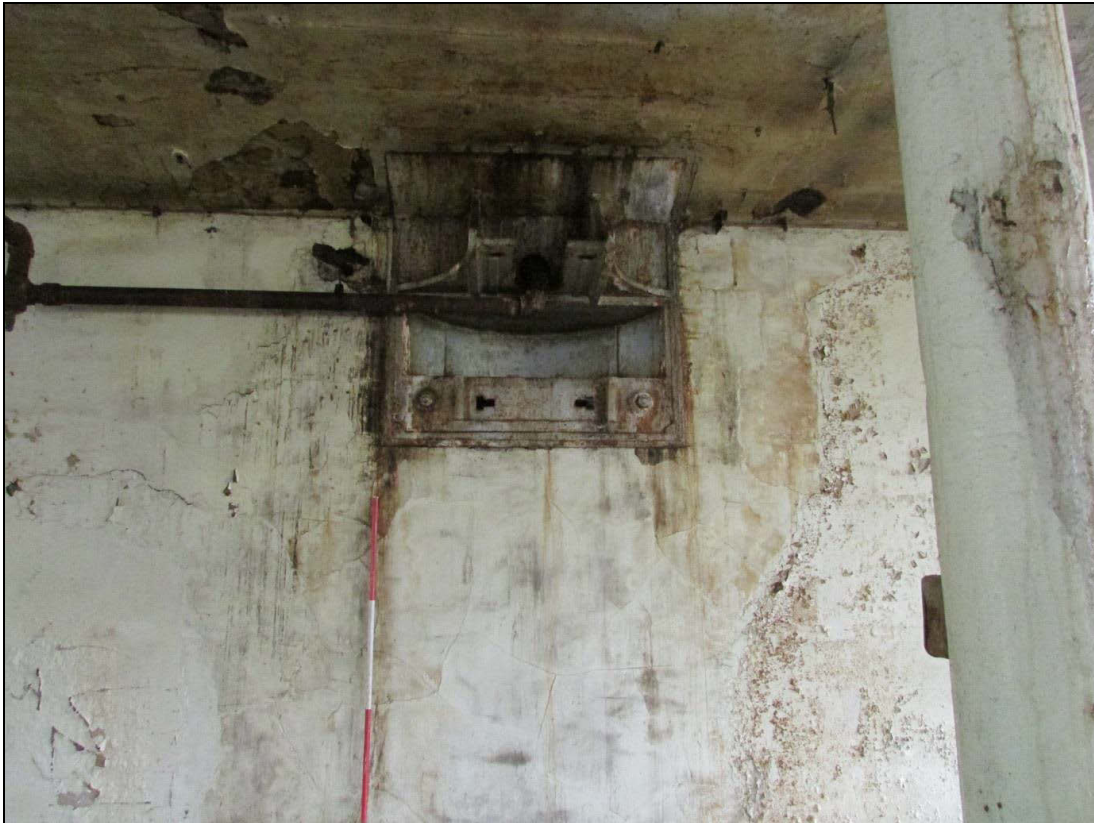
A number of features were noted within the gearing wall, including another large metal bracket which supported the upright shaft (Plate 22). A small aperture is visible in the floor below this fixture, where the upright shaft would have been located. At the southern extreme of this wall is an entrance with a dressed stone surround, blocked with machine-made brick and painted over. To the north of this was a wider entrance which appears to have been inserted at a later stage and

Plate 22 Metal bracket on the second-floor gearing wall to support the upright shaft

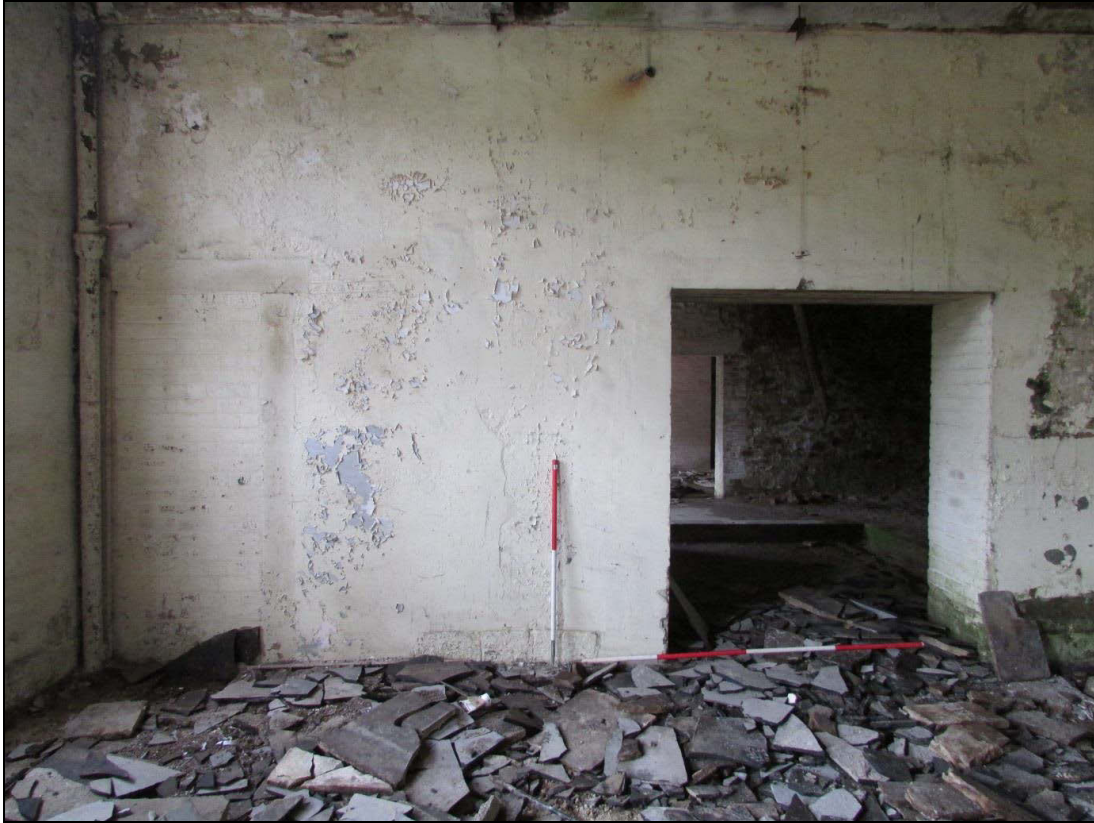
although painted over, the detail of machine-made brick lining the entrance is evident (Plate 23). This entrance appears to be solely for the lift shaft in the engine house as another entrance lies 3.75m to the north of this one. This is also a later addition although it has a stone lintel with machine-made brick squaring the entrance off. There is a third, likely inserted entrance also within this elevation leading to the northern part of the engine house (Plate 24). Although the details have been obscured by later painting, coursed brick outline is visible around the frame of this door, which is wooden and bears a close resemblance to the later, modified entrances from the stair tower.

Plate 23 On the second-floor, the entrance on the right has been inserted at a later date, whilst the entrance to the left has been blocked

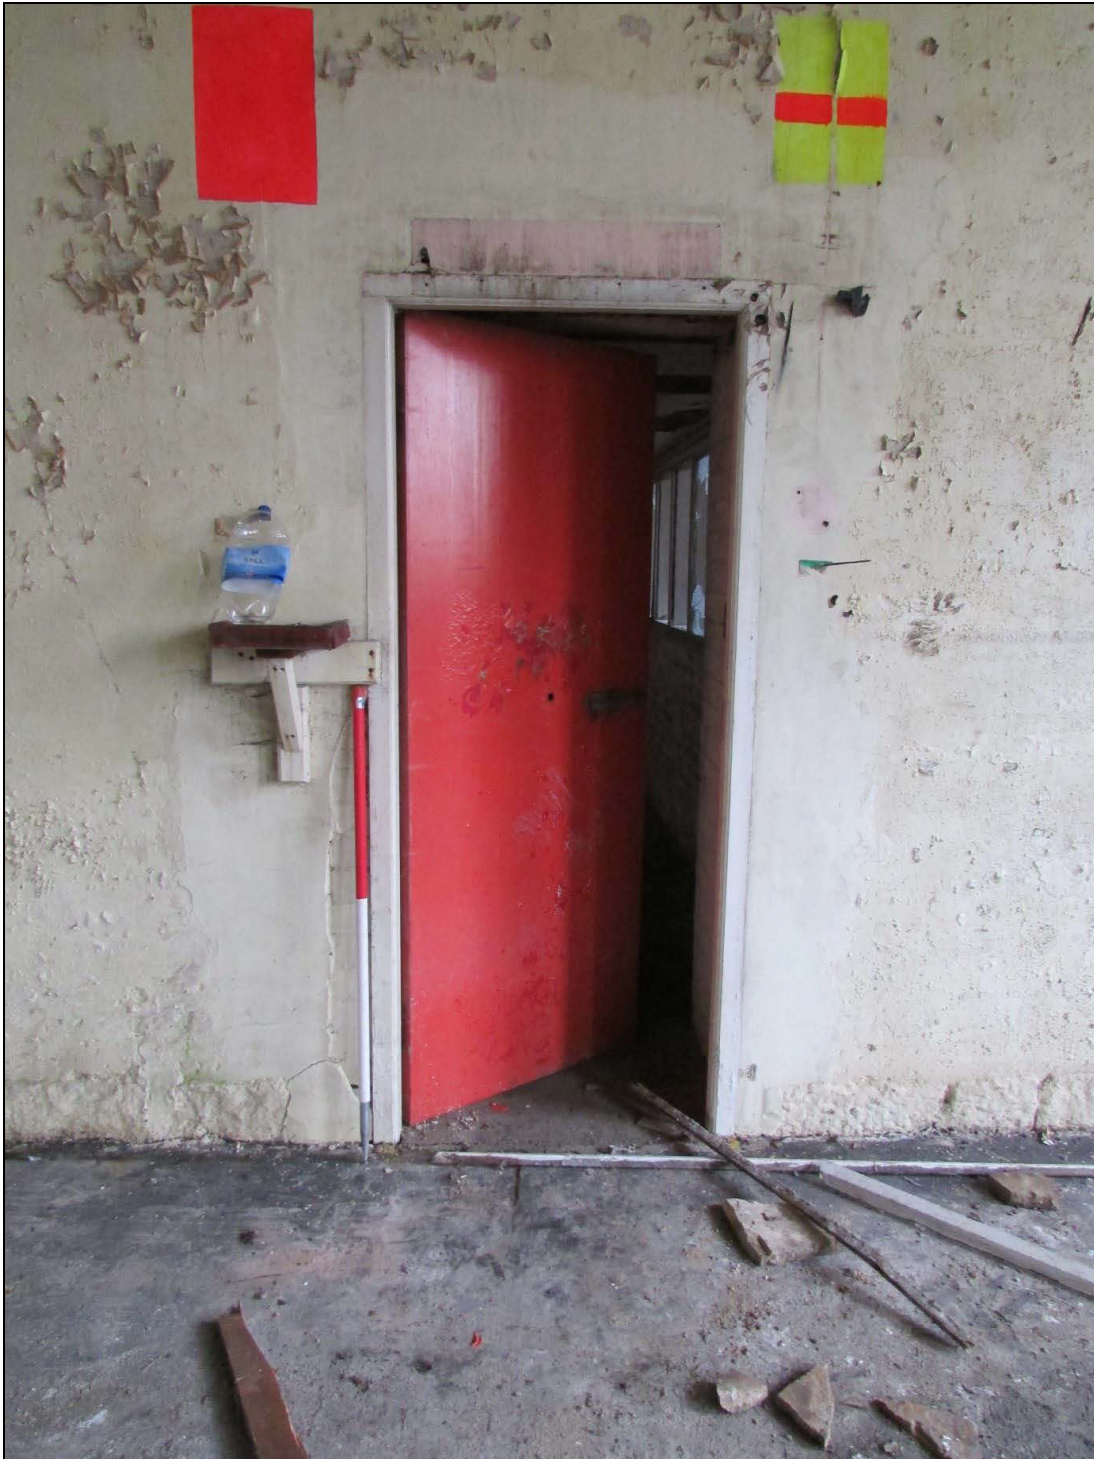
Plate 24 Later inserted entrance into the northern part of the engine house on the second-floor

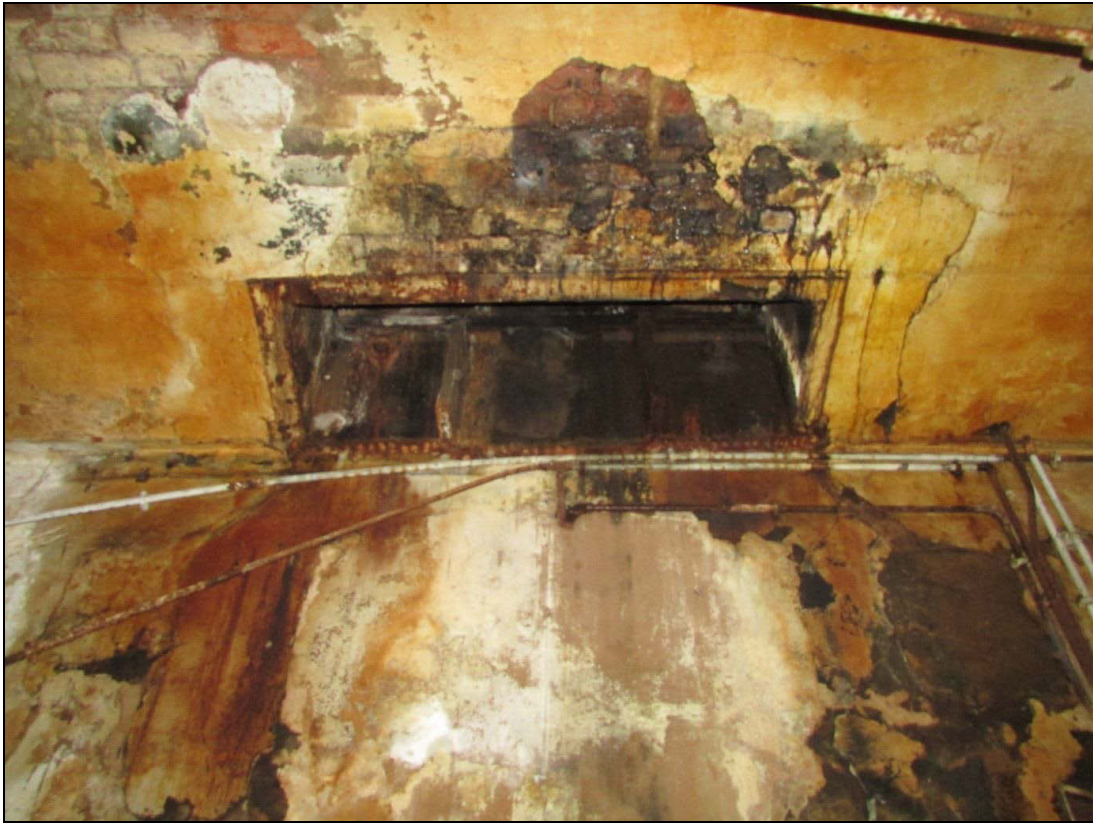
Within the western elevation, an entranceway in the south-west corner had been blocked and a vertical metal pipe runs from floor to ceiling at the southern extreme. An entrance to the engine house appears to be a later addition, with a metal lintel inserted and machine-made brick constructed to shore the created gap. Where the plaster is missing, the stone wall exposed on this elevation consists of uncoursed random rubble. Within the floor close to this entrance was an infilled aperture measuring 1.50 x 1.20m. Further north and within the ceiling was another aperture, lined with metal, possibly for the power transmission system (Plate 26), measuring 1.00 x 0.30m.

Plate 26 A metal lined aperture inserted into the ceiling on the third-floor

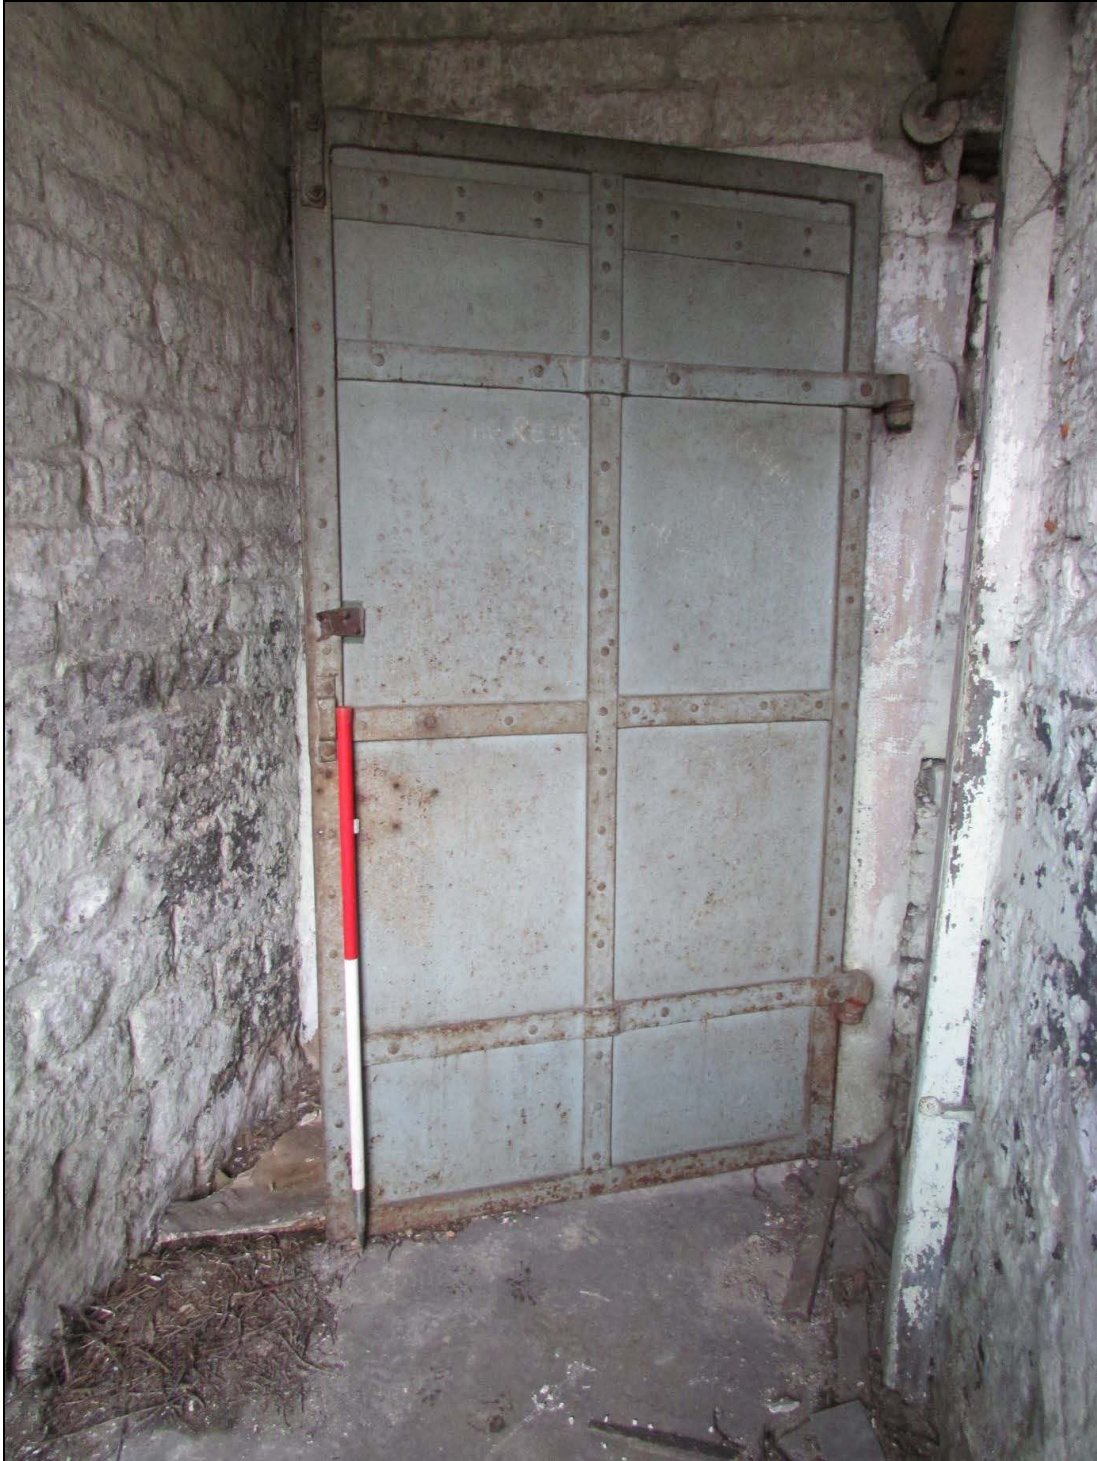
Access was as described for the floors below, except the door on this floor appears to be original with a large metal door that opened out onto the stairs (Plate 27). Many of the windows had been removed from this floor, and much of the flooring had been robbed out. The windows on this floor were smaller than the lower floors and the hand-made brick arched interior lintels were exposed throughout on this floor. As with the lower floors, two rows of 15 axial columns ran east/west supporting a timber triple pitch span roof. To support the timbers, the columns were flanged at the top to support an iron bracket housing the tie beam, which was bolted in (Plate 28). Each pitch consisted of a tie beam, supporting a king post with straight struts between the post and rafters (Plate 29). The ends of the roof trusses were supported by channel-section housings in the top of the columns.

Plate 27 Possibly the original door leading from the stair tower onto the fourth-floor

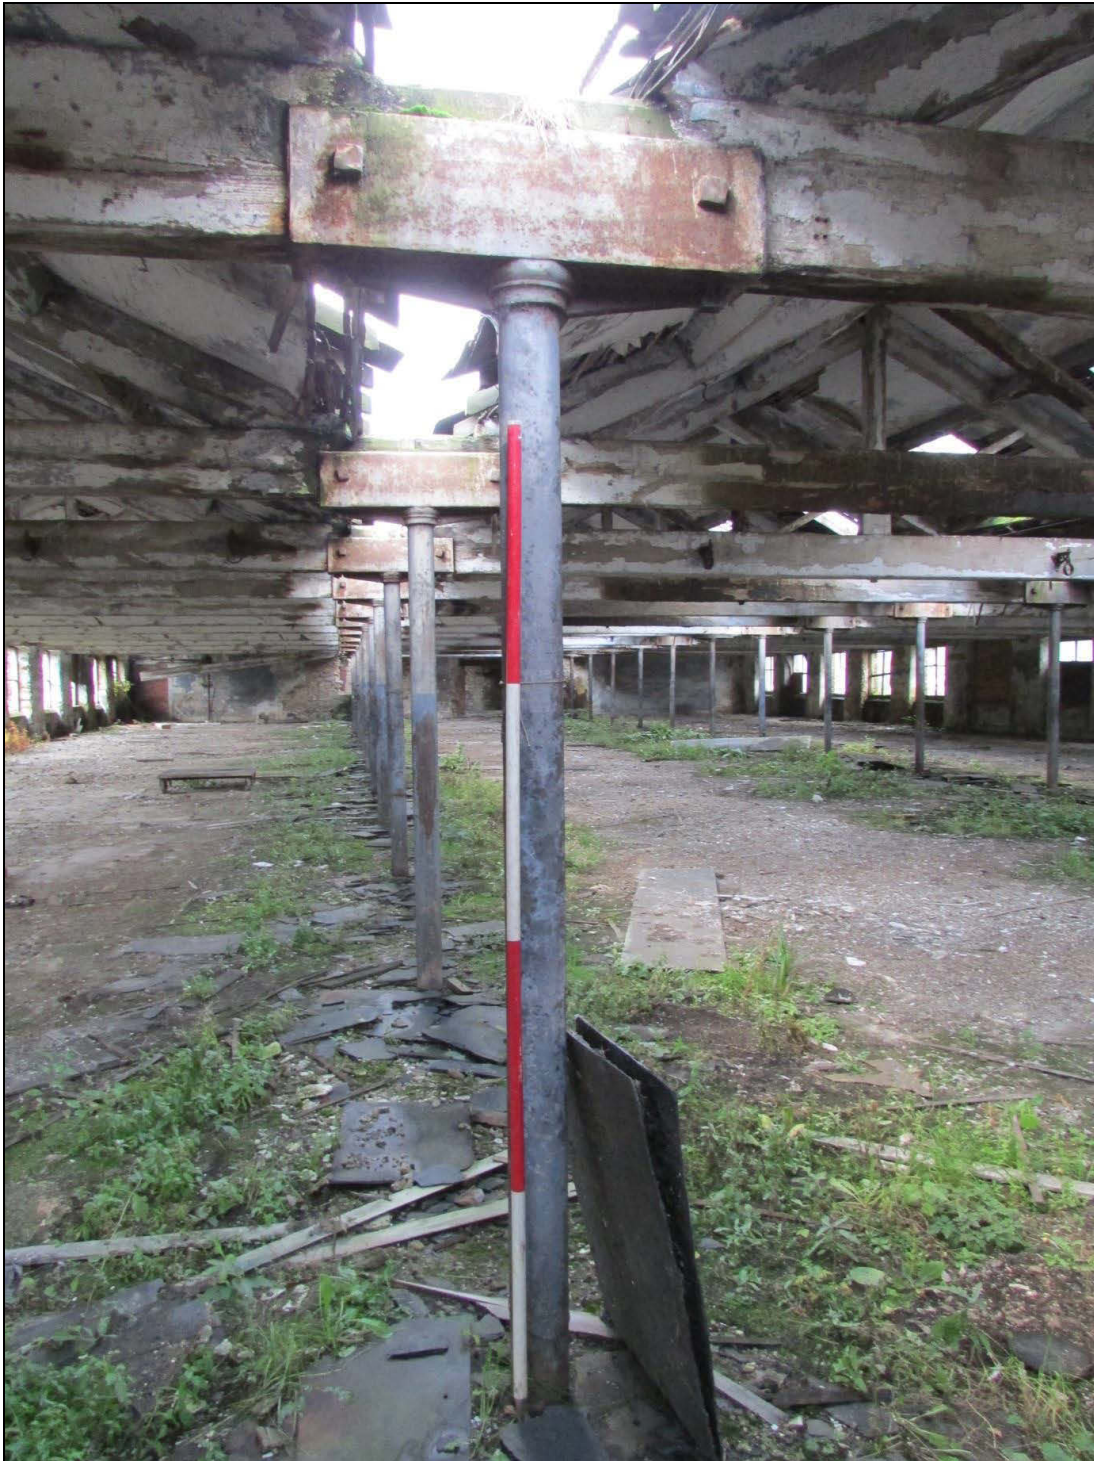
Plate 28 Detailed shot showing how the roof was supported using the cast iron columns

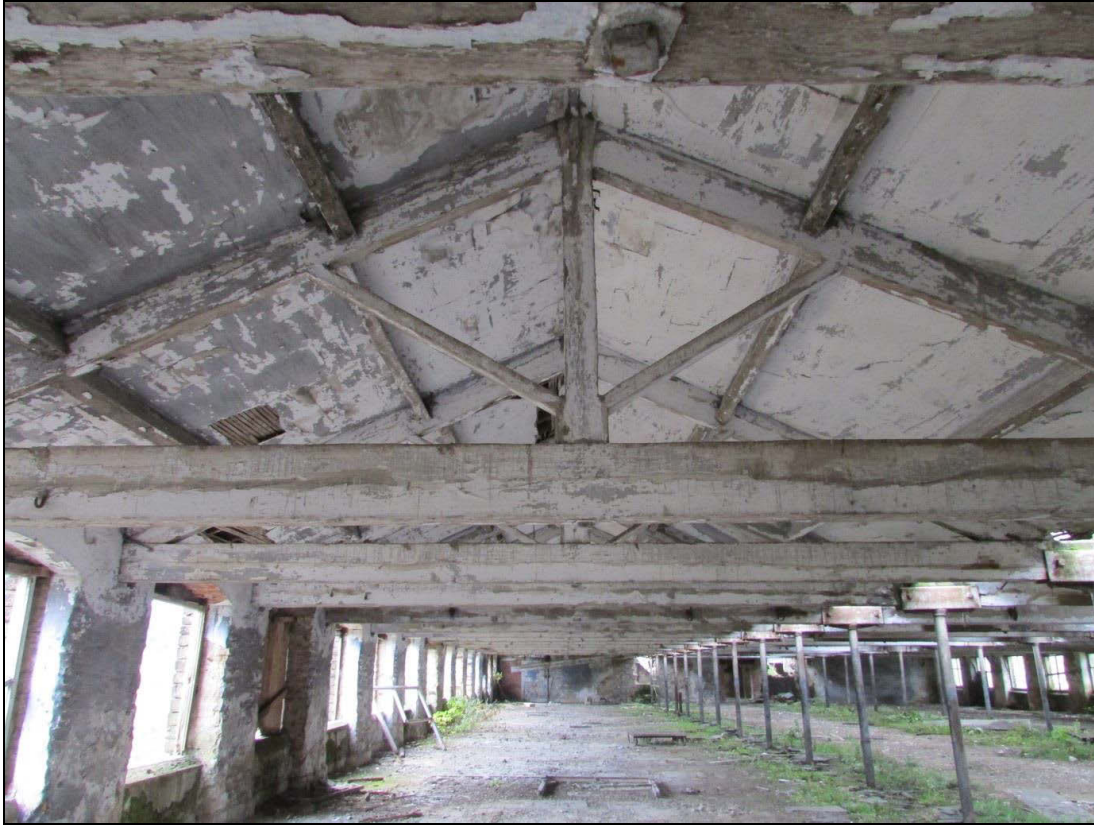
Plate 29 One of the three pitches spanning the roof showing the king post style structure
